PRELIMINARY OPERATING ASSESSMENT ADVANCED HEAT RECOVERY  
INCINERATOR SITE TWO: BASIC ENVIRONMENTAL ENGINEERING, INC.

March 1983

An Investigation Conducted by  
SANDERS & THOMAS, INC.  
Consulting Engineers  
Pottstown, Pennsylvania

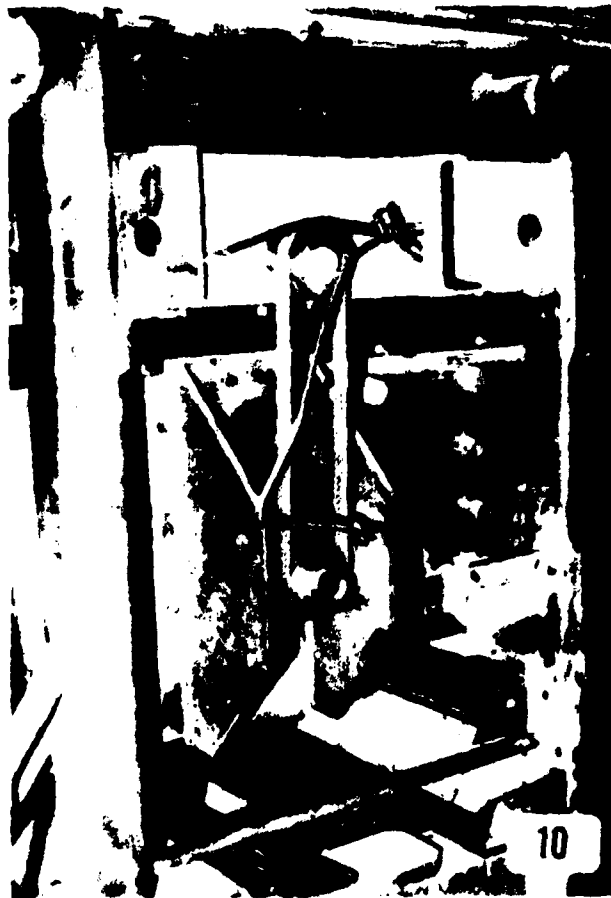
Photograph 10: Hearth cable suspension detail.

2. Eight steel rollers, two per side of each hearth, were installed during the maintenance shutdown preceding these observations to minimize lateral motion of the upper and lower hearths. A roller is visible in Photograph 10, to the right of the hearth support cable. Unequal pulsing pressure in the air bags or asymmetrical distribution of waste on the hearths may cause lateral motion and impact with external furnace structure and contribute to refractory cracking and failure.

4. The original steel hearth support arms have been replaced with wire cables. The cable system, shown on Photograph 10, permits a freer motion of the hearths when pulsed, allowing a reduction in pulse air pressure from the original 150 psig to approximately 60 psig.

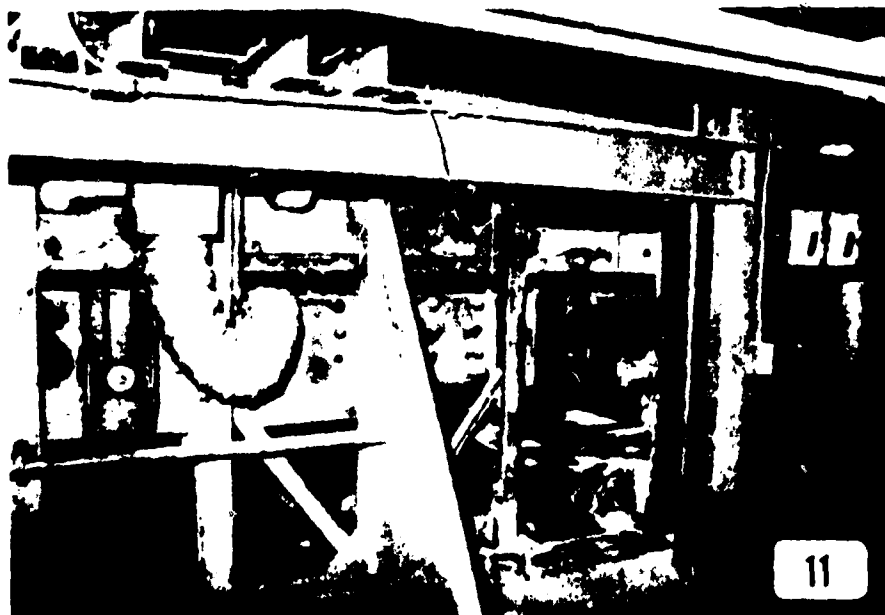
Photograph 11: Exterior view of hearths with combustion air supply and plenum visible.

5. Air infiltration around the hearths has been an ongoing problem. Spring steel seals were installed around the periphery of the hearths and external plates were installed to minimize air leakage. These seals have been readjusted and St. John's personnel are satisfied with the reduction in air infiltration.

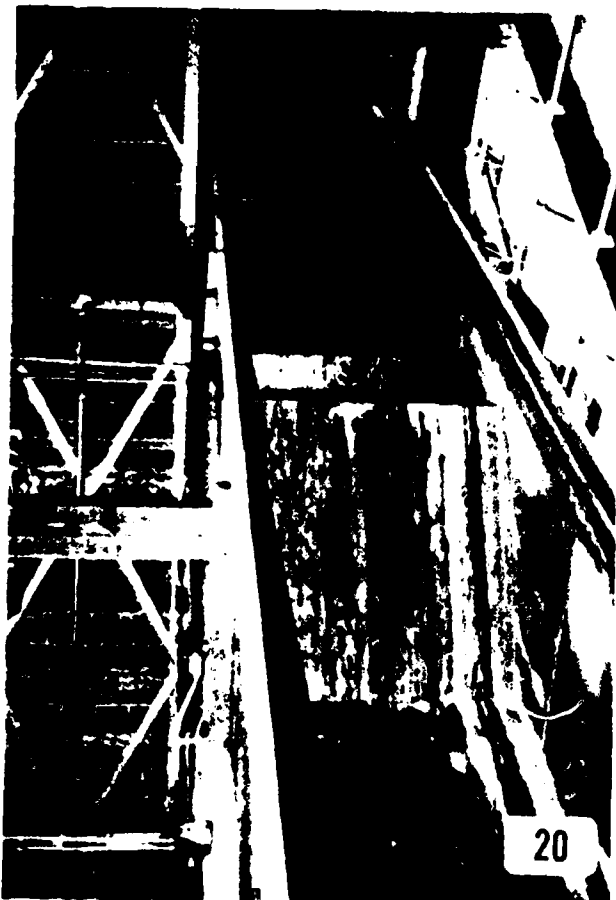
Photograph 20. Ash scoop hoist at top of ash removal conveyor, ash chute door open, and scoop indexing outward.

| <u>Description of Actions</u> | <u>Total Time Elapsed</u> |
|---|---|
| 4. Hoist stops at top of conveyor, ash chute door opens, scoop indexes out and releases residue. | 3 minutes, 40 seconds |
