### *Shore ice ride-up and pile-up features*

*Part I: Alaska's Beaufort Sea coast*

# CRREL Report 83-9

Austin Kovacs

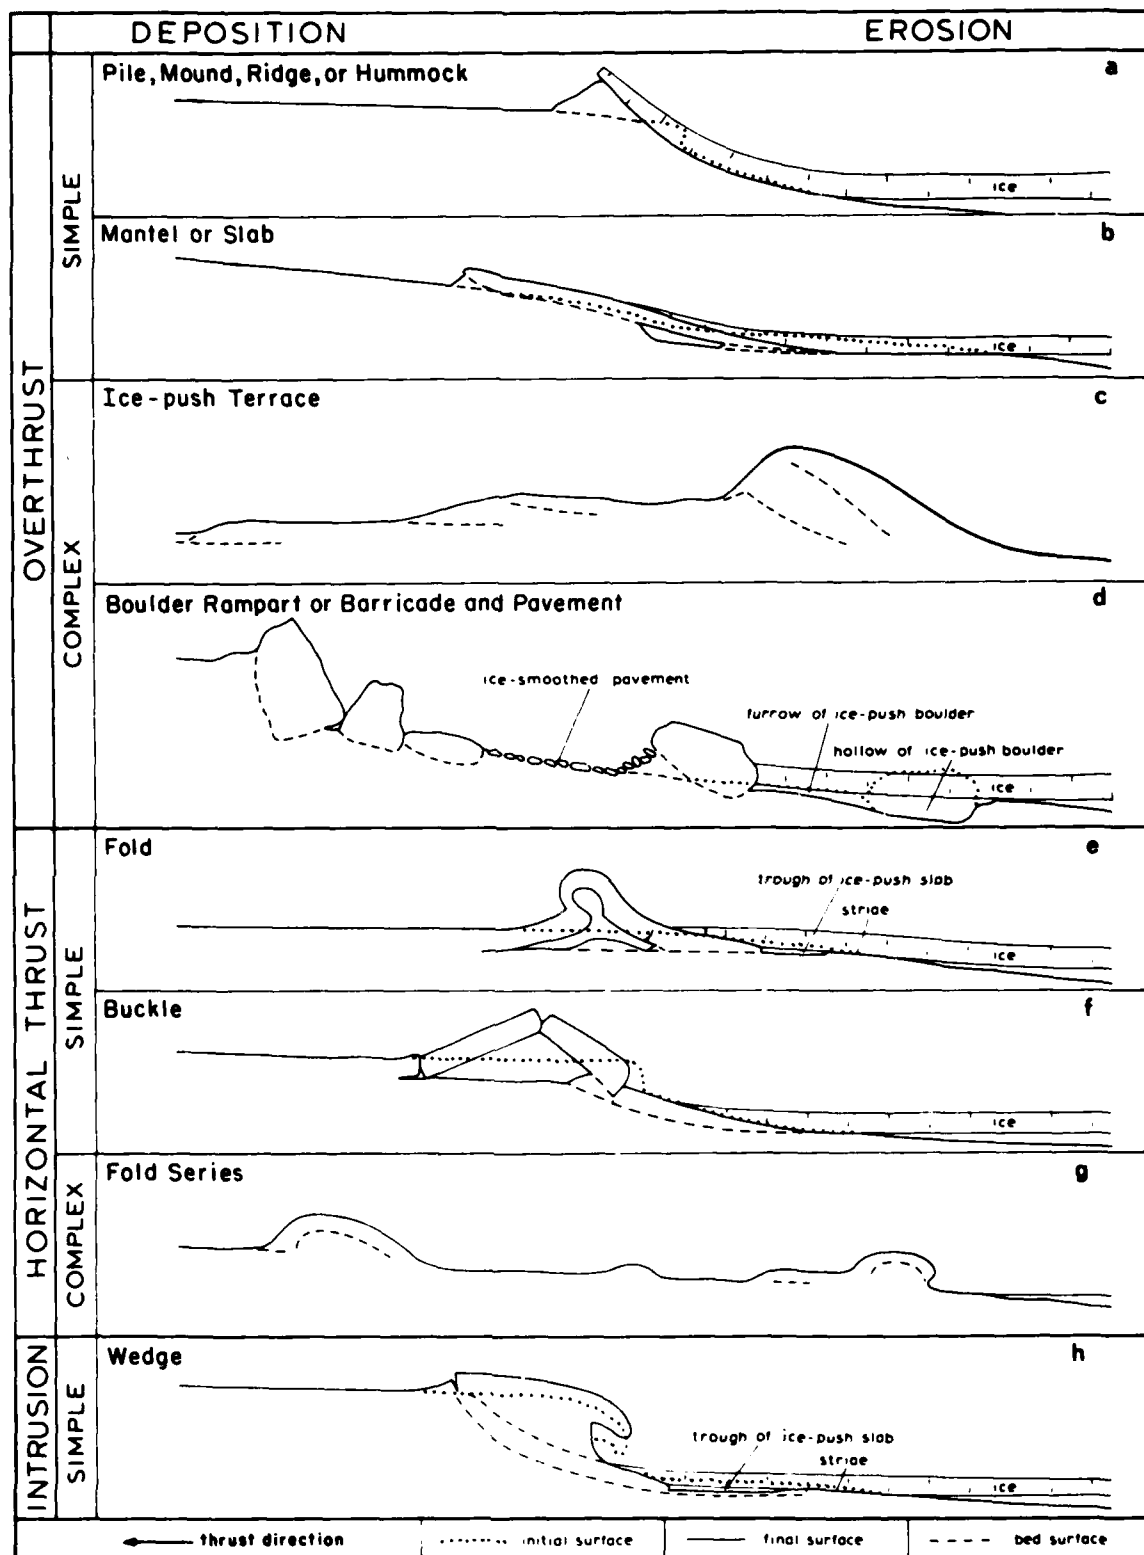
Figure 1. Ice-thrust shore morphology. (After Alestalo and Häikiö 1979.)

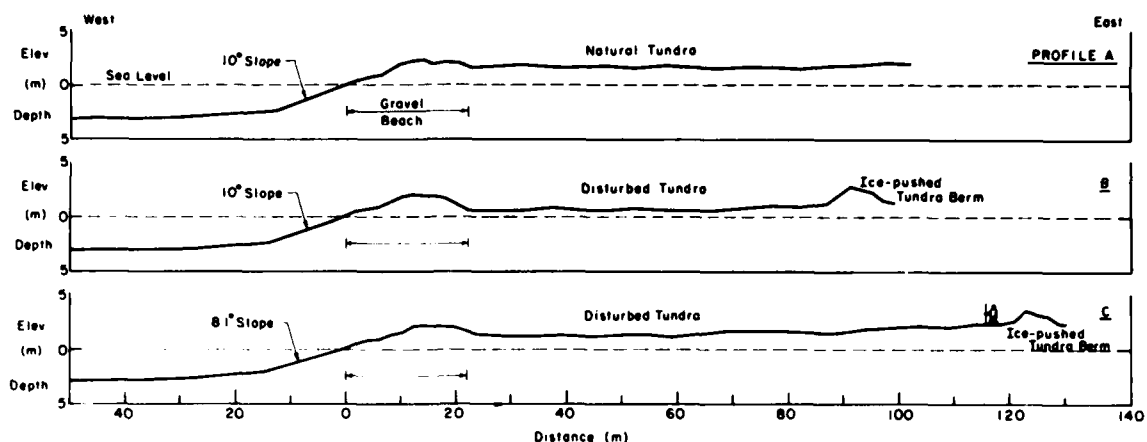
Figure 32. Profiles across coast of undisturbed tundra (A) and ice scars B and C shown in Figure 30.

terrain along profile B. It should be noted that profile B does not represent the deepest area of this ice-scarred feature. The deeper area was up to ½ m below the pond water level, an area we did not attempt to profile.

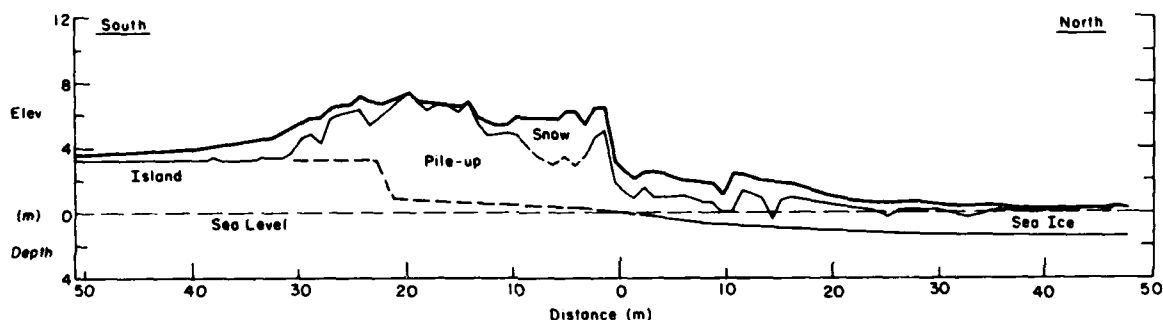
Figure 49. Cross section of Pingok Island sea ice pile-up.

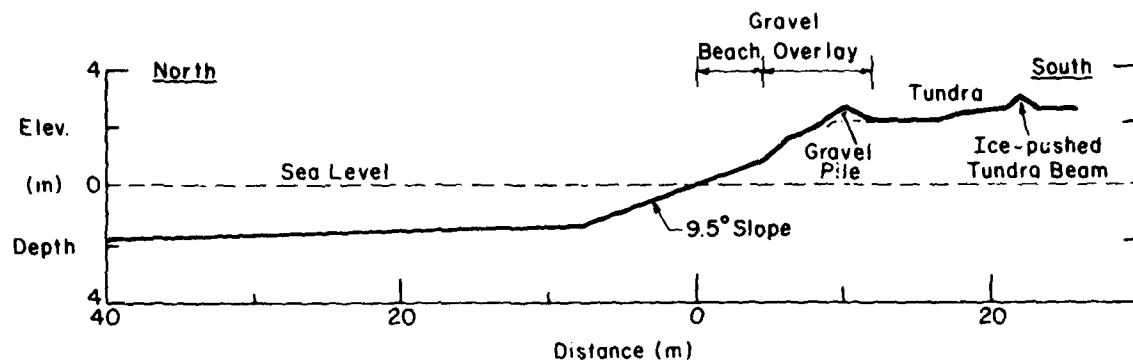
Figure 51. Profile across coast at old ice ride-up tundra scar near left arm of position 17b bracket in Figure B2.

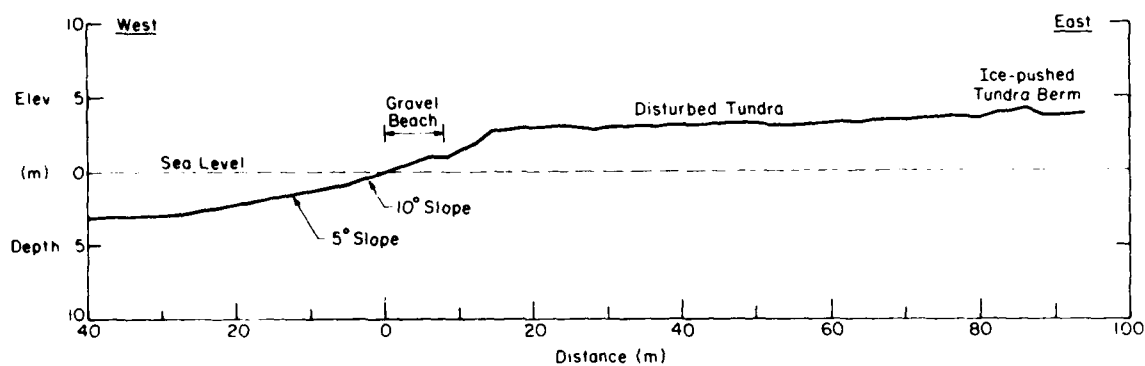
Figure 55. Profile across ice-scarred coast at position C in Figure 33.

On 13 August we visited the site of the ice-scarred feature at position C in Figure 33. An aerial view of the scarred terrain and a view from seaward of the bluff are shown in Figures 53 and 54, respectively. The bluff area where the ice ride-up occurred is not as steep as it is to the north (Fig. 53). The implication is that disturbance of the tundra by ice-ploughing accelerated permafrost melting and related subsidence in the scar area. The longest ice scar was found to extend 118 m inland and terminated at a ½- to 1-m-high ice-pushed tundra berm. The middle scar was profiled; its relief is shown in Figure 55. This scar extended 95 m inland. The top of the bluff as it existed at the time of our survey was 2½ m high and 15 m in from the sea. Inland from the edge of the bluff the terrain sloped upward
