LIGHTNING TESTS ON THE WC-130 RESEARCH AIRCRAFT(U)  
MCDONNELL AIRCRAFT CO ST LOUIS MO W G BUTTERS ET AL.  
DEC 82 AFWAL-TR-82-3093 F33615-80-C-3406

## LIGHTNING TESTS ON THE WC-130 RESEARCH AIRCRAFT

December 1982

FINAL REPORT FOR PERIOD OCTOBER 1981-SEPTEMBER 1982

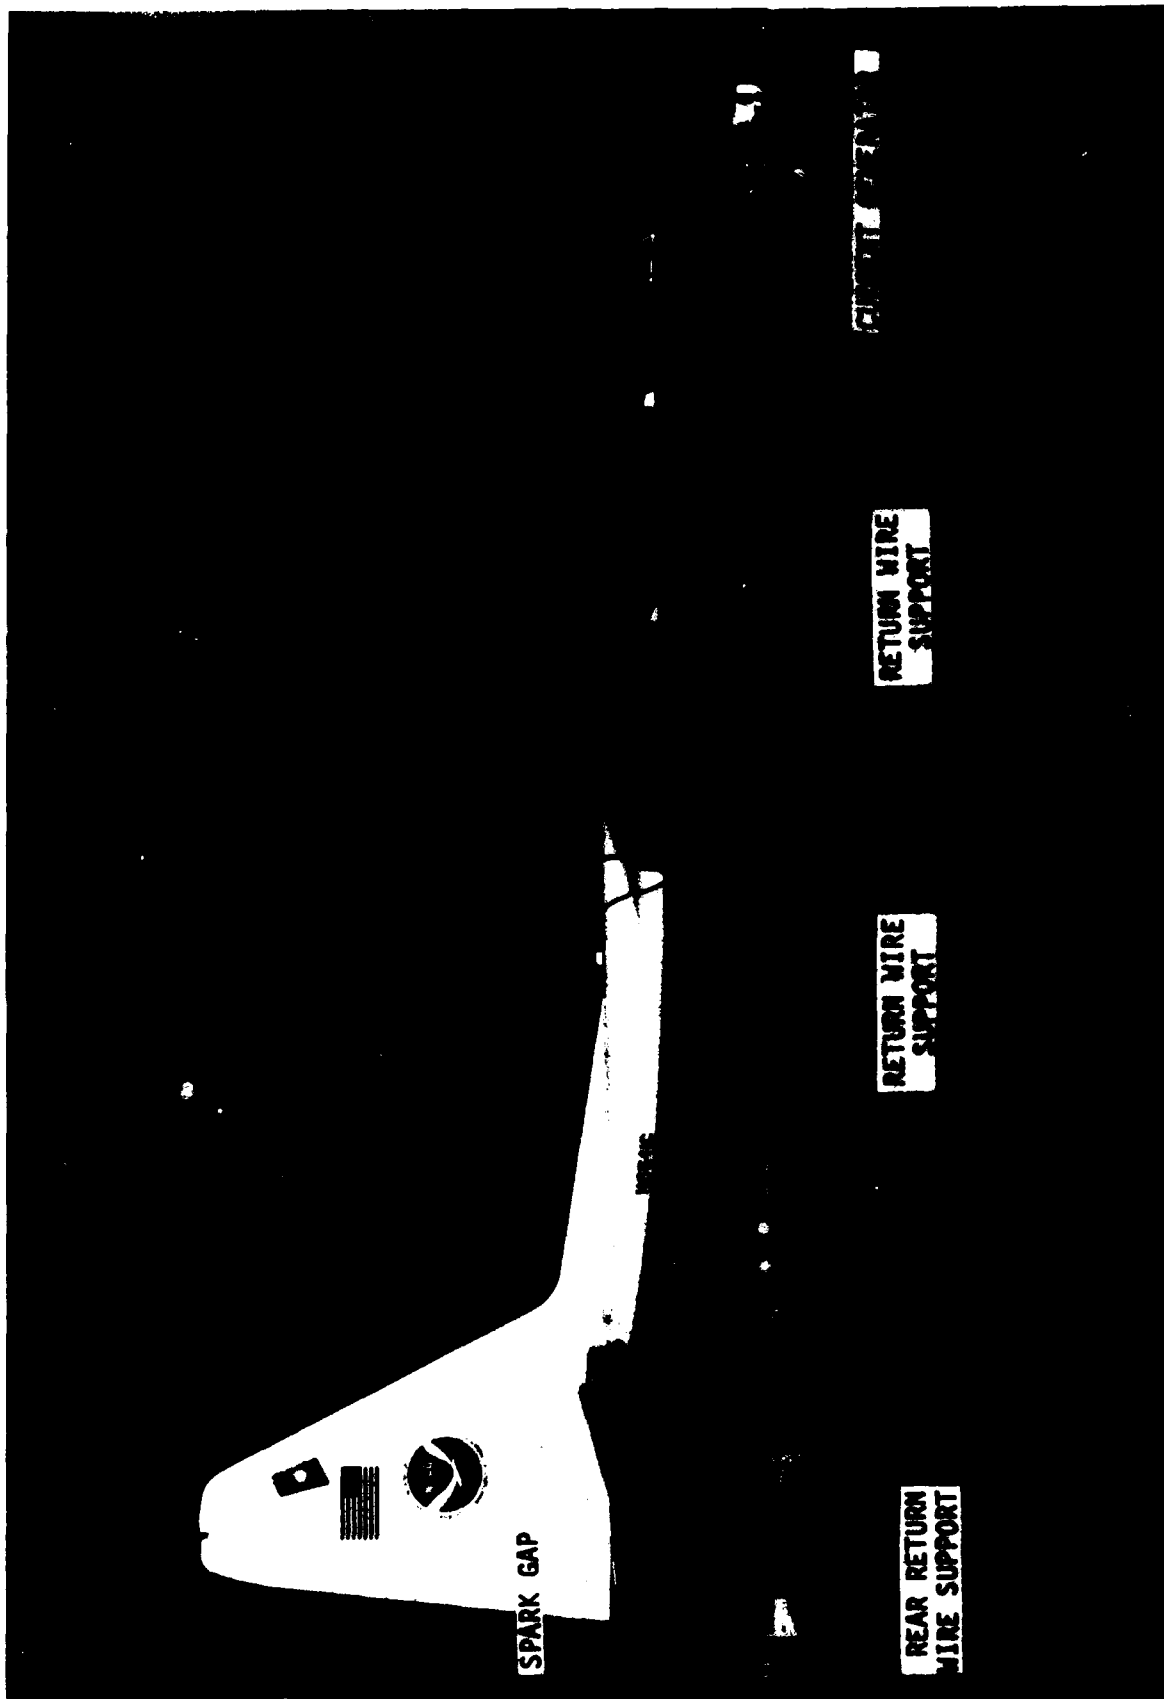
FIGURE III-3. OVERALL WC-130 TEST SETUP

Figure III-3 shows the overall test setup. The aircraft was positioned inside a "coaxial" return system provided by the USAF. The return system consisted of 18 wires strung from the output at the tail to the low-voltage side of the generator located near the nose. Six wires were located above the fuselage, and four wires each were located on the sides and beneath the fuselage. The wires were supported by four wooden stands to make the wires approximately one half meter from the fuselage at the stands; however, the wires sagged between the stands so that in some areas they were nearly touching the fuselage.
