DOT/FAA/CT-83/5
DOT/FAA/RD-82/91

Identification of Exit Taxiways (Retroreflective Markers Only)

Prepared By
FAA Technical Center
Atlantic City Airport, N.J. 08405

April 1983

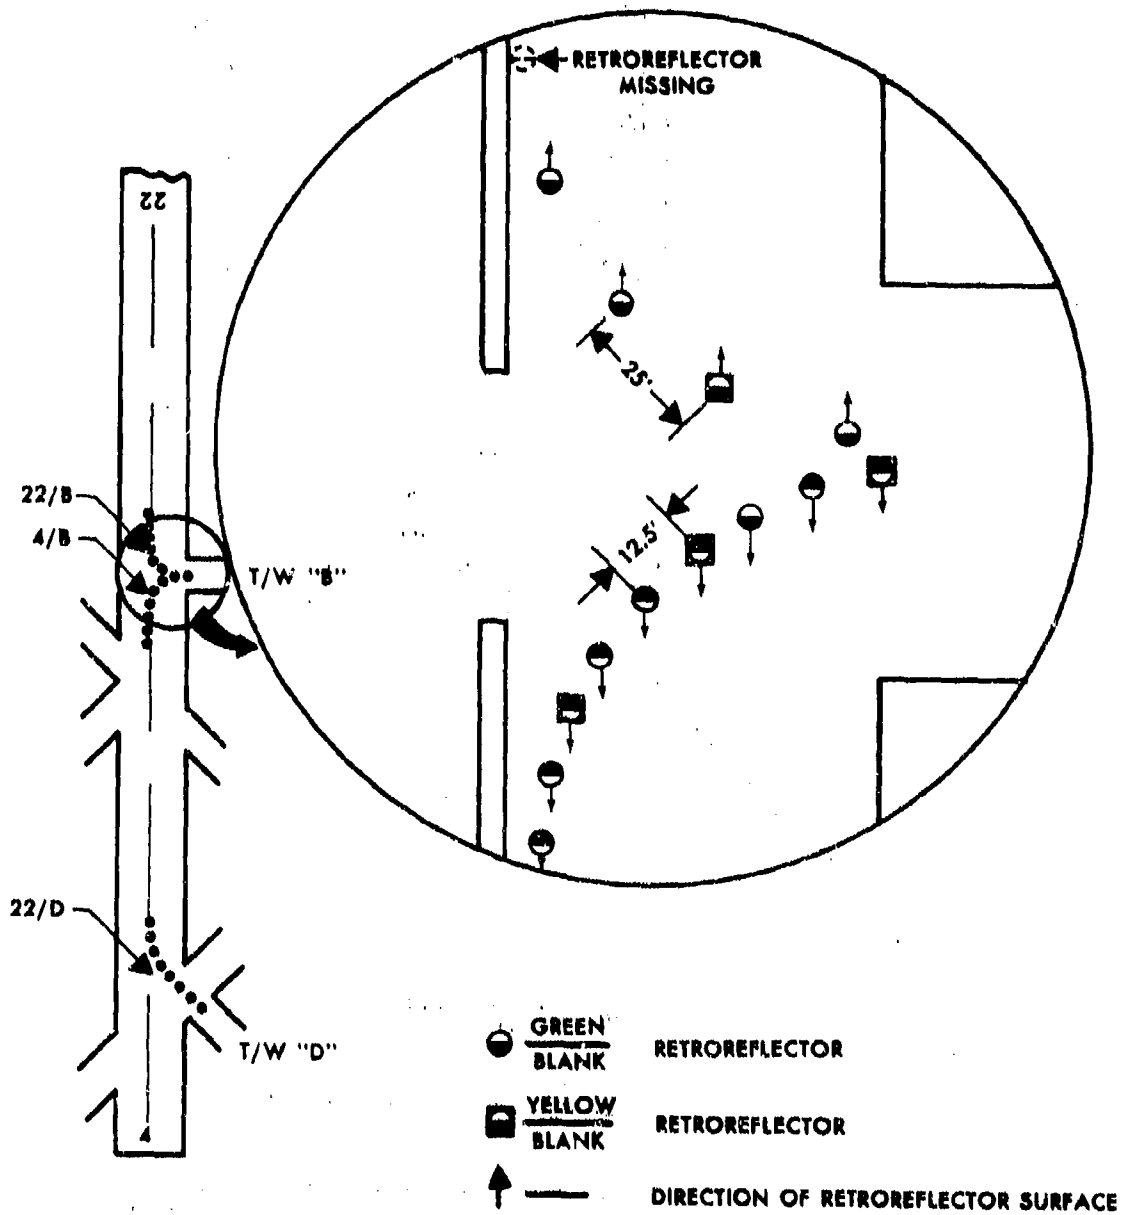
83-5-1

FIGURE 1. RETROREFLECTOR CONFIGURATION AT ATLANTIC CITY AIRPORT
(ACY) ATLANTIC CITY, NEW JERSEY

Retroreflective markers were installed on runway 4/22 at the FAA Technical Center's Atlantic City Airport (ACY). Runway 22 exits identified were Delta and Bravo (22/D and 22/B). Runway 4 had only Bravo exit identified (4/B). For taxiway 4/B 12.5 foot (4 meter) spacing of the retroreflectors was applied along the arc while 25 foot (8 meter) spacing was used for the other exits (figure 1).

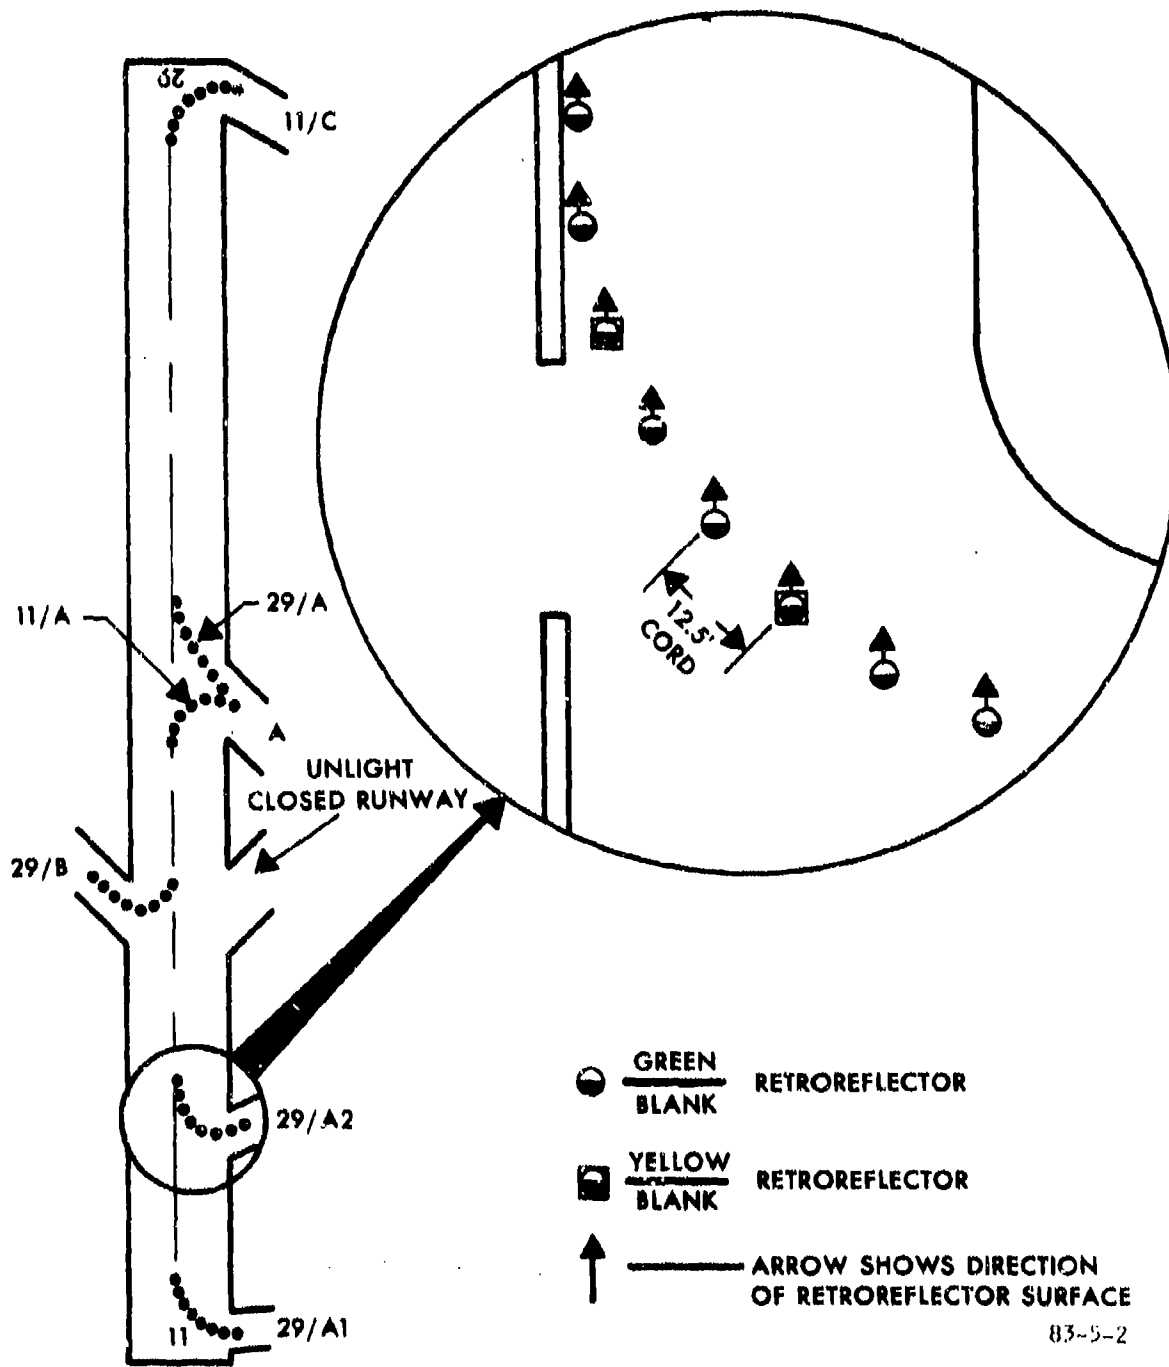
FIGURE 2. RETROREFLECTOR CONFIGURATION AT ATLANTIC CITY/MUNICIPAL/
BADER FIELD (AIY), ATLANTIC CITY, NEW JERSEY

The retroreflective markers were installed with 12.5 foot (4 meter) spacing on runway 11/29 at Bader Field in Atlantic City, N.J. Six exit taxiways were marked with the retroreflectors. Two were marked on runway 11 (11/A and 11/C) and four were marked on runway 29 (29/A, 29/B, 29/A2, and 29/A1) (figure 2). Interviews and questionnaires were used to collect data from the Bader Field test.

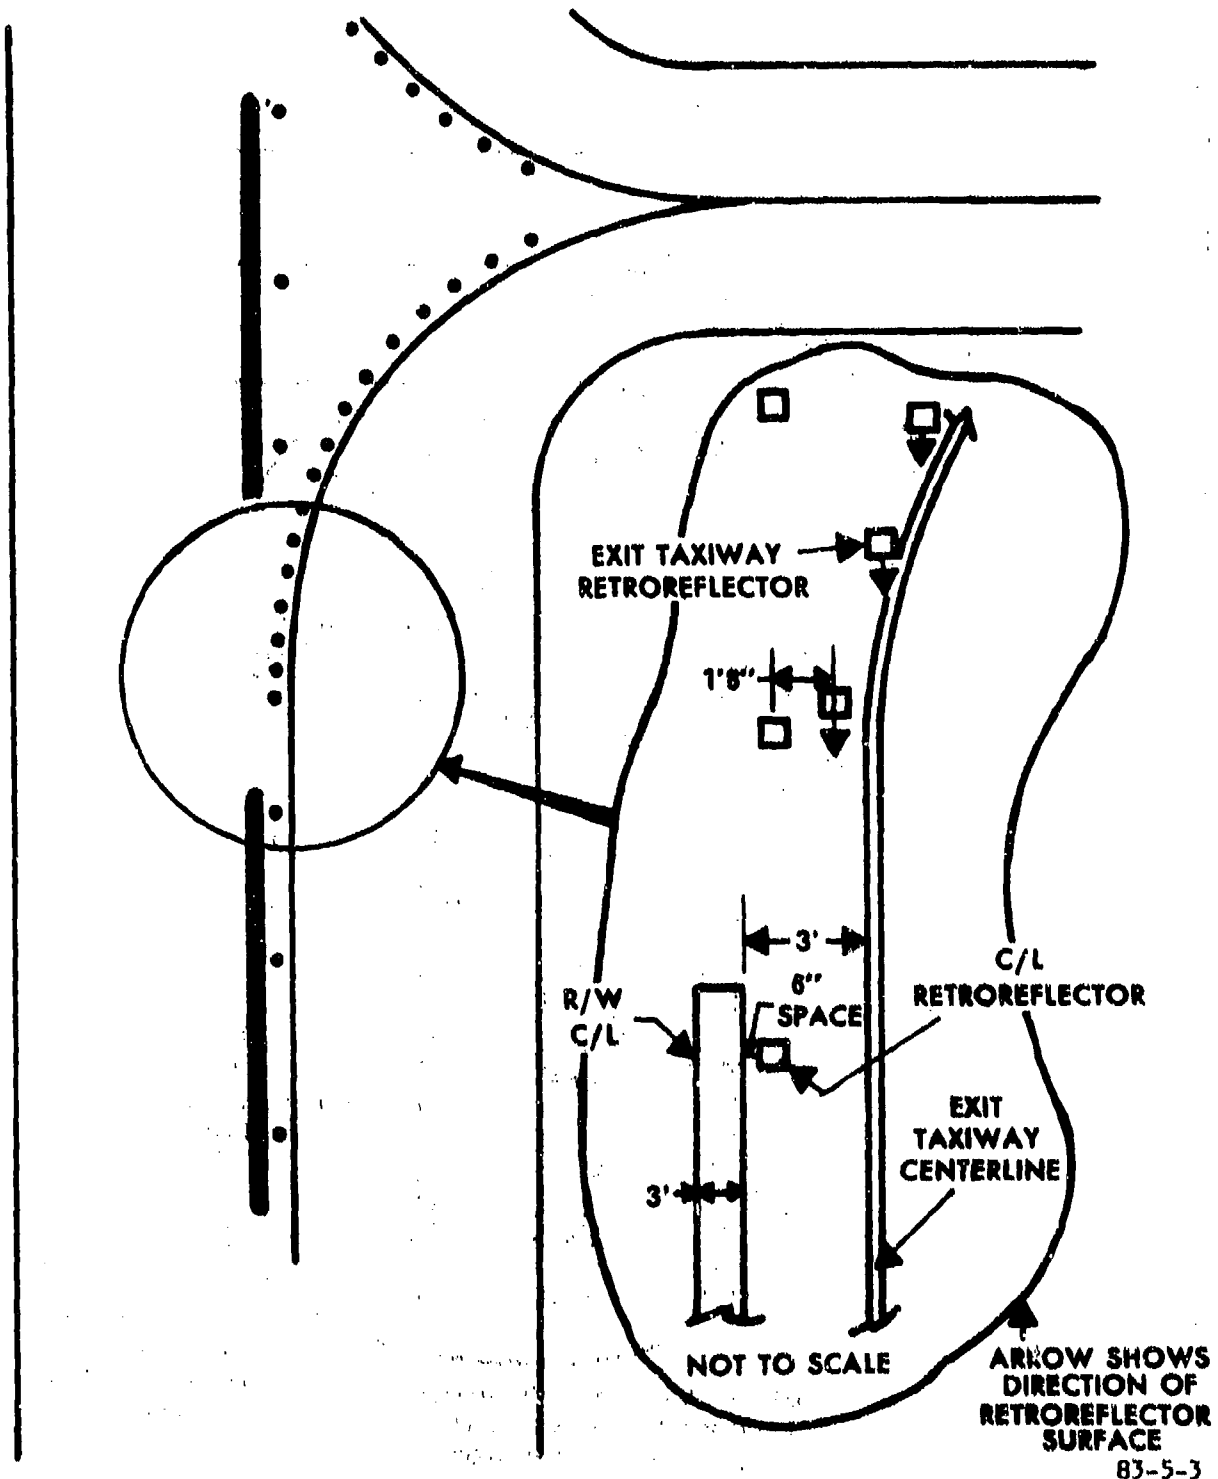
83-5-3

FIGURE 3. LAYOUT OF EXIT TAXIWAY RETROREFLECTORS WITH CENTERLINE RETROREFLECTORS ON SAME SIDE AS EXIT TAXIWAY

The unidirectional retroreflectors should be placed so that they have a cord of 12.5 feet (4 meters) (table 1). The first retroreflector should be located on the arc where it is tangent to the runway centerline. The first exit taxiway retroreflector should be located as close as possible to the centerline of the runway. If runway centerline retroreflectors are used, then the runway centerline retroreflectors should be placed on the side having the most frequently used exits. See figures 3 and 4.

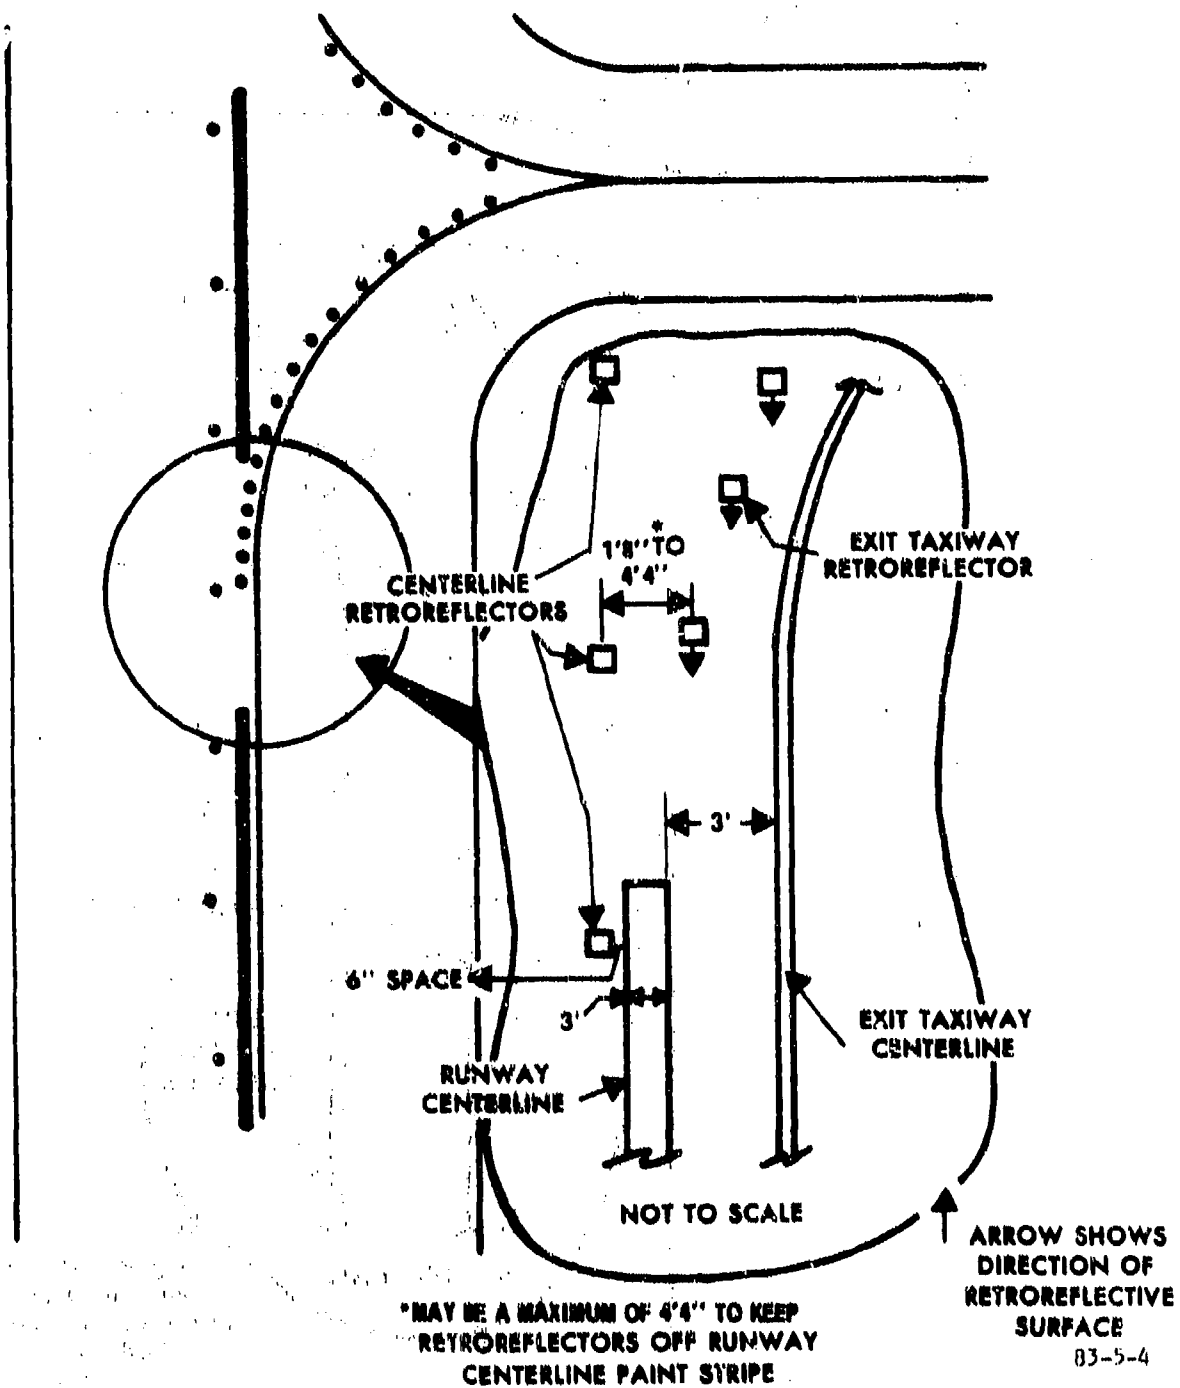
FIGURE 4. LAYOUT OF EXIT TAXIWAY RETROREFLECTORS WITH CENTERLINE RETROREFLECTORS ON OPPOSITE SIDE FROM EXIT TAXIWAY

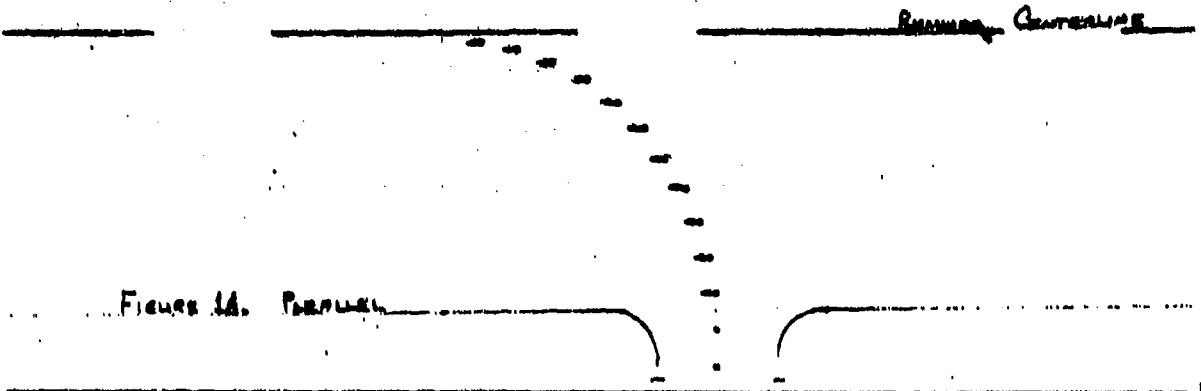
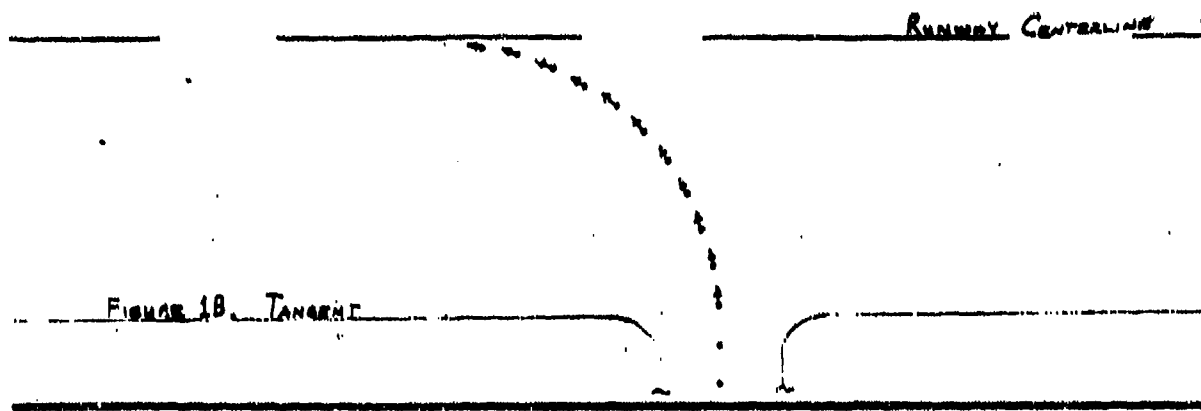
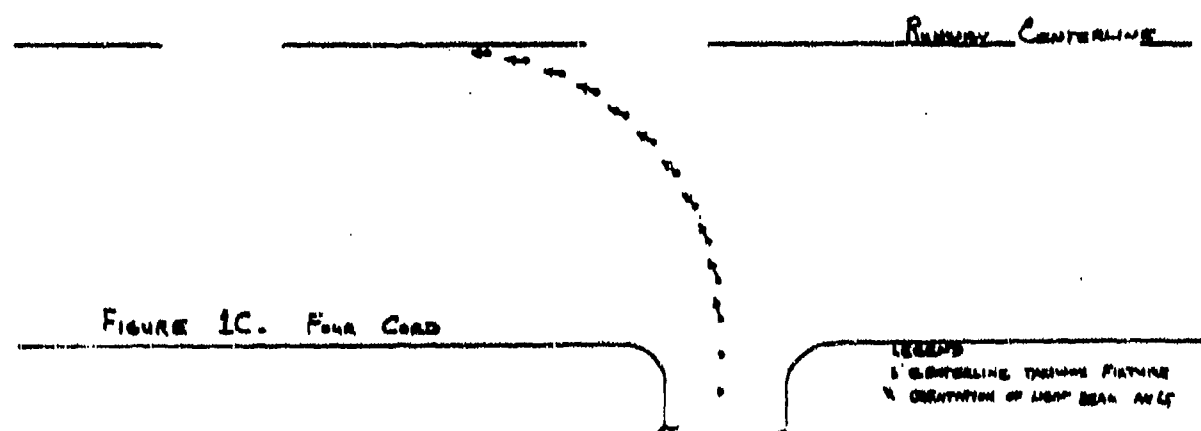
FIGURE 1. EXIT TAXIWAY LIGHT AIMING

1. Parallel to the runway centerline (Figure 1A).
2. Tangent to the exit taxiway centerline curve (Figure 1B).
3. Toed-in to intersect the exit taxiway centerline at a point equal to four times the spacing of the lights (cord) (Figure 1C).
4. Miscellaneous aimings determined by trial and error.

All aiming methods proved to have objectionable characteristics when used with the L-852N fixtures. The tangent and toed-in aiming methods were found to be acceptable when used with the L-852W fixture.

5. The aiming of the L-852W lights four cord ahead for unidirectional lights and tangent to the exit taxiway centerline for bidirectional lights was acceptable.
