MISCELLANEOUS PAPER SL-83-12

# PETROGRAPHIC EXAMINATION OF BELL CANYON TESTS (BCT) 1-FF FIELD GROUTS OVER A THREE-YEAR PERIOD

Structures Laboratory

August 1983  
Interim Report

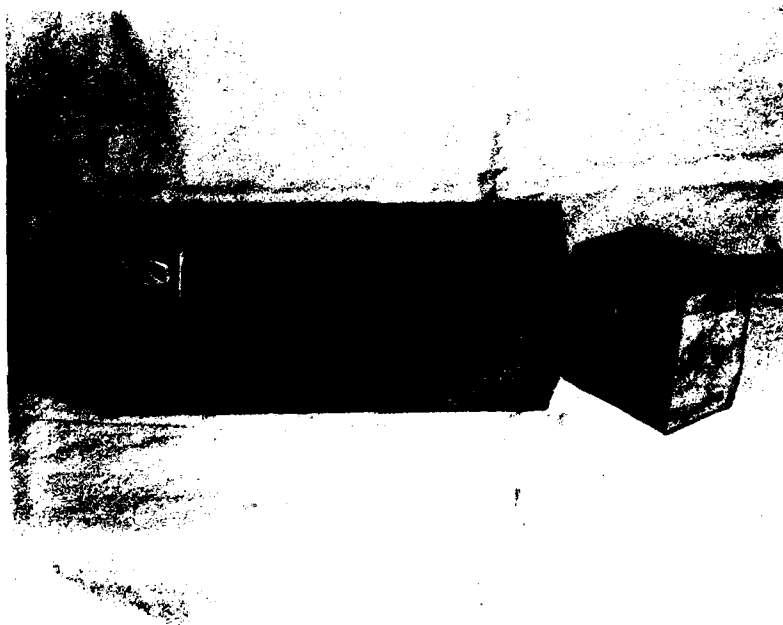
Figure 1. Plug 2 unrestrained prism CL-30 GRT-6 that broke at approximately 1-year age. Note the cracking on the surface and the faint white crack in the center of the top surface, X0.25

13. Cracking was found in samples representing both plugs. Five types of cracking and deterioration were seen. They were: longitudinal, cross, diagonal (all relative to the long axis orientation), spalling, and arch cracking. Deterioration was more prevalent in the larger size samples. The types of samples and the cracking found in those samples are listed in Table 1. A 3-in. by 3-in. by 10-in. unrestrained prism representative of each plug (sample 2C, Plug 1, and sample CL-30 GRT-6, Plug 2) broke along a cross fracture during handling. This is shown for prism CL-30 GRT-6 by Figure 1. The cracking is believed to be due to normal volume change induced by temporary drying and temperature change (100° F to 73° F) of high cement content and no aggregate restraint of grout during testing of the samples.

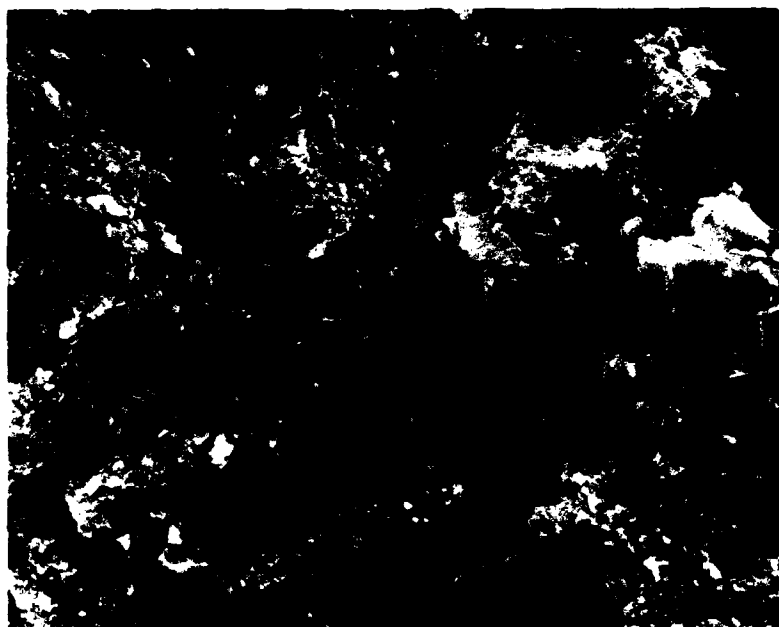
Figure 10. Micrograph 030581-10, X2000. Broken surface of Plug 1 cube A4. This surface shows more porosity than the Plug 2 cube surface (Figures 8, 9). The sample was about 18 months old

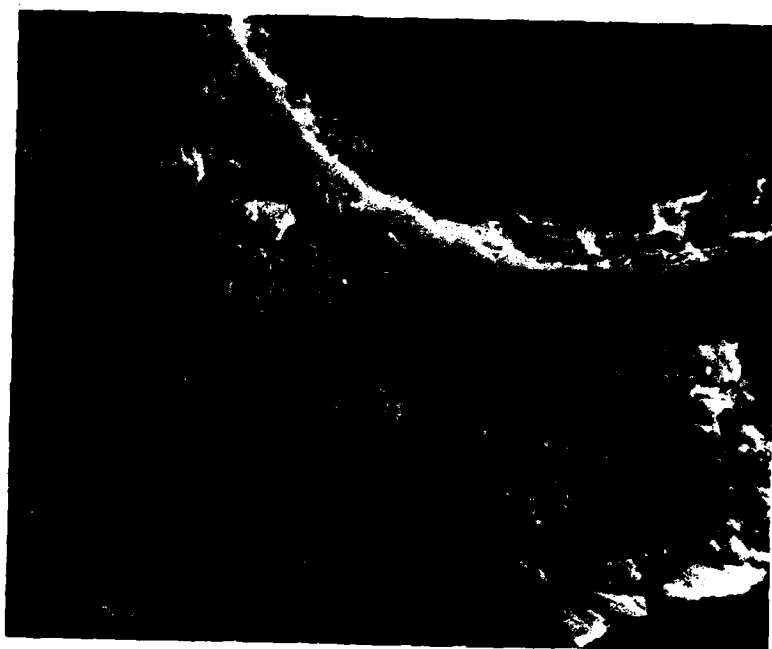
Figure 11. Micrograph 030581-6, X5000. Broken surface of Plug 1 cube A4. A broken fly ash sphere in upper right surrounded by calcium silicate hydrate and calcium hydroxide crystals. The sample was about 18 months old

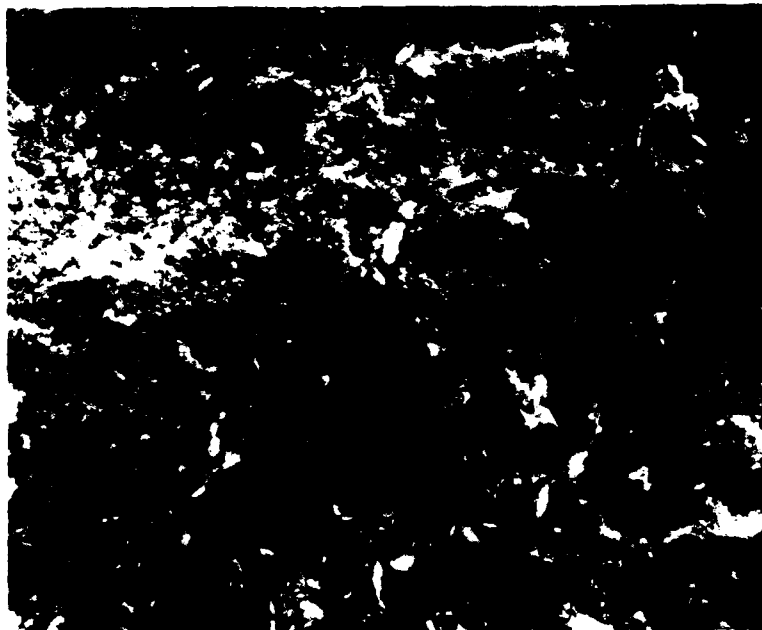
Figure 12. Micrograph 041383-4, X530. Microstructure of Plug 1 grout at 3 years. This sample came from a piece of a cylinder. Three grains of unhydrated cement can be seen in the right central portion of the micrograph. Note the microstructure appears denser than the same grout at 370-days age (Figure 6)

grout fracture surface at about 1 year appearing smoother and thus stronger (denser). Figures 12 and 13 show the microstructure of the Plug 1 and Plug 2 grouts at 3 years age; the Plug 2 grout still shows a slightly denser microstructure than the Plug 1 sample does; however, it is not as apparent as it was at 370 days. Unhydrated grains of portland cement can be seen in both the micrographs of the 3-year-old grout. This suggestion of some difference in the grout of the two plugs is somewhat verified by the physical data through 130 days, especially the dynamic modulus, on page 60 of Reference 2.
