NORTH CAROLINA A&T STATE UNIVERSITY  
Greensboro, NC 27411

FINAL REPORT

"REFINED TEST METHODS IN EVALUATING BRITTLE  
MATERIAL FRACTURE STRENGTHS "

Contract No. N00019-79-C-0574

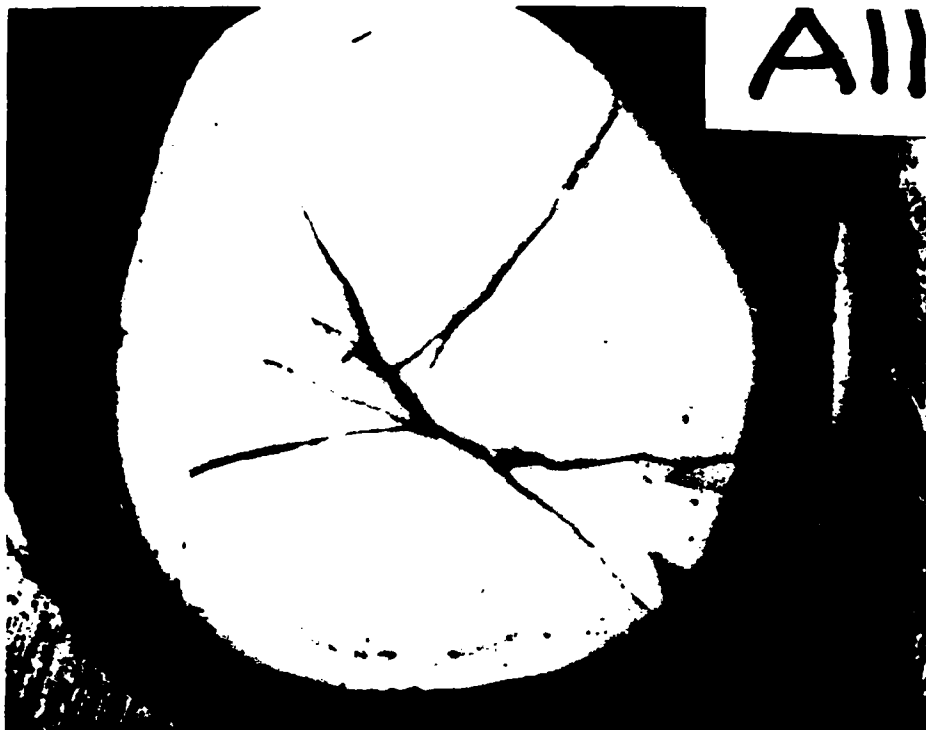
Figure 5.1a. Hydraulic Fracture Specimen A11 - Outer Surface (2.5X)

Figure 5.1b. Hydraulic Fracture Specimen A11P - Inner Surface (3X)

Figure 5.2a. Hydraulic Fracture of Specimens A13 -  
Outer Surface (2.5X)

Figure 5.2b. Hydraulic Fracture of Specimens A13P -  
Inner Surface (3X)

A series of two alumina photos are listed for both specimens A11P and A13P. Figure 5.1a shows the outer side and 5.1b shows the inside. The inside of this specimen and of others are shown in greater magnification to provide enhanced evidence of cracks. It is interesting that this specimen gives no indication of a crack on its compression or inner surface although there is a radial or 'crow foot' pattern in the outer surface, Figure 5.1a. This type of crack was typical of almost all alumina specimens such as Figure 5.2a (outside) and 5.2b (inside). While the outside surface exhibited a series of hairline width cracks, no visual crack could be detected on the inside. Indeed there was little change in pumping pressure as detected by the test operator. In fact, with the alumina, pressures could be re-elevated provided the pumping rate exceeded the small leakage rate through the specimen. There was an attempt to detect incipient cracking by listening while observing the specimens by closed circuit TV. In the case of alumina, this revealed nothing.

Several of the alumina specimens were later cleaned; they appeared still to be intact except for the hairline cracks made visible by rubbing the surface with graphite mixture. Again, future tests could benefit from an addition of a conducting brittle strip to aid in crack detection. These specimens appeared to have cracks, Figures 5.1 and 5.2, that propagated to depth of about 50 mm to 70 mm under the outer surface where they appeared to arrest. The exact cause of the hydraulic leak in alumina seems to have been due to seepage through internal cracks that became sealed after the test and not by leakage at the seal.
