DATA ACQUISITION FOR EVALUATION OF AN AIRBORNE  
LIGHTNING DETECTION SYSTEM(U) AIR FORCE WRIGHT  
AERONAUTICAL LABS WRIGHT-PATTERSON AFB OH

L C WALKO ET AL. SEP 83 AFWAL-TR-83-3083

# DATA ACQUISITION FOR EVALUATION OF AN AIRBORNE LIGHTNING DETECTION SYSTEM

Final Report for Period June 1981 - August 1981

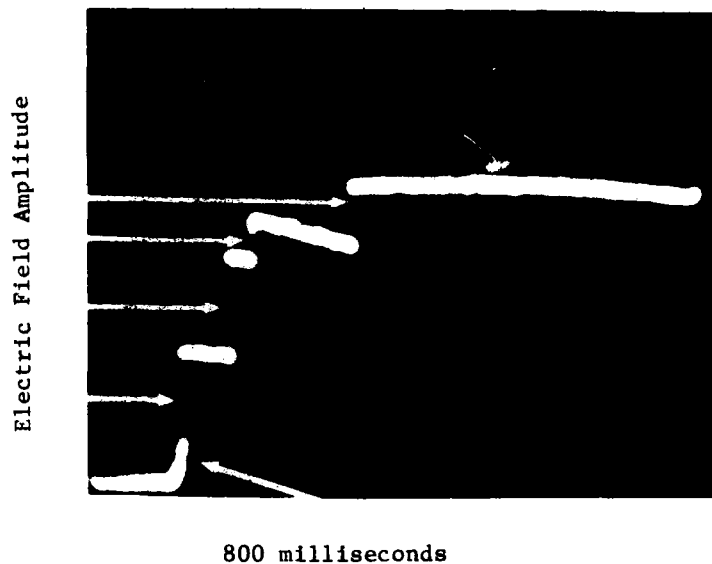
Figure 1. Electric Field Time History of a Four-Stroke Lightning Flash.

When the leader (which may be one of several leaders) nears the ground, upward moving streamers produced by the large electric field make contact with it, connecting it to ground potential. This produces a return stroke characterized by a fast rise to a high current level, then a slow decay. More leaders may then propagate down the channel, followed by subsequent return strokes. Continuing currents also may occur when there is direct charge transfer from cloud-to-ground. A Polaroid oscillograph of the electric field for a typical lightning flash is shown in Figure 1.

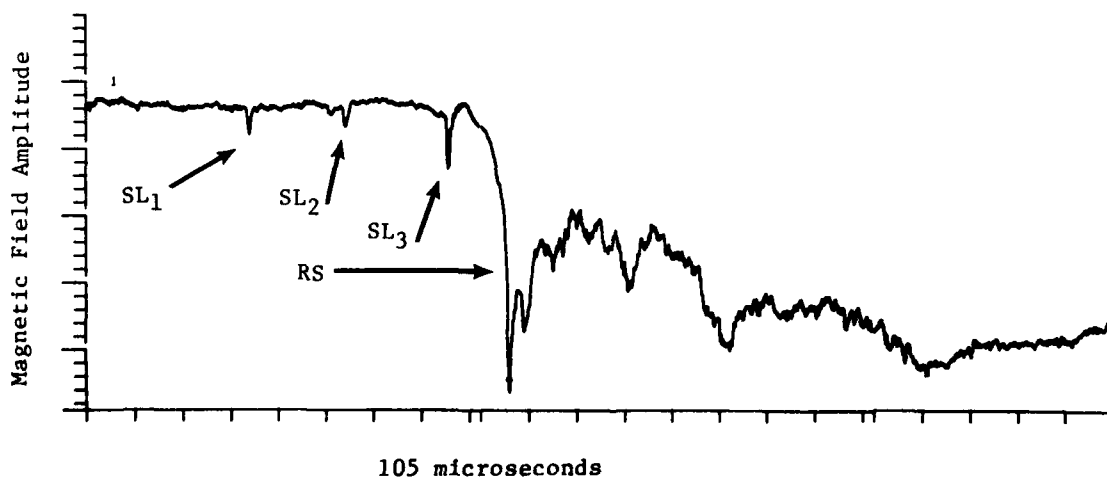
Figure 2. Magnetic Field Time History for the First Return Stroke (RS) of a Lightning Flash (Three Stepped Leaders (SL's) Precede the Return Stroke).

The rapid movement of charge from ground-to-cloud during the return stroke produces a fast changing magnetic field which will in turn induce a current in a loop. If two loops oriented  $90^\circ$  to each other are in the path of the magnetic field, the arctangent of the peak current values will give the azimuth of the stroke from the loop location with a  $180^\circ$  ambiguity. A typical plot of the magnetic field produced during a return stroke is shown in Figure 2.

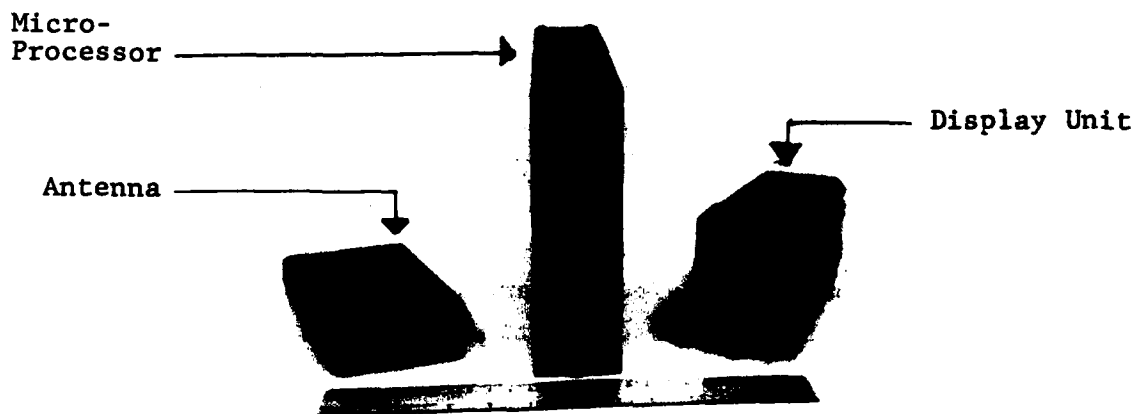
Figure 3. Stormscope Model WX-10 System Components

The WX-10 Model used in this test is the newest Stormscope available, with features including 25, 50, 100, and 200 nautical mile (nmi) range displays, selectable fields of view of full 360° or forward looking 120° segment, a 256 dot memory capacity, and twice the resolution of previous models. All operational controls are in the panel mounted display. A microprocessor unit is included in the package but can be located anywhere in the aircraft. A flat pack ADF-type antenna must be mounted in an electrically noise-free area of the aircraft. The WX-10 display, microprocessor, and antenna are pictured in Figure 3.

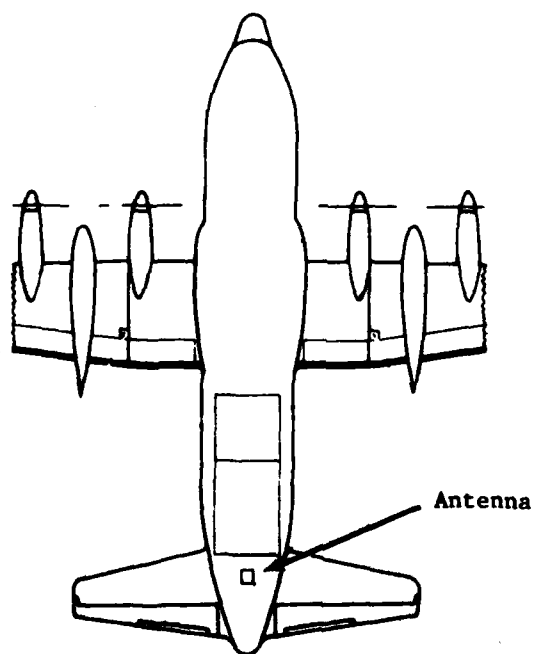
Figure 5. Location of Flat Pack Antenna

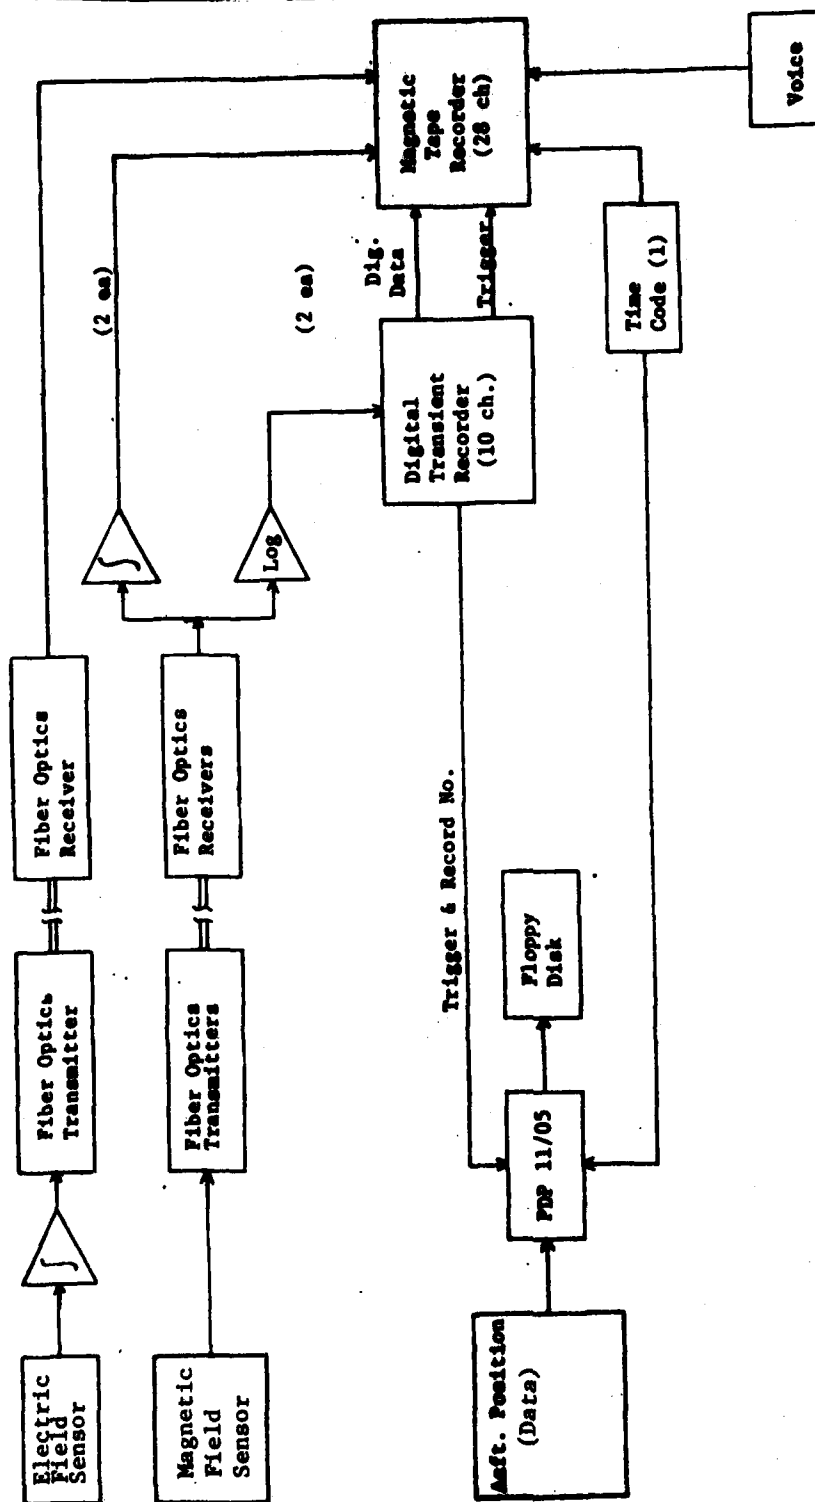
Note 1. IRIG-B synchronized to WWV

Figure 6. Airborne Instrumentation Block Diagram

on the instrumentation recorder and floppy disc could be time correlated with the Stormscope and weather radar data recorded on video tape. Figure 6 is a diagram of the part of the instrumentation system pertaining to the Stormscope study. A more detailed description of the system is included in Reference 5.

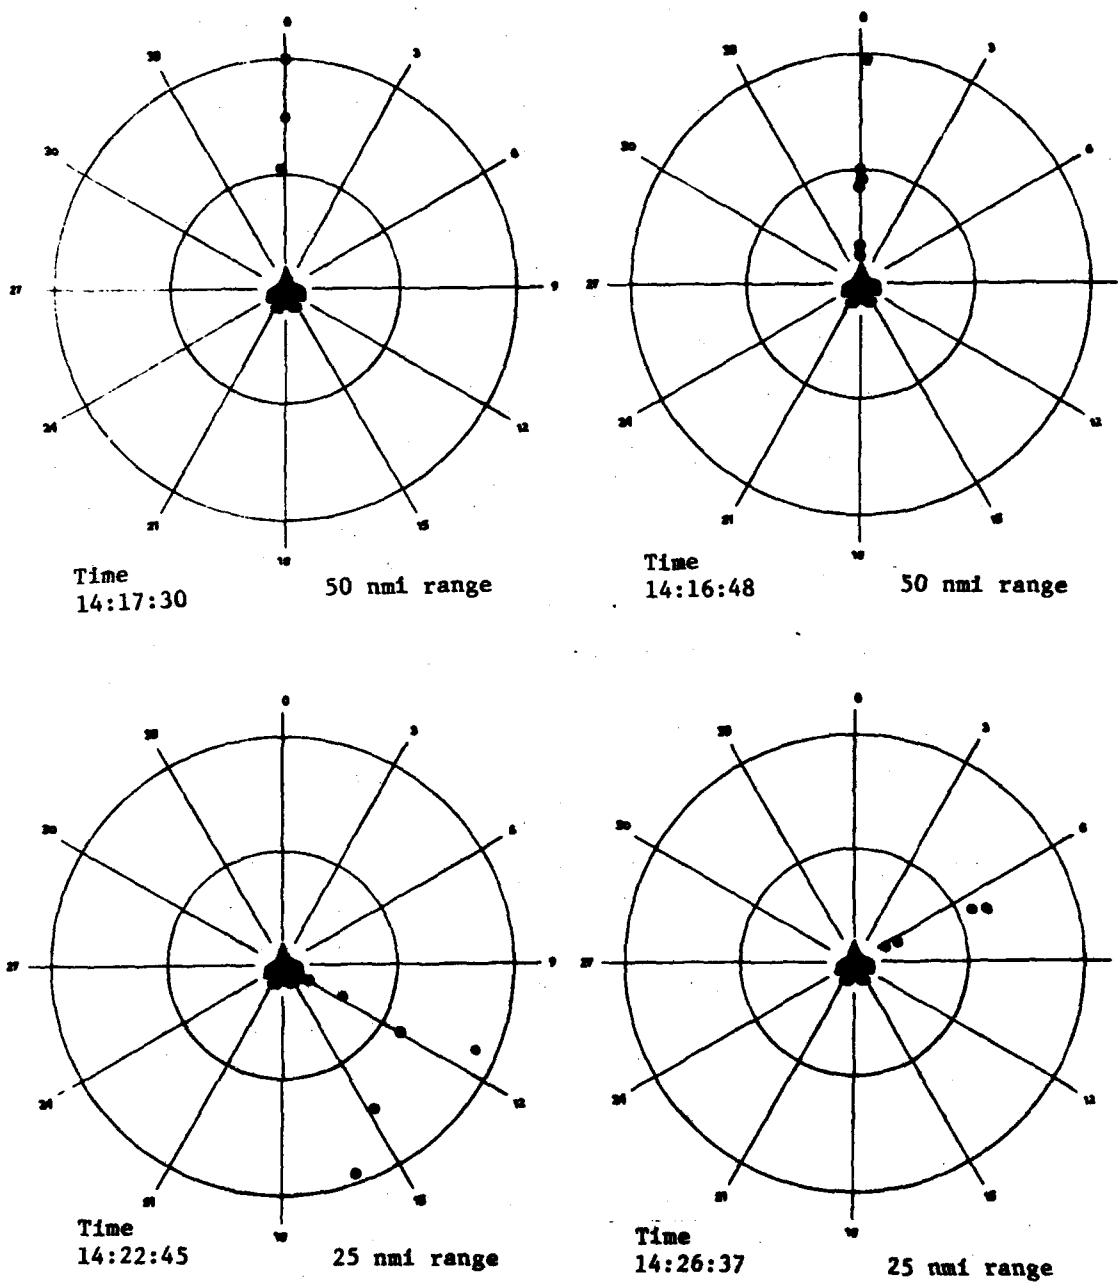
Figure 7. Typical Stormscope Display Patterns During a Storm on 25 August 1981

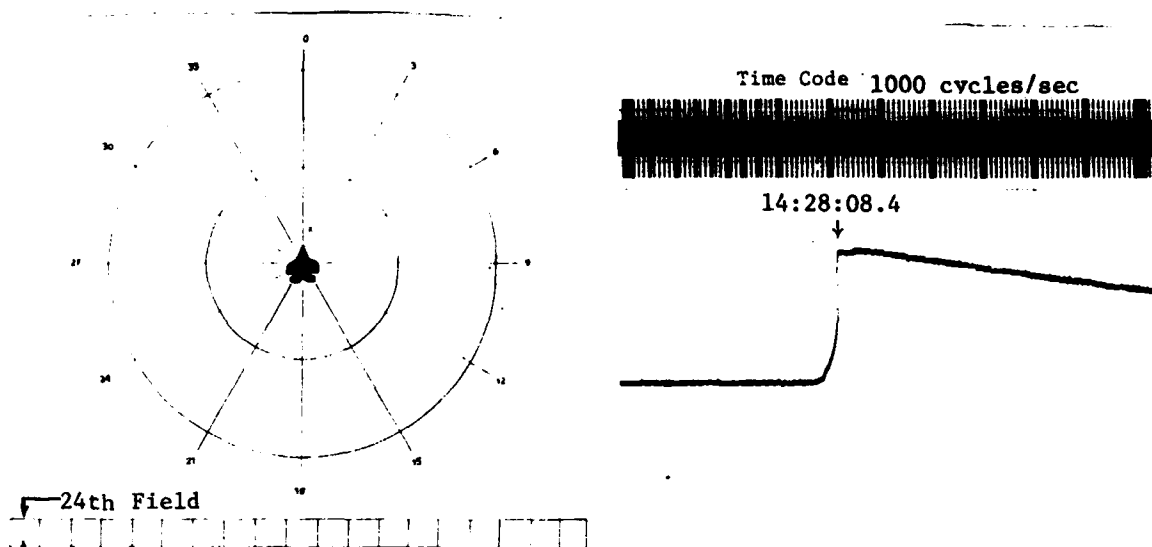
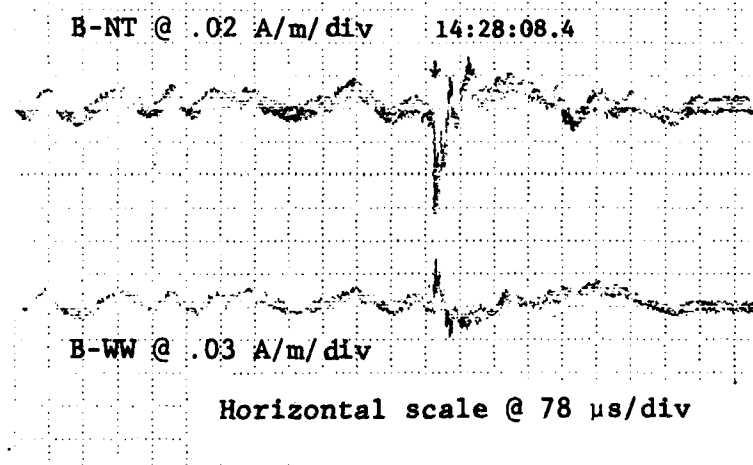
a. Stormscope Display at Time Interval  
14:28:08 - 14:28:09

b. Electric Field Record at Time  
Interval 14:28:08 - 14:28:09

c. Magnetic Field Records from Nose-to-Tail (B-NT)  
and Wing-to-Wing (B-WW) Sensors

Figure 8. Correlation of One Stroke Flash at 14:28:08.4  
on 25 August 1981

Figure 8 illustrates this process. In (a), the x in the first block below the Stormscope display facsimile depicts the first dot that occurred in the time interval between 14:28:08 and 14:28:09. Each block indicates a field or an interval of about 16.6 ms. The position of the dot on the Stormscope is plotted on the display facsimile as it appeared on the actual display. If another dot had appeared on the display within the subsequent 18 fields, the dot would have been plotted using a different symbol on the appropriate block and the facsimile. The dot shown appeared during the twelfth frame after the 14:28:08 update. The dot brightness indicated that it occurred during the second field of the frame, or at time 14:28:08.4. There were no subsequent dots that appeared within the 1 second interval. In (b), the electric field for the same time interval shows a fast change in the electric field, characteristic of a cloud-to-ground strike, that occurred at time 14:28:08.4. The fact that there were no other Stormscope dots or electric field excursions indicates that these two sets of data correspond to the same event. In (c), the magnetic field data is plotted using an expanded time scale so that amplitude measurements can be obtained. First, a zero reference is defined on each trace by averaging the random (noise) oscillations in the trace and positioning the selected average upon one of the horizontal grids. Then the maximum deflections from these references were measured and scaled to the correct engineering units. Taking the ratio of the resulting values from the wing-to-wing ( $B_{WW}$ ) and the nose-to-tail ( $B_{NT}$ ) sensors (0.018 and 0.06, respectively),

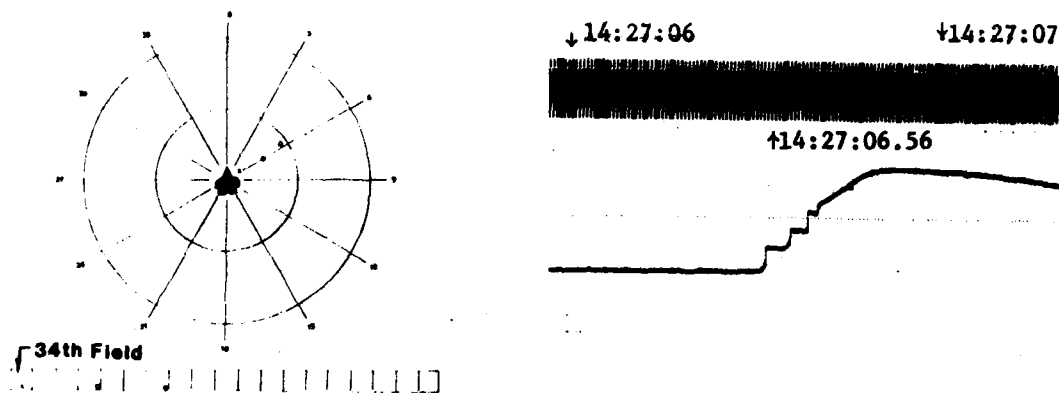
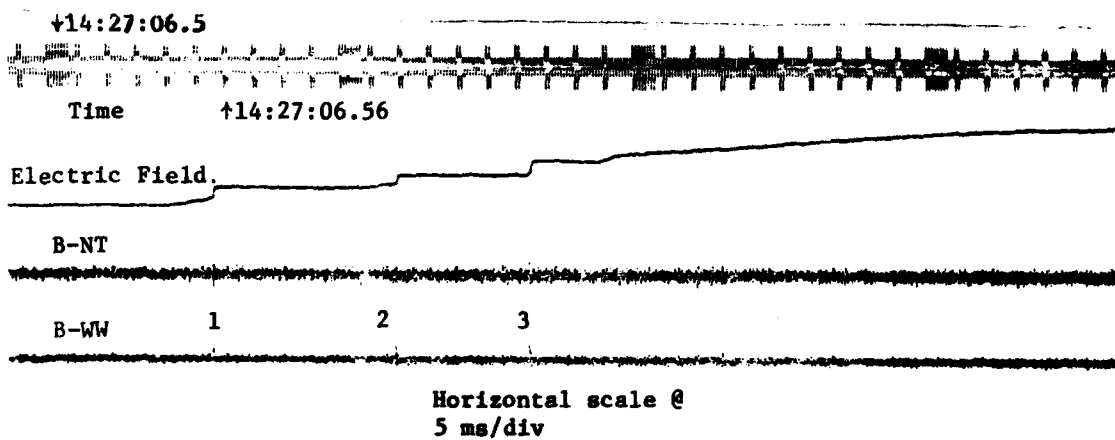
a. Stormscope Display at Time  
Interval 14:27:06 - 14:27:07

b. Electric Field Record at Time  
Interval 14:27:06 - 14:27:07

c. Electric and Magnetic Field Records

Figure 9. Correlation of a Three Stroke Flash at 14:27:06.56  
On 25 August 1981

Figure 9 illustrates correlation of a three-stroke flash that occurred during the first field of the 17th frame after the 14:27:06 time update. The Stormscope display had three dots as shown in (a). Frame-by-frame analysis revealed the sequence in which the dots appeared and the approximate time interval between them. The first dot (x) was bright, indicating its presence during both field scans. The second (o) and third (●) dots were dim, indicating their appearance after the first field of their respective frames. Thus, the second dot appeared at least three fields ( $\approx 50$  ms), but less than four fields ( $\approx 67$  ms), after the first dot. Similarly, the third dot appeared at least two fields ( $\approx 33.3$  ms), but less than three fields ( $\approx 50$  ms), after the second dot. Referring to (b) in the figure, during the time interval between 14:27:06 and 14:27:07, the electric field trace shows an interval of about 60 ms between the first and second, and about 45 ms between the second and third events. This electric field trace indicates a three stroke cloud-to-ground flash at 17:27:06, also followed by a slower field variation which might be related to intracloud processes or continuing current. In (c) of the figure, both magnetic field traces are shown along with the electric field trace and the time code using an expanded time scale. From the  $B_{WW}$  trace, the interval between the events is shown to be about 62.5 ms and 45 ms. In Figure 10, the magnetic field traces for each of the three strokes are shown using an expanded time scale. By the process already explained, the azimuths for the three events were calculated to be  $71^\circ$ ,  $64^\circ$ , and  $67^\circ$ , respectively, as compared to values of  $60^\circ$ ,  $55^\circ$ , and  $60^\circ$  from the Stormscope display data.

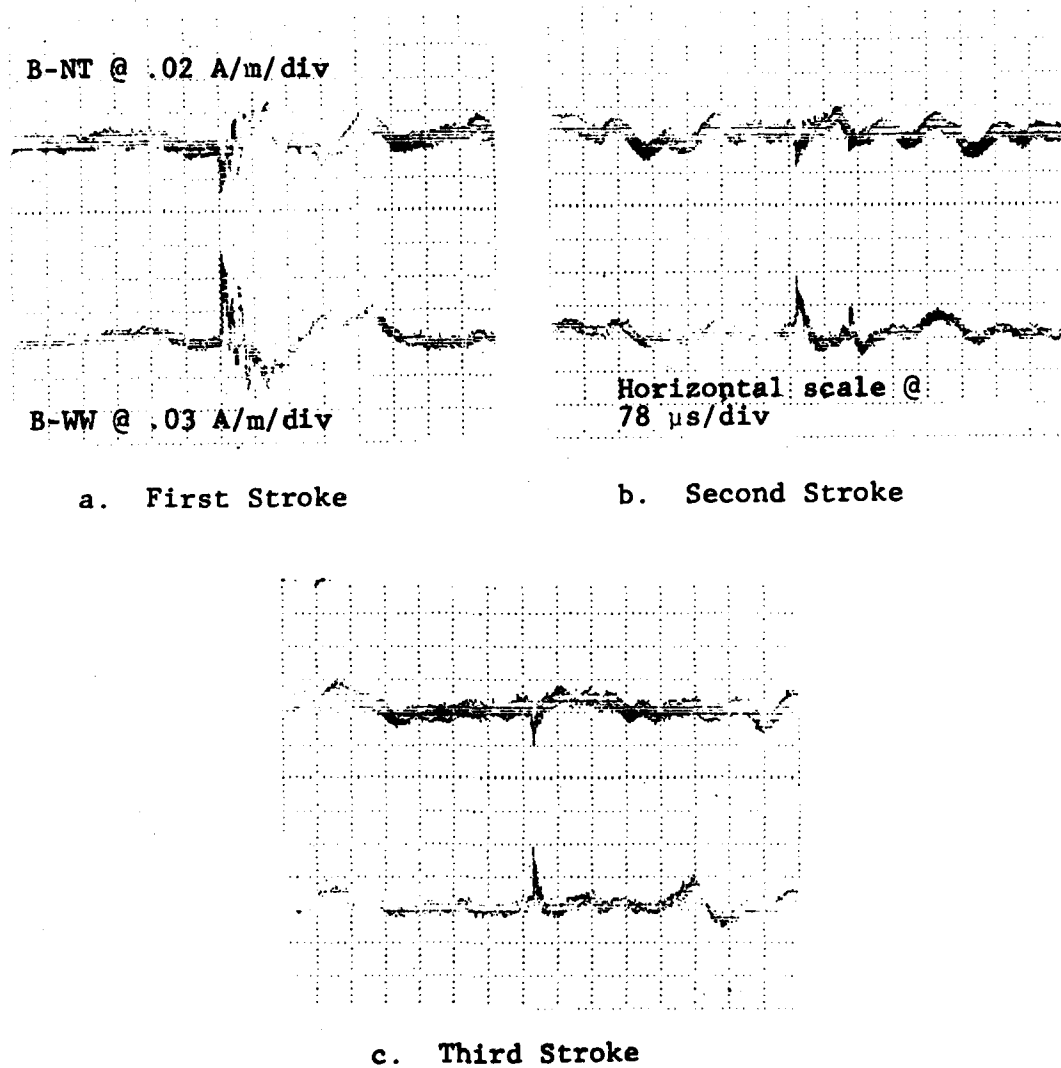
Figure 10. Time Expansion of Magnetic Field Records Shown in Figure 9c.

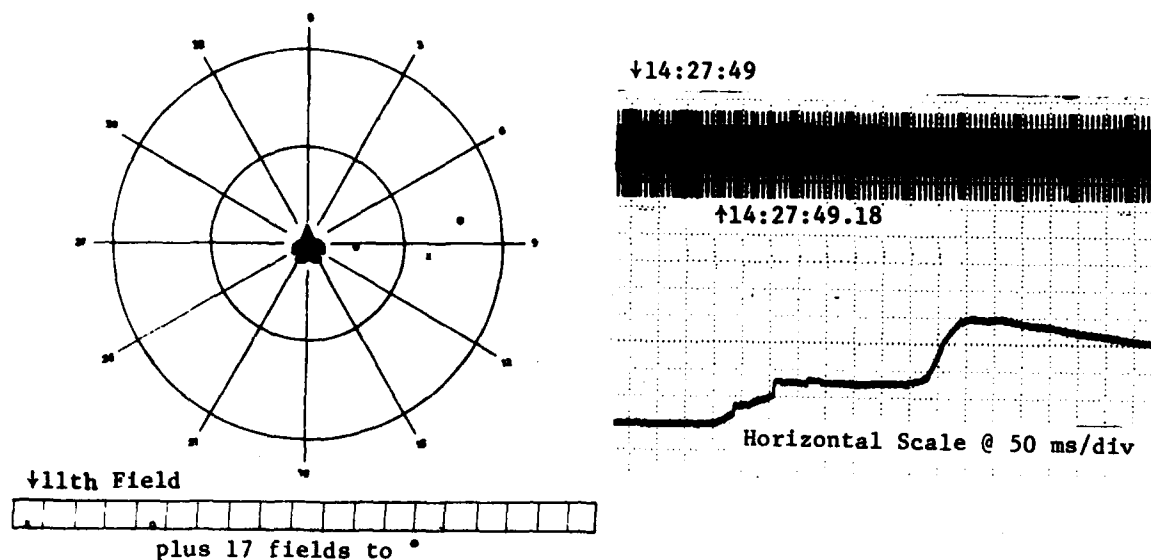
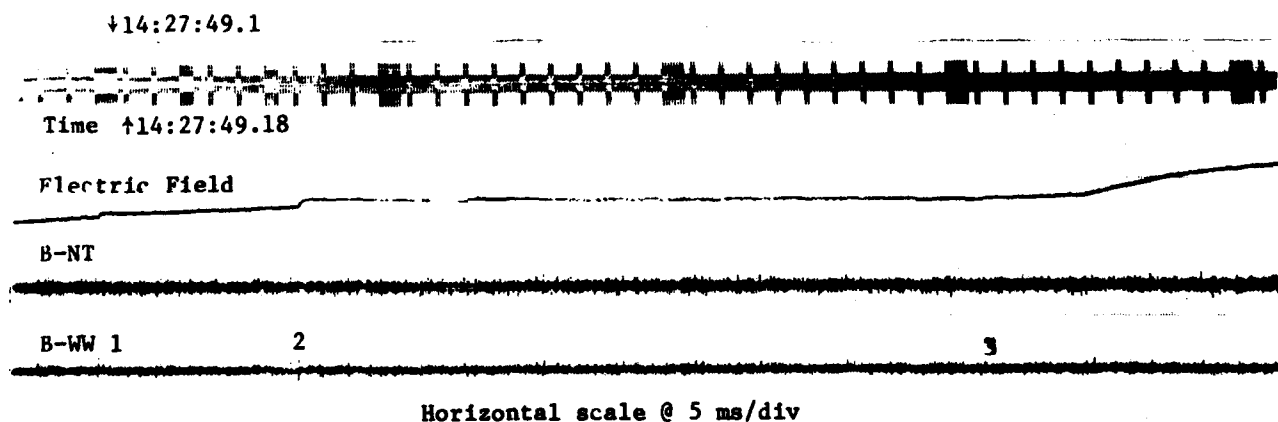
a. Stormscope Display at Time Interval 14:27:49 - 14:27:50

b. Electric Field Record at Time Interval 14:27:49 - 14:27:50

c. Electric and Magnetic Field

Figure 11. Correlation of a Three Stroke Flash at 14:27:49.18 On 25 August 1981

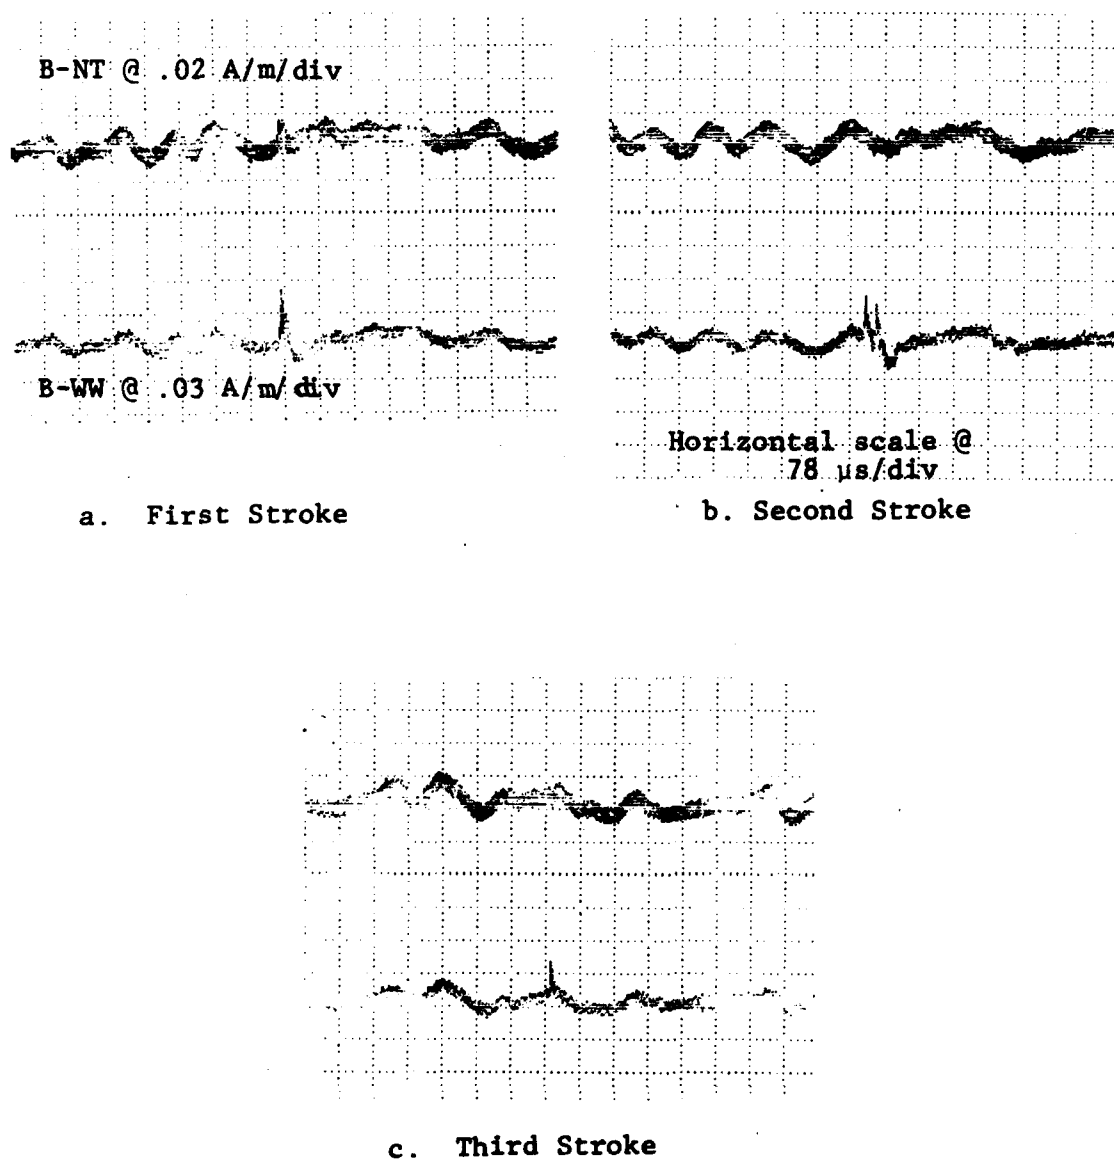
Figure 12. Time Expansion of Magnetic Field Records  
Shown in Figure 11c

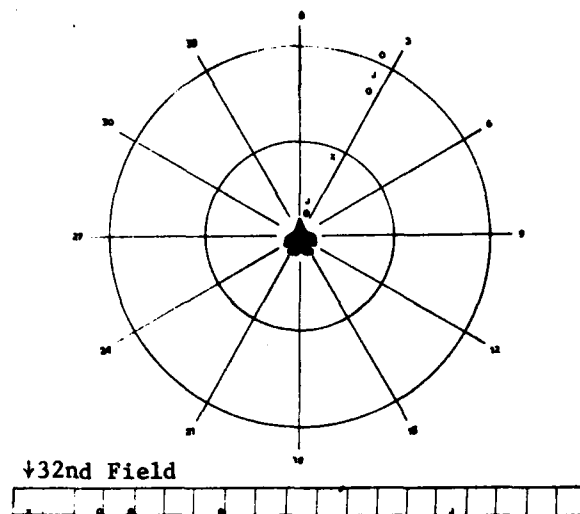
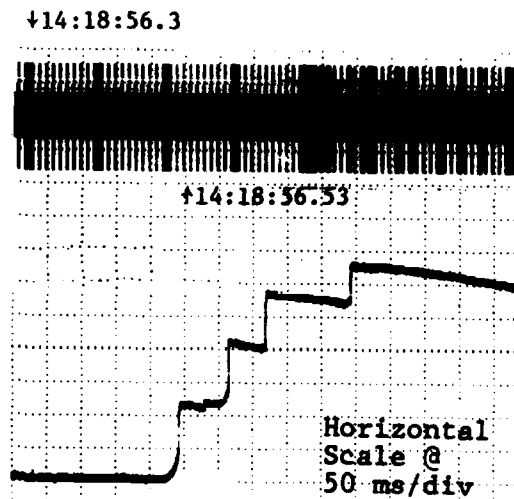
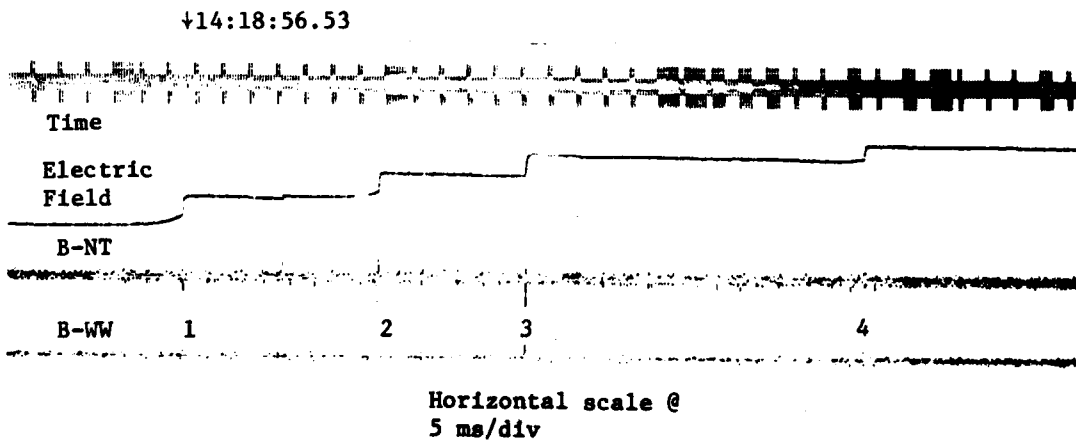
a. Stormscope Display at Time Interval 14:18:56 - 14:18:57

b. Electric Field Record at Time Interval 14:18:56 - 14:18:57

c. Electric and Magnetic Field

Figure 13. Correlation of a Multi-Stroke Flash at 14:18:56

A multi-stroke flash was recorded during the time interval between 14:18:56 and 14:18:57 as shown in Figure 13. The Stormscope display was set to the 25 nmi range. The first dot in (a) appeared 32 fields after the time update at an estimated time of 14:18:56.53. Additional dots appeared 2, 3, 6, and 14 fields later. In the later case, two dots appeared during the same field resulting in a total of six dots. The electric field change as seen in (b) and (c) is of small amplitude for the second dot and the corresponding magnetic field traces in Figure 14(b) indicated a relatively slow rise time when compared to the other events. Fast rise times as shown in 14(a), (c), (d), and (e) are characteristic of cloud-to-ground strokes while slow

rise times are characteristic of other processes such as cloud-to-cloud or intra-cloud discharges. The last two dots, which appeared during the same field, are not separately discernible in the electric field traces shown in Figure 13(b) and (c). However, in the expanded time scale of Figure 14(e), it can be seen that there were two pulses which occurred within a 0.6 ms interval. Comparison of the time intervals between the dots in 13(a) and the intervals between electric field changes in 13(b) shows the correspondence between the two sets of data. The Stormscope azimuth for all the dots is about  $25^{\circ}$  while the calculated azimuths (Figure 14) using magnetic field data were in the range of  $32^{\circ}$  -  $35^{\circ}$ .

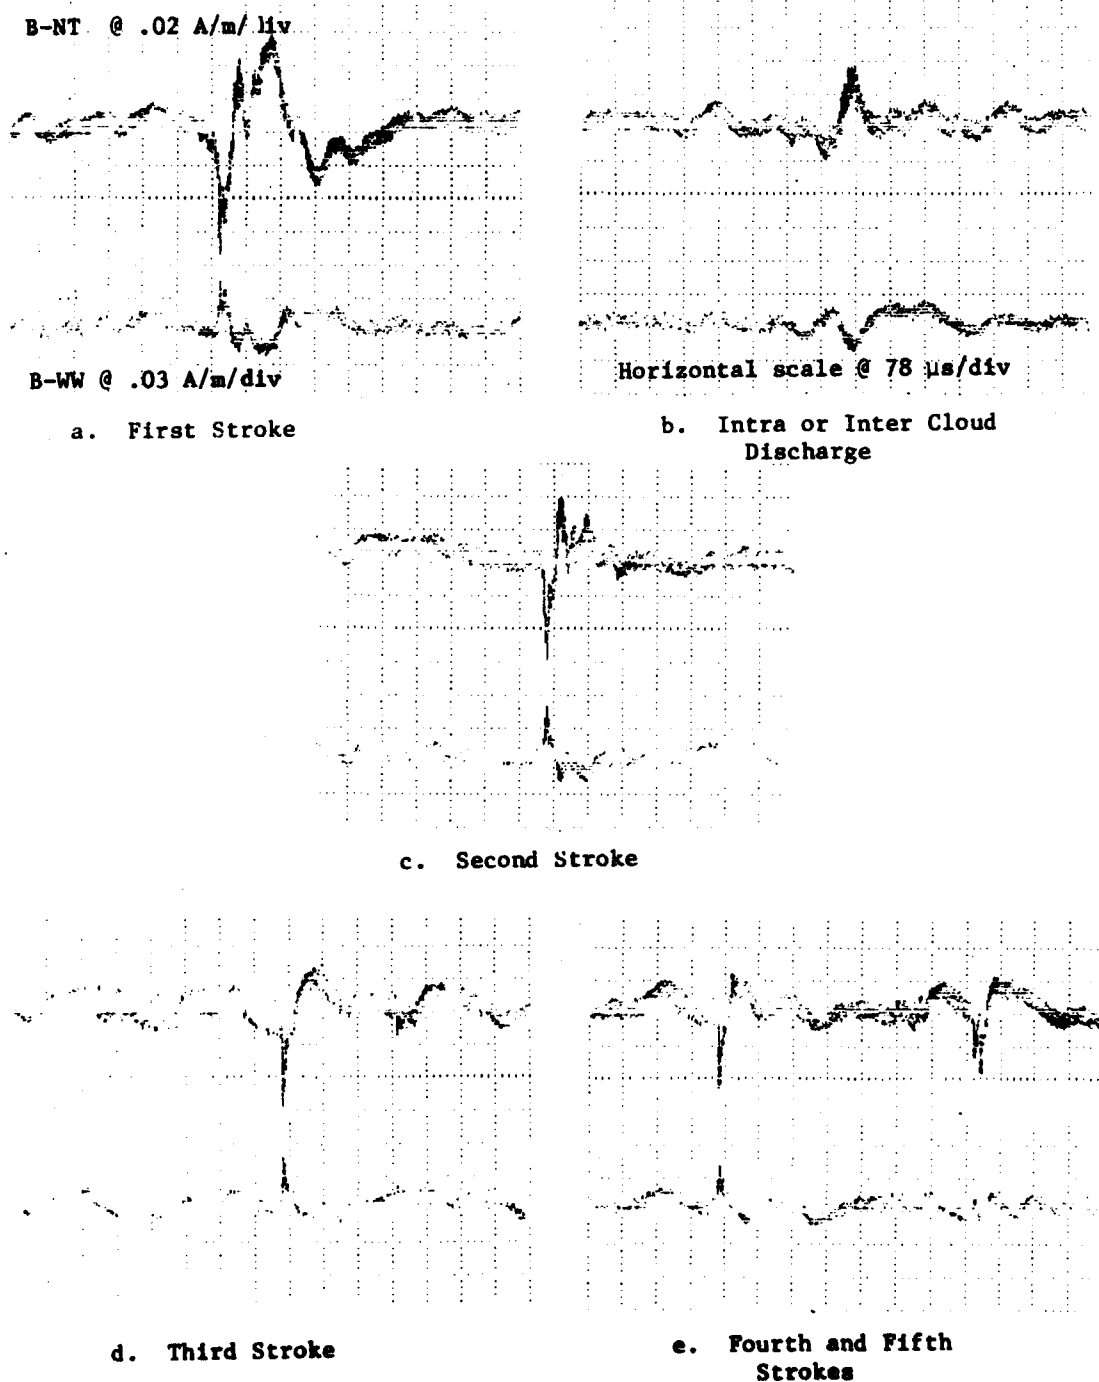
Figure 14. Time Expansions of Magnetic Field Records Shown in Figure 13c

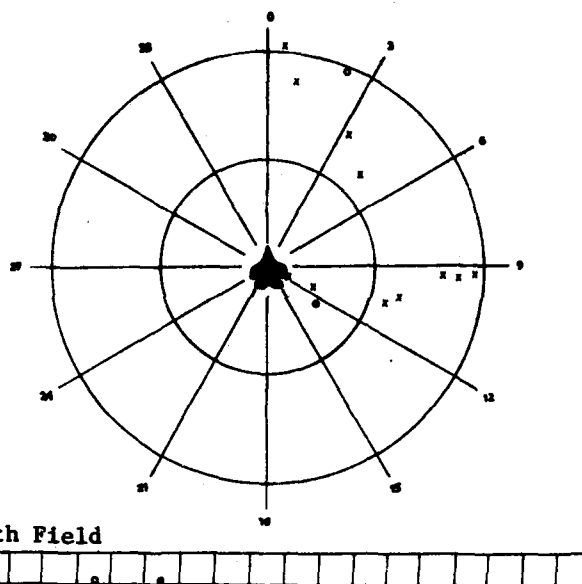
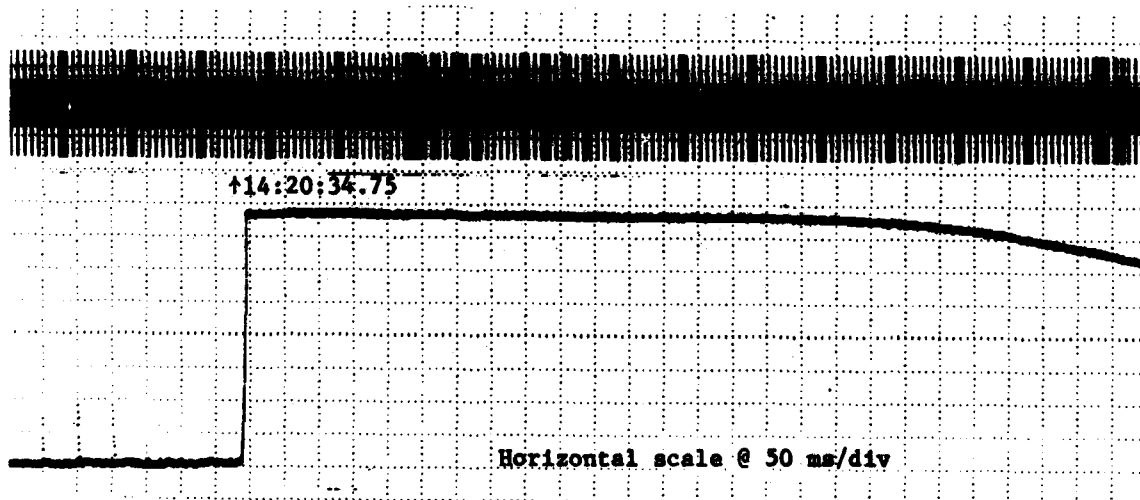
a. Stormscope Display at Time Interval  
14:20:34 - 14:20:35

b. Electric Field Record

Figure 15. Correlation of a Nearby Strike at 14:20:34.75 on  
25 August 1981

During the time interval of 14:20:34 - 14:20:35, a very interesting flash was recorded. The weather radar indicated a storm cell at about 5 kilometers off the right wing. The Stormscope was set on the 25 nmi range. Forty five fields ( $\approx 14:20:34.75$ ) after the time update, eleven dots appeared within the same field (Figure 15(a)). These were followed by single dots four and six fields later. The large amplitude of the electric field sensor (Figure 15(b)) exceeded the dynamic range of the data channel so that direct comparison of Stormscope data with electric field data was not possible except for the start of the flash. The Stormscope pattern included data within a  $90^{\circ}$  quadrant forward and to the right of the aircraft with eight of the 13 dots off of the right wing. Figure 16 shows the electric and magnetic field traces on an expanded time scale. The electric field shows an initial rate of rise with an abrupt transition to a faster (steeper) rate of rise. The initial rate of rise is generally attributed to the rapidly approaching leader while the faster rise is attributed to the cloud-to-ground stroke. Subsequent strokes along the same

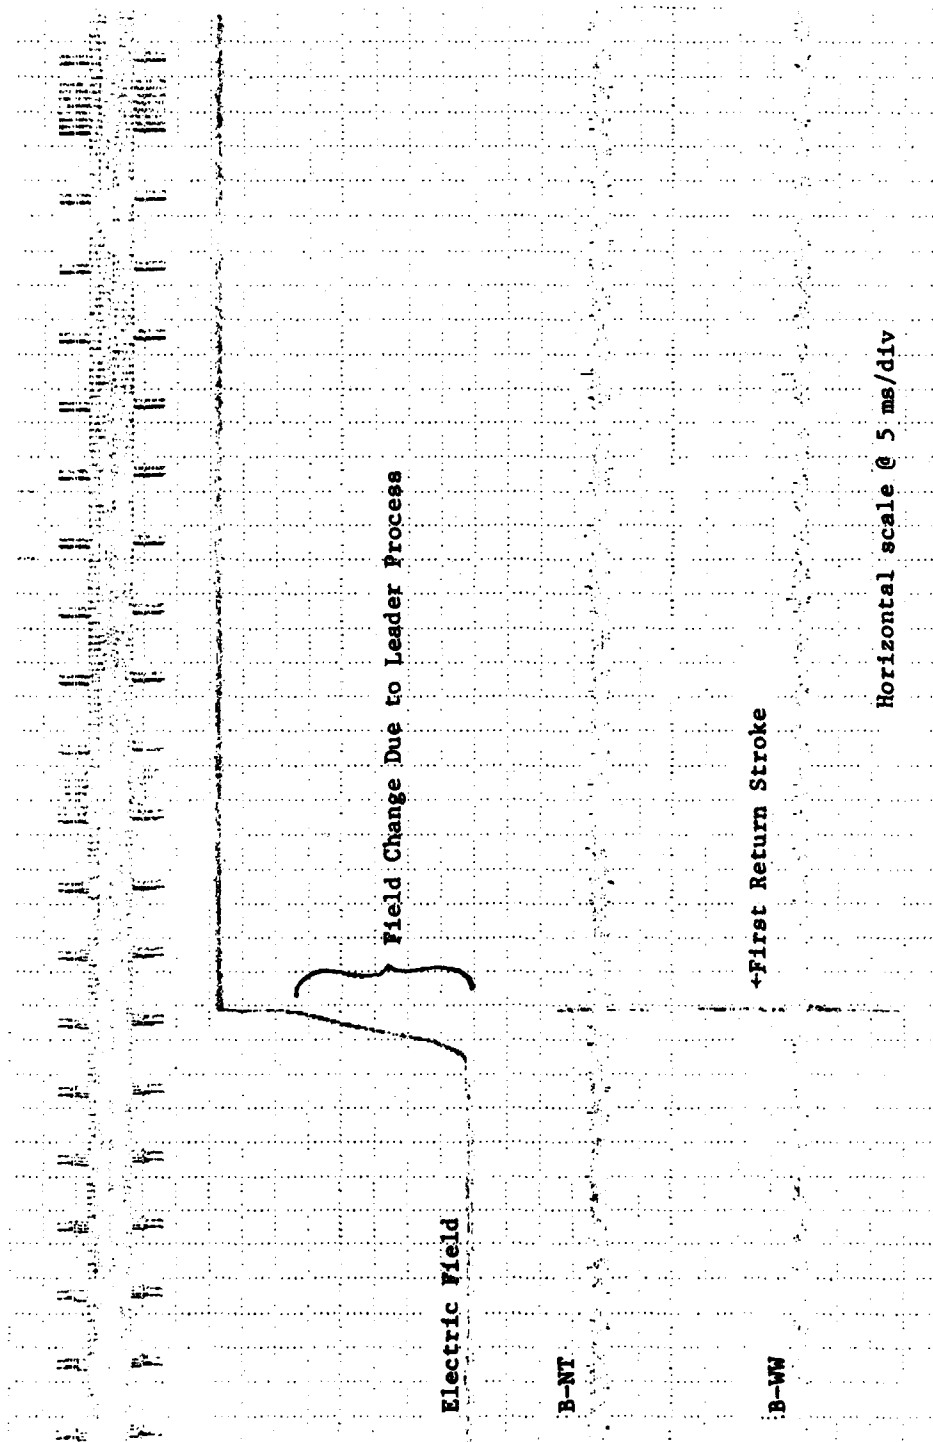
Figure 16. Electric and Magnetic Field Records for Nearby Strike at 14:20:34.75 on 25 August 1981

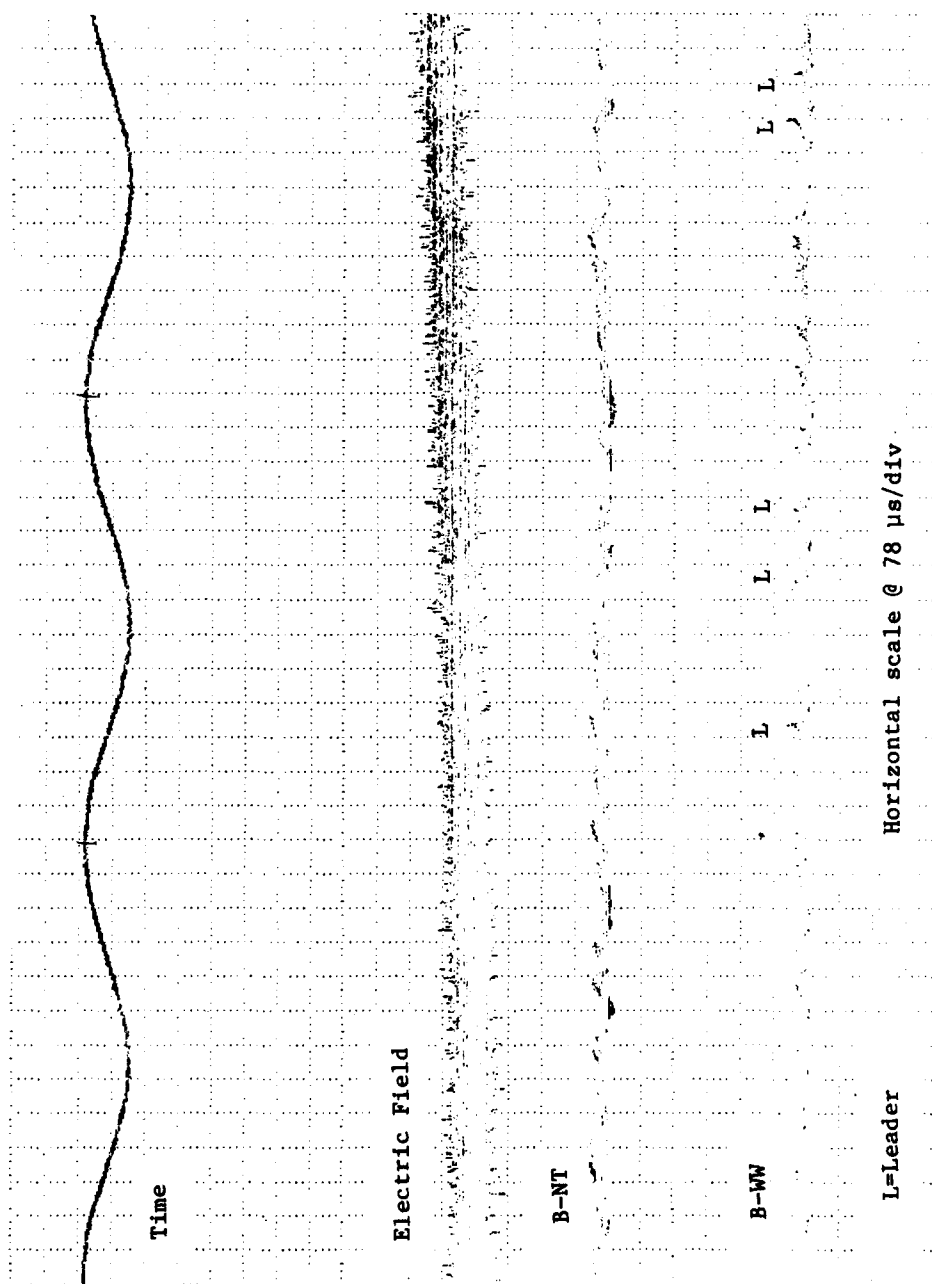
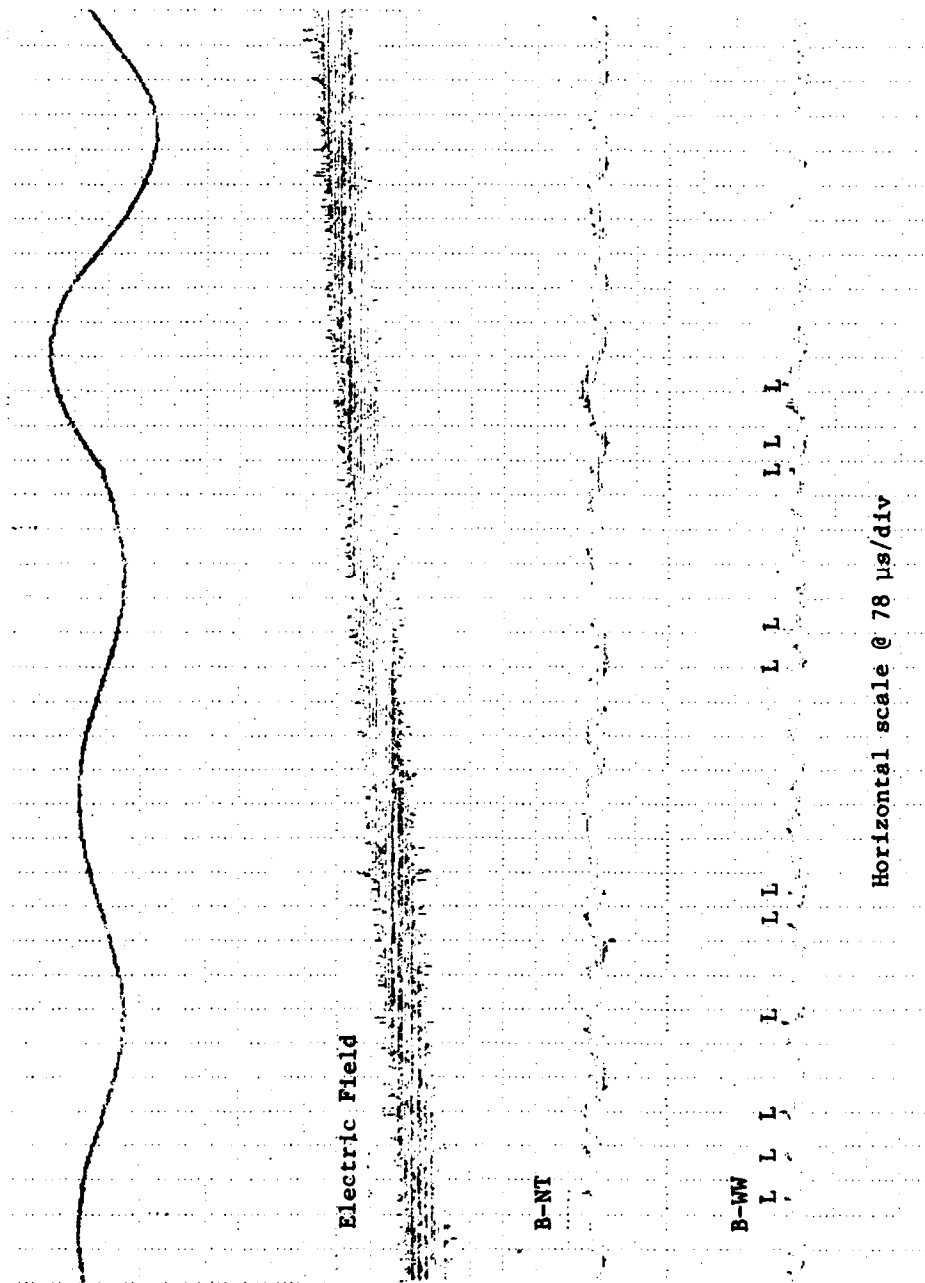
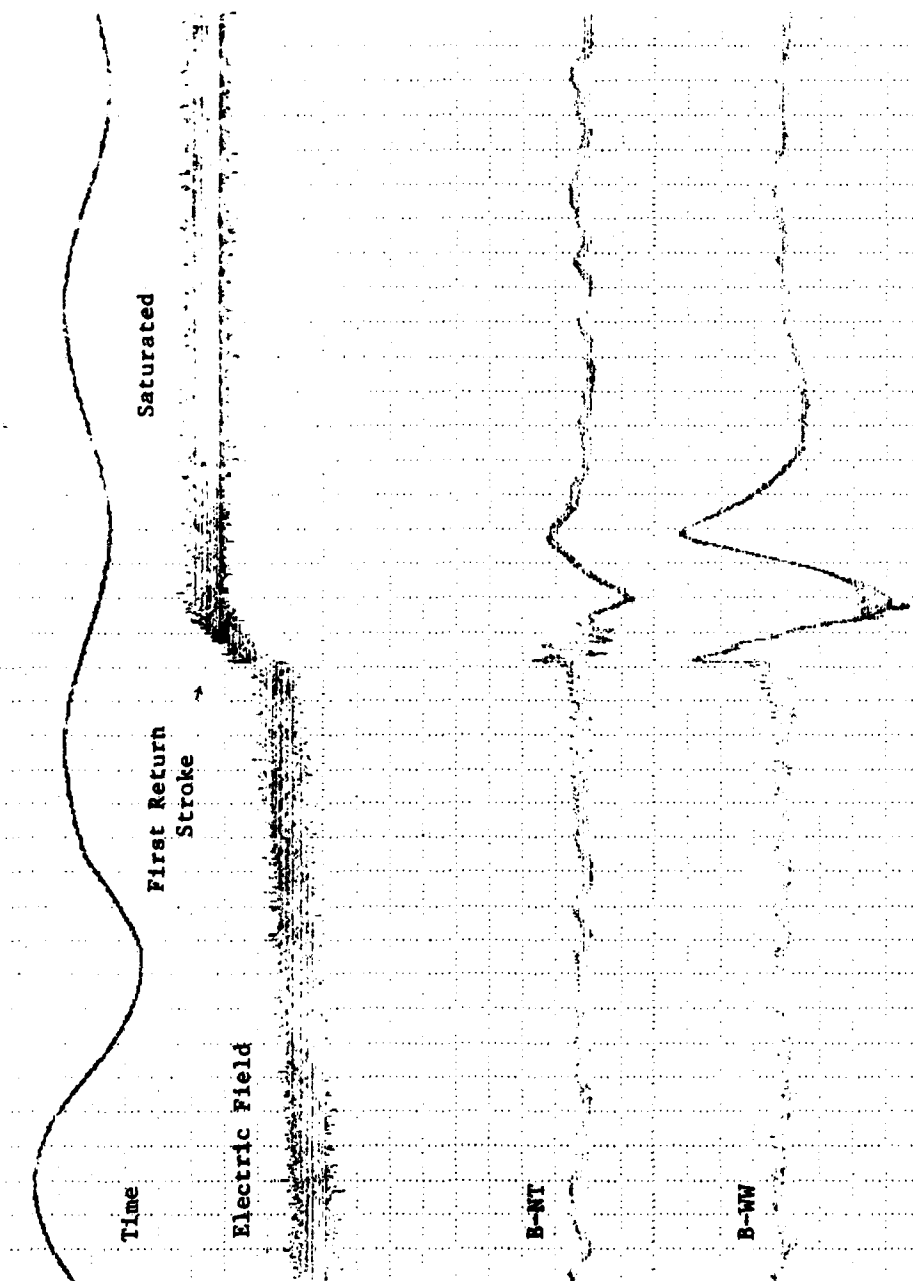
a. Part I

Figure 17. Expanded Electric and Magnetic Field Traces During the Leader Process and First Return Stroke of the Flash at 14:20:34.75 on 25 August 1981

b. Part II

c. Part III

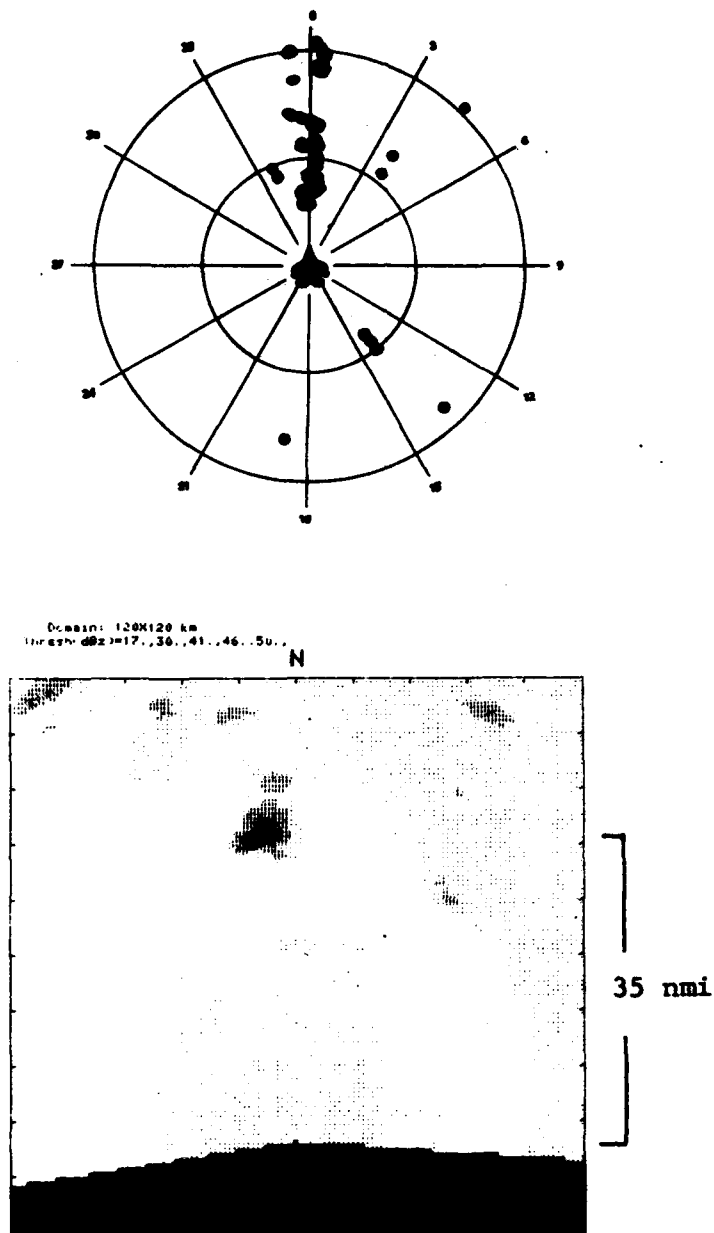
Aircraft at x, heading 355

Figure 19. Stormscope and Weather Radar  
Indications as Aircraft Approaches  
Storm at 15:44:31 EDT on 7 August 1981,  
with Stormscope on 100 nmi Range

A typical sequence of Stormscope indications and the corresponding airborne weather radar data are shown in Figures 19, 20, and 21 as the aircraft flies toward a storm. In Figure 19, the Stormscope is still on the 100 nmi range. Clusters of dots appear on the 360° radial from 28-70 miles out, with scattered dots in other locations. Radar is showing an area with dBz levels up to 51.25 (a third level contour usually indicates about 40 dBz) 37 miles ahead of the aircraft, which is located at the small X near the bottom of the figure. Figure 20 shows the Stormscope pattern shortly after changing to the 50 nmi range. The radar picture is almost the same as before. The Stormscope has only had time to pick up a few events but is still
