DATA ACQUISITION FOR EVALUATION OF AN AIRBORNE  
LIGHTNING DETECTION SYSTEM(U) AIR FORCE WRIGHT  
AERONAUTICAL LABS WRIGHT-PATTERSON AFB OH

L C WALKO ET AL. SEP 83 AFWAL-TR-83-3083

# DATA ACQUISITION FOR EVALUATION OF AN AIRBORNE LIGHTNING DETECTION SYSTEM

Final Report for Period June 1981 - August 1981

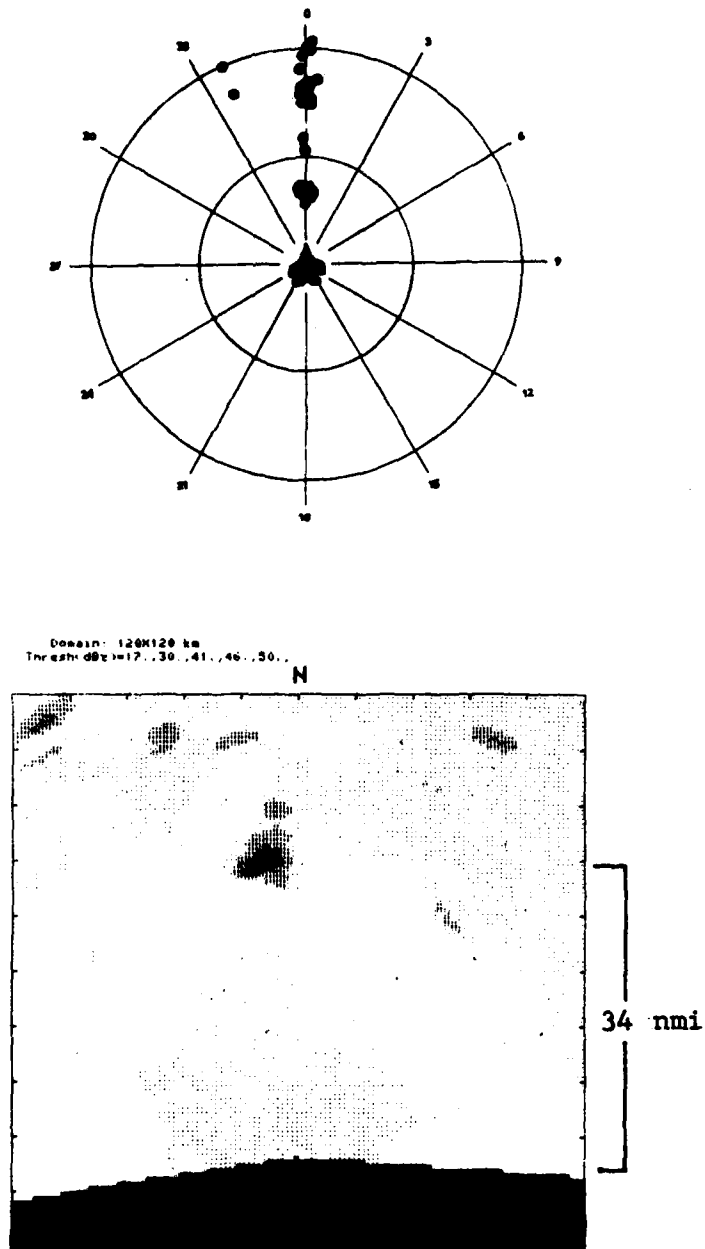
Figure 20. Stormscope and Weather Radar Indications as Aircraft Approaches Storm at 15:44:31 EDT on 7 August 1981, with Stormscope on 50 nmi Range

A typical sequence of Stormscope indications and the corresponding airborne weather radar data are shown in Figures 19, 20, and 21 as the aircraft flies toward a storm. In Figure 19, the Stormscope is still on the 100 nmi range. Clusters of dots appear on the 360° radial from 28-70 miles out, with scattered dots in other locations. Radar is showing an area with dBz levels up to 51.25 (a third level contour usually indicates about 40 dBz) 37 miles ahead of the aircraft, which is located at the small X near the bottom of the figure. Figure 20 shows the Stormscope pattern shortly after changing to the 50 nmi range. The radar picture is almost the same as before. The Stormscope has only had time to pick up a few events but is still

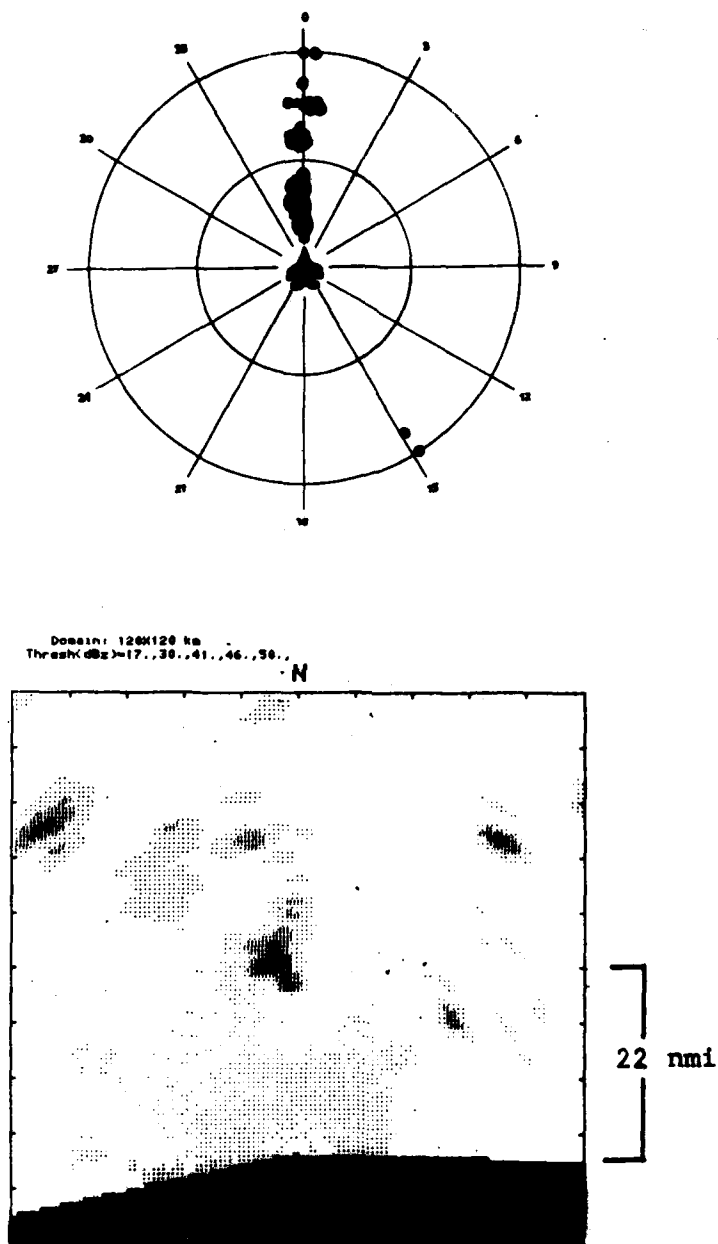
Figure 21. Stormscope and Weather Radar Indications as Aircraft Approaches Storm at 15:50:29 EDT on 7 August 1981, with Stormscope on 50 nmi Range

showing activity from 28-50 miles out on the 360° radial. Figure 21 shows the patterns five minutes later. Radar indicates the storm is 22 nmi away, extending for about 8 miles. Stormscope shows a cluster from 7-23 miles out and light activity from 28-50 miles out. The center of the cluster is at about 15 nmi.

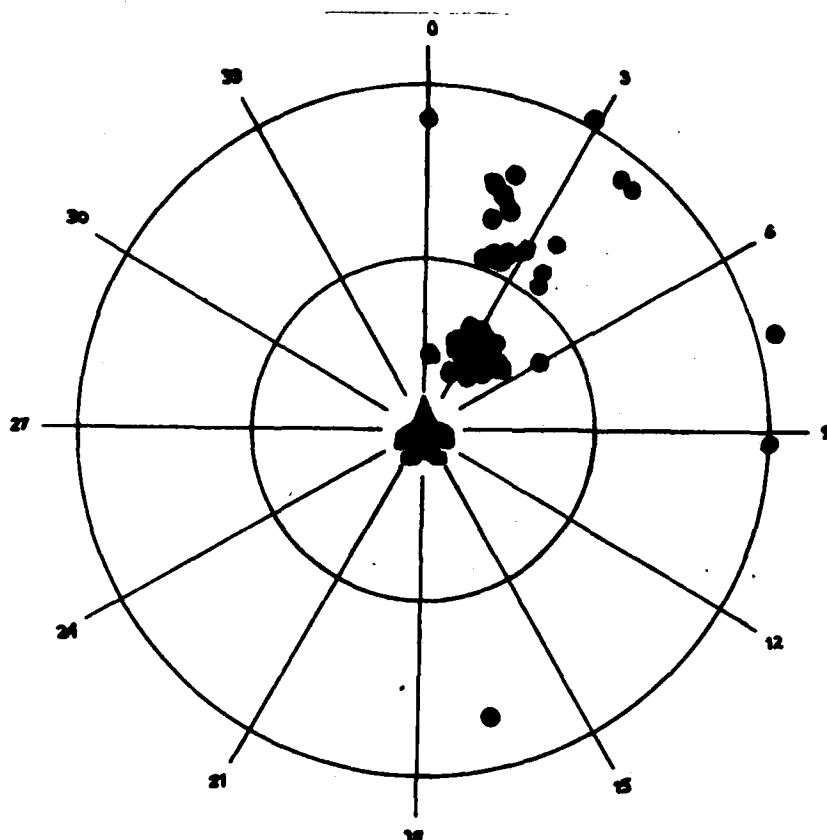
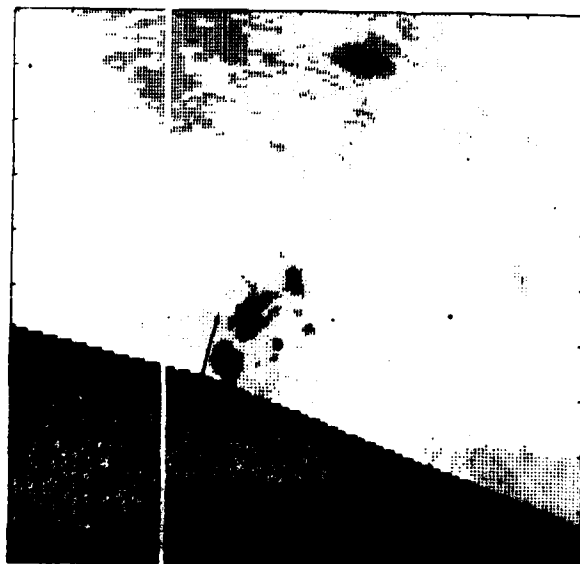
Radar Presentation  
on same scale as  
Stormscope Presenta-  
tion

Figure 22. Stormscope and Weather Radar Indications  
as Aircraft Approaches Storm at  
16:48:41 EDT on 7 August 1981, with  
Stormscope on 50 nmi Range

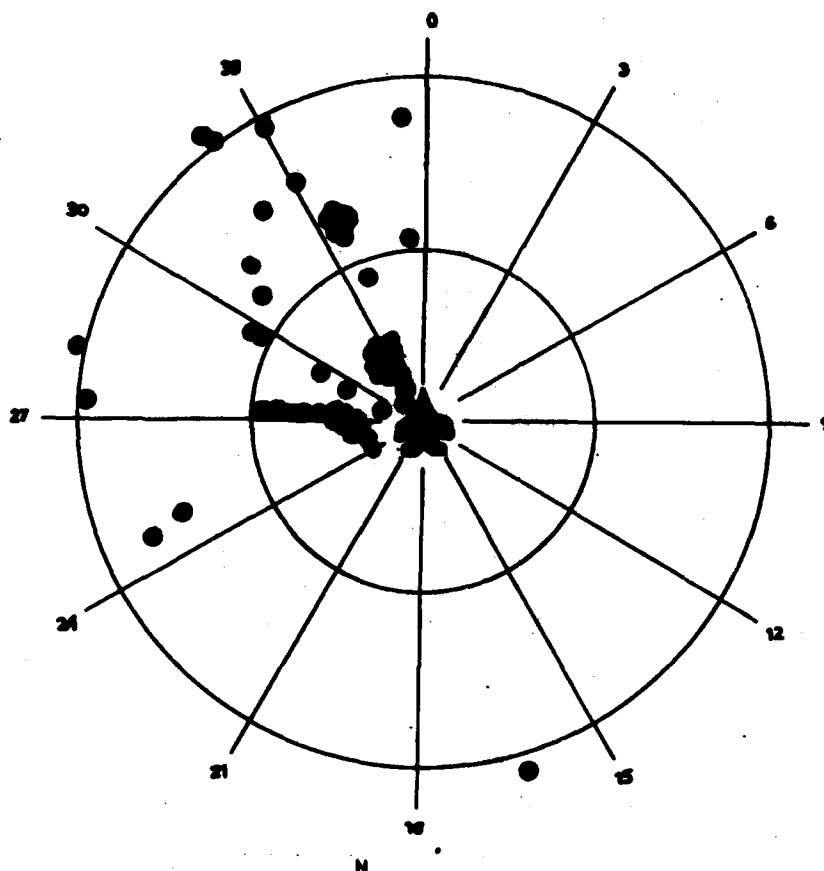
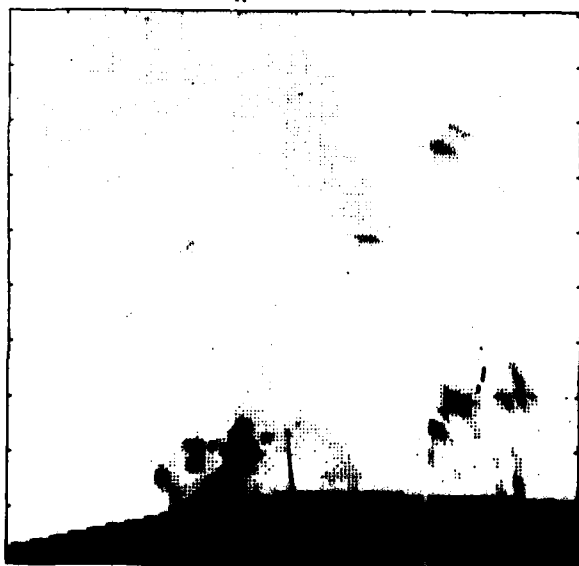
Figure 23. Stormscope and Weather Radar Indications as Aircraft Approaches Storm at 16:54:49 EDT on 7 August 1981, with Stormscope on 50 nmi Range.

Figure 23 illustrates a case in which radar shows activity to the right of the aircraft at about 30 nmi and Stormscope shows a completely clear area. Without penetration of this area it was not possible to tell whether turbulence existed that was not causing electrical activity on the Stormscope or if there was only heavy precipitation. Although the primary purpose of this effort was to study the Stormscope as a lightning detector, two penetrations of this type were made during one flight in which isolated, very small third level contours appeared in areas with no Stormscope indications. In the first penetration, the ride, which lasted approximately 30 seconds, was generally smooth, with only very light turbulence. In the second penetration, however, the 30 second ride included initial light turbulence, then a severe jolt of approximately 20 meters/second up, followed by more light turbulence. No further penetrations were attempted. There were differences of opinion among the flight crew as to the severity, duration, etc. of the turbulence during the second penetration. Similar penetrations, and penetrations in cases where Stormscope shows activity and radar does not, would be needed in a better protected aircraft with turbulence monitoring devices before conclusions could be drawn as to the relative ability of Stormscope vs radar to indicate areas where severe turbulence exists.

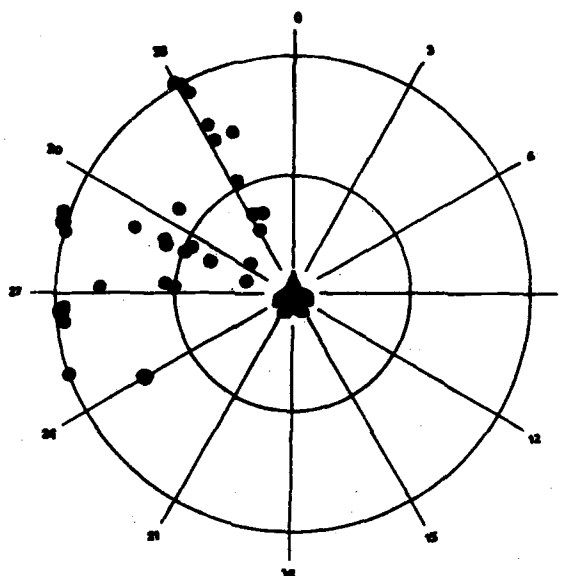
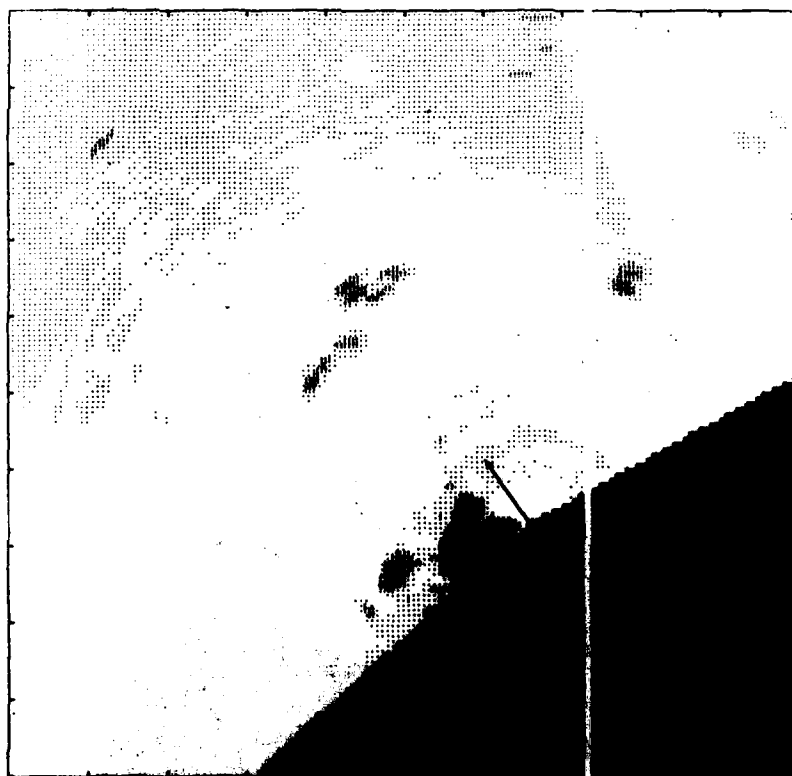
Figure 24. Stormscope and Weather Radar Indications as Aircraft Approaches Storm at 17:08:22 EDT on 7 August 1981, with Stormscope on 25 nmi Range

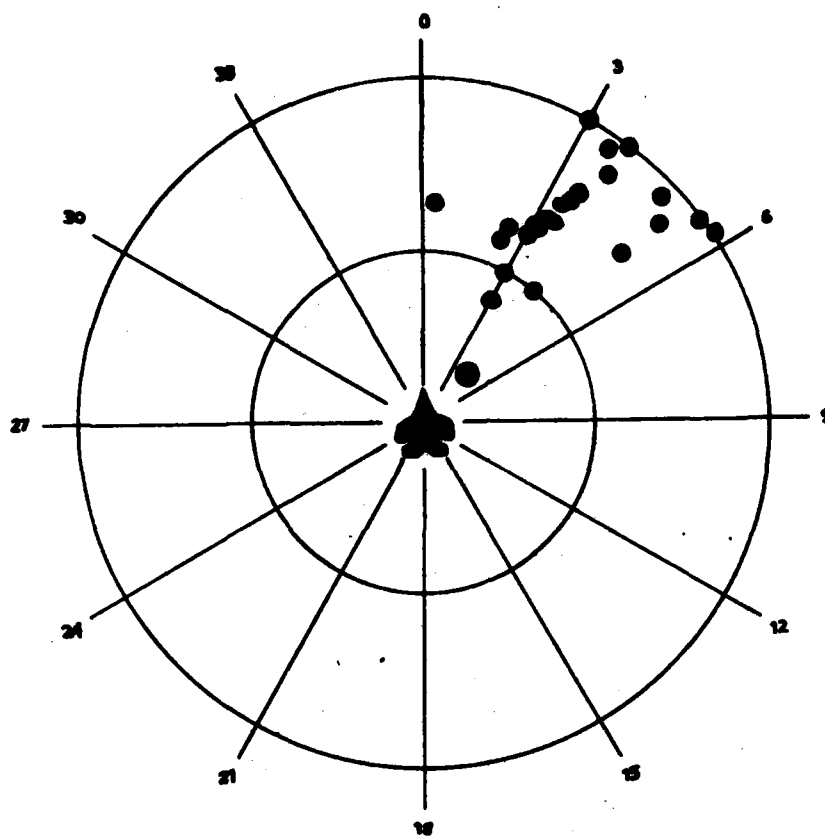
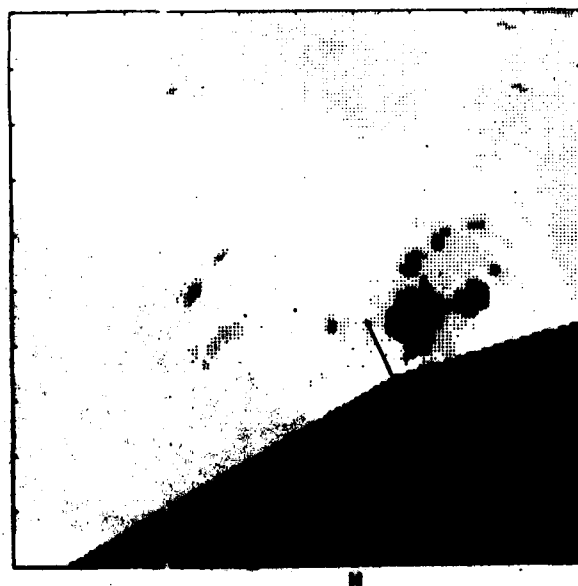
Figure 25. Stormscope and Weather Radar Indications as Aircraft Approaches Storm at 17:13:00 EDT on 7 August 1981, with Stormscope on 50 nmi Range.

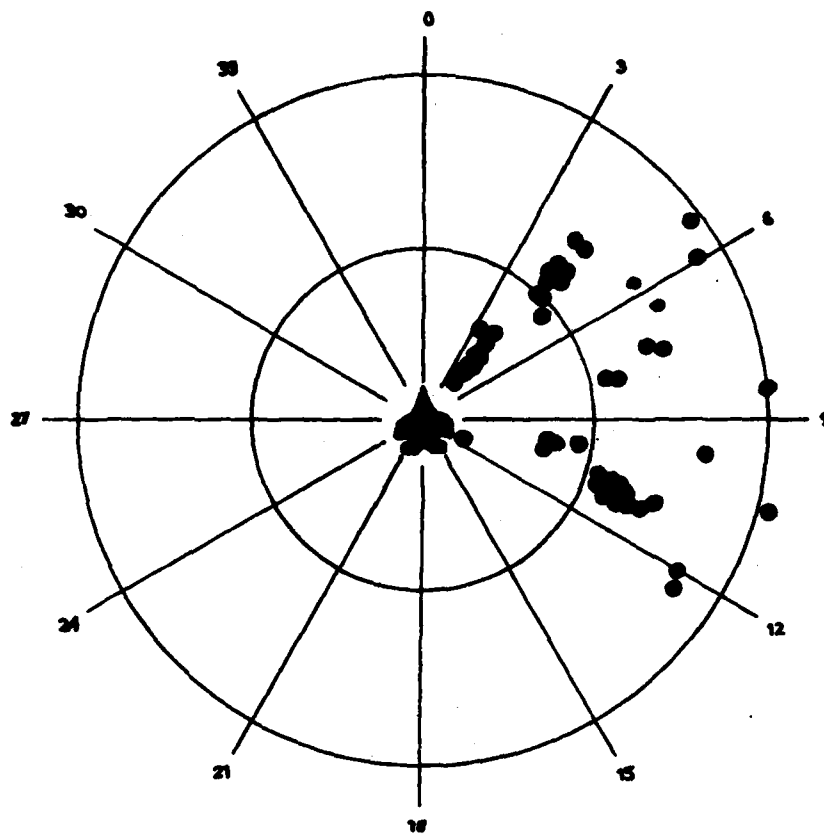
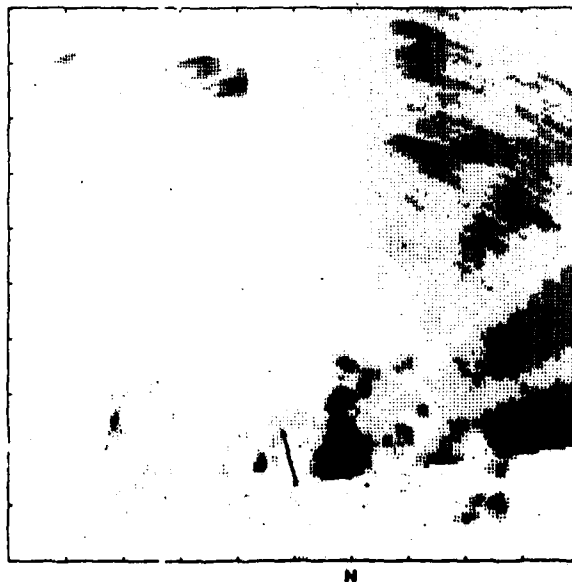
Figure 26. Stormscope and Weather Radar Indications as Aircraft Approaches Storm at 17:14:47 EDT on 7 August 1981, with Stormscope on 50 nmi Range

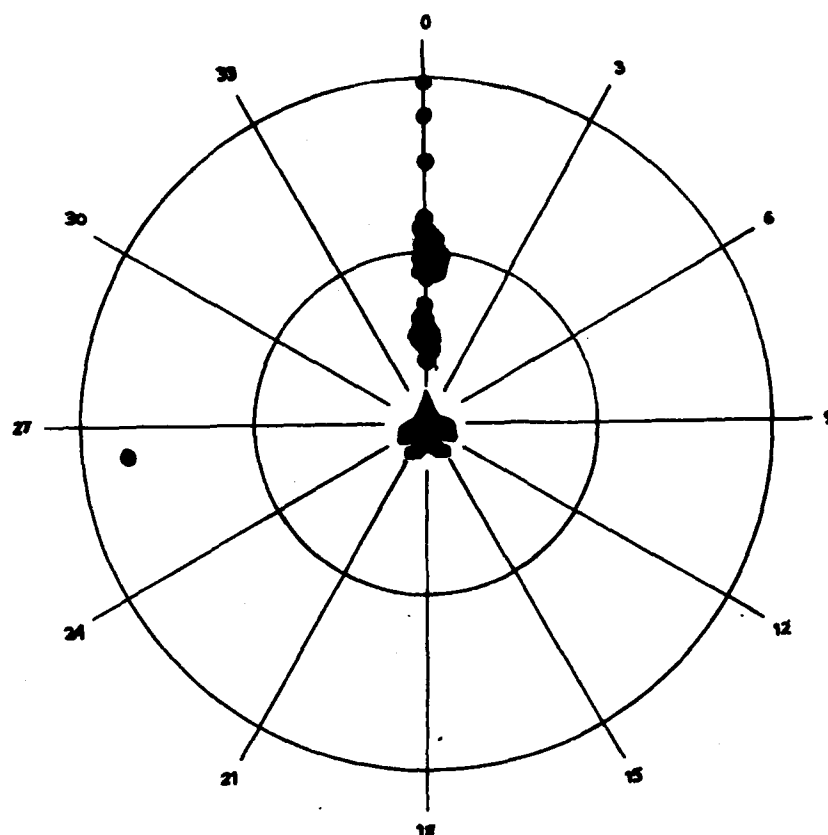
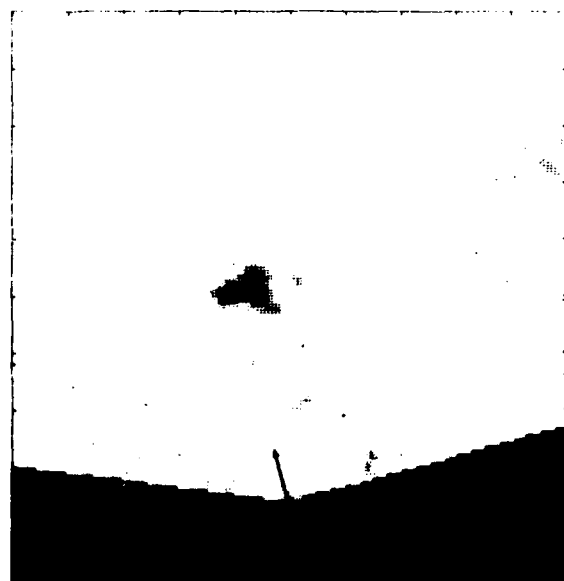
Figure 27. Stormscope and Weather Radar Indications as Aircraft Approaches Storm at 14:14:00 EDT on 25 August 1981, with Stormscope on 50 nmi Range.

Figures 27, 28, 29, and 30 were obtained during the flight on 25 August 1981. In Figures 27 and 30, the Stormscope is on the 50 nmi range. In Figures 28 and 29, it is on the 25 nmi range. Figure 28 is of particular interest in that the Stormscope seems to be showing a non-existent cell at approximately 12 miles out, whereas the cell shown by the radar is at about 25 nmi. In Figure 27, however, a small cell has appeared directly in front of the original storm and it is possible that the earlier Stormscope indications came from this area.

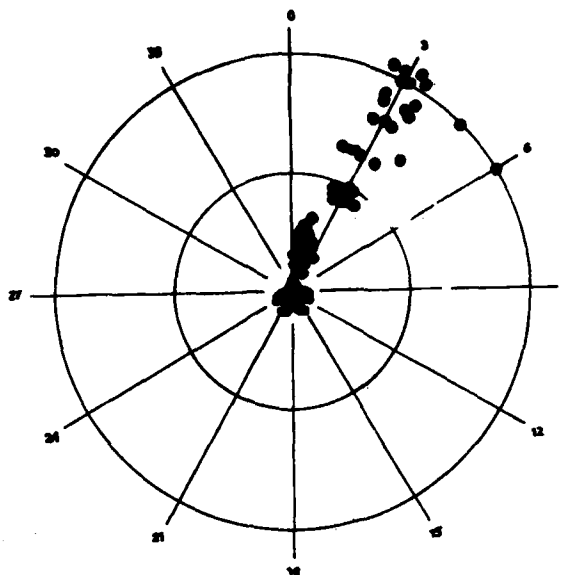
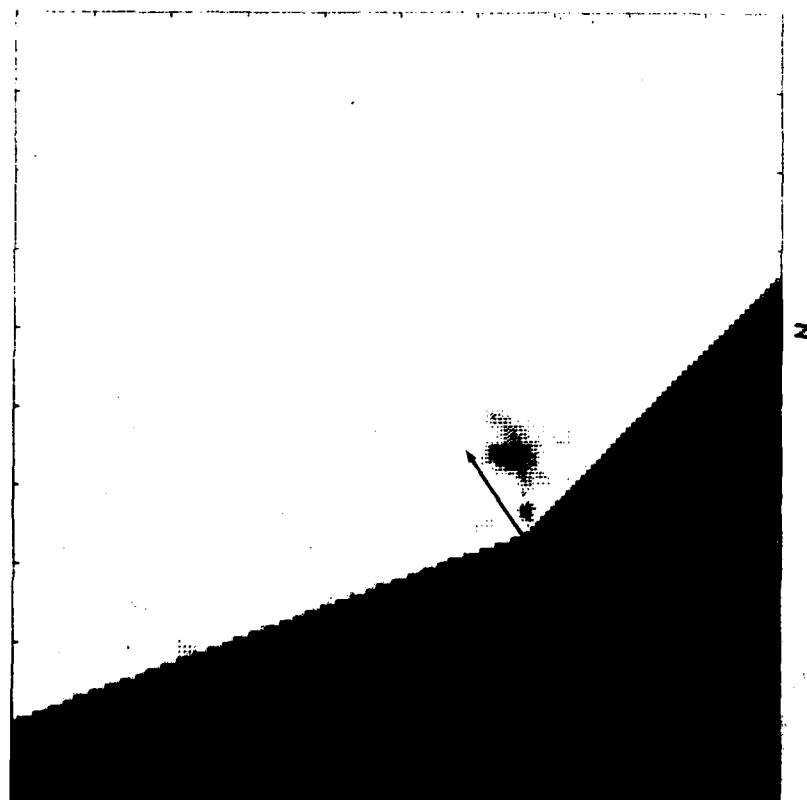
Figure 28. Stormscope and Weather Radar Indications as Aircraft Approaches Storm at 14:19:56 EDT on 25 August 1981, with Stormscope on 25 nmi Range

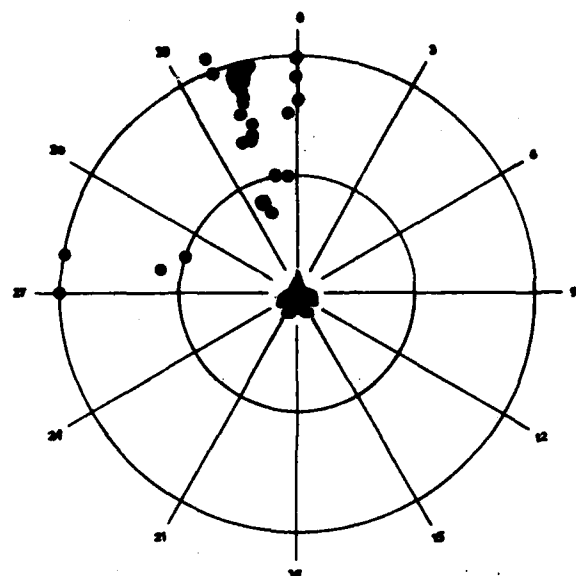
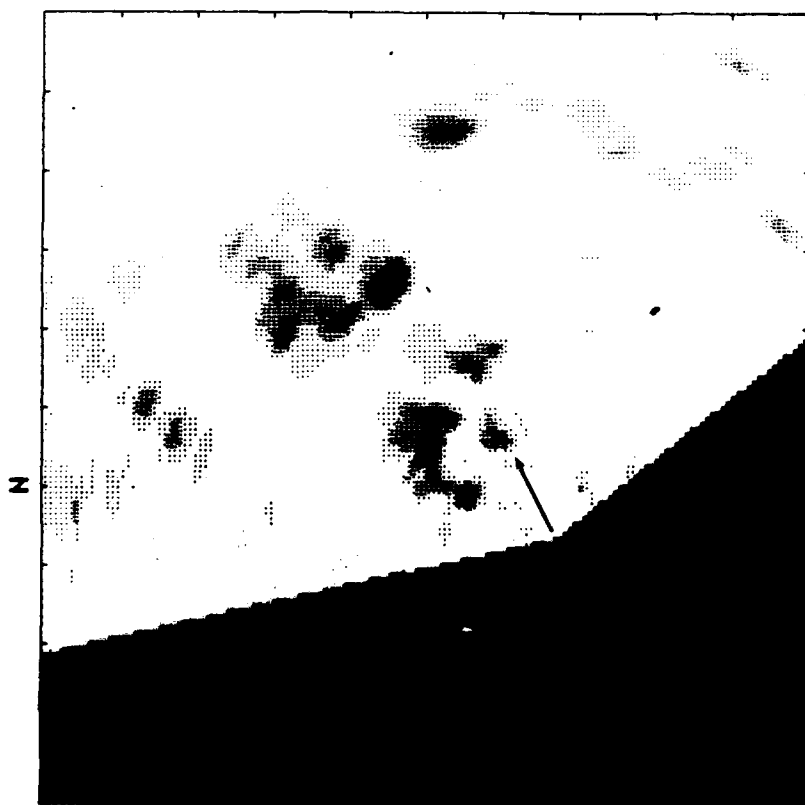
Figure 29. Stormscope and Weather Radar Indications as Aircraft Approaches Storm at 15:24:17 EDT on 25 August 1981, with Stormscope on 25 nmi Range.

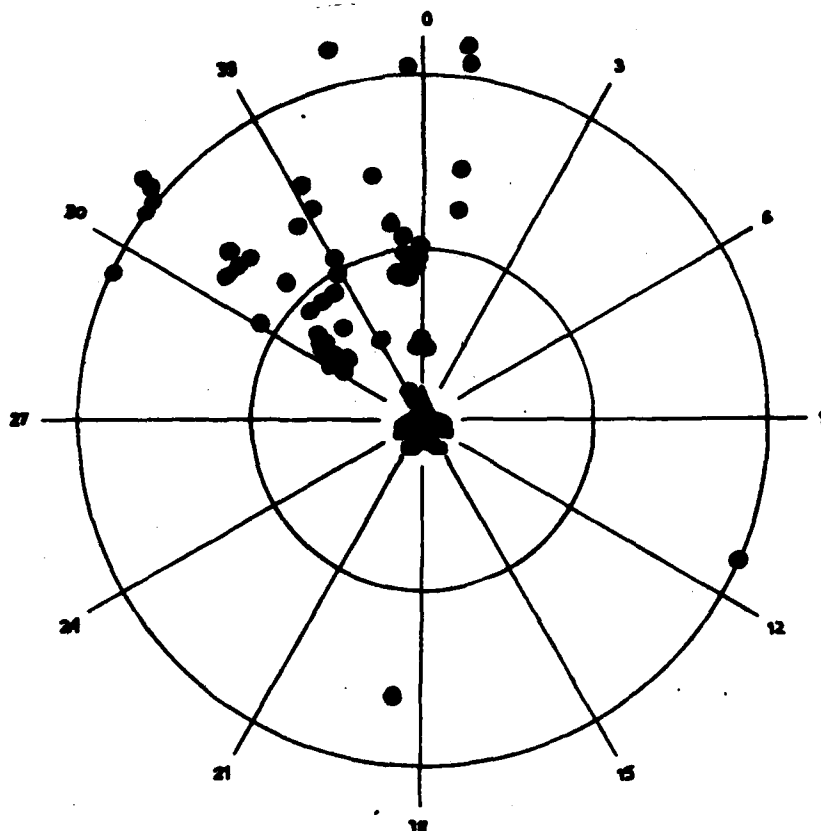
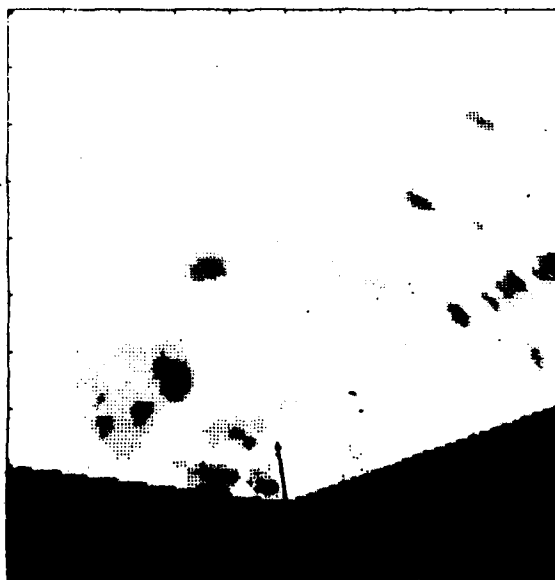
Figure 30. Stormscope and Weather Radar Indications as Aircraft Approaches Storm at 15:26:30EDT on 25 August 1981, with Stormscope on 50 nmi Range

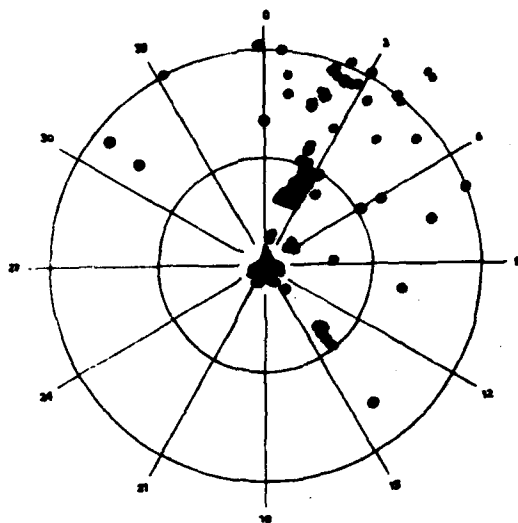
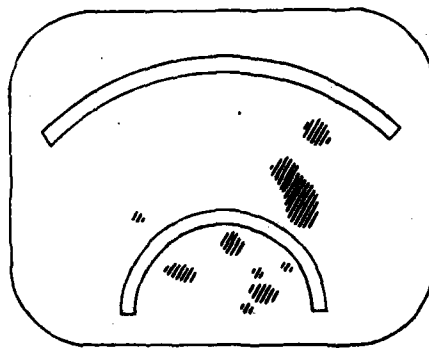
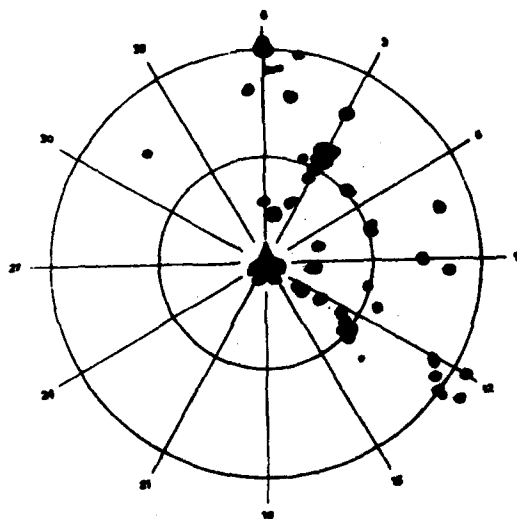
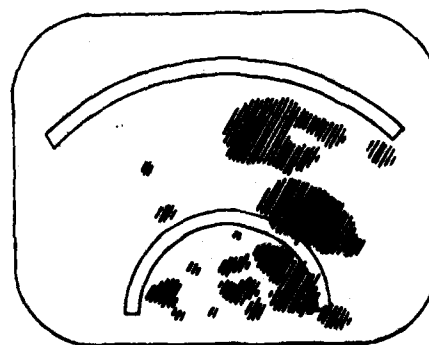
a. 17:17:12 EDT

b. 17:20:29 EDT

Figure 31. Stormscope and Weather Radar Indications Before the Direct Strike on 17 July 1981

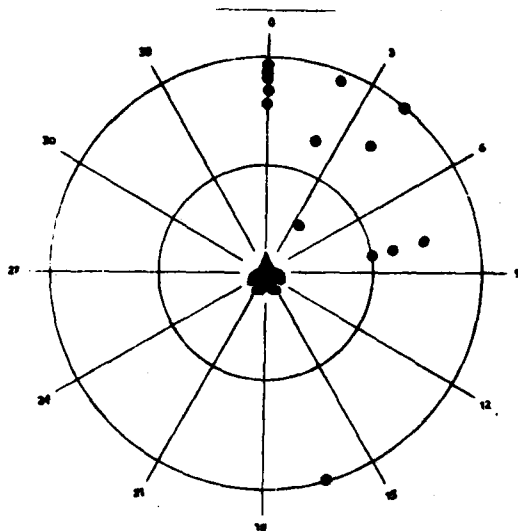
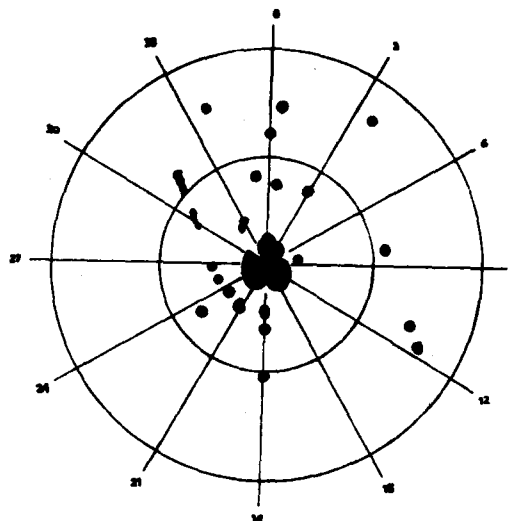
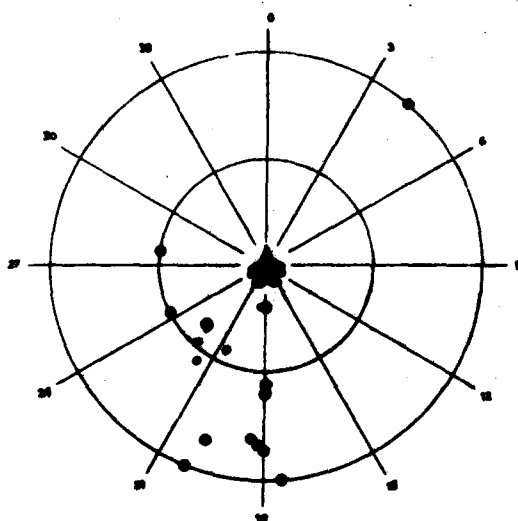
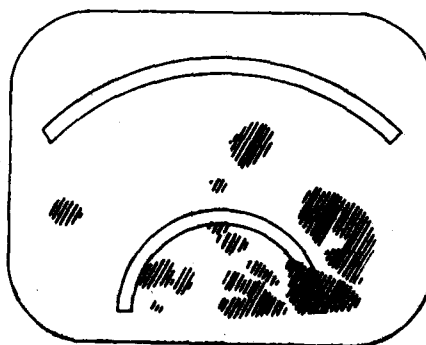
a. Immediately Prior to Strike  
(17:21:37)

b. At Strike  
(17:21:43.9)

c. After Strike  
(17:24:40)

d. Weather Radar  
(17:21:37)

**Figure 32. Stormscope and Weather Radar Indications Associated with The Direct Strike on 17 July 1981**
