NWC TP 6517

An Evaluation of Permanent Solder Masks for High Reliability Applications

Donna J. Sanger
Engineering Department

FEBRUARY 1984

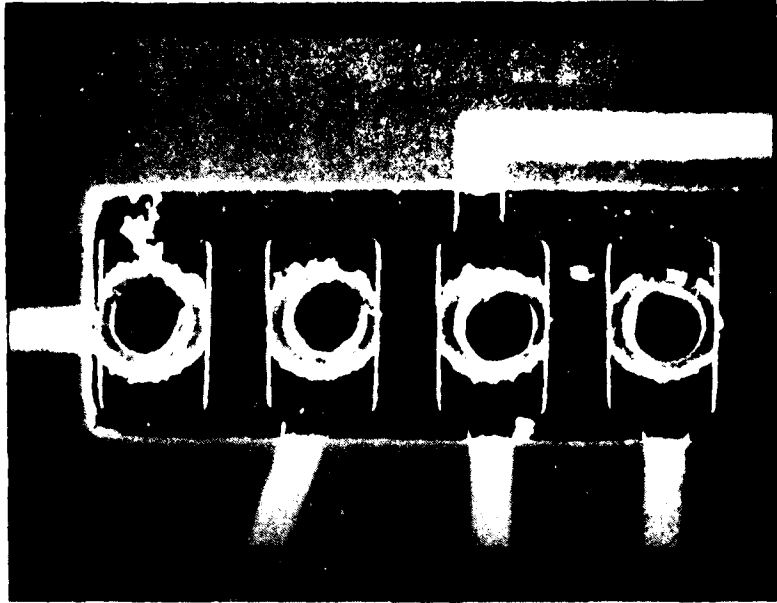
FIGURE 2. Vactel 740FR. Solder Mask on Perimeter of Plated-Thru-Holes.

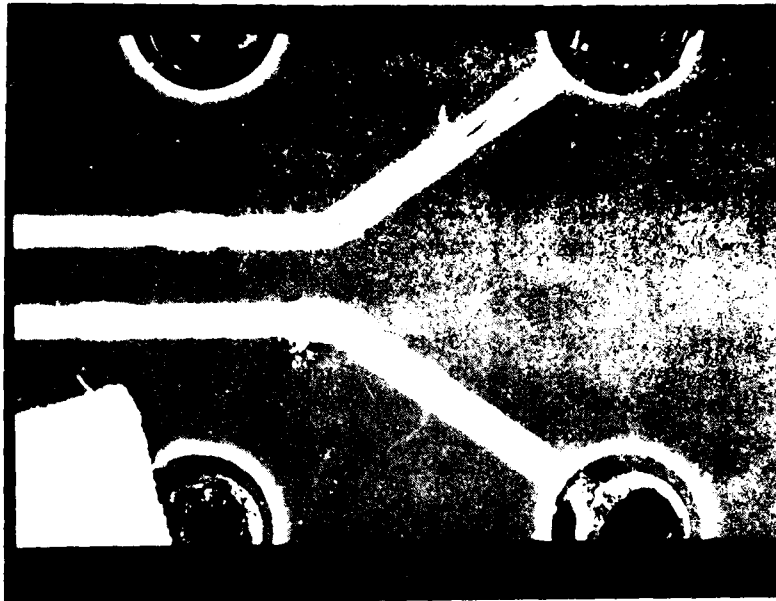
FIGURE 18. Laminar RM. Mask Loose and Cracked on "Y" Pattern.

The cleanliness test solution caused the Laminar RM to separate from the laminate and the metal in many areas but flux remained trapped under the mask that had not separated. See Figures 18, 19, and 20. Probing easily flaked the mask off of the board. See Figure 21. Ionic contamination values were unacceptably high at an average of 15 micrograms/square inch.

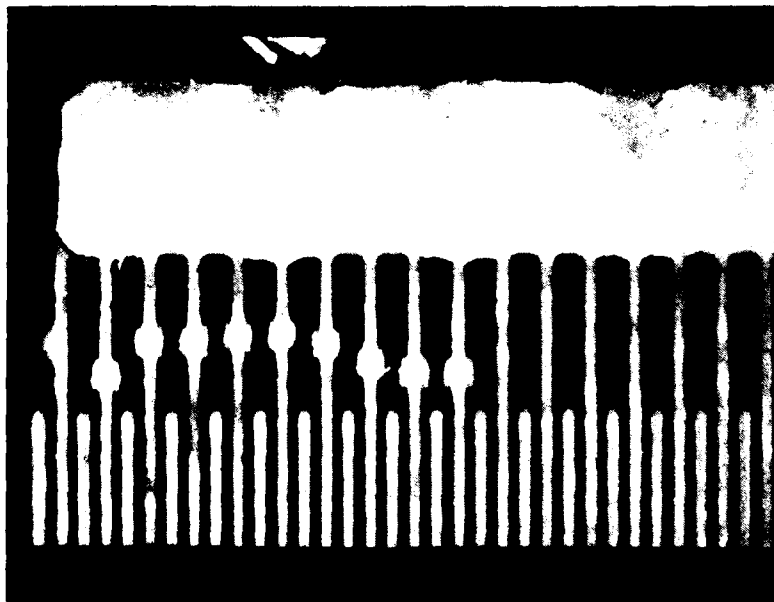
FIGURE 19. Laminar RM. Mask Lifted and Blistered on Comb Pattern.

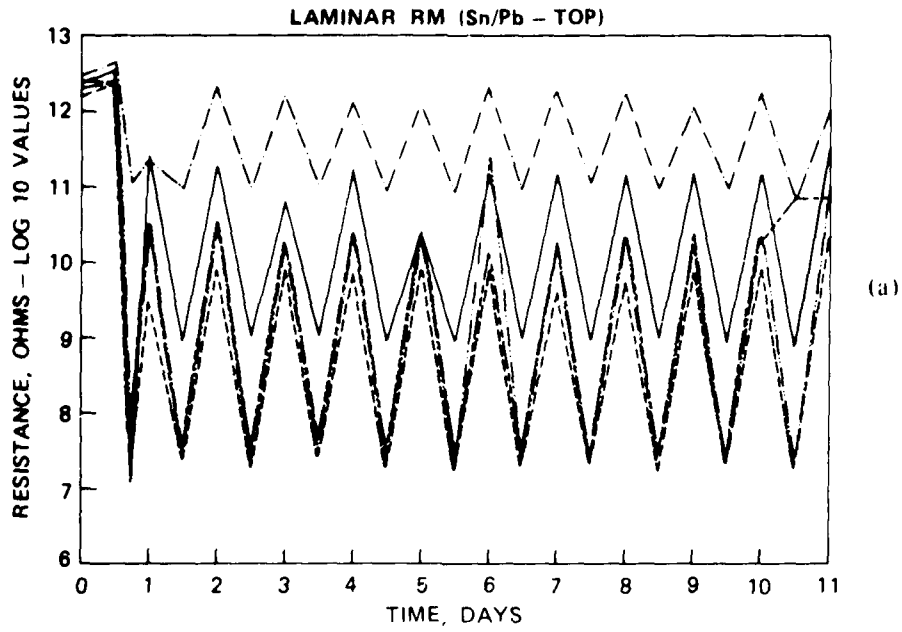
FIGURE 22. Laminar RM. Resistance Values, Tin/Lead.
(a) Top. (b) bottom.

The resistance readings for Laminar RM taken during the moisture/temperature cycling test were lower than the unmasked standard but were above the megohm range. See Figures 22 and 23. An explanation for the lower readings could be the board fabrication and processing variables in addition to the higher ionic level of the Laminar RM that would encourage a lower resistance between the traces of the comb. The very high resistance values for the tin/lead board (top) Sample B are probably due to board fabrication variations.

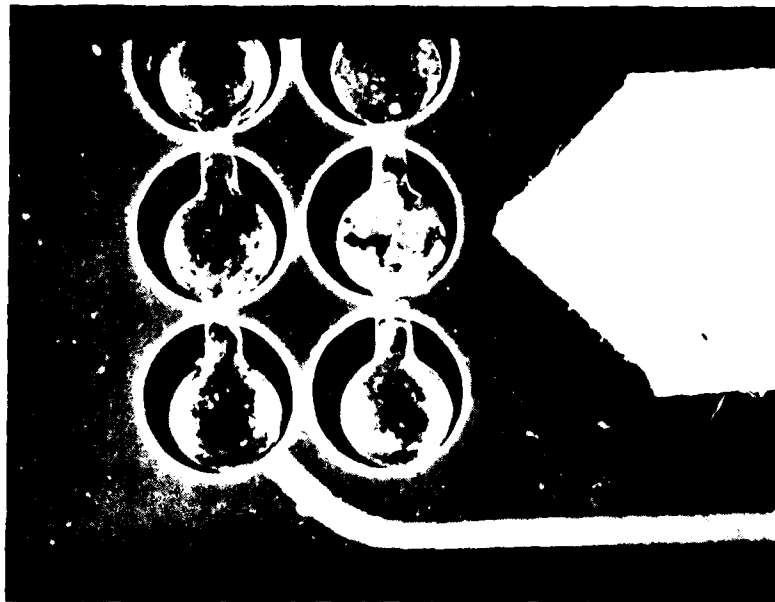
FIGURE 30. Laminar RM (IPC-B-25). Unsolderable Pad Due to Solder Mask Debris.

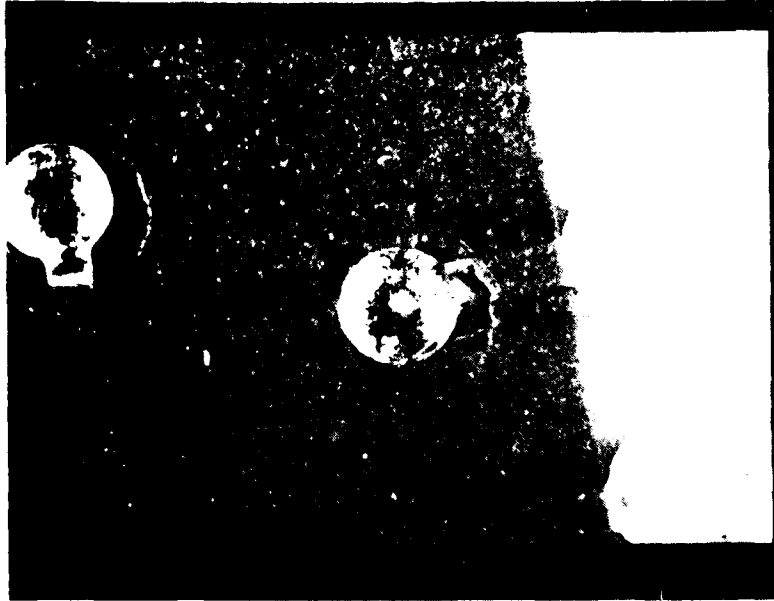
FIGURE 32. Hysol SR1010. Misregistration of Mask on Pads.

Visual inspection before testing of SR1010 showed many voids, bubbles, and pinholes across the boards, inclusions, areas of thin and thick coverage, and irregular pad openings. The irregular pad openings were caused by a misalignment on the second pass of the squeegee. See Figures 31 and 32. A grid pattern from the screen was visible on the open area of some of the ground planes. See Figure 33.

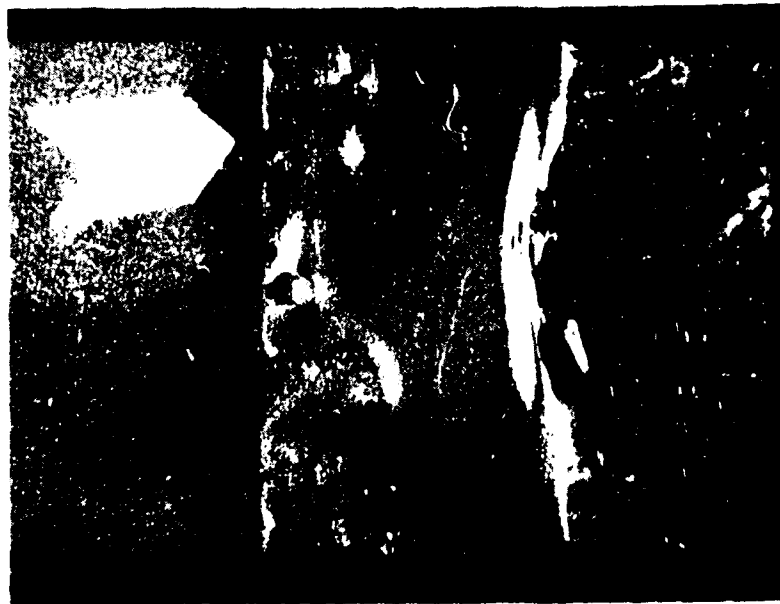
FIGURE 37. Hysol SR1000. Flux Trapped Under Wrinkled Mask on Ground Plane.

The wave soldering process caused wrinkling of both masks over the tin lead. In areas where misregistration allowed solder mask onto the pad, the fillets were deformed. Flux was trapped under the wrinkled mask in the ground plane and along traces for one-quarter inch from the opening. See Figures 37 and 38. The traces were wrinkled on both the top and bottom sides of the boards and after 24 hours, the flux could be seen near the edges of the traces where it had seeped from under the wrinkled mask. See Figure 39.

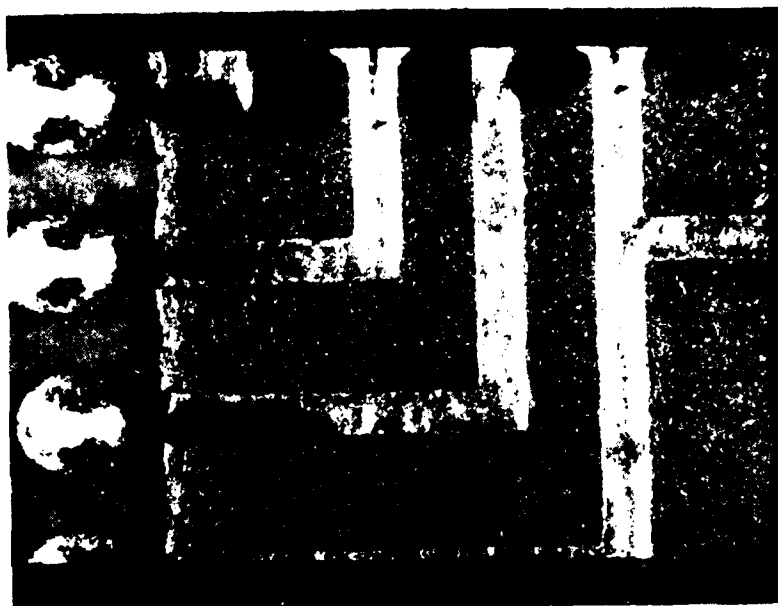
FIGURE 38. Hysol SR1010. Flux Trapped Under Wrinkled Mask on Ground Plane.

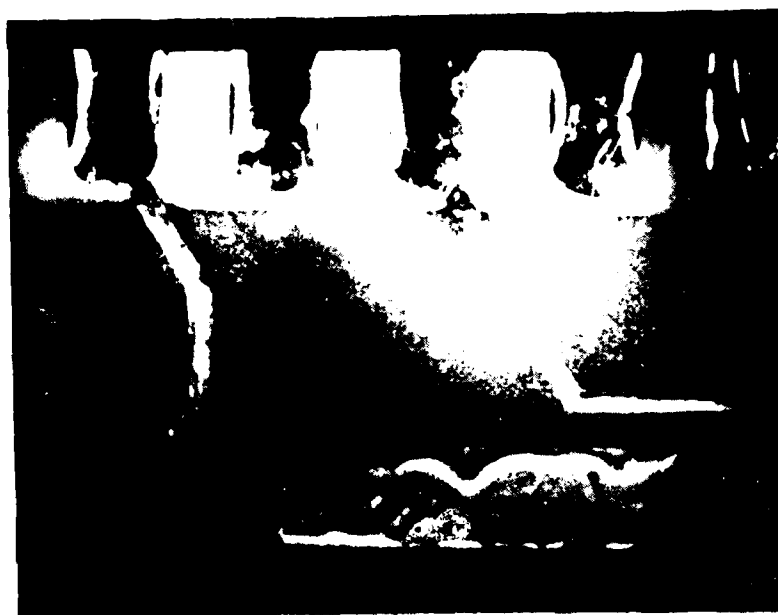
FIGURE 39. Hysol SR1010. Flux Seeped Out From Under Wrinkled Mask.

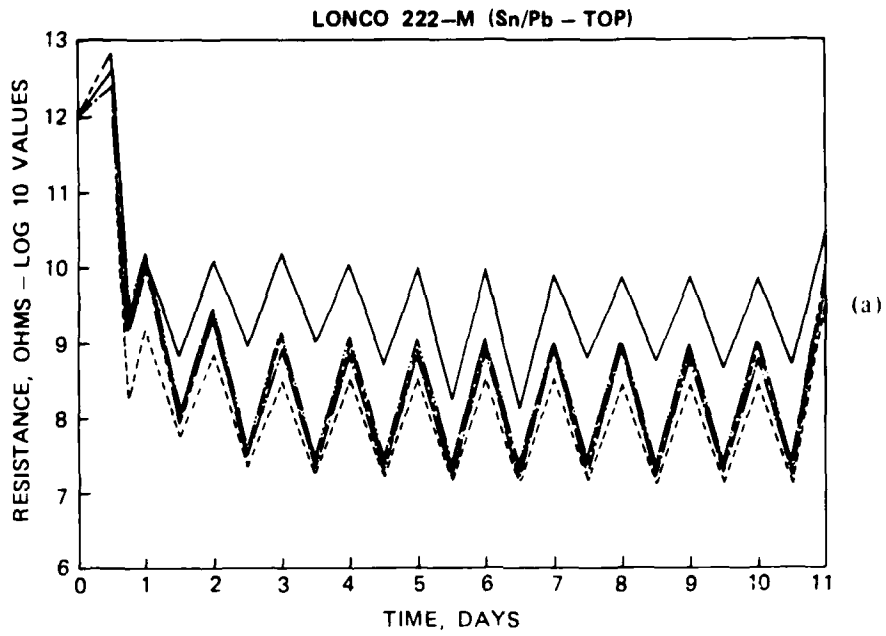
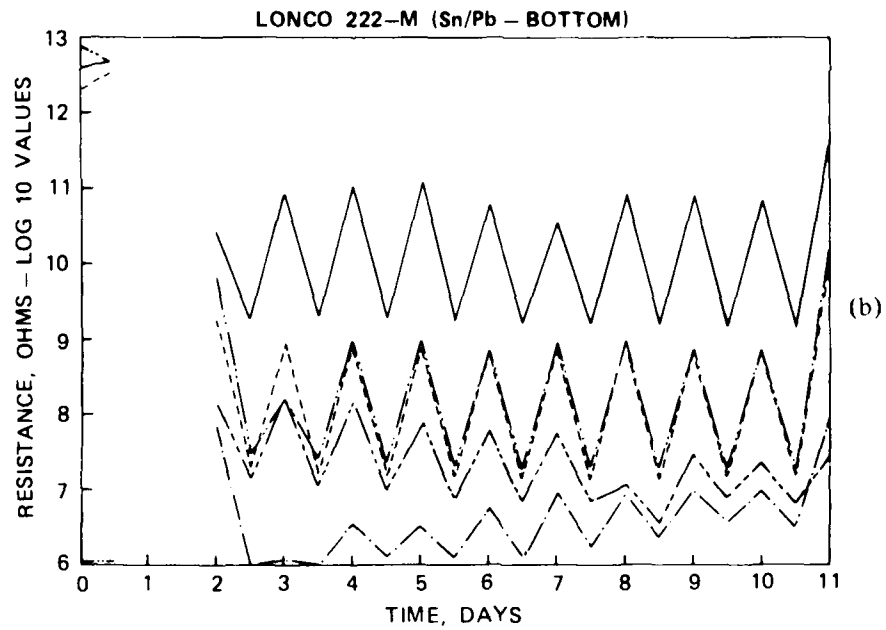
FIGURE 50. Lonco 222-M. Resistance Readings. Tin/Lead.
(a) Top. (b) bottom.

Resistance measurements of the Lonco 222-M taken during the moisture/temperature cycling test were all lower than the standard unmasked board. See Figures 50 and 51. Because of pinholes throughout, the coating probably absorbed moisture, thus allowing the resistance to decrease. The wave soldered side of one tin/lead board had values in the megohm range which is considered to be a failure. This failure is believed to be due to the porosity of the mask caused by the application procedure.
