SSI 8306-5

# INDUSTRIAL HARDENING AND POPULATION BLAST SHELTER TESTS AT THE DIRECT COURSE EVENT

FINAL REPORT

| REPORT DOCUMENTATION PAGE | | READ INSTRUCTIONS<br>BEFORE COMPLETING FORM |
|---|---|---|
| 7. AUTHOR(s)<br><br>C. Wilton and J.V. Zaccor | | 8. CONTRACT OR GRANT NUMBER(s)<br><br>Contract No. EMW-C-1097 |

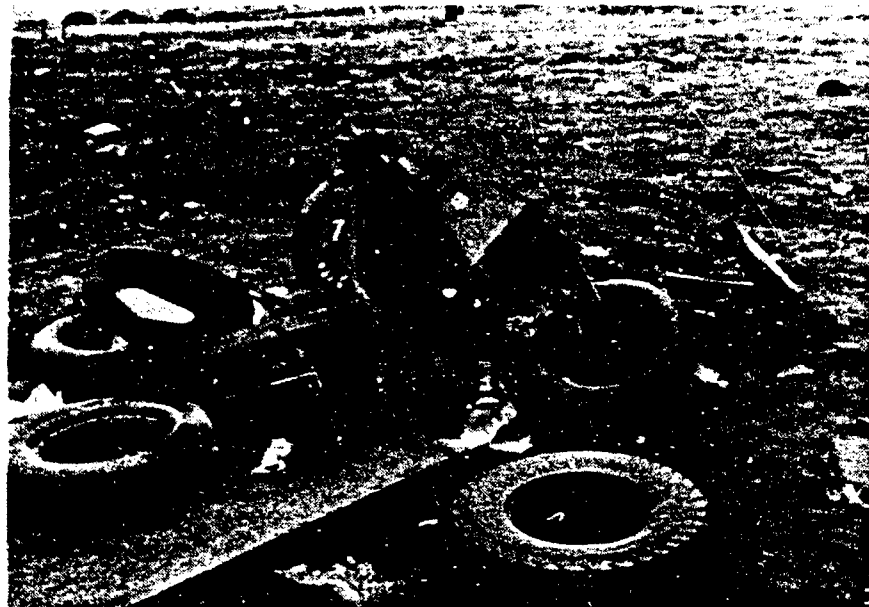
Fig. 2-3. Posttest Photographs of Experiment 4100-A.

It had been estimated that this cluster, with a horizontal dynamic pressure impulse of  $I_q = 0.3$  psi-s, would translate approximately 3 ft, and not overturn, if the array maintained its integrity.\* The displacement observed was 6 ft (corresponding to an  $I_q = 0.42$ ), and the array came apart to the extent that the first row of equipment was lifted over the second row (compare Figure 2-3 with Figure 2-2) when the banding ceased to hold the array together because the light sheet metal portion of the equipment deformed. Posttest examination of the equipment indicated that, although the legs of the bandsaws were damaged beyond repair, many of the saws themselves were still operable. The posttest condition of each of the items is listed below along with the actual repair time to put them into running condition.

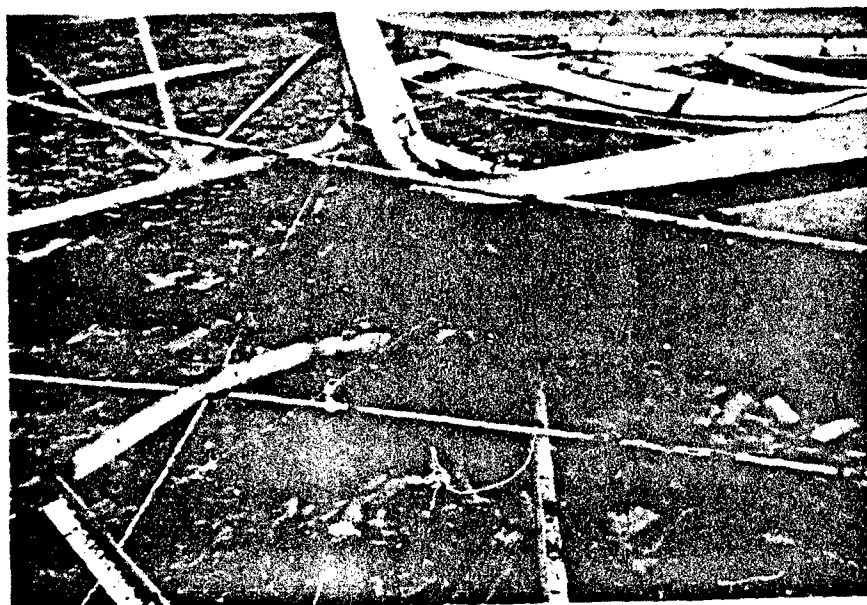
Fig. 2-9. Posttest Photographs of Collapsed WES Building.

The overpressure received at the building was 27 psi. The structure collapsed as shown in Figure 2-9. The cluster displaced approximately the same distance as those exposed in the open, but unfortunately this put it under one of the major structural members of the collapsing building. The resulting mess is shown in Figures 2-10 and 2-11. In spite of the apparent heavy damage, three of the saws were easily repairable. The posttest condition of each of the items along with the repair time is presented below.

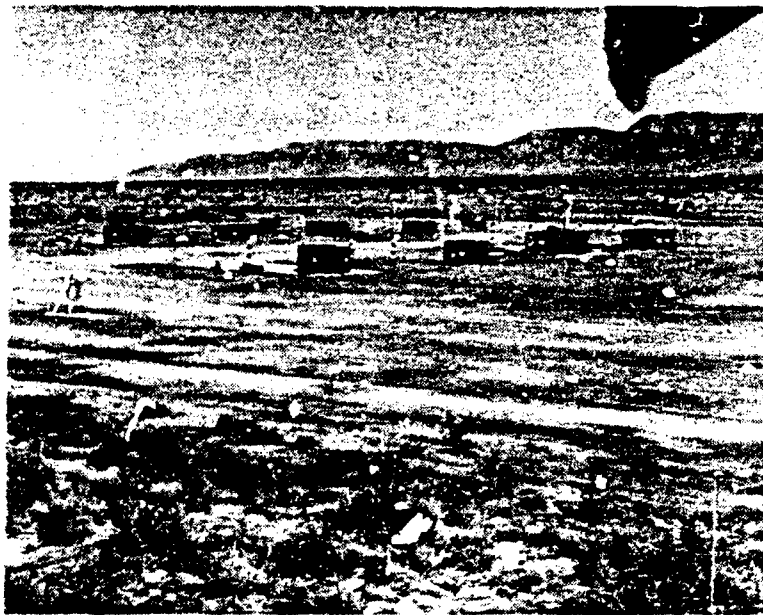
Fig. 2-12. Pretest Photograph of Experiment 4115.

The estimated peak overpressure from the BRL northern instrumentation line was 44.31 psi. (The corresponding dynamic pressures at this location is not known.) As noted above, WES measurements made in front of this experiment indicate that the pressures may have been significantly higher, on the order of 20% to 30% higher. The damage to the arrays was extensive; at this overpressure all of the arrays broke up, and the individual drums were then subjected to the dynamic pressure as individual objects (negating the cluster concept over a major portion of the pulse). Breakup of the arrays occurred for two reasons: because some drum lids came off and let the drums deform as the fluids ejected, and because the seatbelt webbing ruptured where the drums did not deform. High-speed photography from farther down range show drums lofted as high as 30 to 50 feet in the air. For example, at the seven-barrel array on the concrete pad (4115-A), the seatbelt webbing ruptured

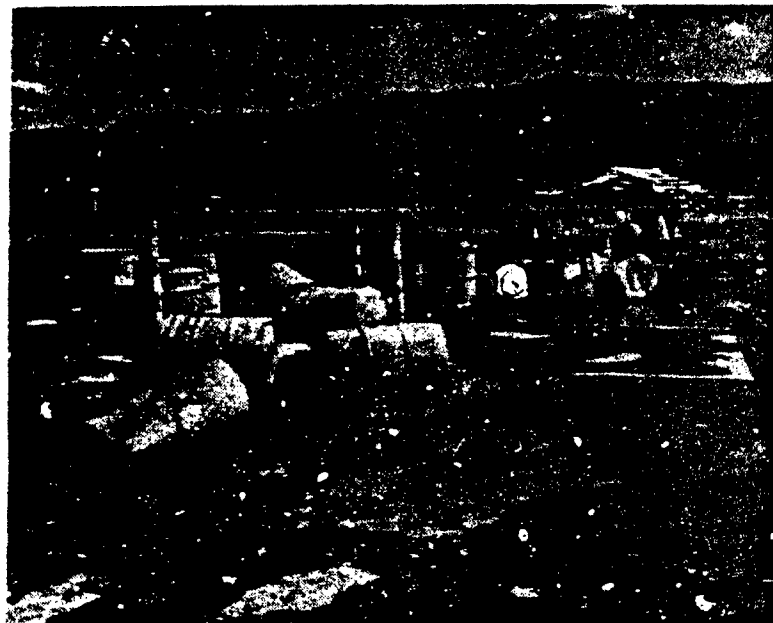
Fig. 2-15. Posttest Photographs of Experiment 4120.

The estimated overpressure based on the BRL northern instrumentation line was 38.82 psi and the horizontal dynamic pressure was 23.7 psi. (The horizontal dynamic pressure impulse was 0.776 psi-s.) As noted above it is expected that the loadings at the experiment location may have been somewhat higher than that indicated by the gauge line. The array movement at this range was less severe than at the 40 psi range, as shown in Figures 2-15 and 2-16, but the drums were severely crushed here as well. The arrays all suffered some degree of breakup, in this case always due to drums losing lids and deforming so that the webbing loosened and released additional drums from the cluster. In array 4120-D, most of the array stayed intact even though two of the drums partially deformed after losing their lids (see farthest array in the upper picture of Figure 2-15). This suggests that rigid bodies can be successfully clustered at this pressure level and bound with 8,000 lb tensile strength seatbelt webbing, successfully. However, successful clustering of hazardous materials in drums would be very dependent on all the drums in an array remaining sealed so that integrity of the array was not lost through deforming of any of its members.

It can be concluded that, at this overpressure level, rigid body items can be successfully clustered and bound with 8,000 pound seatbelt webbing. Fluid filled drums may also be successfully clustered at this pressure level providing the drums maintain their integrity and stay sealed.

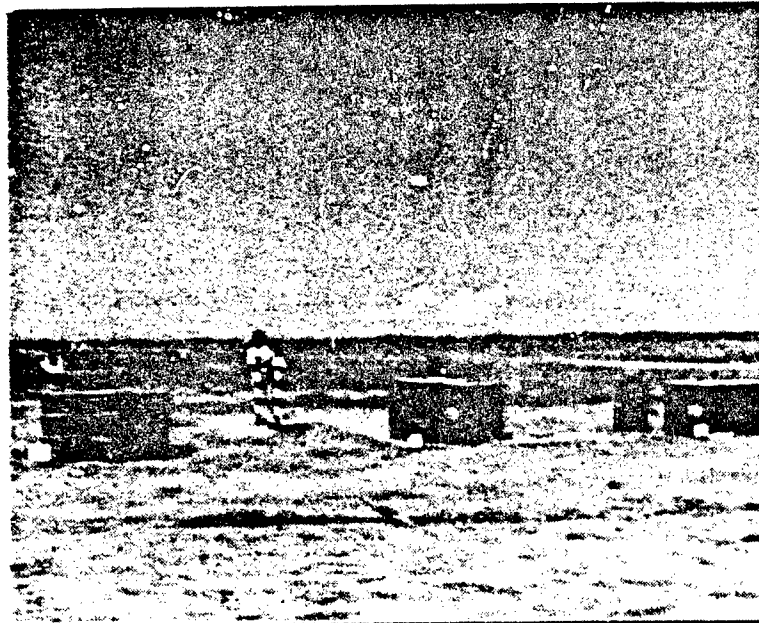
Fig. 2-17. Pretest Photograph of Experiment 4125.

The estimated peak overpressure based on the BRL northern instrumentation line was 23.22 psi. No WES measurements were made at this ground range. Neither of the nylon cord bindings was adequate to hold an array together at this pressure level, but the 4,000 pound seatbelt webbing was (see Figure 2-18). The figure also shows that the cluster on dirt that remained together moved only 1 foot. Much less motion occurs on a dirt surface, because the static overpressure forces the drum edges into the soil and helps to hold them in place against the dynamic pressure.

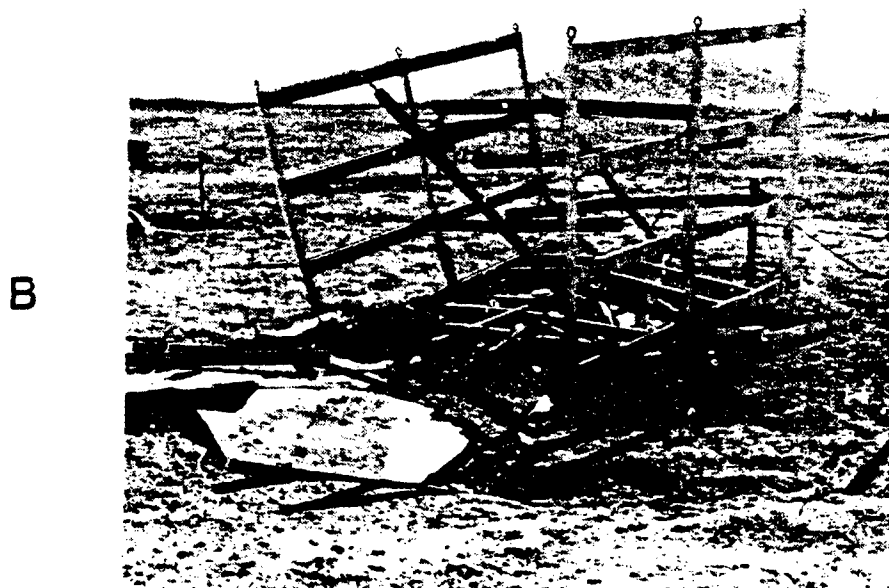
Fig. 3-10. Posttest Photographs of Steel Frame Building, Experiment 4140.

The steel building (Experiment 4140) was extensively damaged by the blast, as shown in Figures 3-10 and 3-11. The first story columns formed yield hinges at the ground level and at the second story floor line (see Figures 3-10, 3-12, 3-13 for Column line 1 and Figures 3-14 and 3-15 for Column Line 3). The second, third, and fourth stories appear to be relatively intact and square (i.e., they underwent rigid body translation/rotation). The center frame lost all but two of its girders (the first floor girders, which were shored). The center frame, unlike the exterior frames, formed yield hinges at the level of the basement foundation bolts, and rotated without much deformation about the yield hinges at the foundation level (see Figures 3-11 and 3-16). The frame closest to the camera (Column Line 3) translated over 38 inches at the second floor line and translated  $49\frac{1}{2}$  inches at the roof line. The second, third, and fourth stories on this particular frame appear to be intact and not to have deformed much, i.e., the frame translated/rotated from its original position without undergoing joint/member deformation. The frame farthest away from the camera (Column line 1) translated 29 inches from its original position at the second

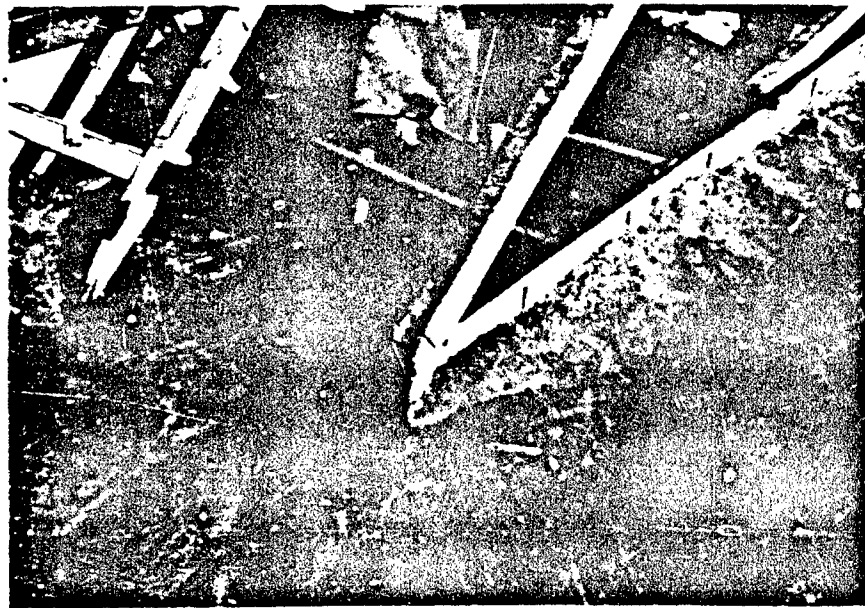
Fig. 3-15. Posttest Photographs of Column Line ③ of the Steel Frame Building, Experiment 4140.

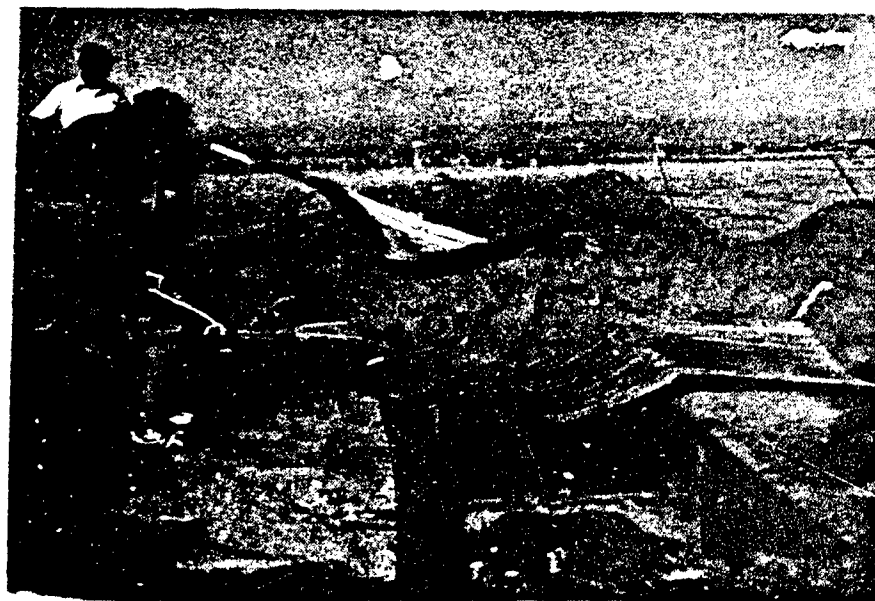
Fig. 5-12. Posttest Photograph of Corrugated Steel Closure.

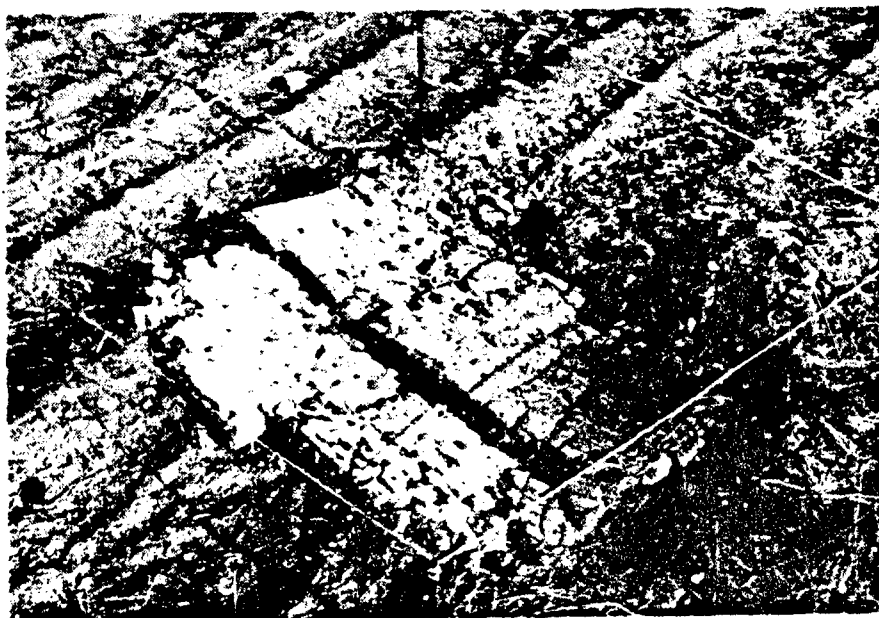
Fig. B-9. Steel Building Debris at 583 Feet.

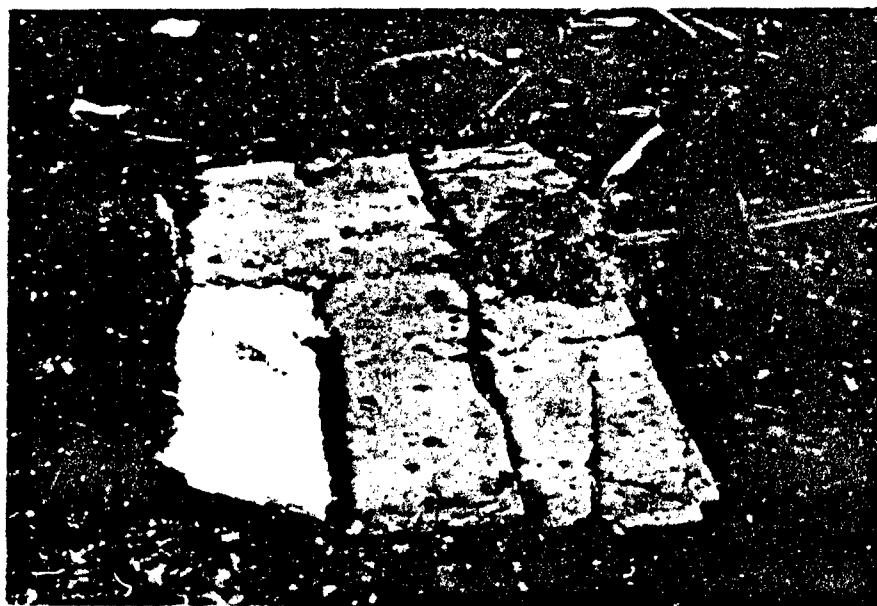
Fig. B-10. Steel Building Debris at 706 Feet.

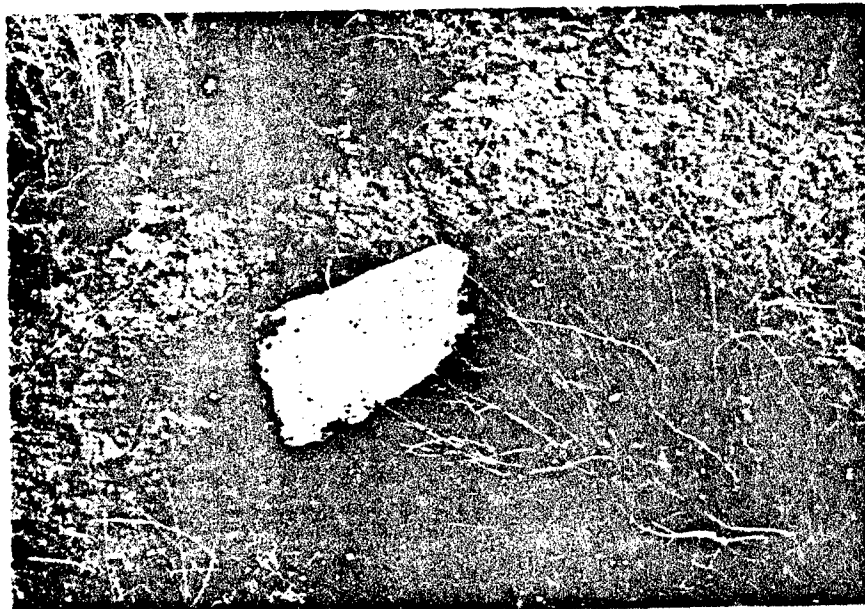
Fig. B-11. Steel Building Wall Fragment at 875 Feet.

| Distance Along<br>Radial From<br>Front of Bldg. | Distance<br>From Radial | Description |
|---|---|---|
| 875 ft | Left 120 ft | SW (S-3), 8 in. X 8 in.<br>(see Figure B-11) |
