RUBBER TO BACKING BOND STRENGTH FOR STAVE BEARINGS

SHIP MATERIALS ENGINEERING DEPARTMENT
RESEARCH AND DEVELOPMENT REPORT

April 1984

DTNSRDC-84/009

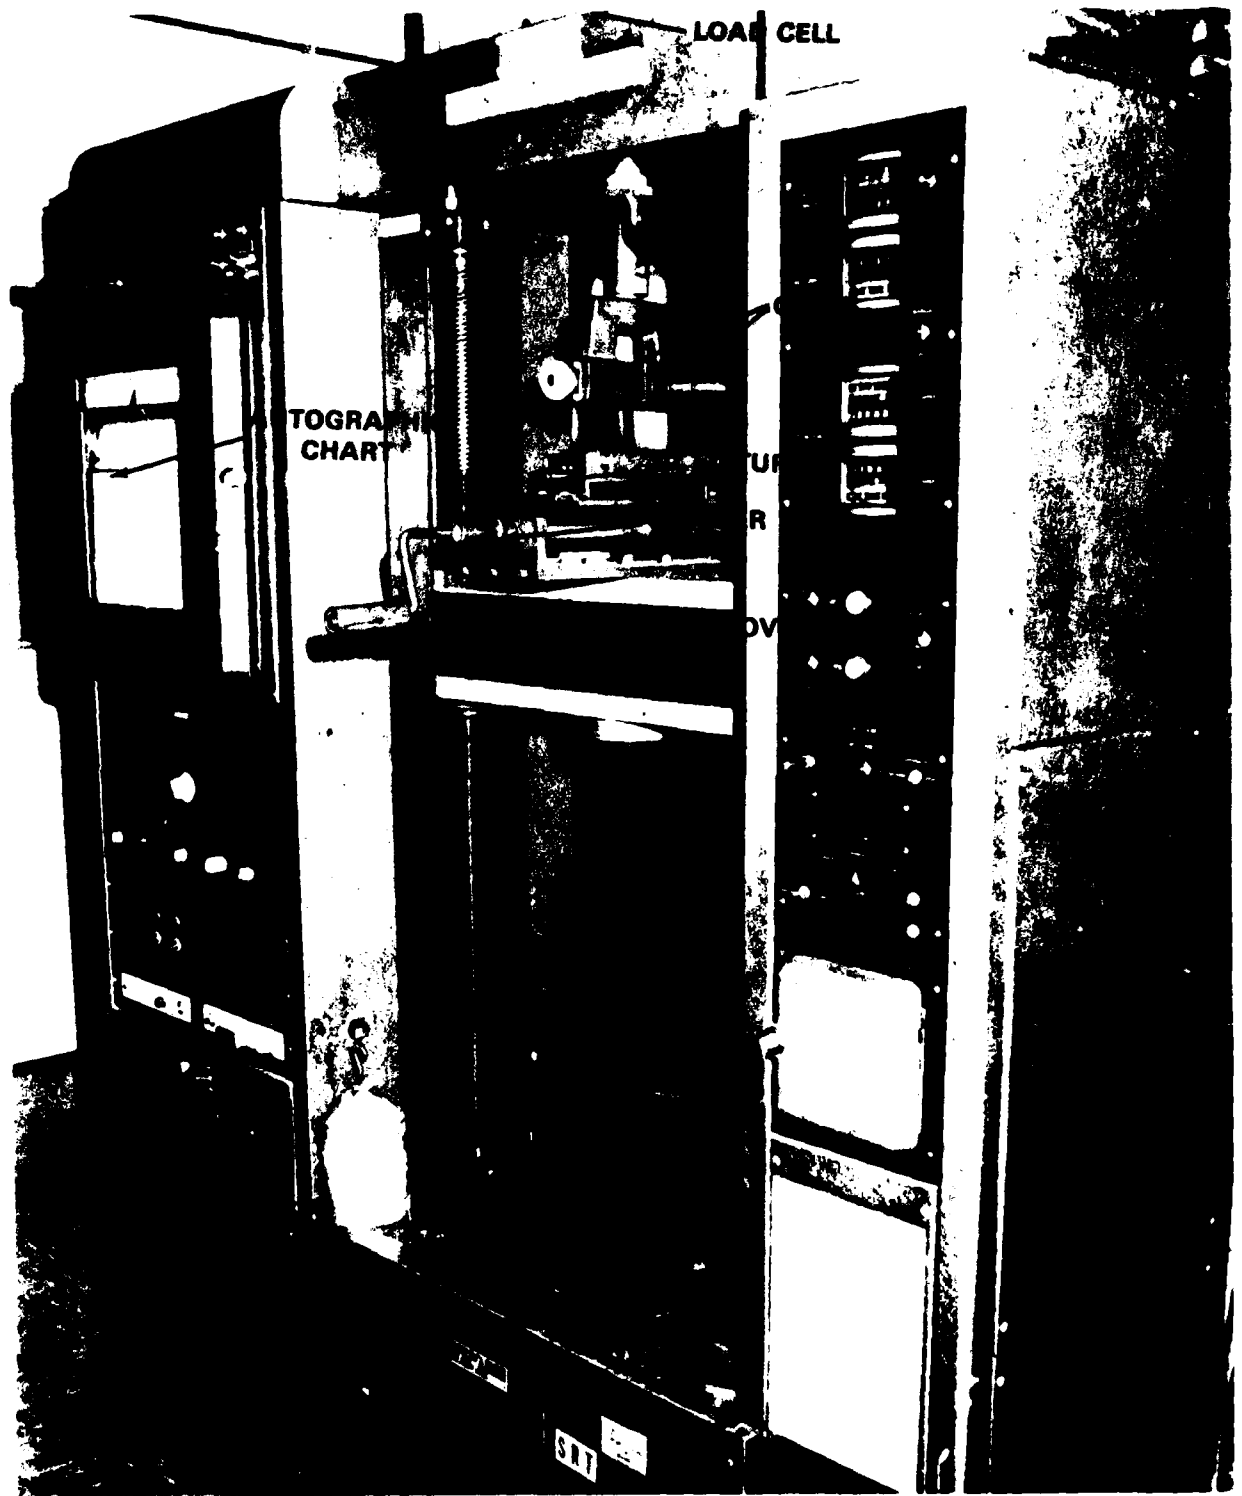
Figure 5 - Right Angle Pull Test Machine

Autographic chart prints out continuous trace of the magnitude of force needed (as sensed by the load cell) to pull the test strip from the backing.
