CRC REPORT NO. NAV A/W 8

PHASE 4 REPORT

DESIGN, CONSTRUCTION, DEMONSTRATION AND
DELIVERY OF AN AUTOMATED NARROW GAP
WELDING SYSTEM
CONTRACT NO. N00600-81-C-E923

CRC AUTOMATIC WELDING
SEPTEMBER 30, 1983

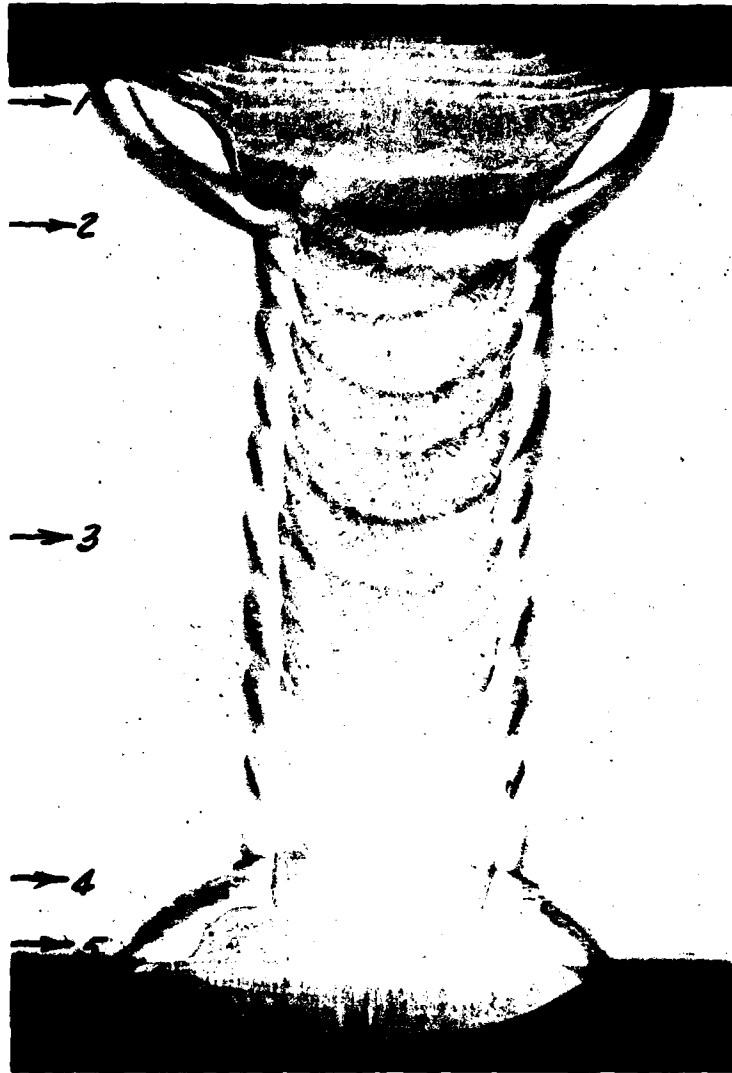
3L543

FIGURE 1. PHOTOMACROGRAPH OF NARROW-GAP WELD IN 2-
-INCH-THICK HY-100 STEEL

Arrows indicate location of hardness traverses.

A photomicrograph of this section is in Figure 1. The weld is sound throughout. No porosity, lack of fusion, inclusions, or cracks were present. The pore-like feature in the right heat-affected zone of the second fill pass is an artifact and was not present in the actual specimen. The cap pass and/or the last fill pass are unbalanced to the left side of the joint. The arc oscillation possibly was biased in this direction.

Microhardness (Knoop 500 gram) traverses were made across the width of the weld joint at five locations. These are shown by the arrows and accompanying numbers in Figure 1. Traverses 1 and 5 were made at a location 1/16 inch below the top and bottom surfaces respectively, of the specimen. At this location, measurements were made in the untempered weld metal of the cap and root passes and their heat-affected zones. Traverses 2 and 4 were made at a location approximately 1/8 inch below the bottoms of the cap and root passes. Traverse 3 was made at the middle of the specimen. Each traverse included at least three measurements in each base metal, six measurements in each heat-affected zone, and five measurements in the weld metal. The spacing

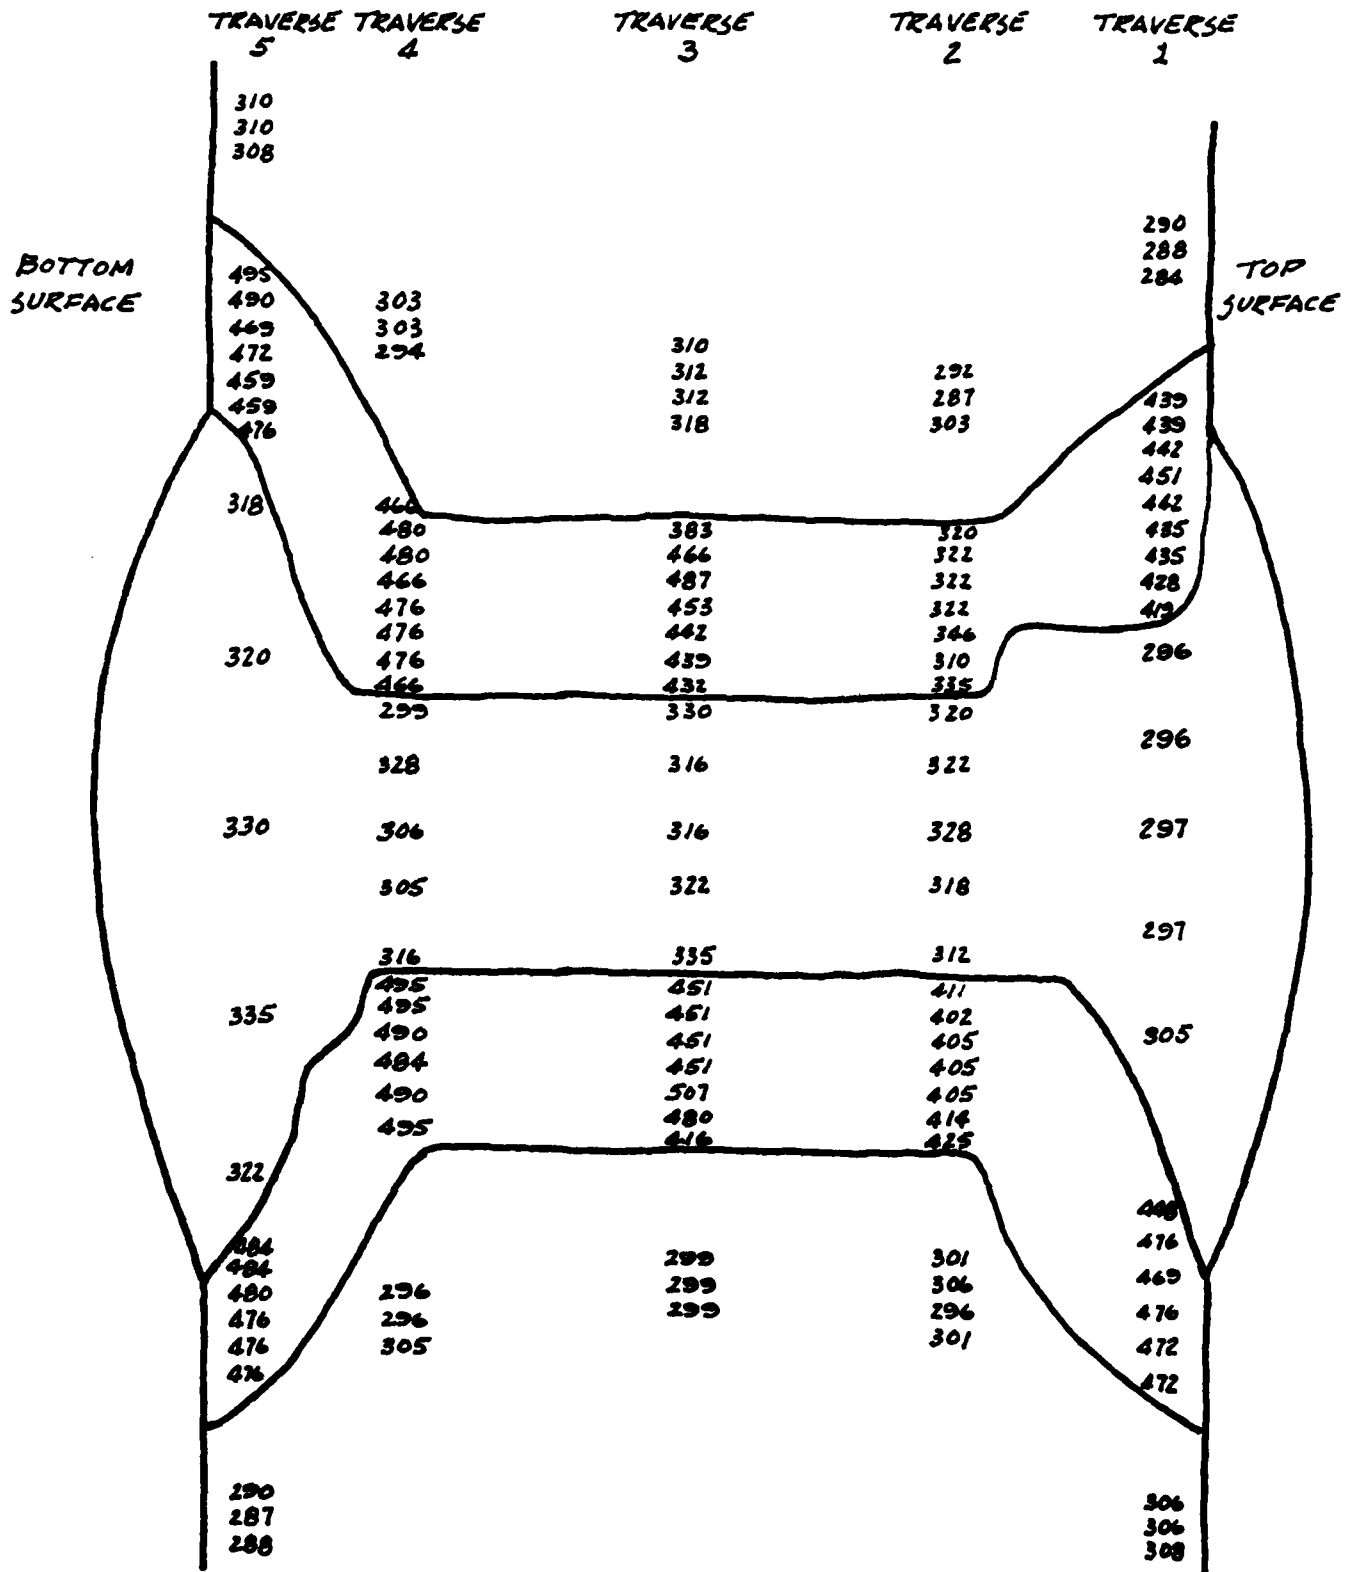
FIGURE 2. KNOOP 500 GM HARDNESS MEASUREMENTS OF NARROW-GAP WELD

The results of these measurements are given in Figure 2. (This figure is schematic and not to scale.)

The hardnesses of the various zones are reasonably consistent except for the heat-affected zones of Traverse 2. These hardnesses, particularly on the left side, are significantly lower than at any other area of the heat-affected zone. In these areas, the hardness measurements were taken just at the bottom edge of the cap pass heat-affected zone. On the left side, this location also is directly under the area of the cap or last fill pass where the arc oscillation appears unbalanced. These areas experienced thermal cycles (possibly multiple cycles) that were different from other areas of the heat-affected zone. The different heating-cooling profiles may account for the softer structure.
