# DESIGN OF ALTERNATE LAUNCH AND RECOVERY SURFACES FOR ENVIRONMENTAL EFFECTS

A.J. BUSH III, R.C. GUNKEL, SR.  
G.L. REGAN, and R.L. BERG

U.S. ARMY ENGINEER WATERWAYS EXPERIMENT STATION  
GEOTECHNICAL LABORATORY  
P.O. BOX 631, VICKSBURG, MS 39180

JULY 1984

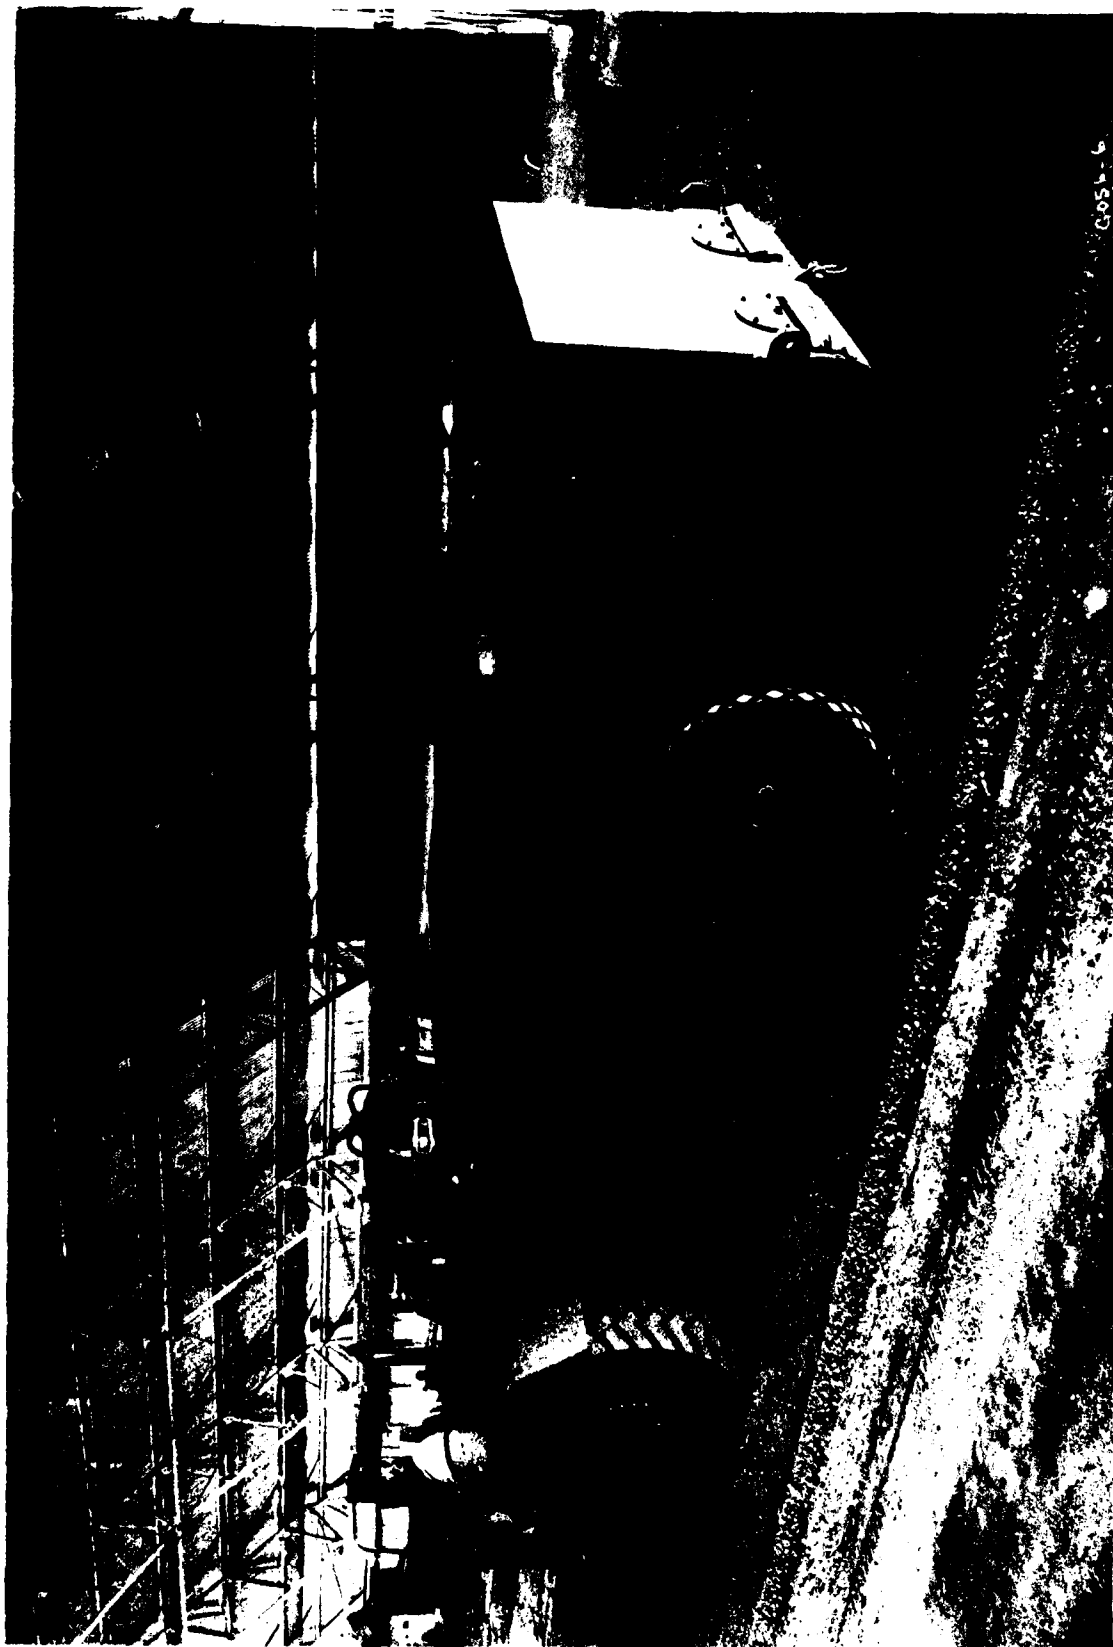
PHOTO C-3. Compacting Limestone with 50-ton Roller

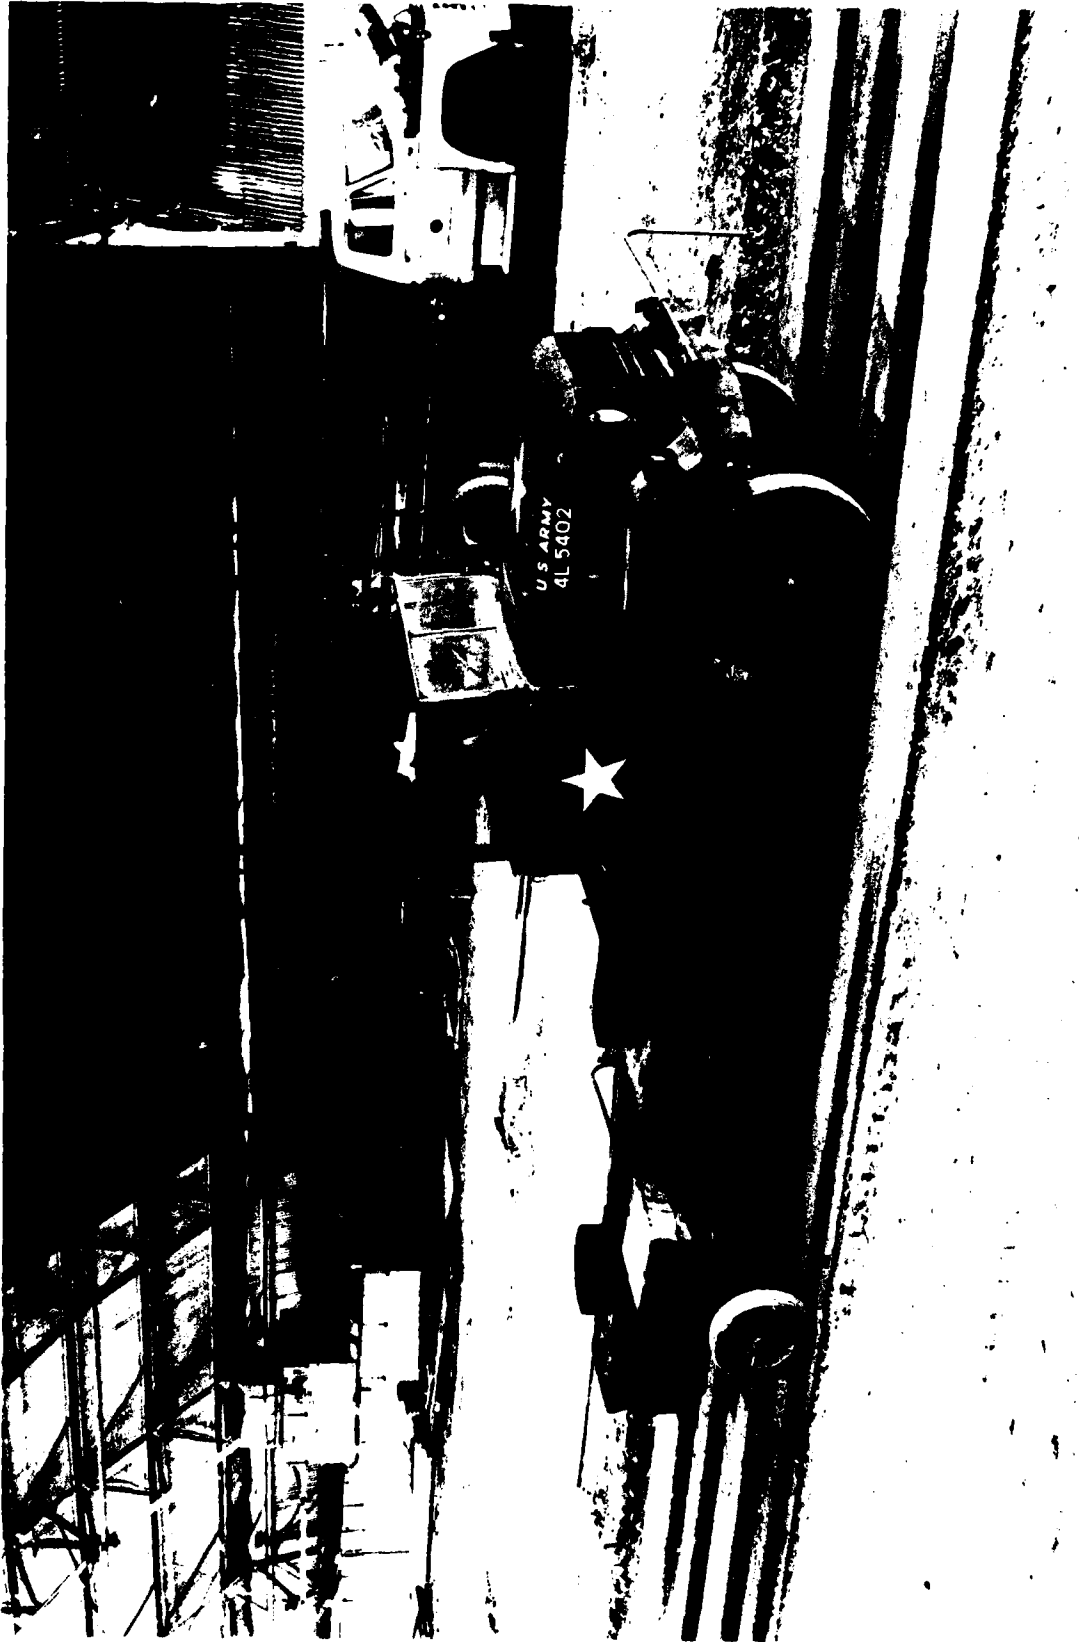
PHOTO C-7. F-4 Aircraft Load Cart

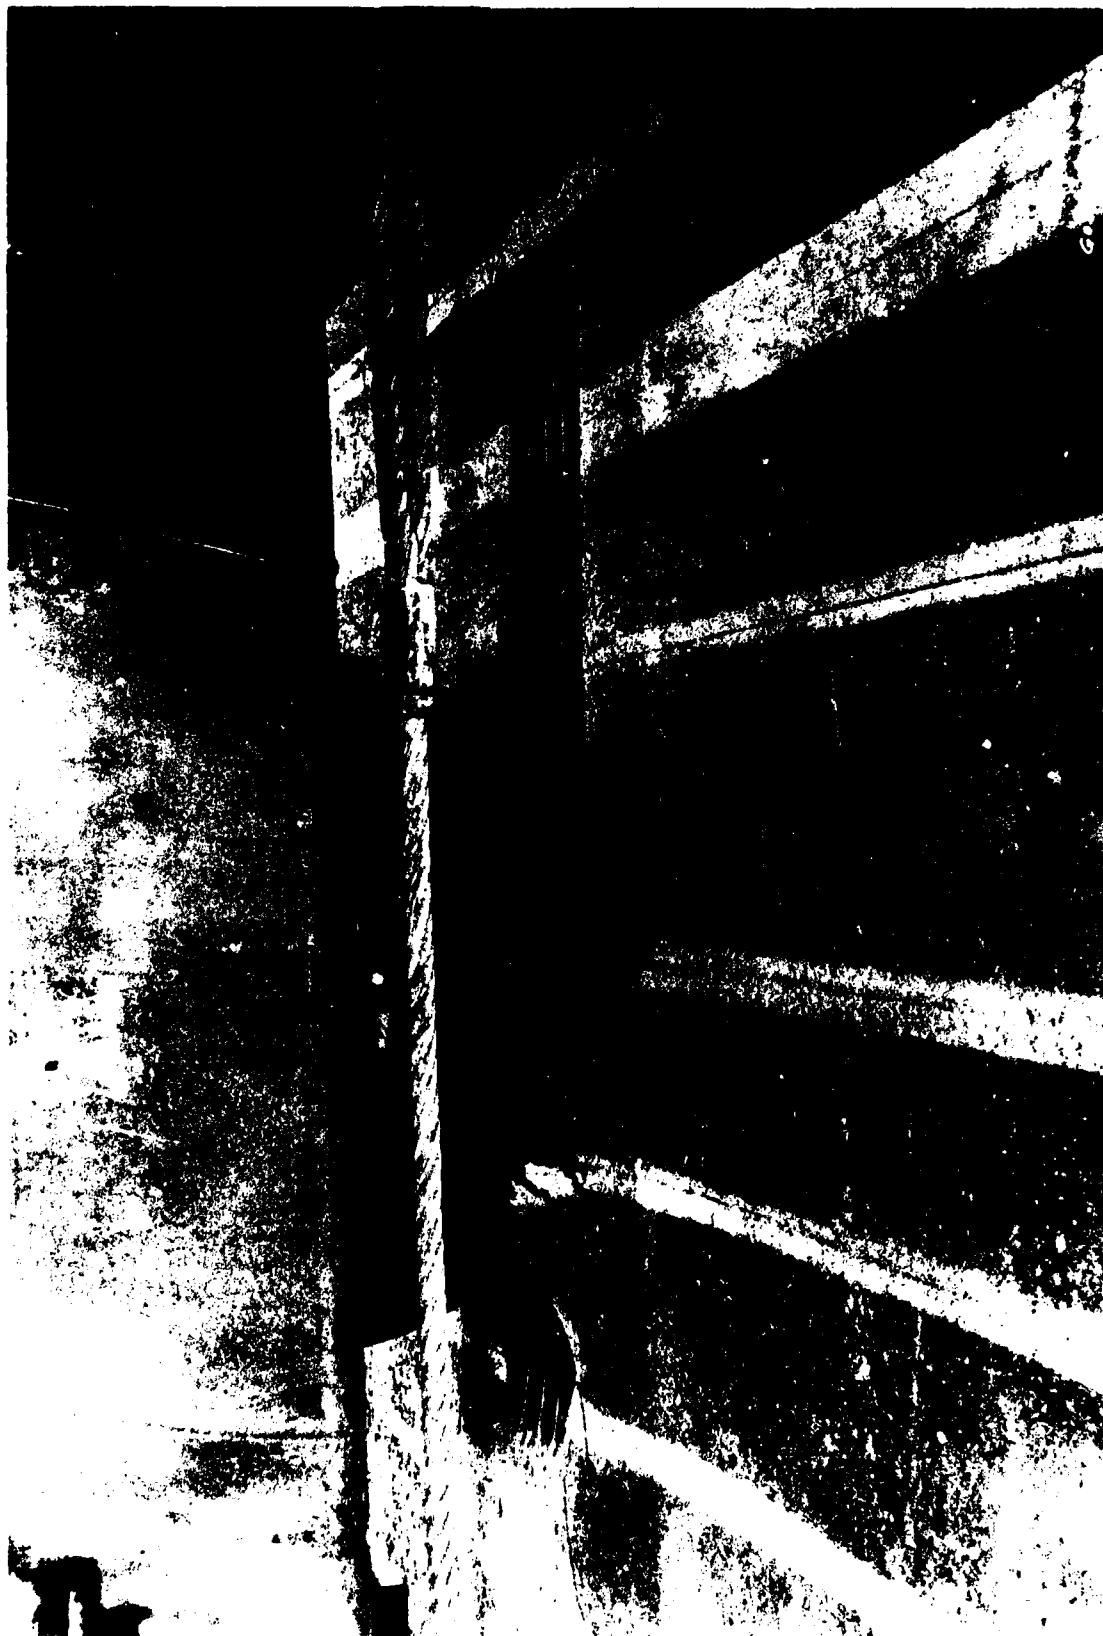
PHOTO C-10. Failure of 2-inch Asphalt (Item 1) After Four Locked-Wheel Skids

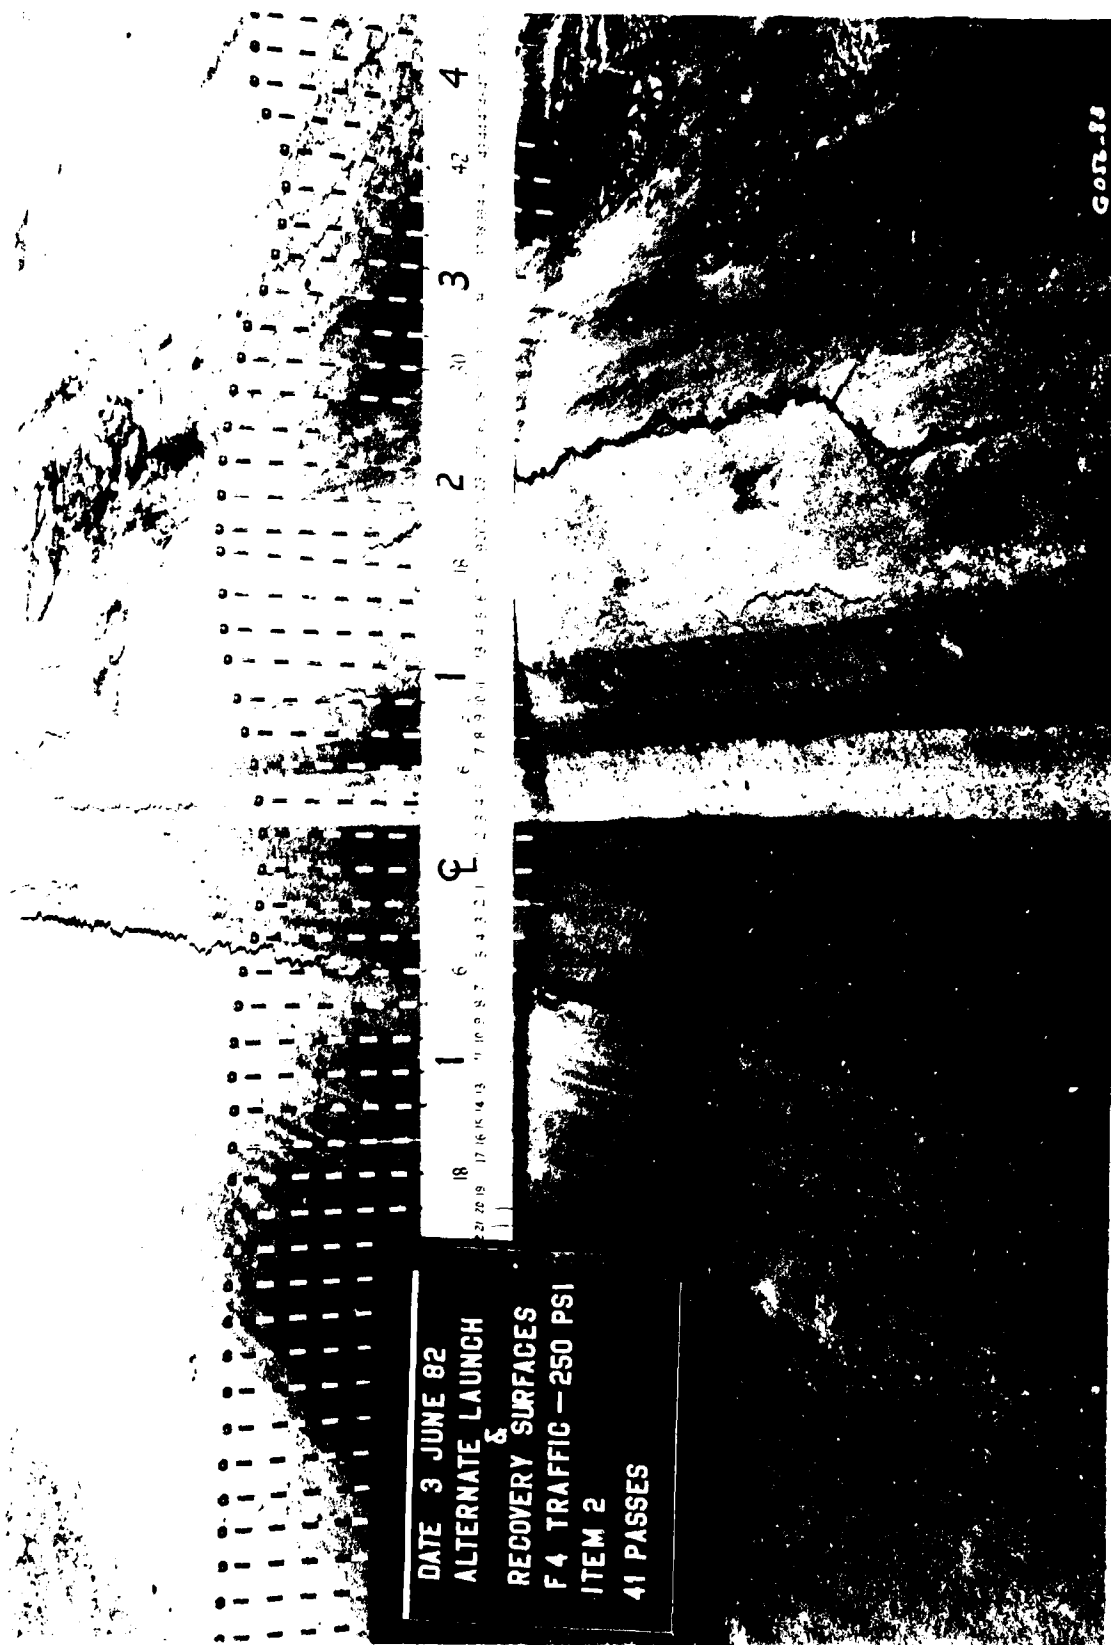
PHOTO C-12. Failure of 1-inch Asphalt (Item 2) Under Channelized Traffic

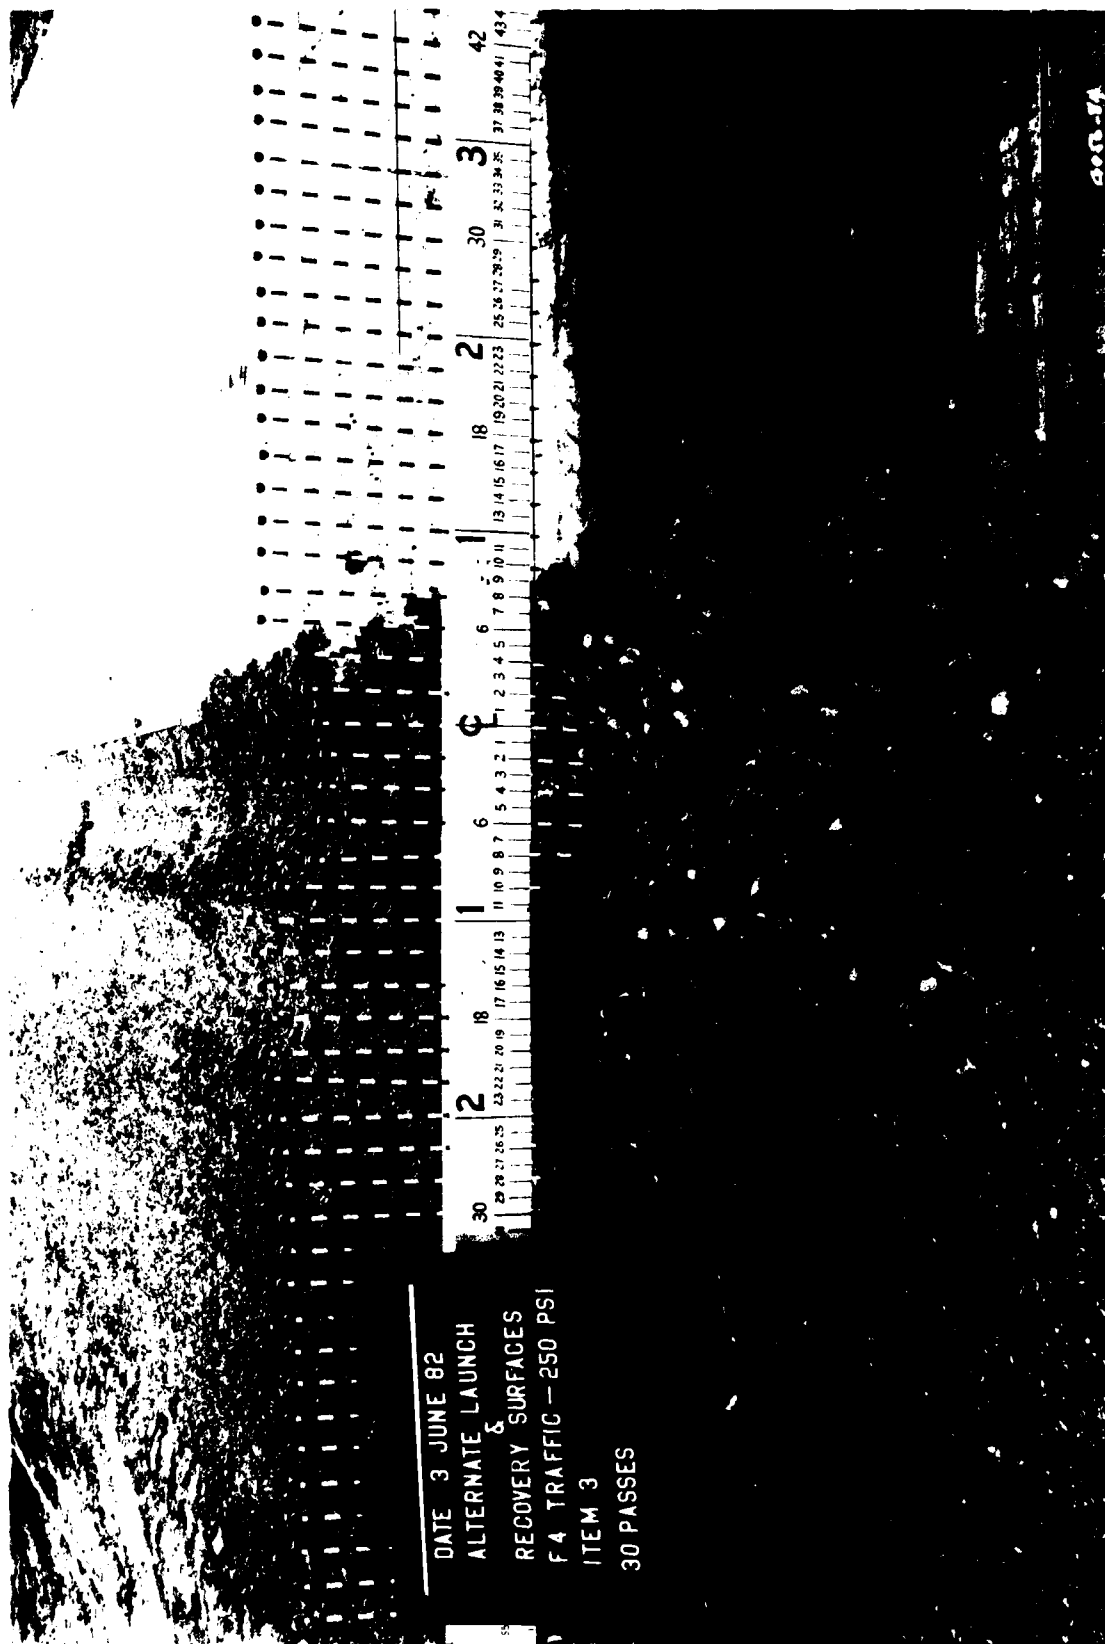
PHOTO C-15. Failure of DBST (Item 3) Under Channelized Traffic (30 Passes)

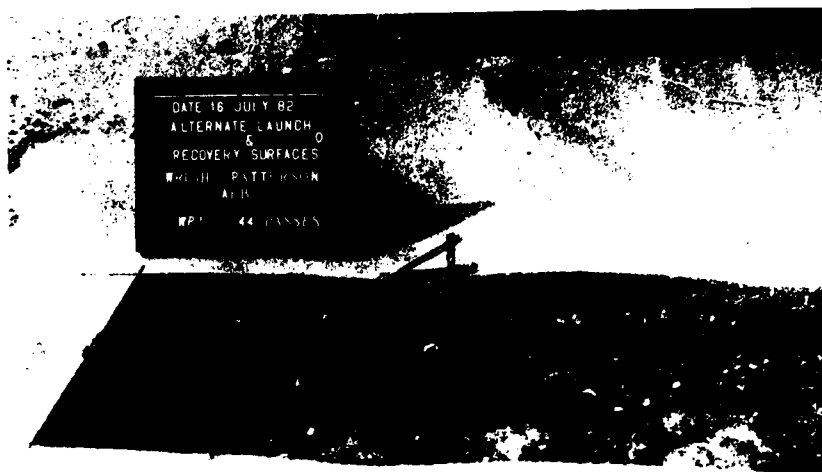
PHOTO C-17. Typical View of Test Trench After Removal of Pavement Surface

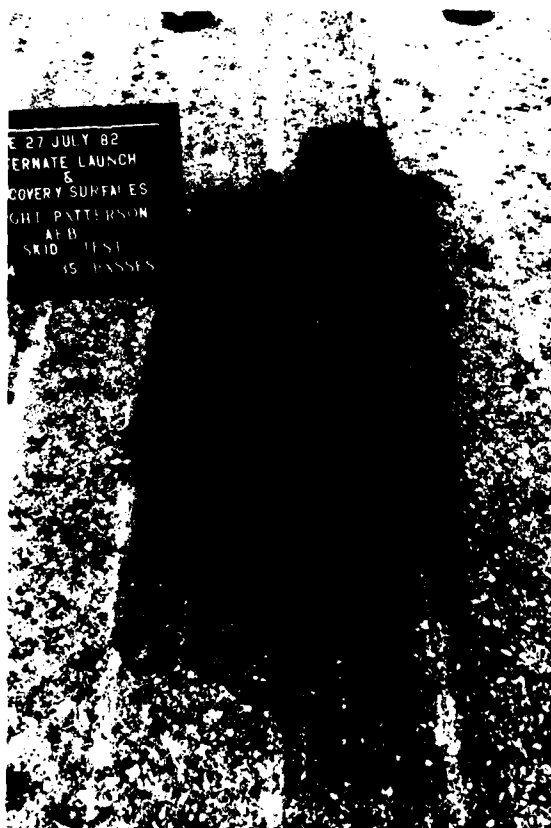
PHOTO C-36. Same Area After Failure

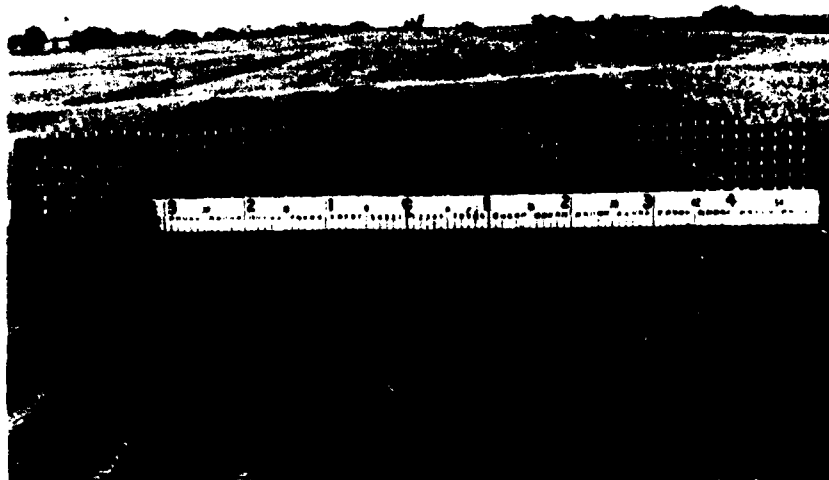
PHOTO C-37. Breaking Up of DBST After 100 Passes on Test Feature W-1

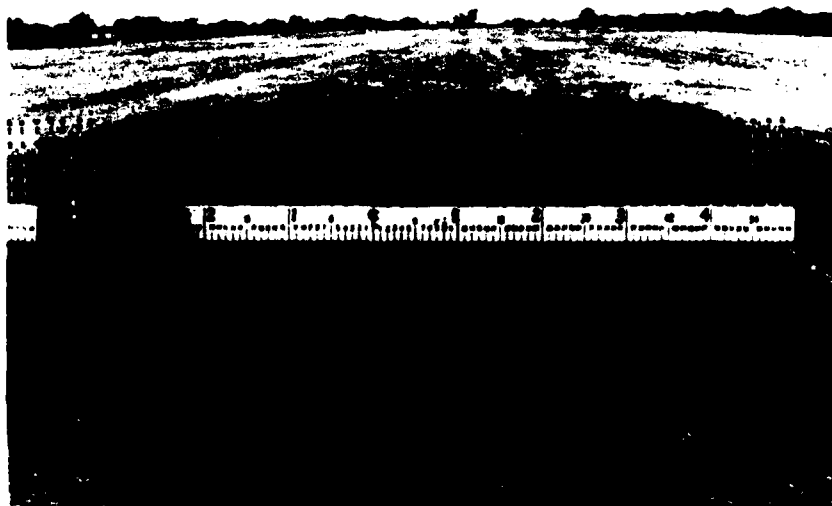
PHOTO C-38. Failed Condition of the W-1 Feature; Rut Depth in Excess of 3 Inches

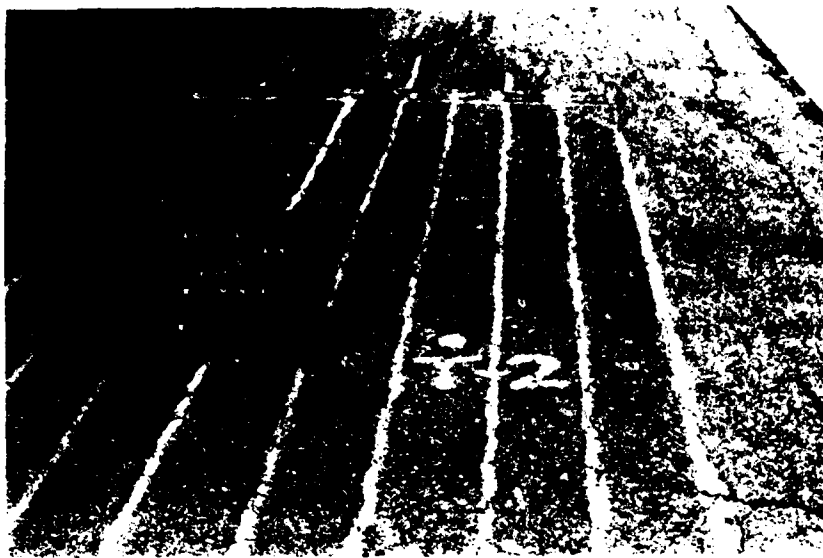
PHOTO C-45. View of Turning Test Area Before Traffic

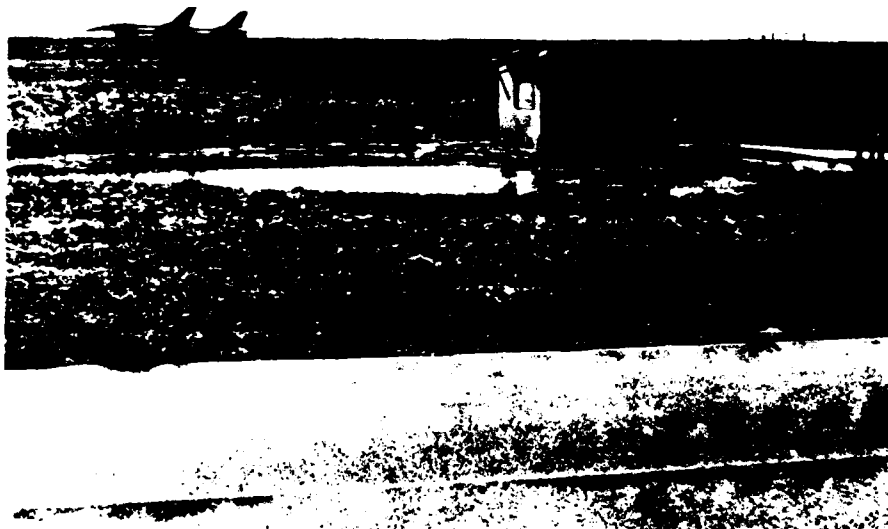
PHOTO C-55. Example of Surface Drainage Problem, Hahn ALRS
