MEMORANDUM REPORT BRL-MR-3387

TEST TO DETERMINE THE FEASIBILITY OF
CONTROLLING FRAGMENTATION FROM THE
DETONATION OF COLLOCATED MUNITIONS

US ARMY BALLISTIC RESEARCH LABORATORY
ABERDEEN PROVING GROUND, MARYLAND

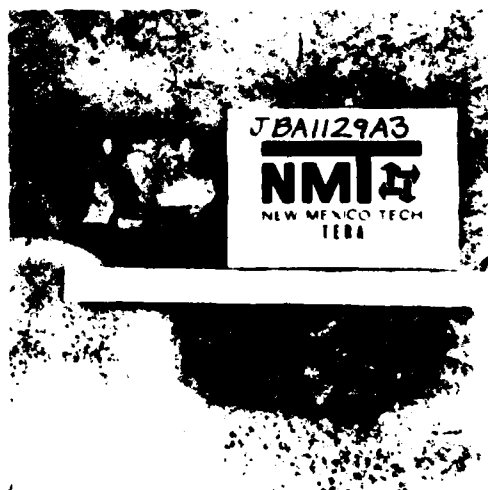
Figure 4. Test JBA1129A3 (continued)

CLOSEUP OF PARTIAL PENETRATION OF WITNESS SHEET
AFTER TEST

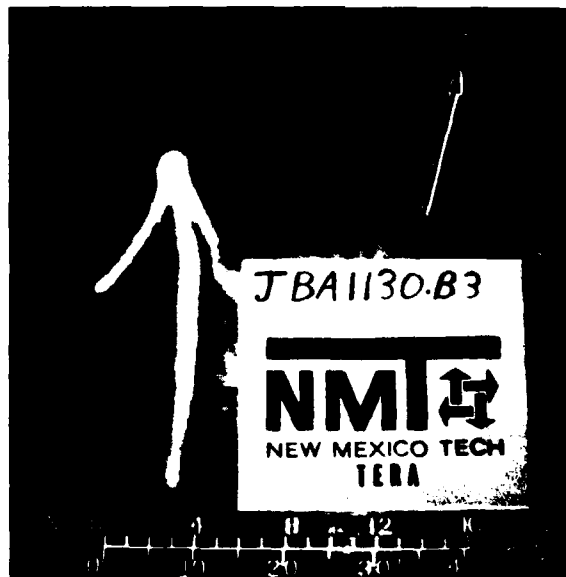
CLOSEUP OF WITNESS SHEET DAMAGE
AFTER TEST

FRAGMENT PERFORATION SHOWN BY ARROW
Figure 6. Test JBA1130B3 (continued)

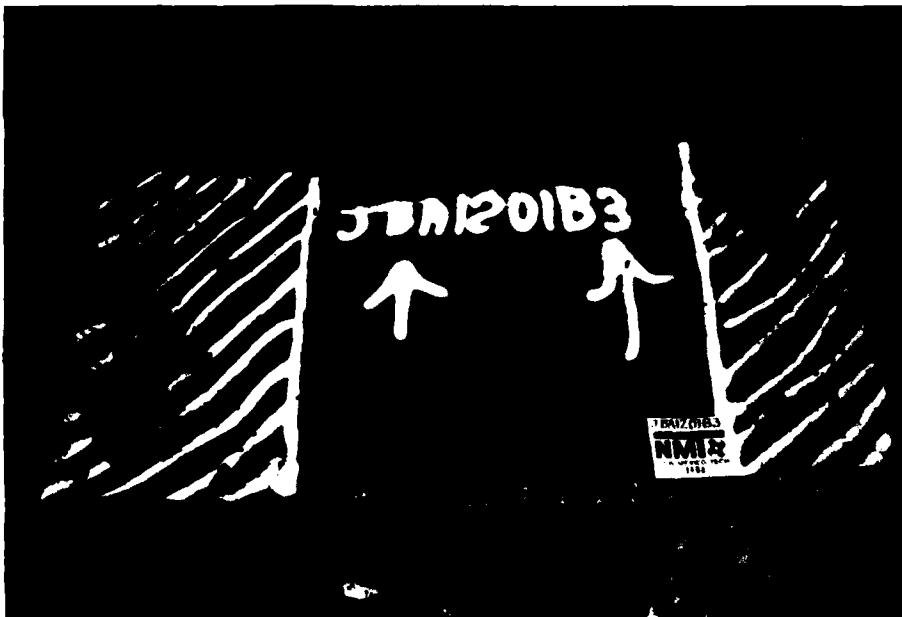
Figure 8. Test JBA1201B3 (continued)

WITNESS SHEET DAMAGE - AFTER TEST
FRAGMENT PERFORATION SHOWN BY ARROW

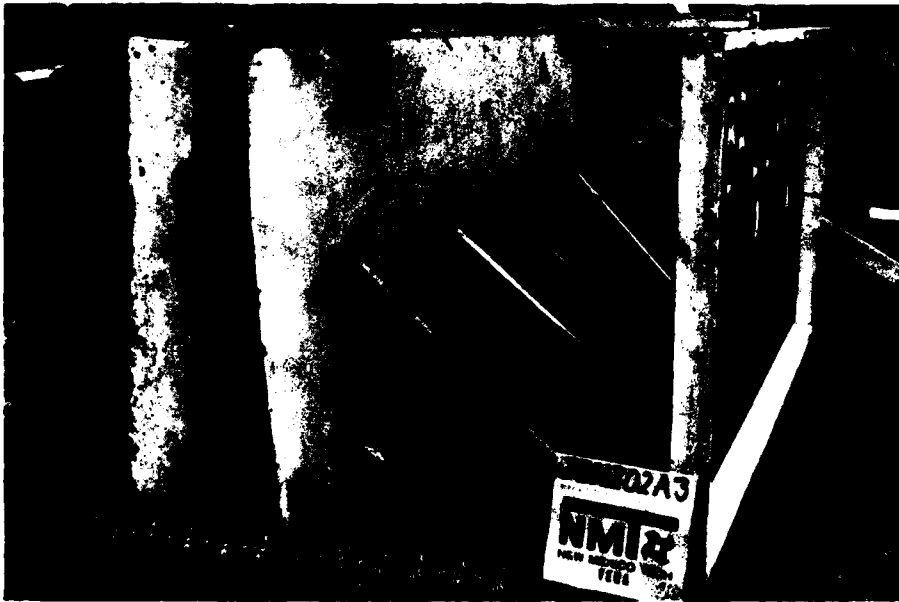
Figure 9. Test JBA1202A3 (continued)

CLOSEUP OF TARGET WALL CONSTRUCTION DETAIL - BEFORE TEST
