# Special Report 84-25

August 1984

## *Salt action on concrete*

John M. Sayward

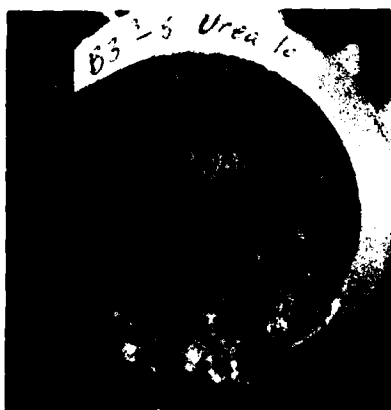
Figure 12. Typical crystal exudations, Period II (66 days).

Figure 12 (cont'd). Typical crystal exudations, Period II (66 days).

Permeation, exudation, cracking, chipping and particle lifting are described in the following sections. Solid crystalline exudations had many forms: almost imperceptible hair-like fuzz, silky thread-like filaments or whiskers, uniform "grassy" white cover, thinly scattered or localized, straight, curved or curly, widely varying filament diameter and height, single or multiple filaments, plant-like clusters of columns, chunky or platy, fused crust and filaments patterned around stones. The photographs of Figures 11 and 12 are typical. Presumably the filaments may represent

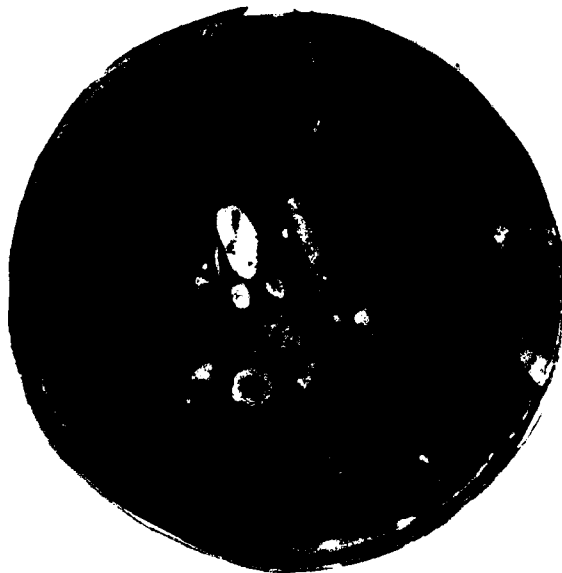
Figure 17. Drastic and early cracking of concrete F with  $\text{CaCl}_2$  high.

Drastic cracking. Within a week of starting the tests, drastic cracking began in one case. By chance, concrete F and  $\text{CaCl}_2$  high had been paired in the only use of the latter initially, test F4-4. A crack through mortar and stone was noted only eight days after preparation, just as air flow was started for Period II. It showed up on a photo taken the previous day and developed more drastically by the next day. Figure 17 shows it before the test and at 9 days.

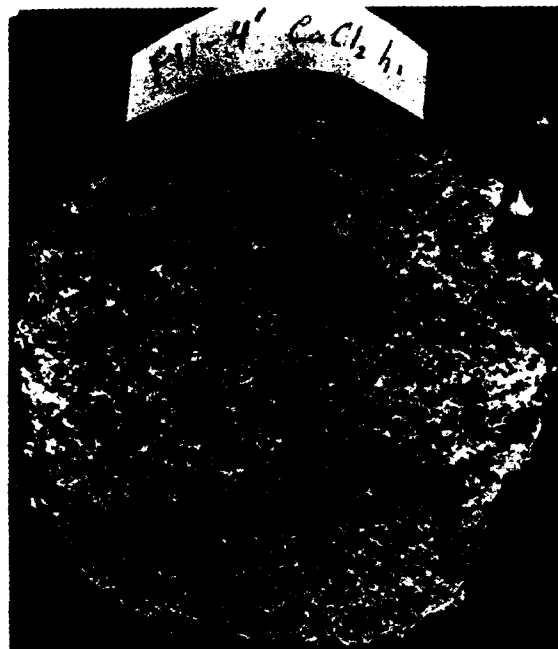
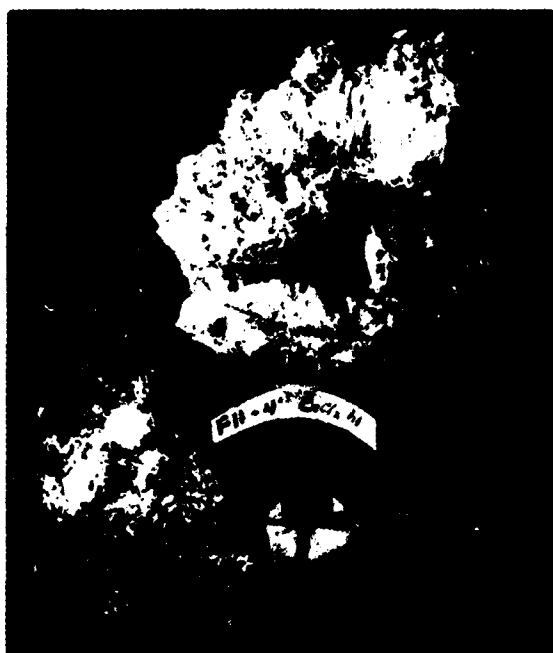
Figure 19. Disintegration of concrete F with  $\text{CaCl}_2$  high in storage.

After another four months (February 1980), expansion-disintegration had progressed even more dramatically (Fig. 19c). At the September 1979 viewing (under summer humidity), the mass must have contained considerable solution. Now this must have crystallized (at lower winter humidity), for the granular mass had expanded greatly and was full of fibrous crystals, presumably  $\text{CaCl}_2 \cdot 6\text{H}_2\text{O}$ . The original concrete had lost its integrity. Upon return of higher humidities in summer (late June 1980), the erupted crystals subsided considerably, revealing some dislodged stones (Fig. 19d).
