USAAEFA PROJECT NO. 84-09

# PRELIMINARY AIRWORTHINESS EVALUATION AH-1S (MC) HELICOPTER WITH EXTERNAL FUEL TANKS INSTALLED

JULY 1984

FINAL REPORT

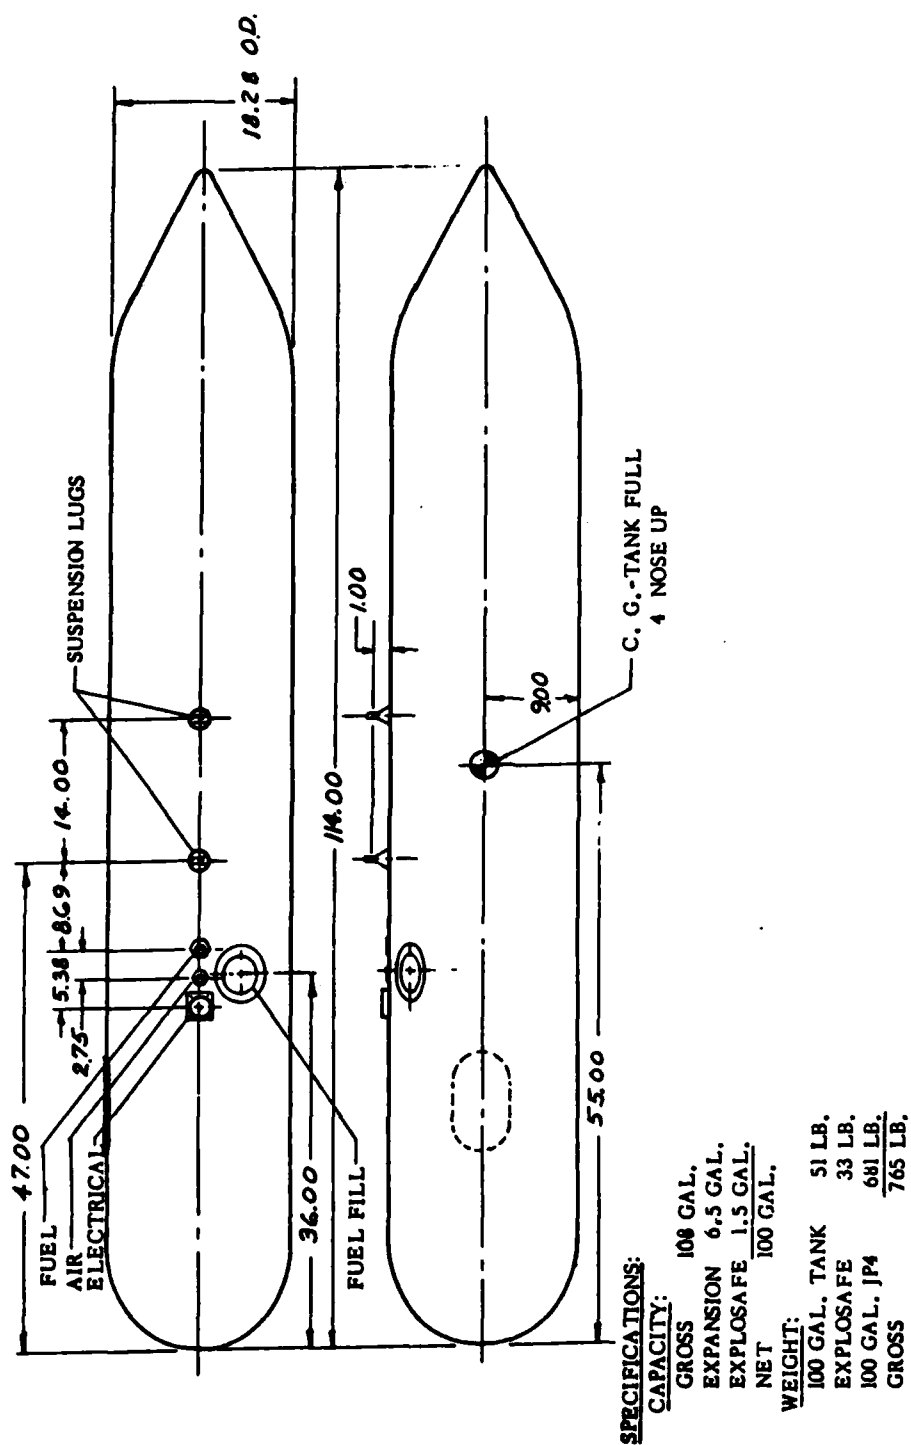
Figure 1. Kellett Auxiliary Fuel Tanks

4. The auxiliary fuel system (photos 1 through 7) consists of two 100-gallon Kellet fuel tanks (fig. 1), two pump assemblies and brackets which have been qualified for use on US Navy's AH-1T helicopters. The fuel transfer lines, electrical power lines, fittings, control panel and circuit breaker panel were prototypes designed for a short term mission. The inadequate crashworthiness in that the tanks are filled with "EXPLOSAFE" material. None of the lines or connectors are self sealing and the entire system is pressurized. The system is manually operated through switches mounted at the pilot's station. These switches control air pumps mounted on the outboard pylons (photo 3). The pumps are designed to pressurize the tanks and force fuel by air pressure through the fuel transfer lines (photo 7) to the main tanks. Check valves located in the area under the transmission (photo 6) prevent reverse flow of the fuel from the main tank back into the external tanks. Actual fuel flow is indicated to the pilot through the use of two fuel flow lights (one for each tank) located on the control panel. A second set of lights on the control panel indicate low fuel level (approximately 10 gallons remaining) in each external tank. The weight of each 100 gallon kellet tank is 84 pounds.

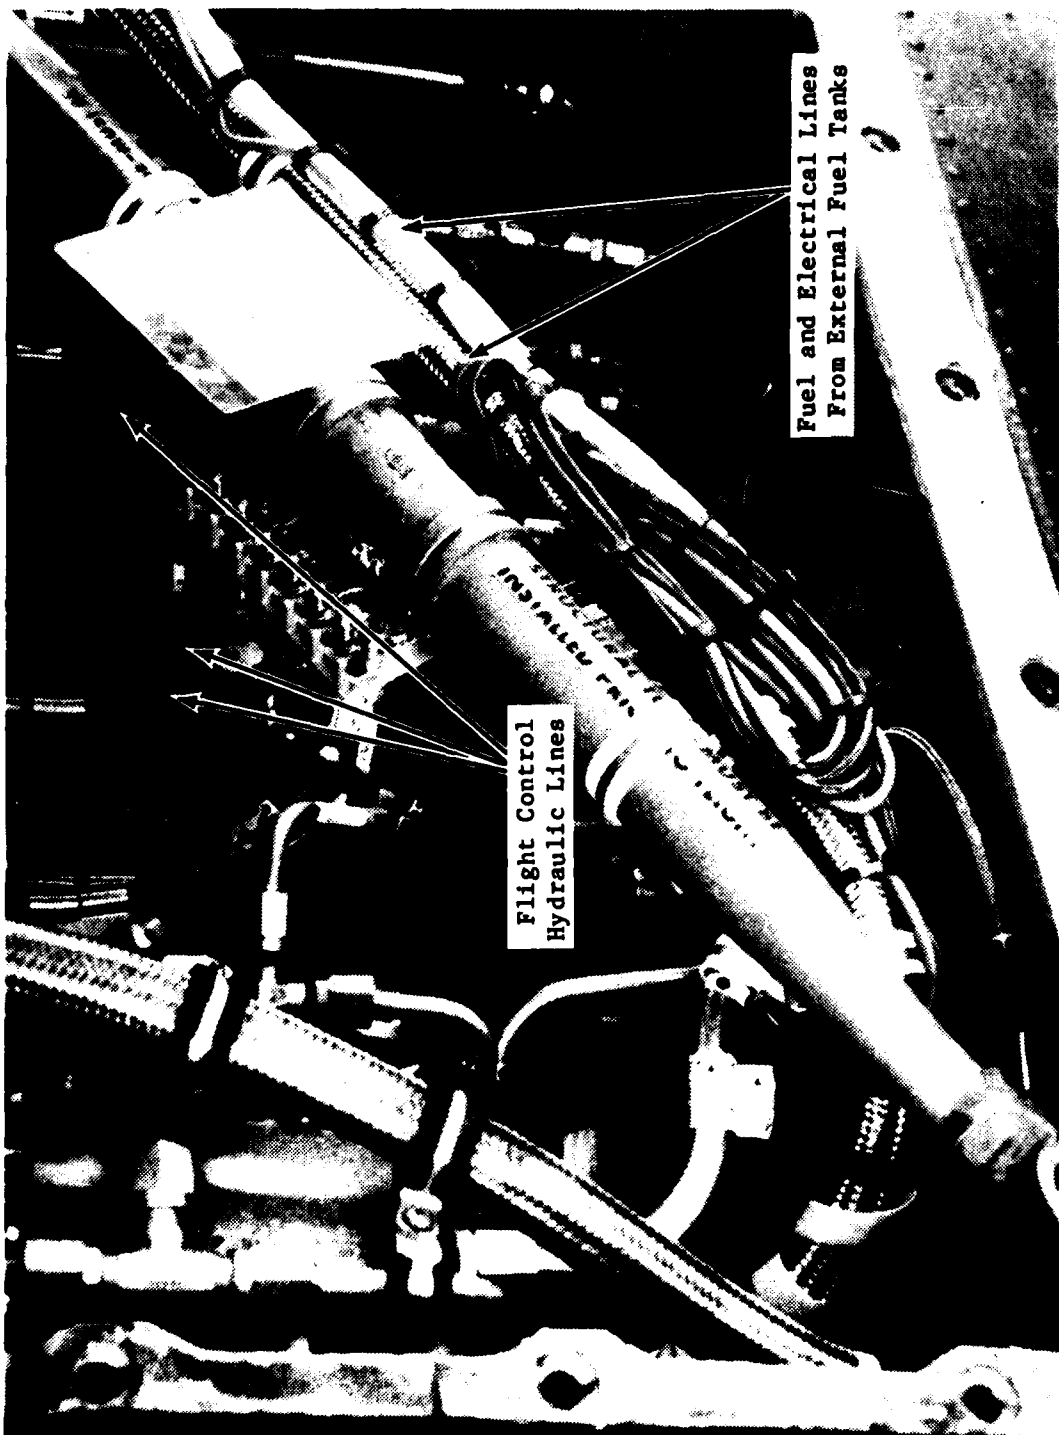
Photo 5. Compartment Beneath Transmission - Right Side

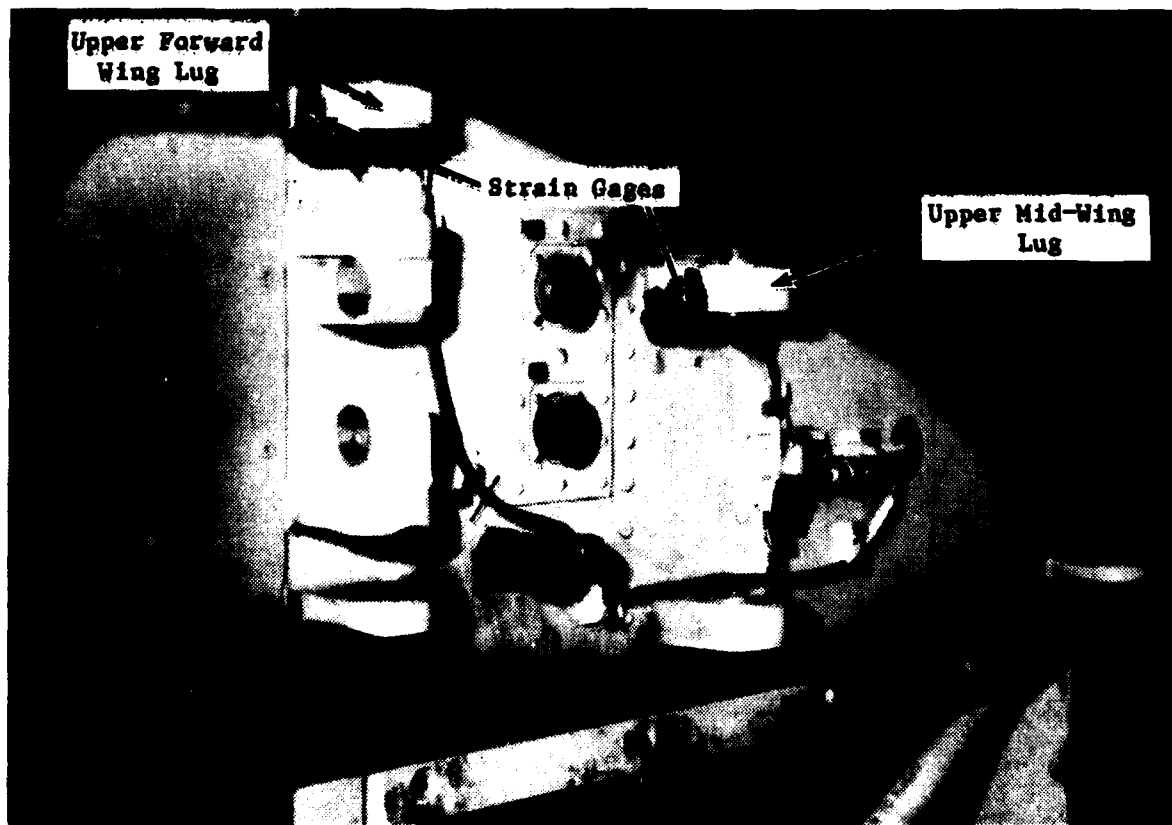
Photo 1. Wing Lug Strain Gage Locations

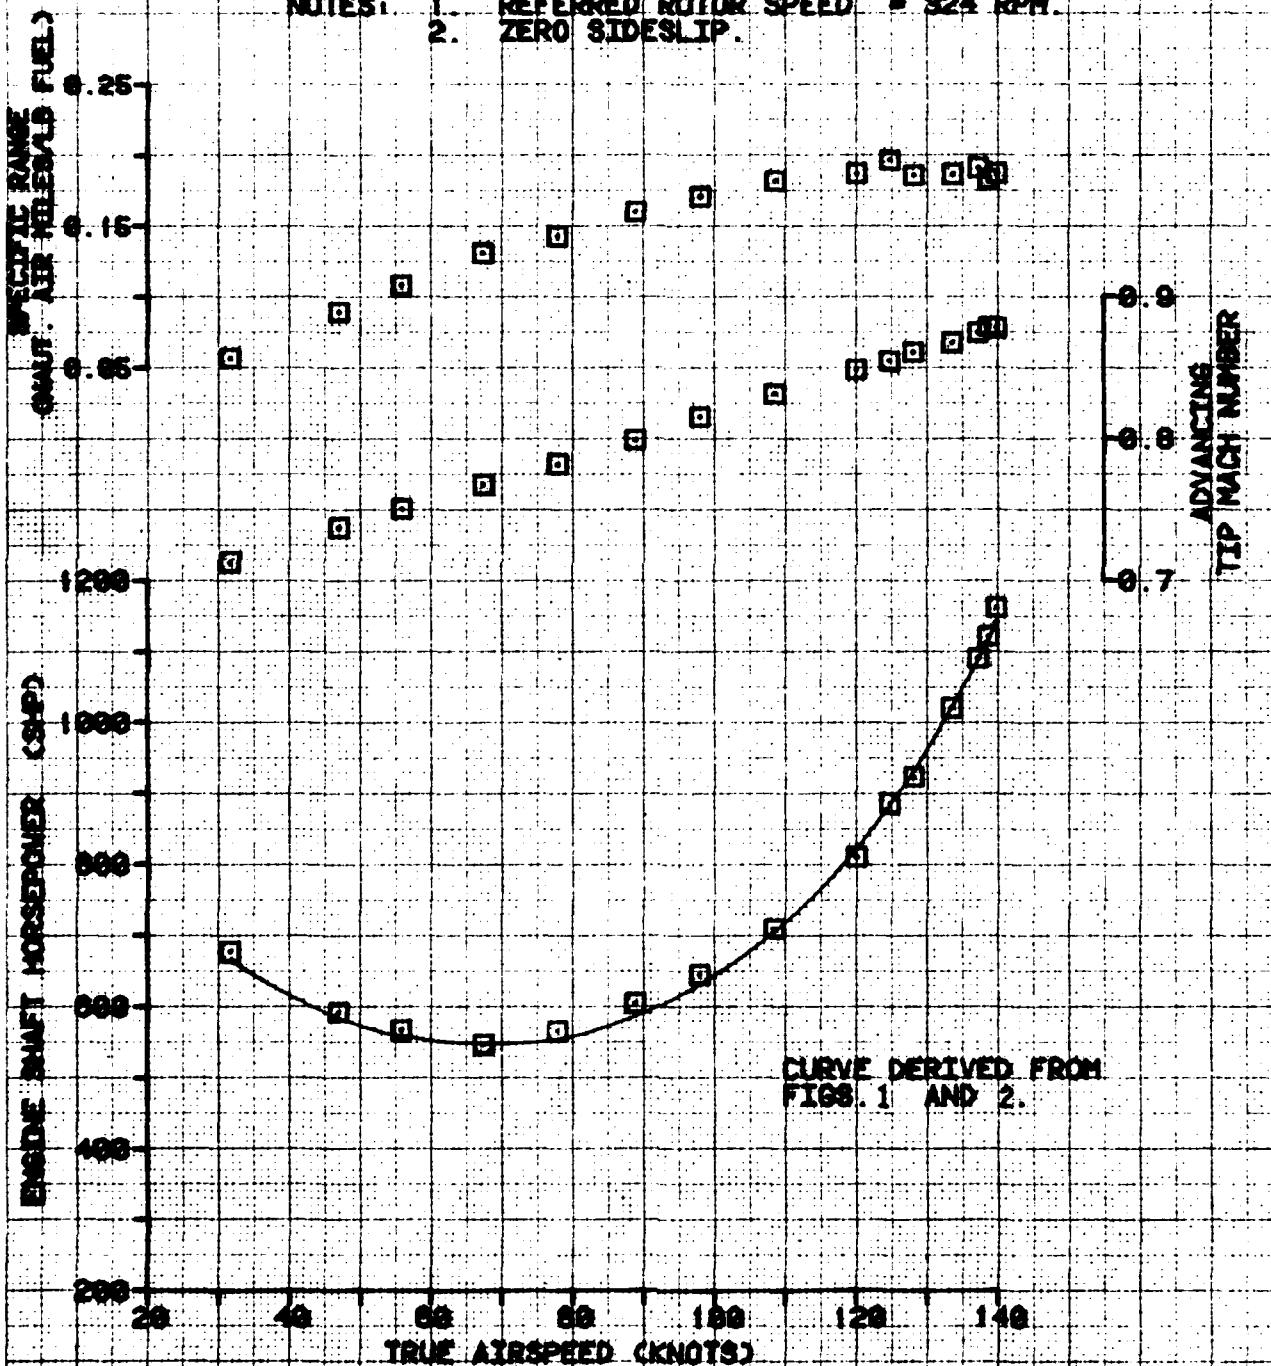
CURVE DERIVED FROM  
FIGS. 1 AND 2.

**FIGURE 4**  
**LEVEL FLIGHT PERFORMANCE**  
**AH-1B MODERNIZED COBRA (HC) USA S/N 00-10423**

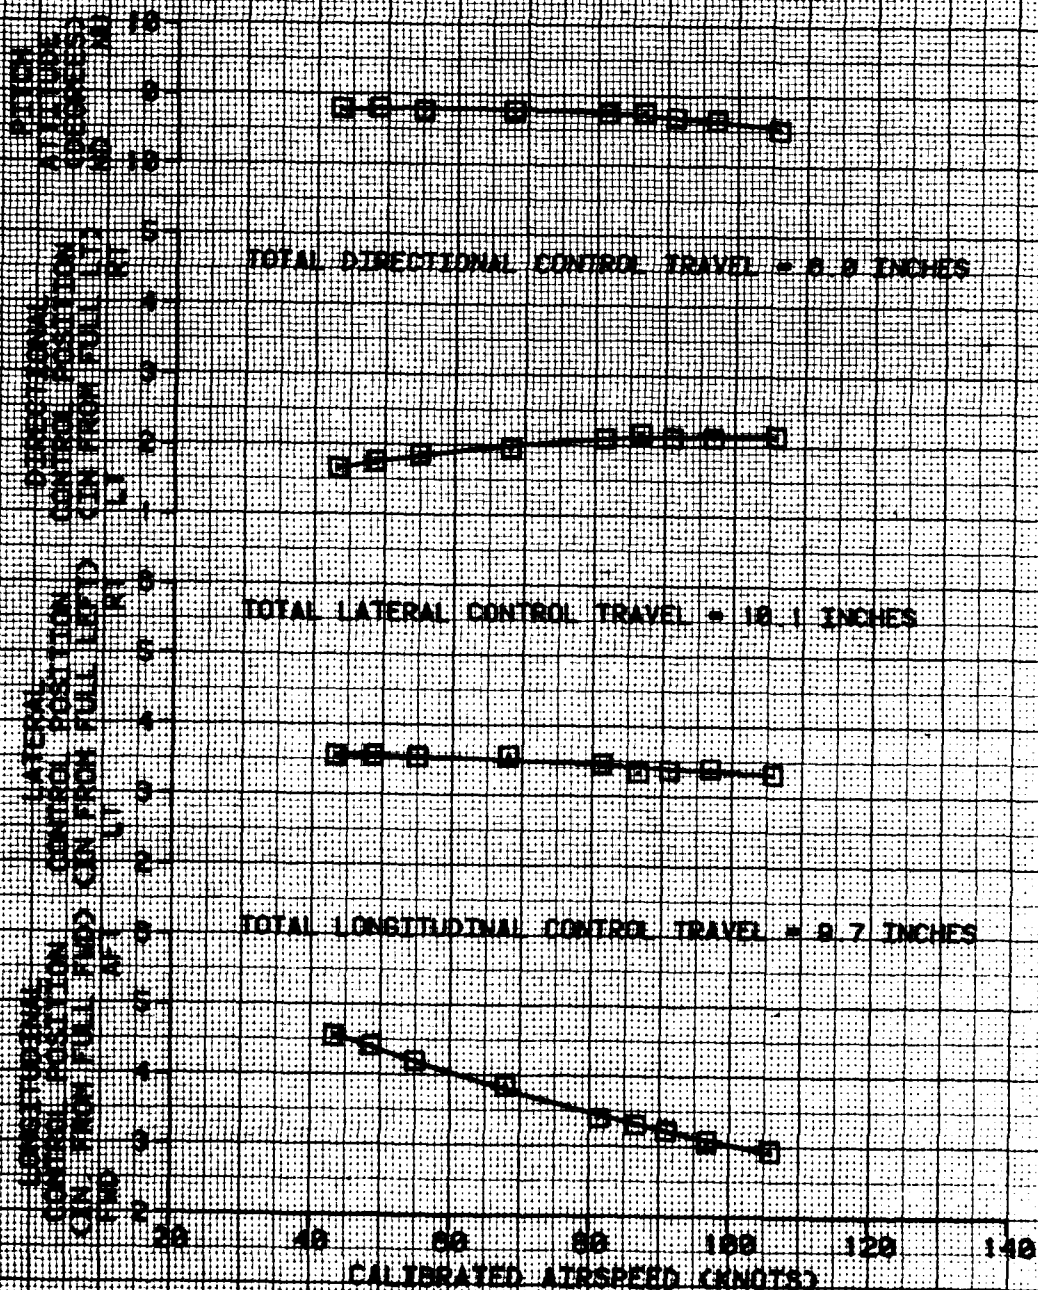
FIGURE 18  
CONTROL POSITIONS IN AUTOROTATIONAL FLIGHT  
AH-1S MODERNIZED COBRA (MC) USA S/N 89-16423

NOTES: 1. SCAS ON  
2. AUTOROTATION  
3. BALL-CENTERED FLIGHT

14. Control positions in autorotational flight were evaluated at the conditions listed in table 2 and the data are presented in figure 18, appendix E. The longitudinal control position trend in autorotation was essentially linear and as airspeed was increased more forward longitudinal cyclic control was required. The significant longitudinal and lateral cyclic trim change in autorotative flight were similar to those previously reported for the standard AH-1S aircraft and are satisfactory.

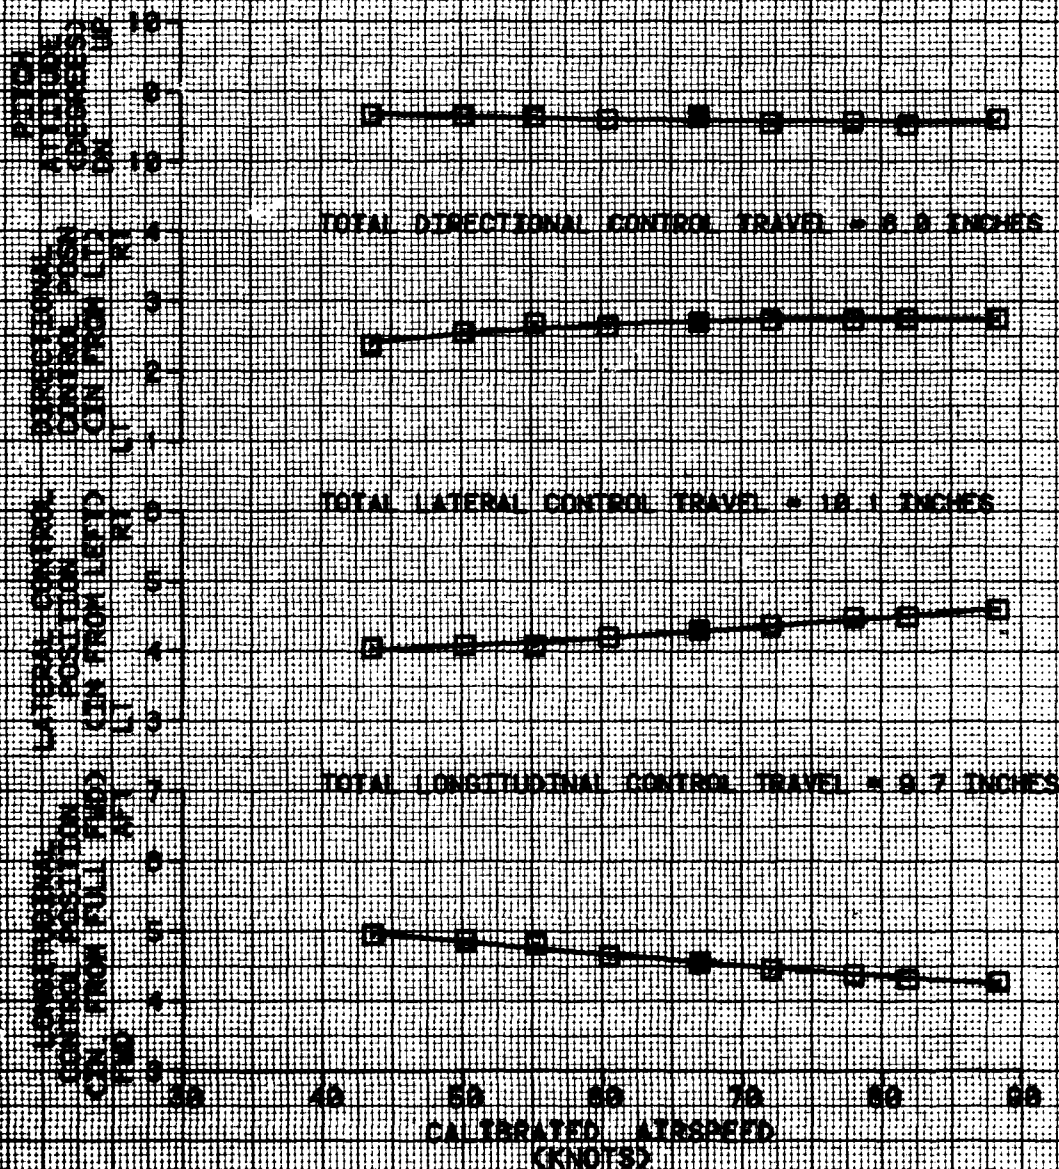
**FIGURE 20**  
**STATIC LONGITUDINAL STABILITY**  
**AH-1S MODERNIZED COBRA (MO) USA S/N 69-16423**

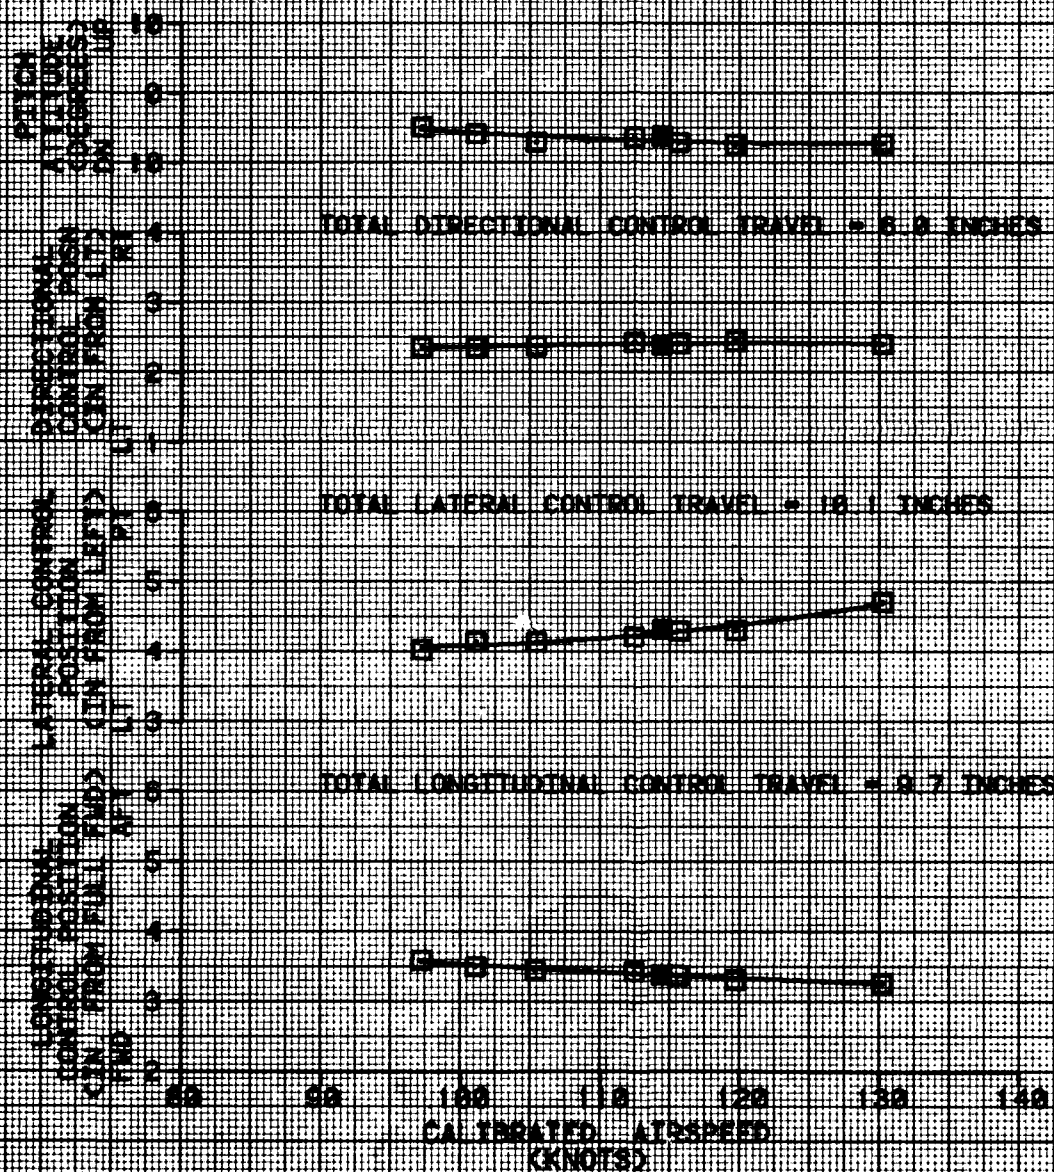
FIGURE 21

STATIC LATERAL-DIRECTIONAL STABILITY  
AH-1S MODERNIZED COBRA (MC) USA S/N 00-10423

16. The static lateral-directional stability characteristics of the test aircraft were evaluated at the conditions shown in table 2. Tests were conducted by first trimming the aircraft at ball-centered level flight at 65 and 110 KCAS and then stabilizing at incrementally increasing left and right sideslip angles. Data were recorded at zero turn rate with airspeed, collective control, and sideslip angle held constant. Test data are presented in figures 21 and 22, appendix E. Static directional stability was positive (increasing left directional control with increasing right sideslip) throughout the sideslip envelope for both trim airspeeds and is satisfactory. Dihedral effect was also positive (increasing right lateral cyclic control with increasing right sideslip) for both trim airspeeds and is satisfactory. The sideforce cues (as indicated by bank angle variation with sideslip) at 65 KCAS were weak. At this airspeed the lack of sideforce cues increased the pilot workload to maintain aircraft trim. At 110 KCAS the sideforce cues were stronger and the pilot workload to maintain trimmed flight was reduced. A comparison of the static lateral-directional characteristics with those previously reported (ref 9, app A) indicated the characteristics were essentially unaffected by the installation of the external fuel tank subsystem.

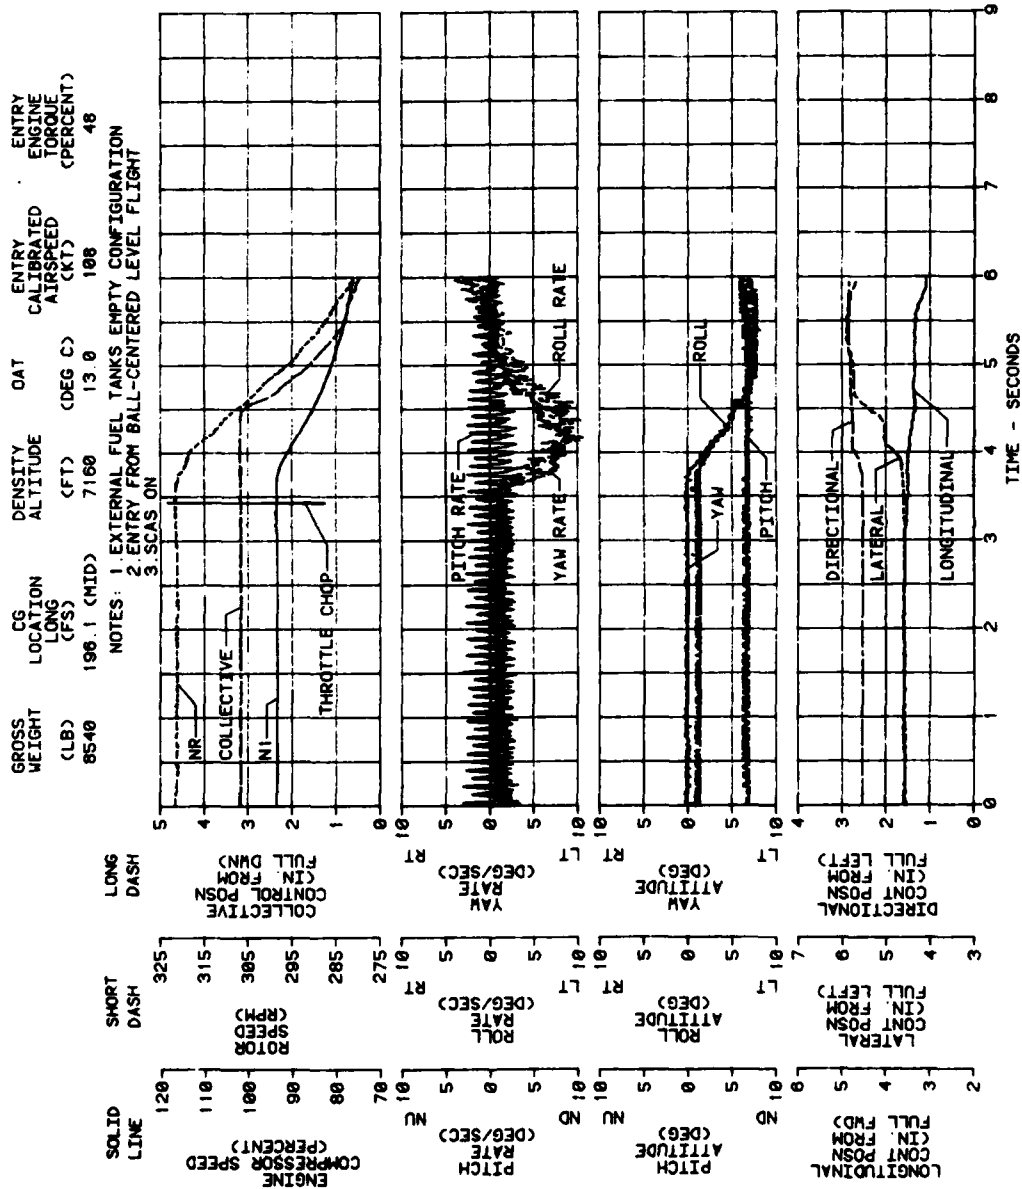
FIGURE 30  
SIMULATED ENGINE FAILURE  
AH-1S MODERNIZED COBRA (MC) USA S/N 69-16423

20. The response of the AH-1S(MC) to simulated sudden engine failures (with the external fuel tanks installed) were evaluated in forward level flight at the conditions listed in table 2. Engine failure was simulated by rapidly rolling the throttle to flight-idle. Flight controls were held fixed until one of the following occurred: (1) 2 seconds following the simulated power loss, (2) the minimum transient rotor speed was reached, or (3) the pilot deemed recovery necessary. Representative time history plots are presented in figures 29 and 30, appendix E. The test results indicate flight control delay times were approximately 0.5 seconds for entries at airspeeds greater than 100 KCAS. The high roll and yaw rates following the loss of power provided immediate cues to the pilot and the low rotor rpm warning system provided an audio cue approximately 1 second following the power loss at which time collective was reduced. Due to the high roll acceleration generated by the simulated engine failure very large lateral cyclic control inputs were required (approximately 1.5 inches to the right). The 2-second collective delay requirement of paragraph 3.5.5 of MIL-H-8501A (ref 11, app A) could not be attained at airspeeds greater than 100 KCAS. The delay times are consistent with those observed in USAAEFA Project No. 75-18, reference 12. The installation of the external fuel tank subsystem did not affect the aircraft reaction following the simulated engine failures.

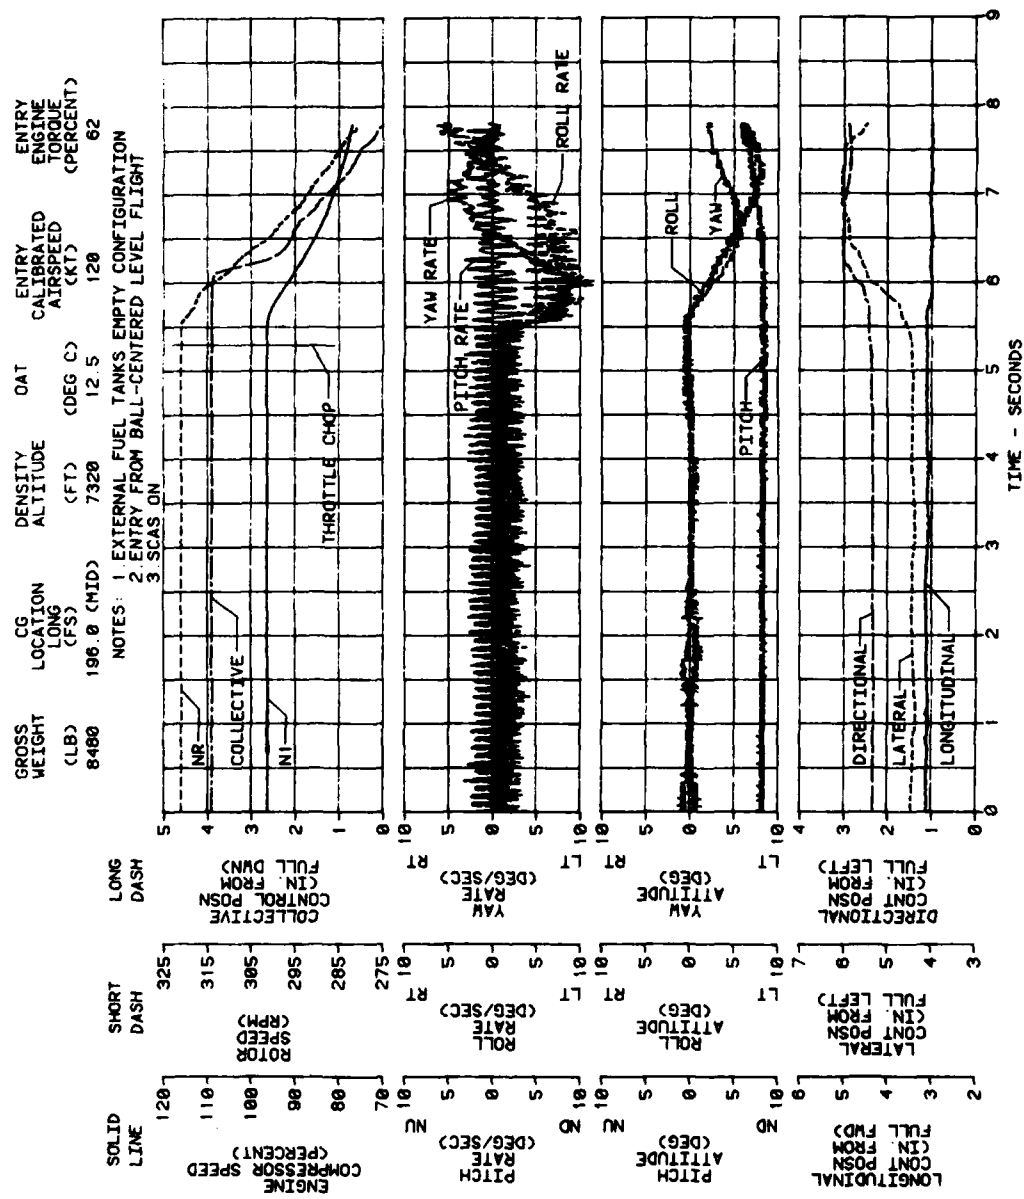
FIGURE 31  
SCAS DISENGAGEMENT  
AH-1S MODERNIZED COBRA (MC) USA S/N 69-16423

21. Simultaneous three-axis Stability and Control Augmentation System (SCAS) failures were evaluated in the external fuel tank configuration (empty and full tanks) at the conditions listed in table 2. Representative data are presented in figures 31 through 34, appendix E. The failures were evaluated at airspeeds from 65 to 117 KCAS. The tests were accomplished by stabilizing the aircraft at the appropriate trim speed, then simultaneously

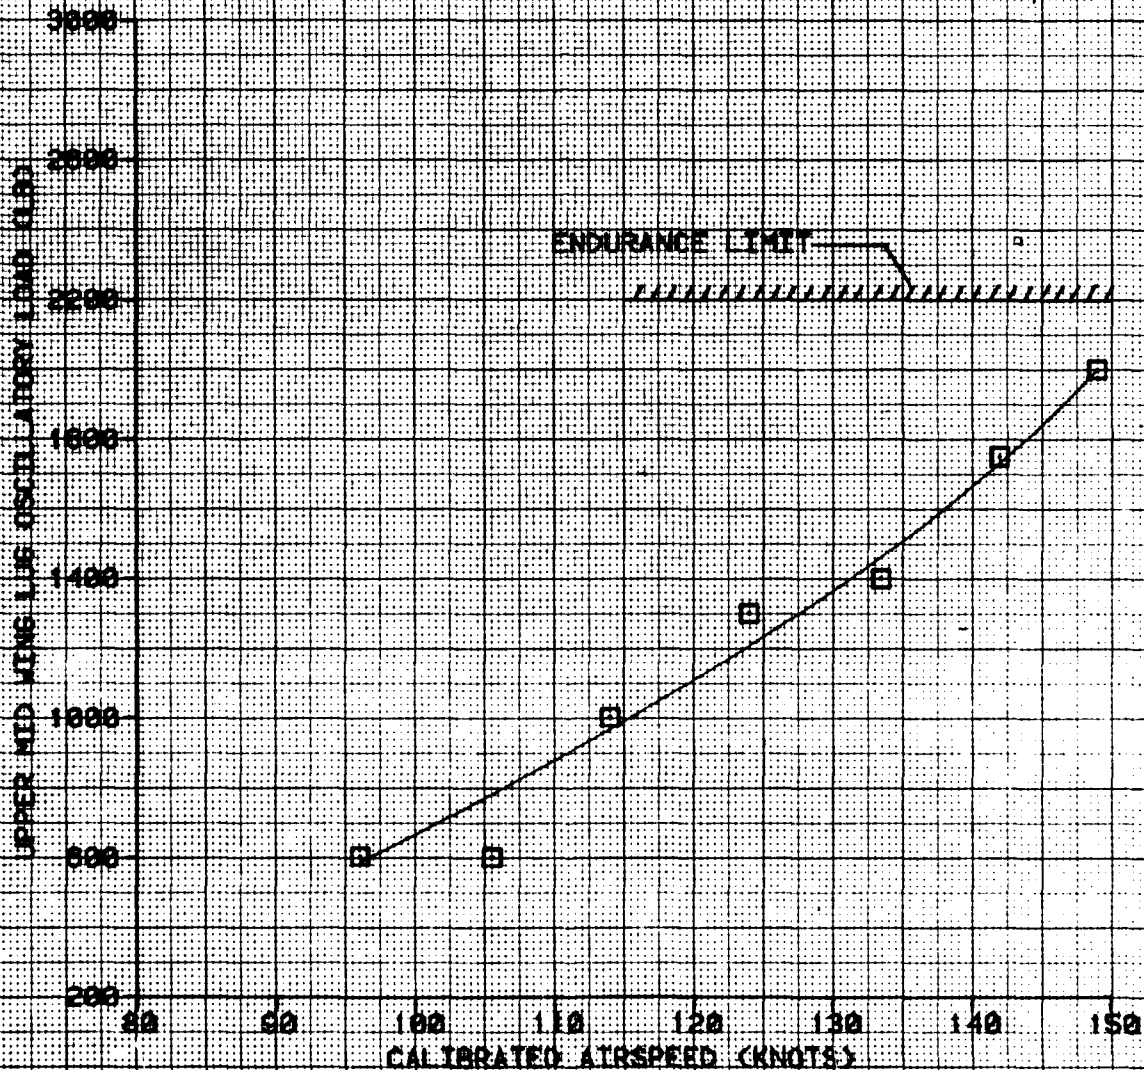
FIGURE 36

UPPER MID WING LUG OSCILLATORY LOAD  
AH-1S MODERNIZED COBRA (MC) USA S/N 69-16423

- NOTES: 1. EXTERNAL FUEL TANKS FULL CONFIGURATION  
2. LEFT TURNS □  
RIGHT TURNS ▲

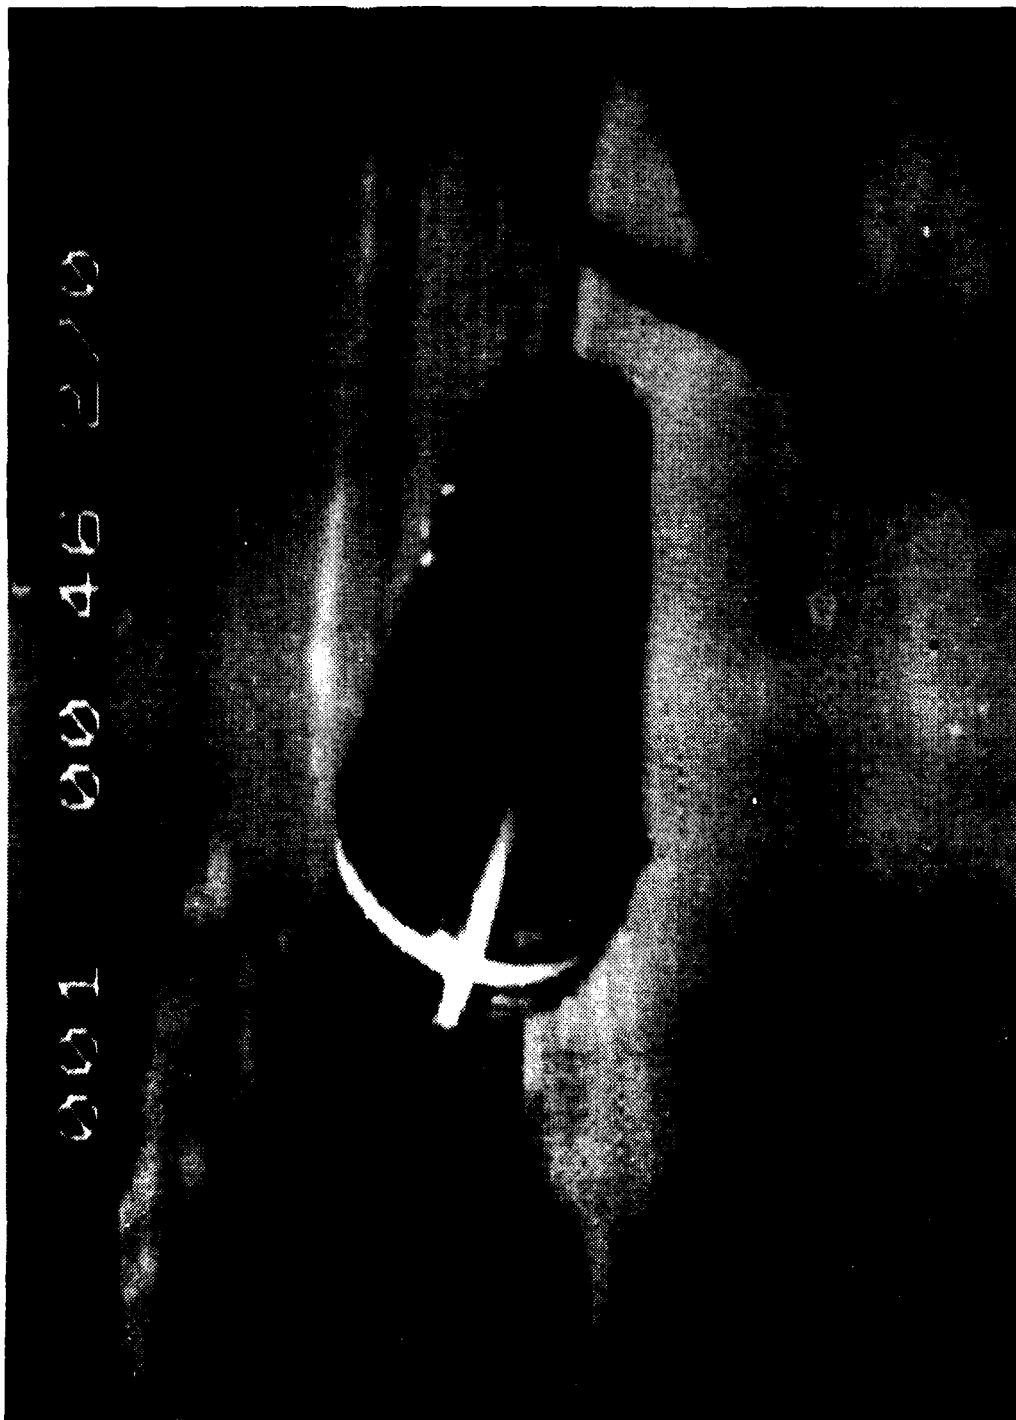
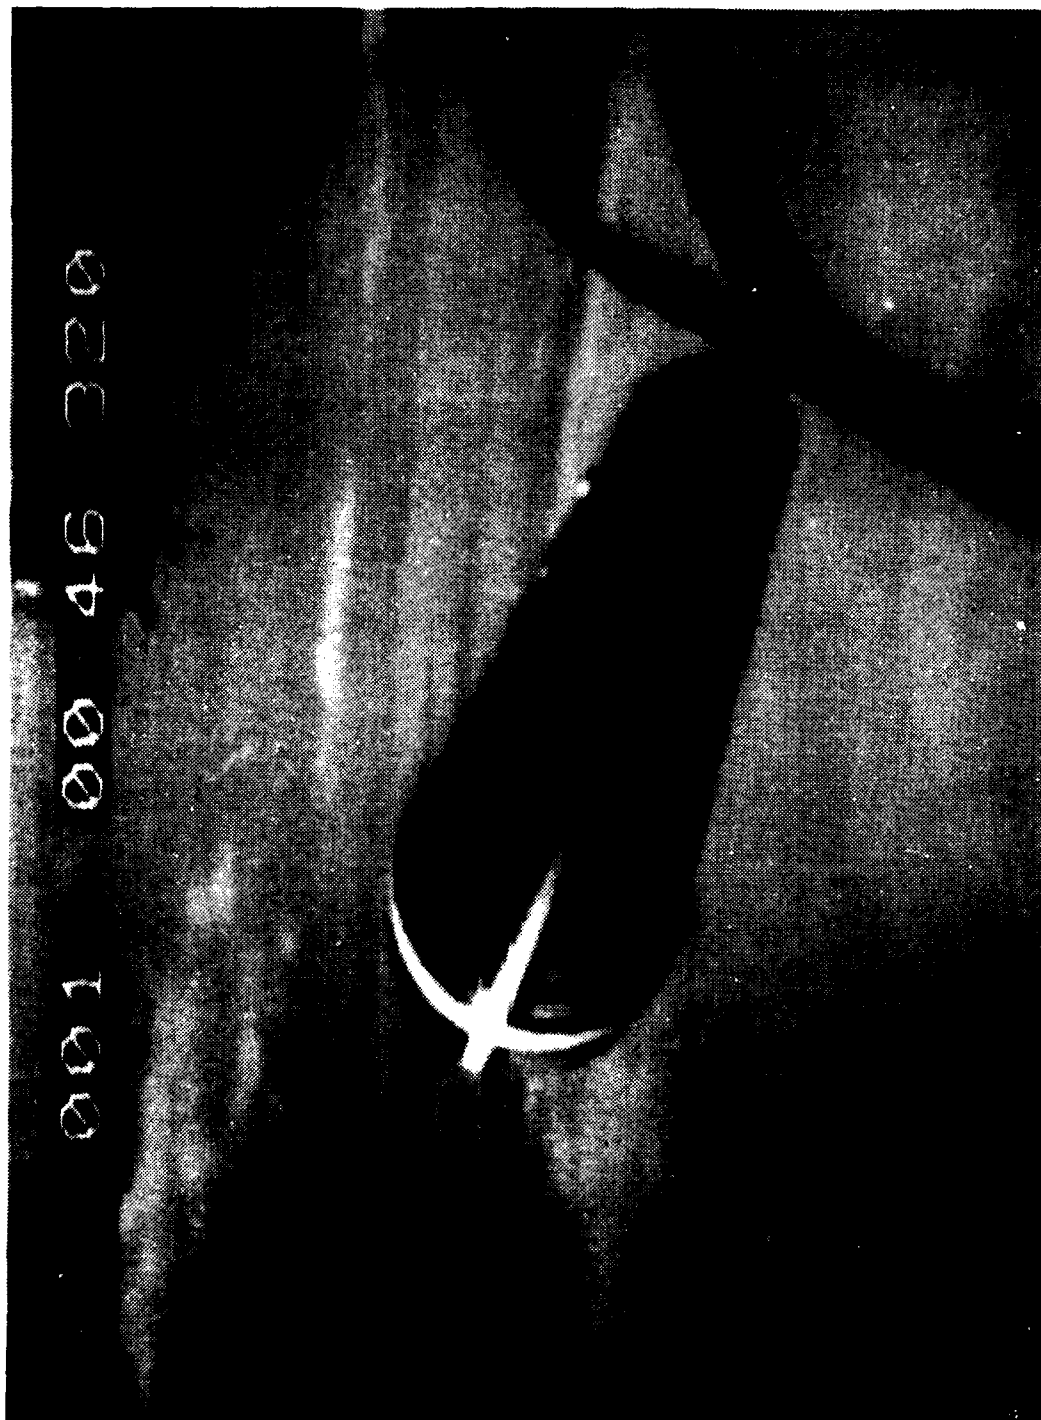
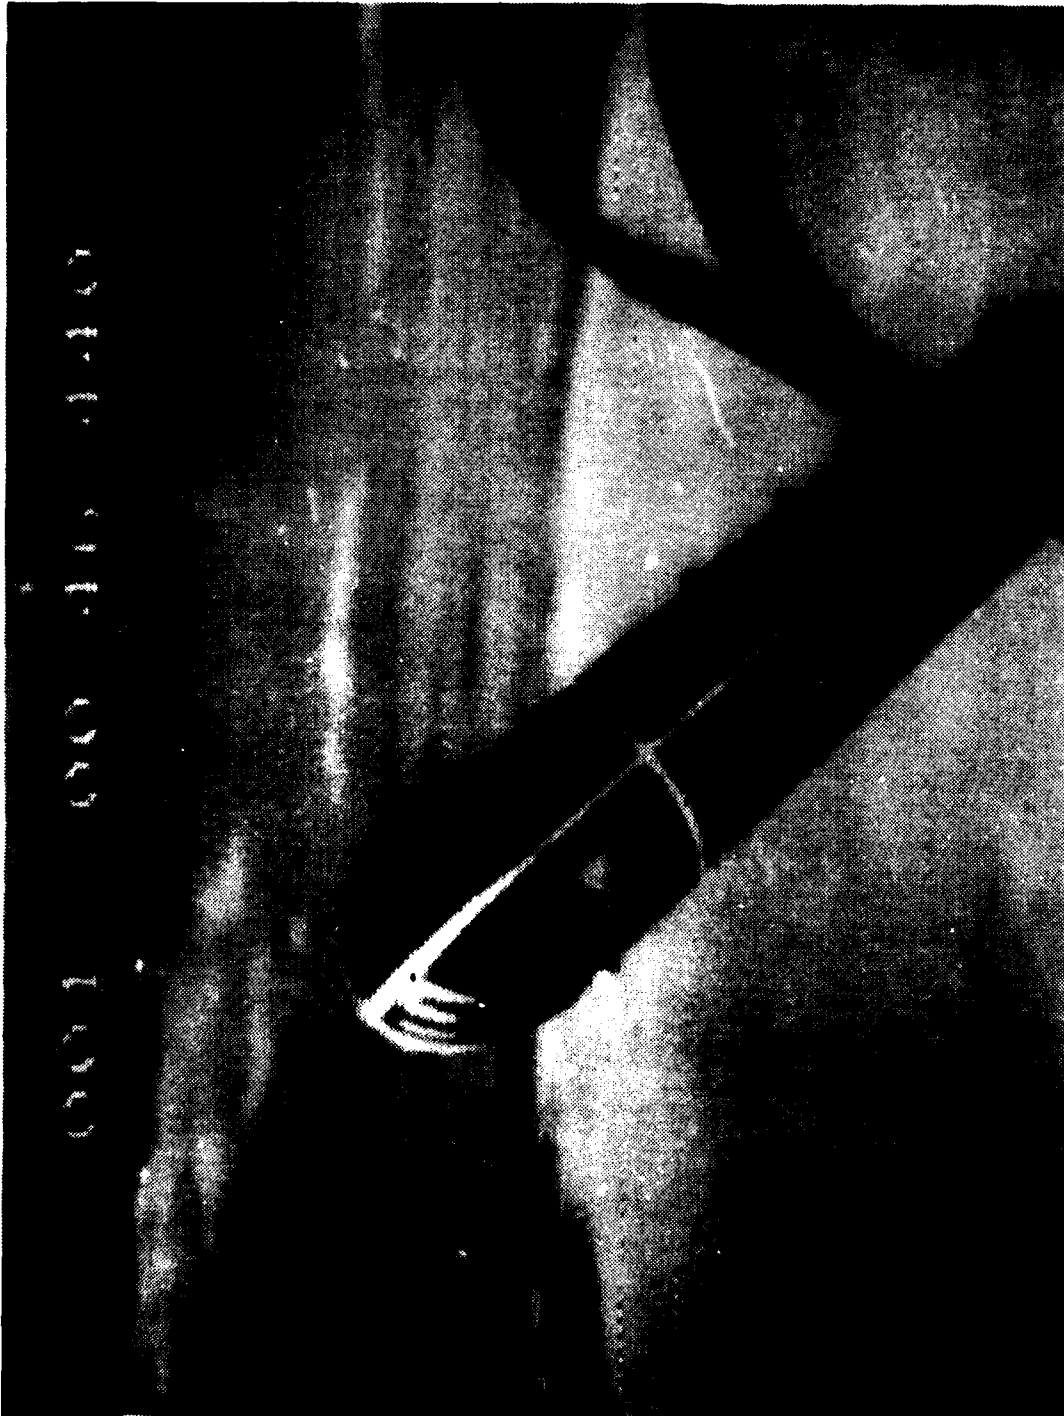
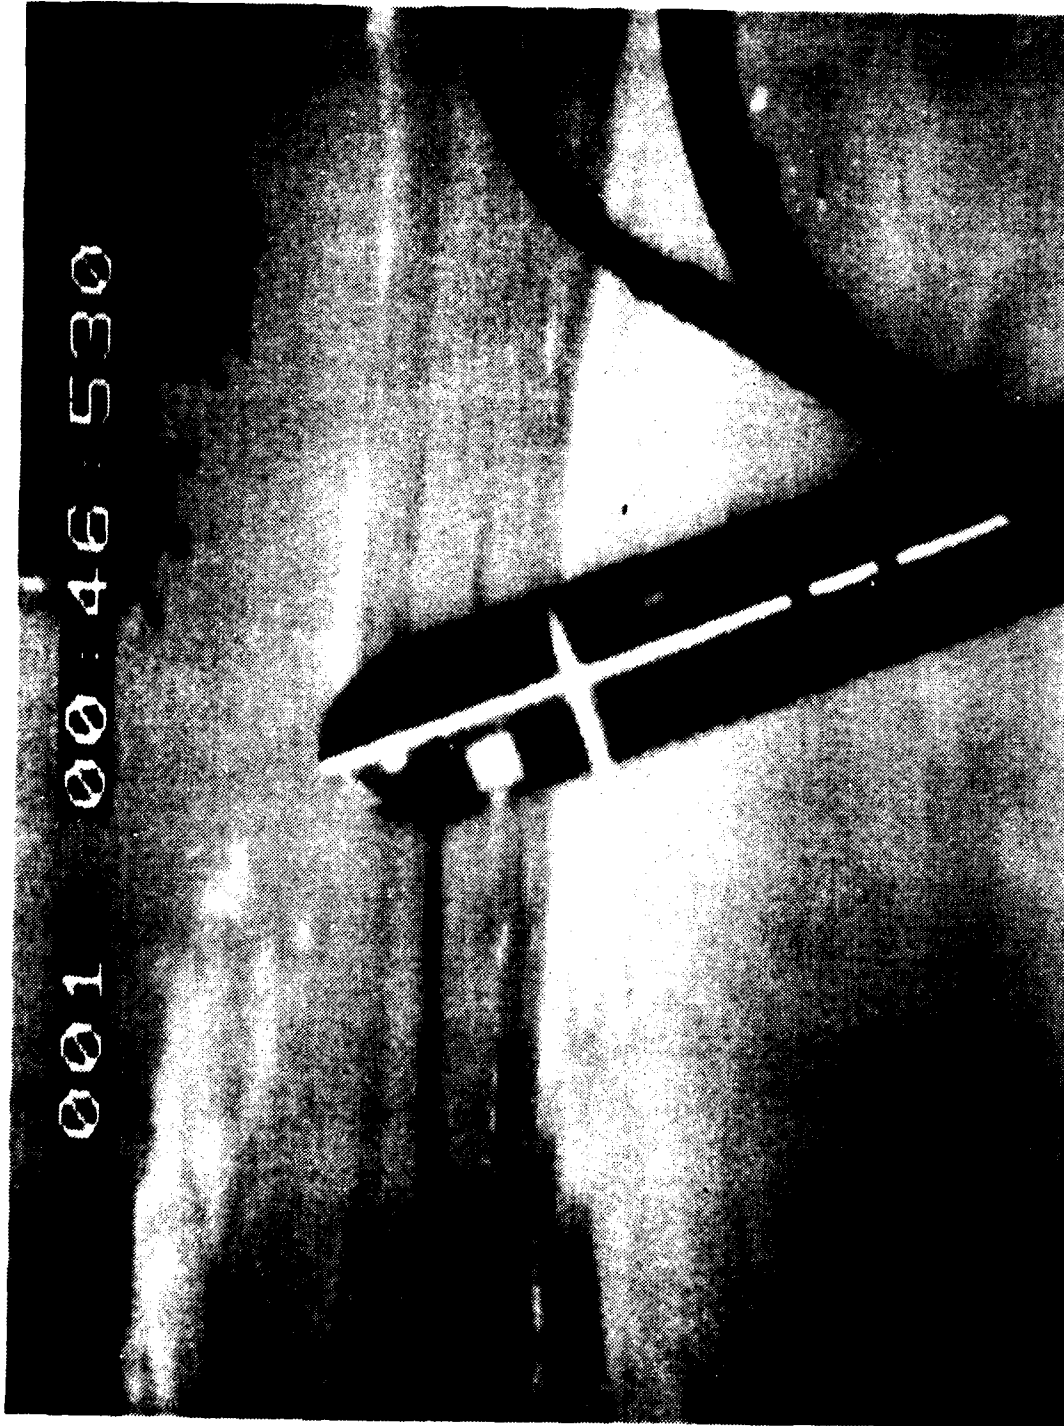
Photo 1. External Fuel Tank Jettison Sequence  
106 KCAS Autorotation

19. A total of 5 external fuel tank jettison tests were accomplished at the conditions listed in table 3. The tanks used during the jettisons were approximately 30 pounds lighter than the operational external fuel tanks since no "EXPLOSAFE" was installed. Since the "EXPLOSAFE" is evenly distributed in the operational tanks, the moments of inertia about all axes of these tanks will be higher than that of the empty tanks. Therefore, the angular rates and accelerations of the empty tanks observed during the jettison tests should be higher than those of the operational tanks. During the jettisons in level flight at 121 KCAS (approximate cruise airspeed) and in autorotation at 61 KCAS (approximate minimum rate of descent airspeed) the separations were very clean with no observable attitude changes to the tank until it was well clear of the aircraft. At 106 KCAS, in ball-centered autorotation, the jettison characteristics of the tank degraded significantly. The tank started to pitch up 0.08 seconds after jettison initiation, approximately 18 inches below the wings, and the nose started a right yaw 0.05 seconds later. The tank reached a 90 degree pitch up approximately 0.3 seconds after jettison initiation and the nose of the tank cleared the wing pylon mounts by approximately 1 foot. The tank then continued its pitching motion but continued to drop away from the aircraft and did not impact with the aircraft. The jettison sequence is shown in photos 1 through 5, appendix E. Jettison at
