USAARL REPORT NO. 85-1

**SPH-4 U. S. ARMY FLIGHT HELMET PERFORMANCE  
1972-1983**

**BIODYNAMICS RESEARCH DIVISION**

**U.S. ARMY AEROMEDICAL RESEARCH LABORATORY  
FORT RUCKER, ALABAMA 36362**

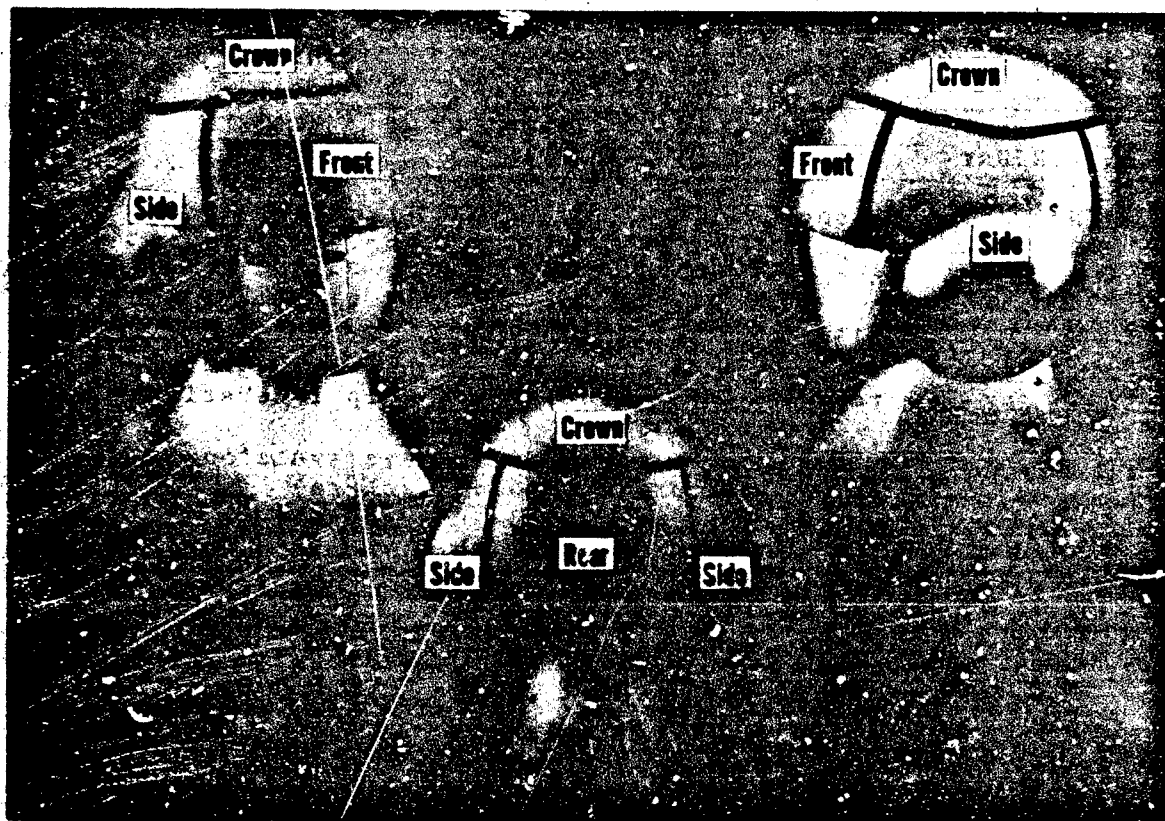
FIGURE 4. Division of Helmet to Determine Impact Location.

1. Location. The helmet was divided into five large areas: crown, front, rear, left, and right sides (Figure 4). These five areas were further subdivided as indicated in Appendix B. (The smaller subdivisions were not used in the current analysis.) As many as five impacts per helmet were cataloged by location in these five areas.

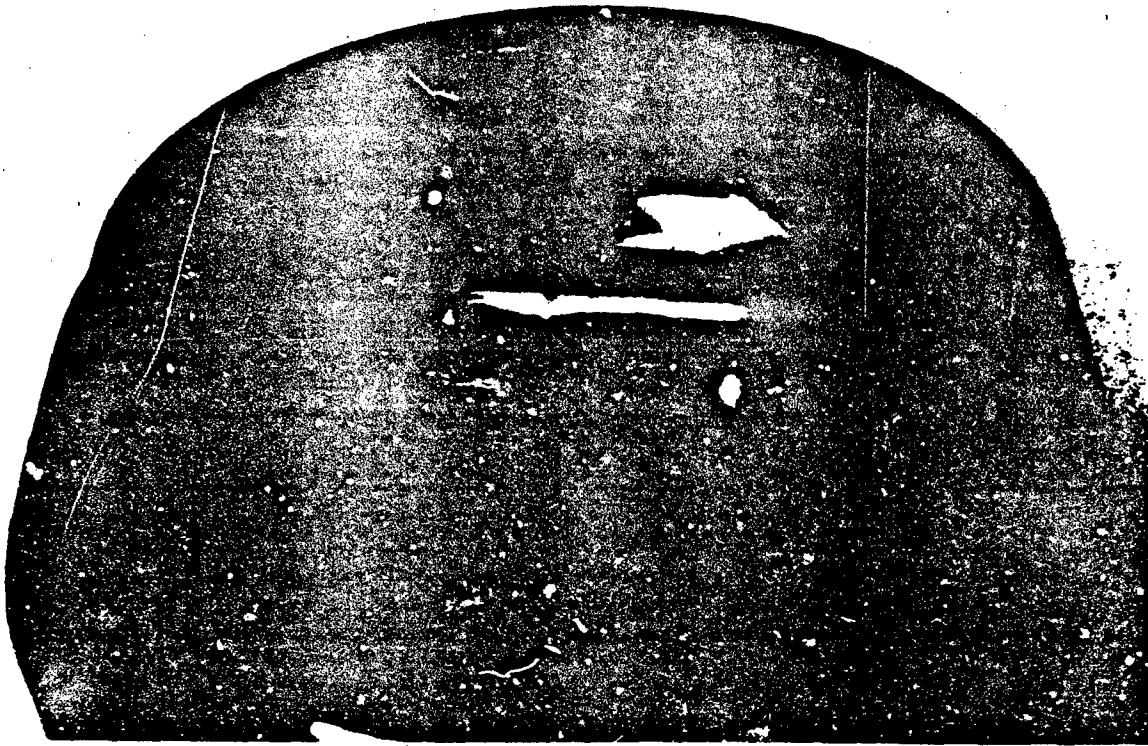
FIGURE 8. Example of Damaged Earcup.

Forty-two cases of earcup damage were noted, and only four of these cases had AIS values below five. Figure 8 depicts representative earcup damage. Thirty of the 42 cases (71.4 percent) were considered survivable or potentially survivable. In 18 of these cases, all circumstances indicated that an energy-absorbing earcup would have lessened the severity of the injuries sustained.

4. An energy-absorbing earcup should be designed and deployed for the SPH-4 and such requirements should be a part of all future helmet designs.
5. The visor should be worn down at all times during flight operations except when the use of Night Vision Goggles or target acquisition equipment prohibits it.

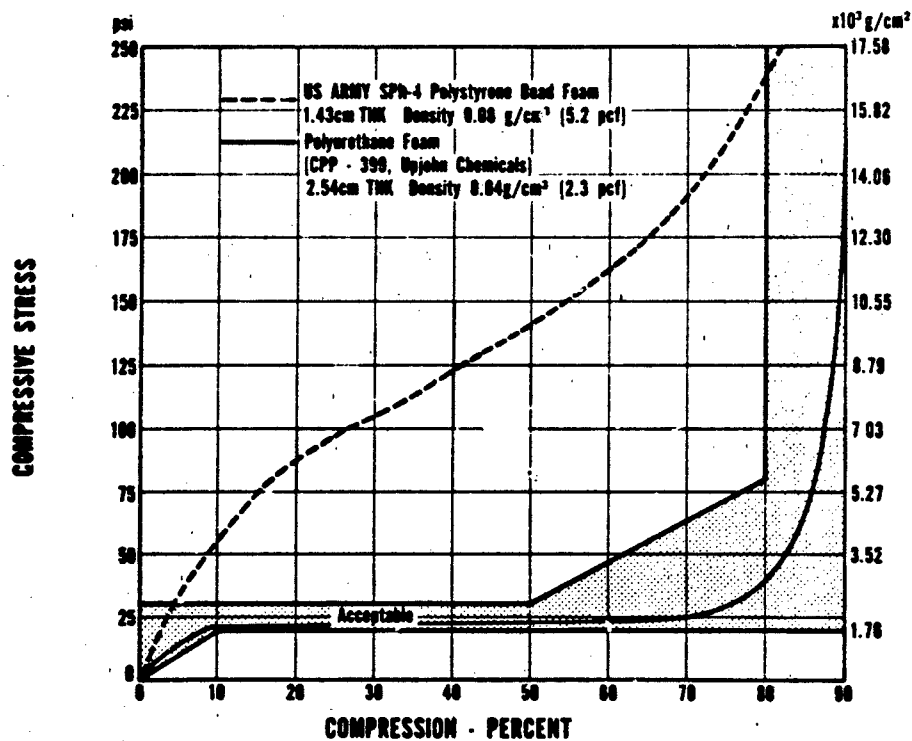
FIGURE 11. Compressive Stress-Strain Curve of Present and Experimental Foam.

A review of Table 10 shows that severe head injuries (AIS 3 or greater) are occurring with a minimum amount of residual foam compression. For example, 28 AIS 3 or higher injuries (21 percent of the total; 38 percent of the AIS 3 or higher cases) occurred with less than 20 percent foam compression. On the other hand, the foam was fully utilized (>50 percent compression) in only 11 cases (8 percent of the total), all of which were AIS 3 or greater (15 percent of the AIS 3 or higher cases). In essence, the data show that the "crushable" foam does not compress at a low enough load. We believe that the present foam liner, which crushes at a stress value of 140 psi ( $10 \text{ kg/cm}^2$ ), as shown in Figure 11, is five times more than needed. Note also in Figure 11 that a polyurethane foam of 44 percent the density of the present SPH-4 polystyrene foam provides much better energy absorption. USAARL experimental dynamic tests have shown it is possible to reduce the average acceleration of a helmet dropped from a 2.44m height from 150g with a standard helmet to approximately 75g with a modified helmet by the substitution of a liner 3.5 cm thick and a lower crush strength. Recommended stress-strain properties for the helmet liner also are shown in Figure 11. As discussed earlier, this liner of decreased density and increased thickness can be provided in flight helmets without significantly altering the overall helmet in size and weight. The use of com-

pressive stress versus strain as design criteria to meet various standards is discussed in more detail by Haley et al., 1983.

4. The most common impactors in peace time accidents in US Army aircraft are flat surfaces. There is a minimal threat of severe puncture damage. Current standards for puncture protection in aviation helmets make them excessively rigid, and heavy. Consequently, the energy-attenuating foam liner is less compressible and absorbs less of the impact energy than it might.
