EOS (ELECTRICAL OVERSTRESS) PROTECTION FOR VLSI (VERY  
LARGE SCALE INTEGRATION) (U) MARTIN MARIETTA AEROSPACE  
DENVER CO D D WILSON ET AL. SEP 84 MCR-84-506

RADC-TR-84-183  
Final Technical Report  
September 1984

## ***EOS PROTECTION FOR VLSI DEVICES***

**Martin Marietta Denver Aerospace**

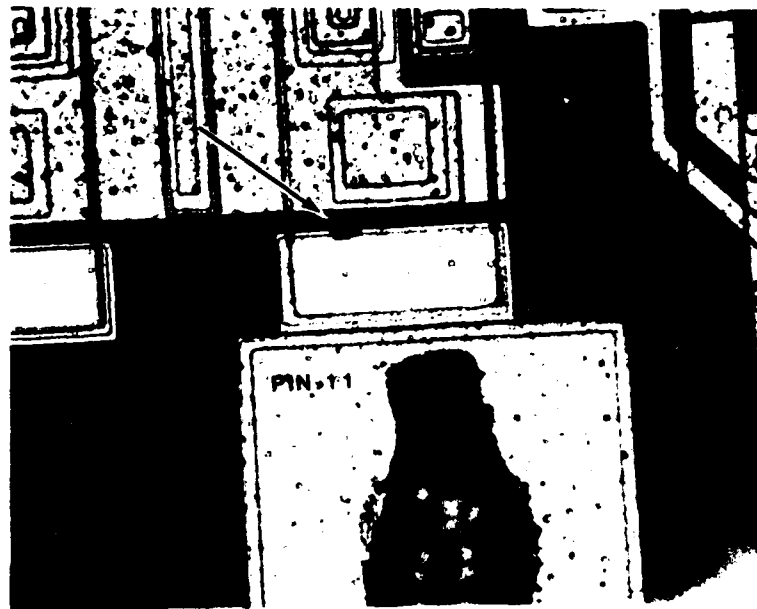
Figure V.C.19 - Pin 11 Input Failure Location.

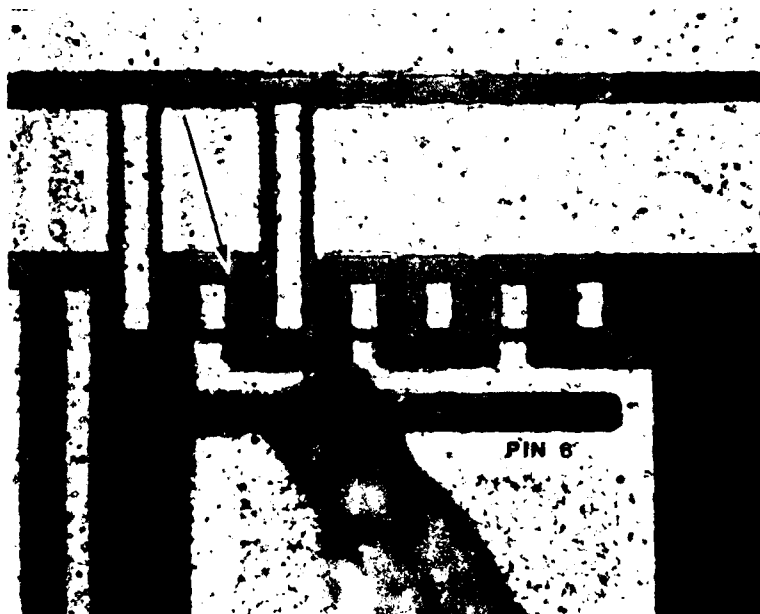
Figure V.F.28 - CD Stress, Pin 6 Output Damage

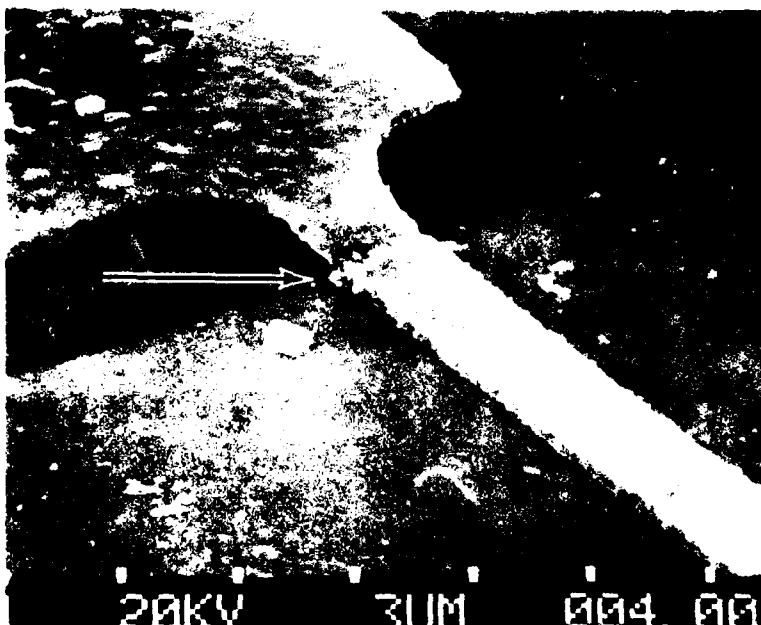
Figure V.H.37 - CD Stress, Pin 5 Polysilicon Breakdown Site
