SEM INVESTIGATION OF SILICON DIODES USING THE ELECTRON BEAM INDUCED CURRENT METHOD

1Lt Mark E. Snyder

December 1984

AIR FORCE WEAPONS LABORATORY  
Air Force Systems Command  
Kirtland Air Force Base, NM 87117

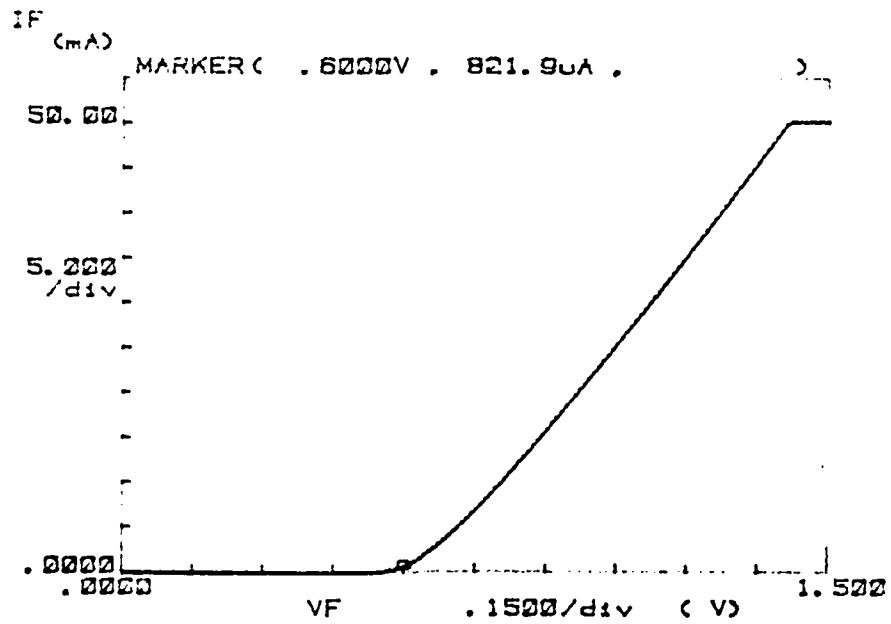
(a) Forward bias Characteristics

(b) Reverse bias characteristics

Figure 5. Current-voltage characteristics for diode 034.

The avalanche voltage of diode 034 is greater than that of diode 001. The addition of a soft breakdown knee with a sharp knee formation (Fig. 5c). These formations were observed during characterization runs when diodes 001 through 050 showed the avalanche knee--that were not stable. Examination of diodes 001 through 050 showed that the avalanche breakdown voltage (despite the fact that it was at reverse currents which varied between 100 and 1000  $\mu$ A) for all diodes went through the same production process. The initial P+ diffusion may be the source of the soft knee characteristics. It was also determined that the characteristics for both sets of devices were greatly improved by a one-sided step junction (Fig. 6). Thus, the soft knee does not appear to be solely dependent on the production process.

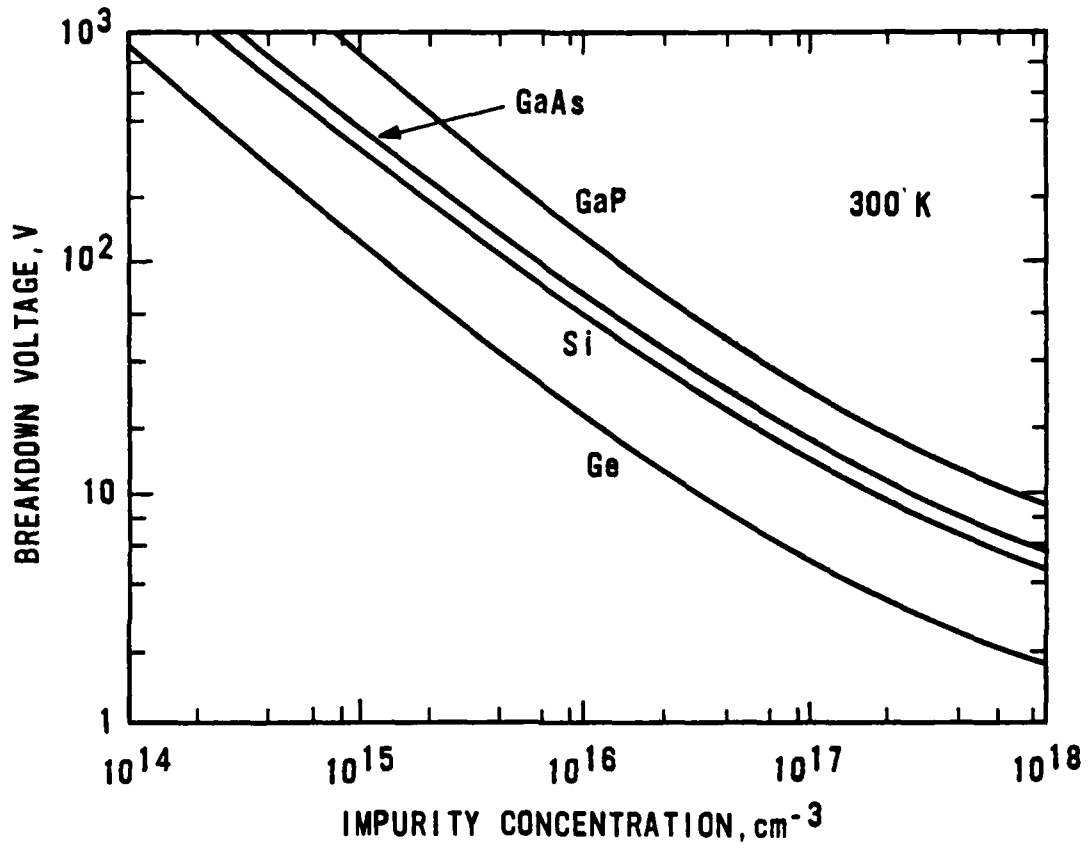
Figure 6. Calculated avalanche breakdown voltage of a one-sided step junction as a function of impurity concentration in the lightly doped side (after Ref. 6).
