NAVAL POSTGRADUATE SCHOOL

THESIS

AN INVESTIGATION OF ELEVATED TEMPERATURE
FATIGUE CRACK INITIATION IN
2 1/2 CR-1 MO LOW ALLOY STEEL

June 1984

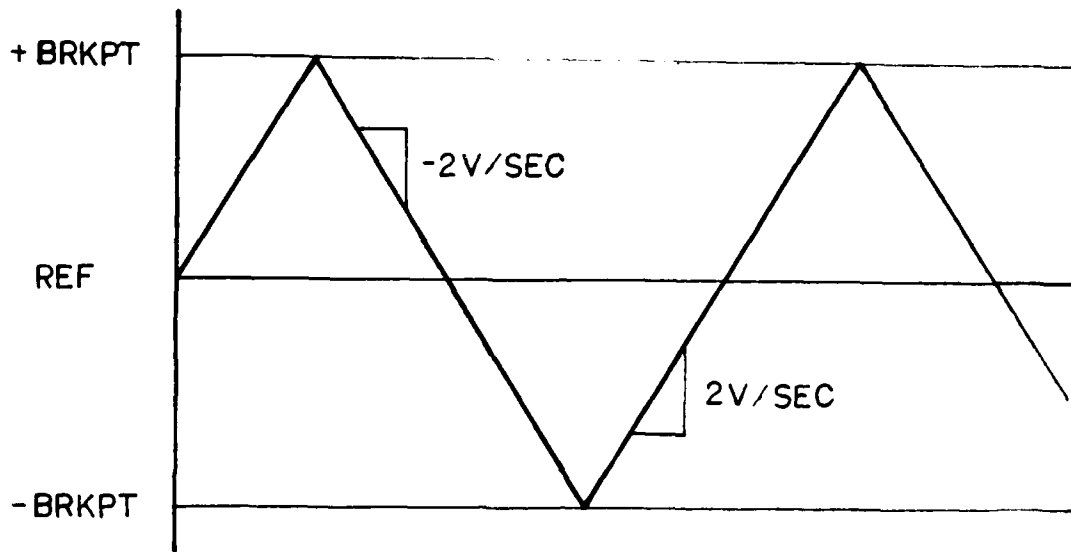
Figure 3.6 MTS Function Generator Output Voltage.

The function generator was then set to produce a strain rate of $4 \times 10^{-3} \text{ sec}^{-1}$ by means of reversing ramp function with a rate of 2 volts/sec, Figure 3.6. The peak values were determined by setting the break point percent adjustment. For example, to obtain total strain range of 0.005, the break point adjustment was set at 1.25, which yields a peak voltage of ± 1.25 volts, which in turn corresponds to an elongation of $\pm .0025$ inches, or a total strain of .005. To conduct a subsequent test, the only adjustment required was to the break point.

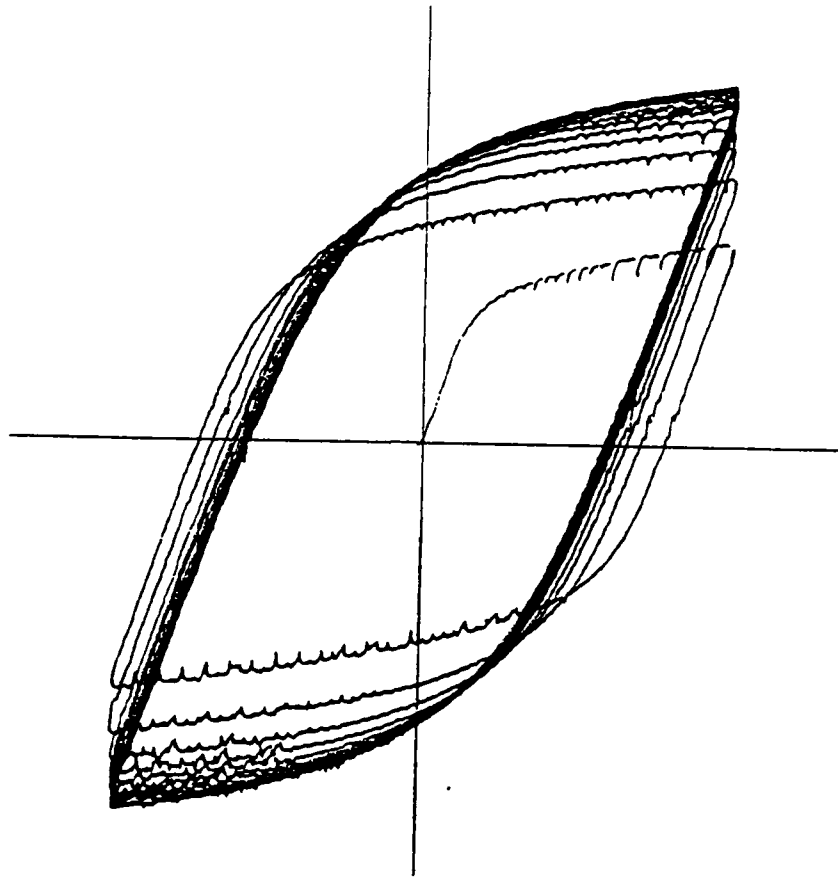
Figure 3.7 Typical Hysteresis Loops with Strain Hardening.

Since most of the tests were conducted under conditions resulting in significant plastic strain, it was necessary to develop a procedure to match hysteresis behavior before and after the test interruption and examination, as if cycling were continuous. To accomplish this, the test was always stopped as the strain reached zero from negative values. The load therefore was positive and increasing. The hysteresis of the cycle just prior to interruption was recorded on the X-Y recorder and the load voltage was recorded just after the test was interrupted. The MTS controller was switched to load control and the load was reduced to zero. The specimen was cooled at a rate of approximately 1 °C/sec, and removed for examination. Upon reinitiation of the test, the procedure above was followed. After the 15 minute hold period, the load was increased to the load recorded just after test interruption and the strain was zeroed. The controller was switched to strain

control, the X-Y recorder was started and cycling began. This superimposed the hysteresis of cycles after the interruption on to that just prior to the interruption. This gave immediate indication of how well the two matched. With the exception of some softening, the hysteresis loops matched and within a few cycles, strain hardening brought the new hysteresis loop to coincide with those prior to test interruption.

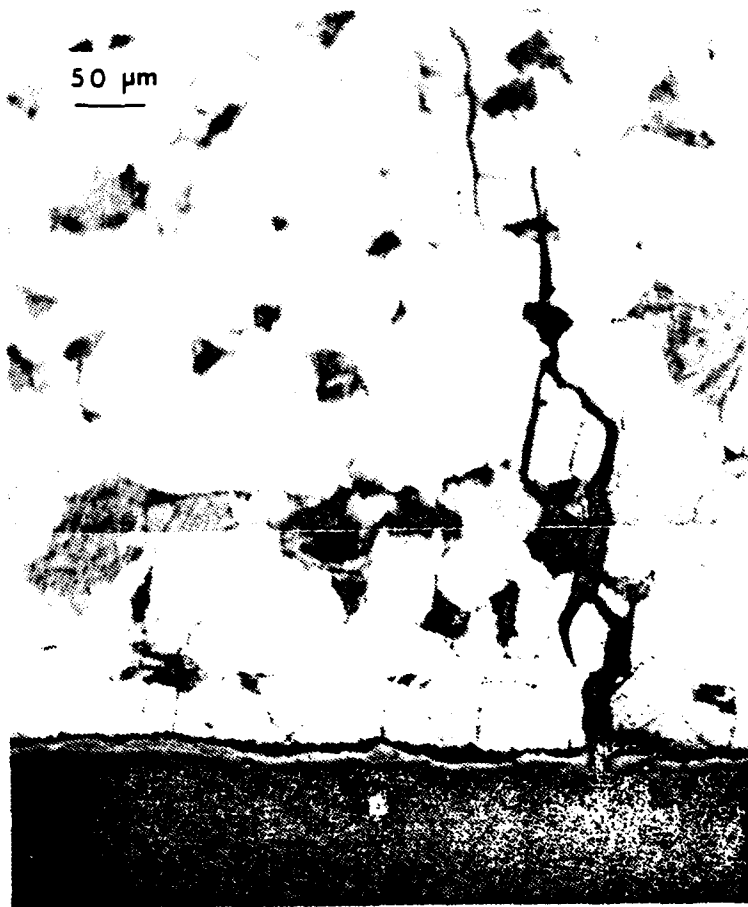
Figure A.35 Specimen #15 1430 Cycles.

Examination of the cracks, Figures A.35 and A.36 show that the cracks propagated transgranularly, cutting both pearlite and ferrite grains. Scanning Electron Microscope examination of the profile of the crack revealed similar findings, Figures A.36 to A.41. Figure A.36 shows one such crack that is less than one grain diameter in length.

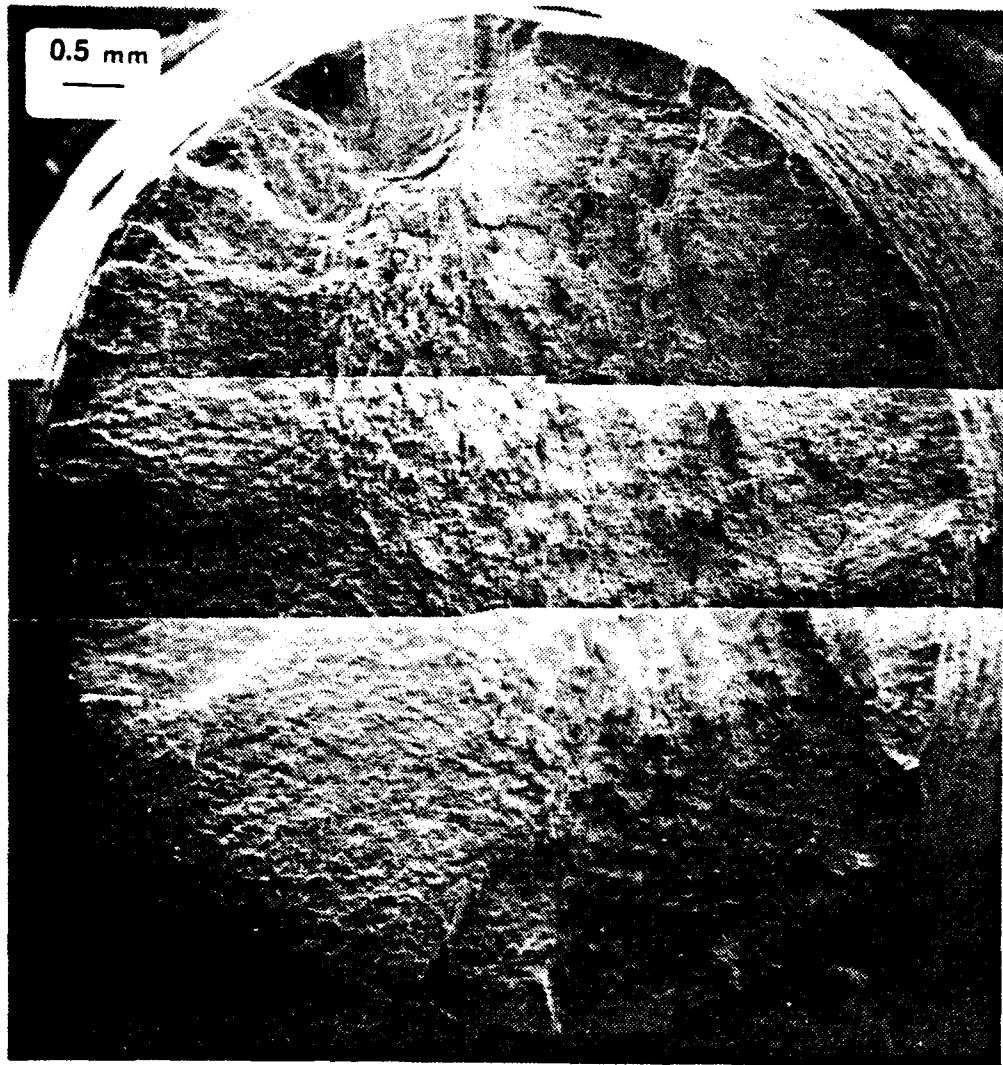
Figure A.78 Specimen #32 Fracture Surface.

Examination of the fracture surface showed that the fatigue crack initiated on numerous points on the surface of the specimen. These individual cracks grew to form a single crack which was convex toward the specimen surface, which is typical of a fatigue initiated by a circumferential groove, Figure A.78. All specimens cycled without dwell had a single crack initiation site and the crack front was concave toward the origin. This clearly shows that oxide cracks must initiate the cracks in the substrate, since the compressive dwell's initial affect is to promote profuse circumferential oxide cracks.
