LOCALIZED CORROSION CURRENTS FROM GRAPHITE/ALUMINUM AND
WELDED SiC/AL METAL MATRIX COMPOSITES(U) NAVAL RESEARCH
LAB WASHINGTON DC C R CROWE 28 FEB 85 NRL-MR-5415

LOCALIZED CORROSION CURRENTS FROM GRAPHITE/ALUMINUM
AND WELDED SiC/Al METAL MATRIX COMPOSITES

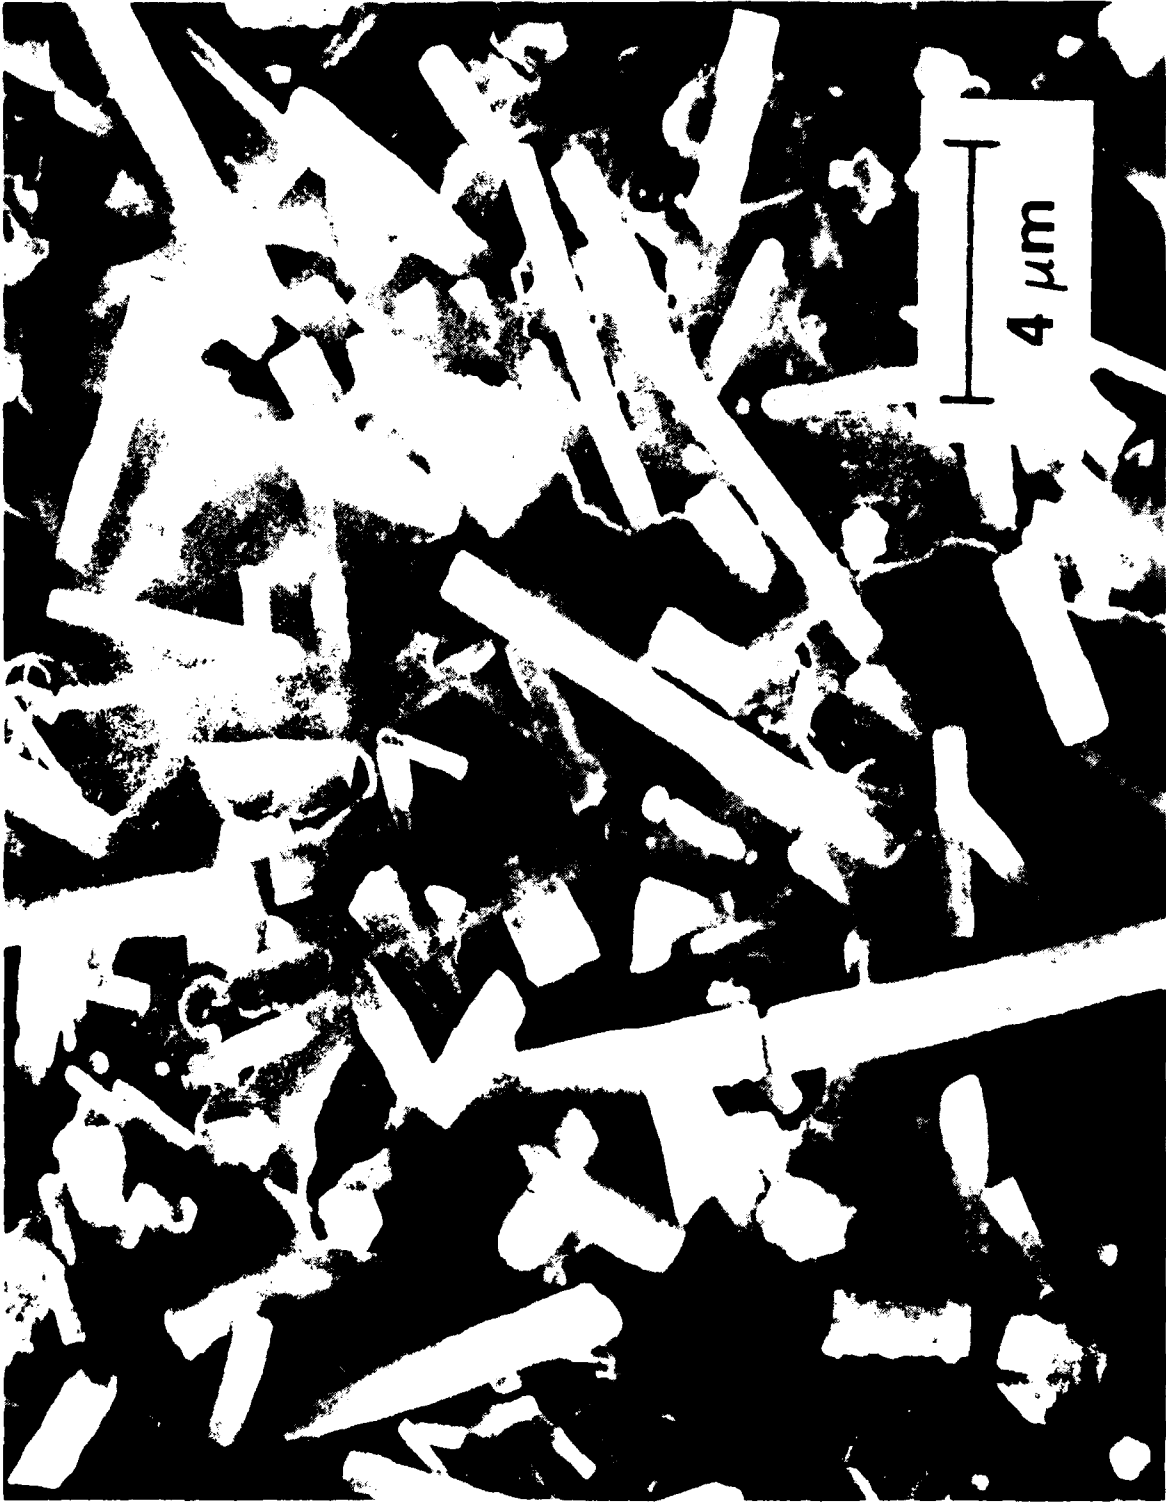
Fig. 2 - Micrograph of 20V/o F-9 SiC/6061-T6 aluminum metal matrix composites

Three MMC specimens were studied using the scanning vibrating electrode technique (SVET). Two were welded discontinuous SiCw/6061 Al composite specimens. The composite was obtained from ARCO Metals Inc., Greer, South Carolina in the form of 6.35 mm thick rolled plate containing 20 v/o F-9 SiC whisker reinforcement in 6061 aluminum matrix. A micrograph of the composite material is shown in Fig. 2. The plate was provided in a nominal T-6 temper. Weldments were fabricated using methods developed at Martin Marietta Research Labs.⁶ The plate was first degassed in vacuum at 10^{-5} torr at 500°C for 24 hours to remove trapped hydrogen by heat treating prior to welding. Joining was accomplished by gas-metal-arc welding (GMAC) using either 4043 aluminum alloy or 5356 aluminum alloy filler metals to form the joints. Macrographs of these joints showing the parent composite material, the heat affected zone (HAZ), and weld metal are shown in Fig. 3(a & b).

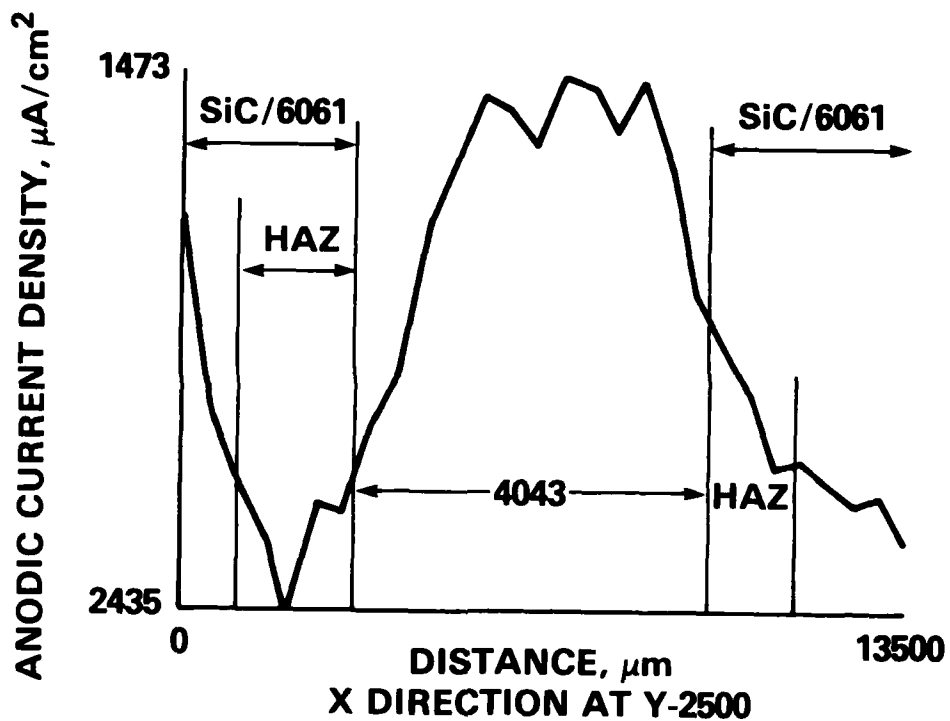
Fig. 6 - Cross sections from the current density contour maps: a) in X direction at $\gamma = 2500 \mu\text{m}$ on SiC/Al with 4043 Al weldment and b) in X direction at $\gamma = 3500 \mu\text{m}$ on SiC/Al with 5356 Al weldment
