# A HISTORY OF FULL-SCALE TESTING OF AIRCRAFT STRUCTURES AT THE NATIONAL AERONAUTICAL ESTABLISHMENT

R.L. Hewitt

National Aeronautical Establishment

AERONAUTICAL NOTE  
NAE-AN-24  
NRC NO. 24089

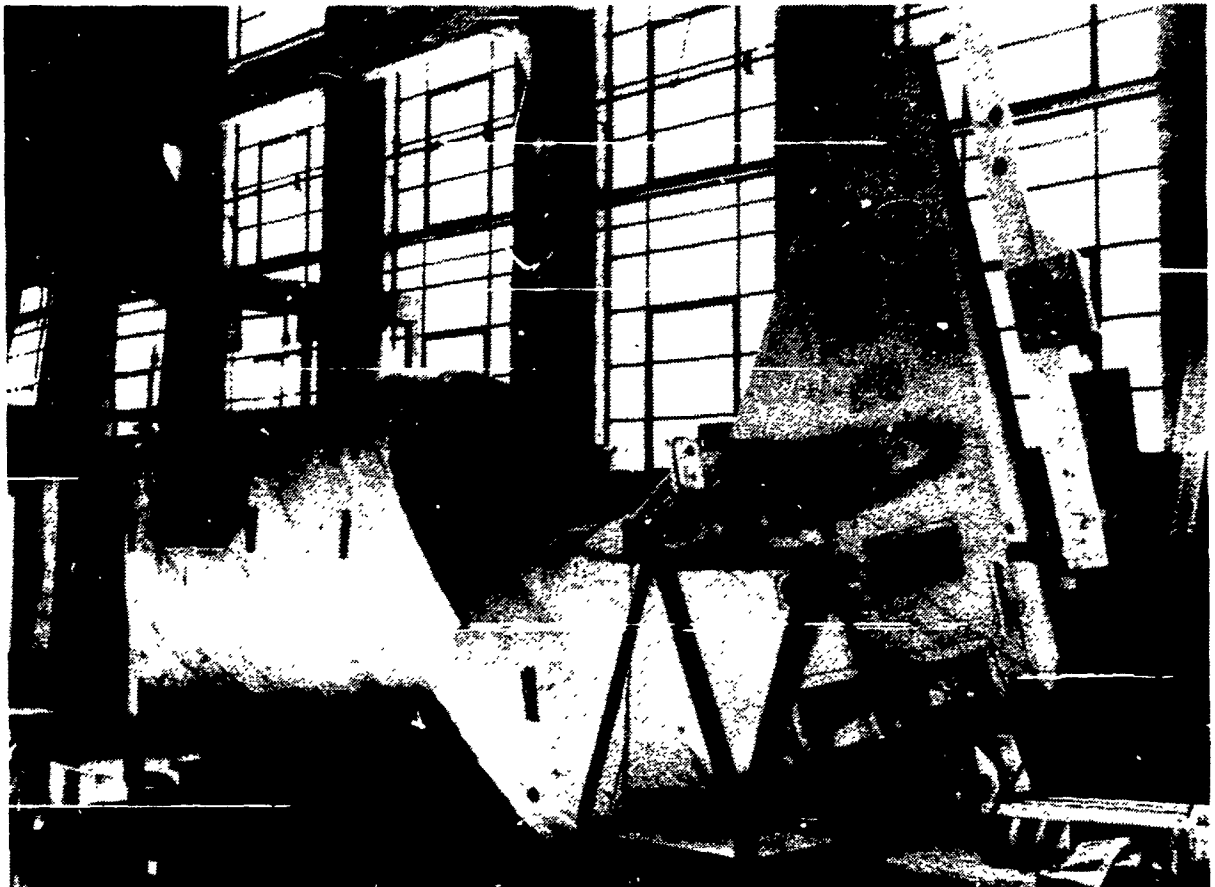
FIG. 8: FAILURE OF MOULDED PLYWOOD HARVARD FUSELAGE UNDER  
A SPECIAL TAILWHEEL CONDITION

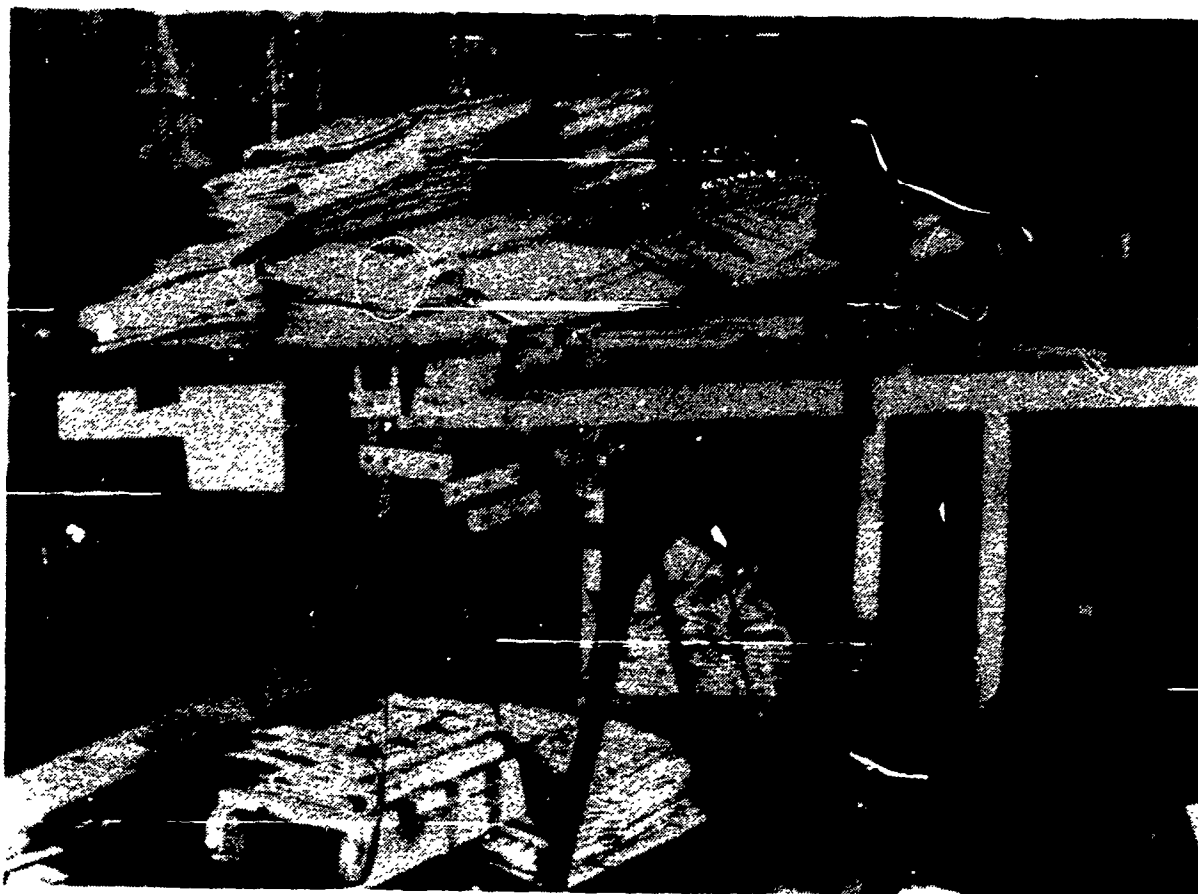
FIG. 9: STATIC TEST OF MOULDED PLYWOOD HARVARD STABILIZER

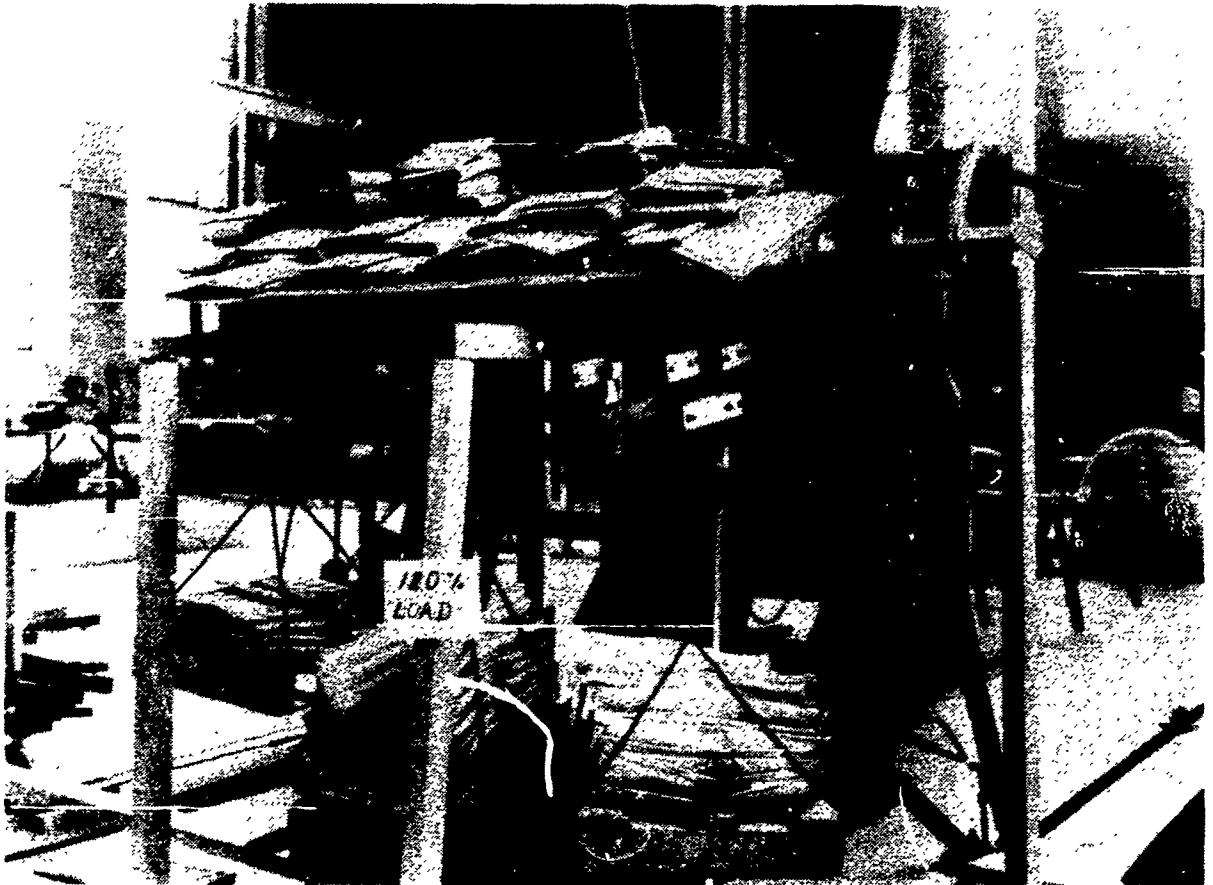
FIG. 10: STATIC TEST OF MOULDED PLYWOOD HARVARD ELEVATOR

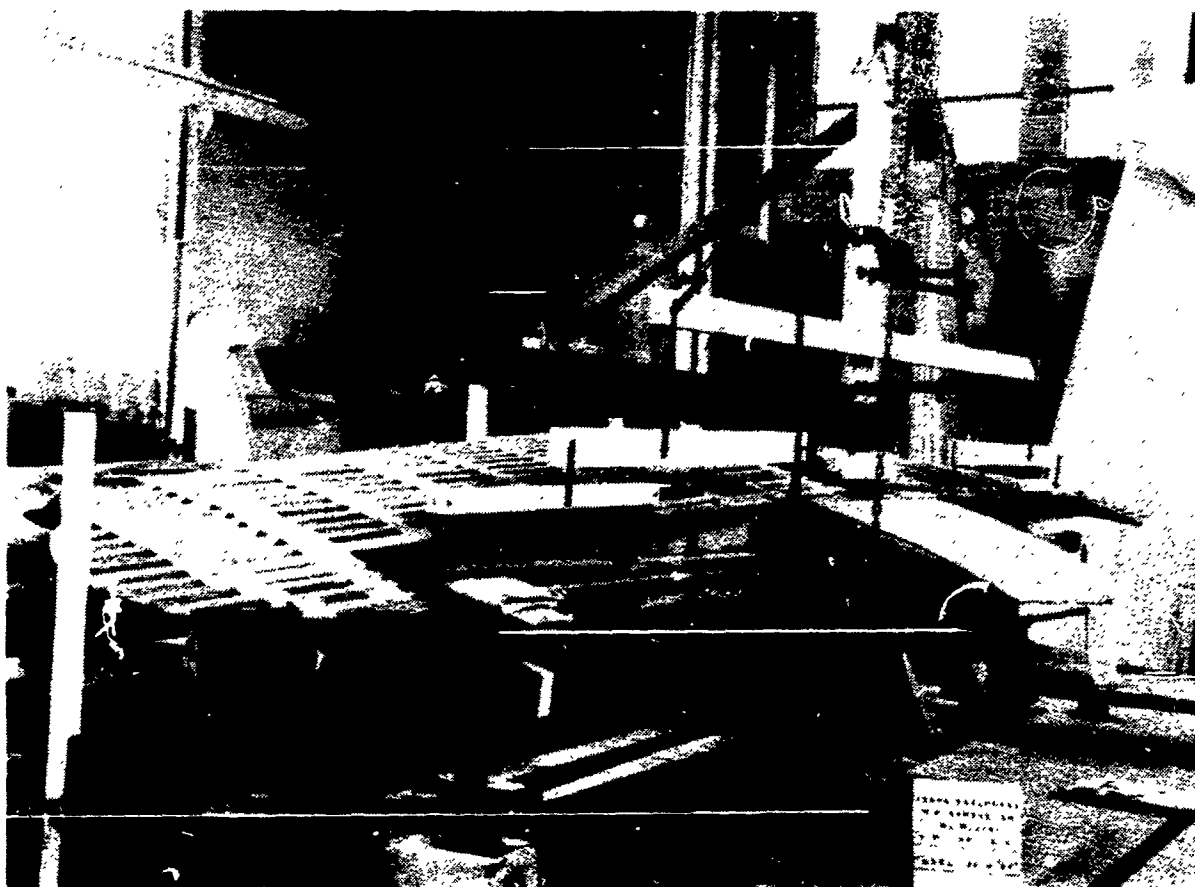
FIG. 13: TEST SET-UP FOR ANSON TAILPLANE

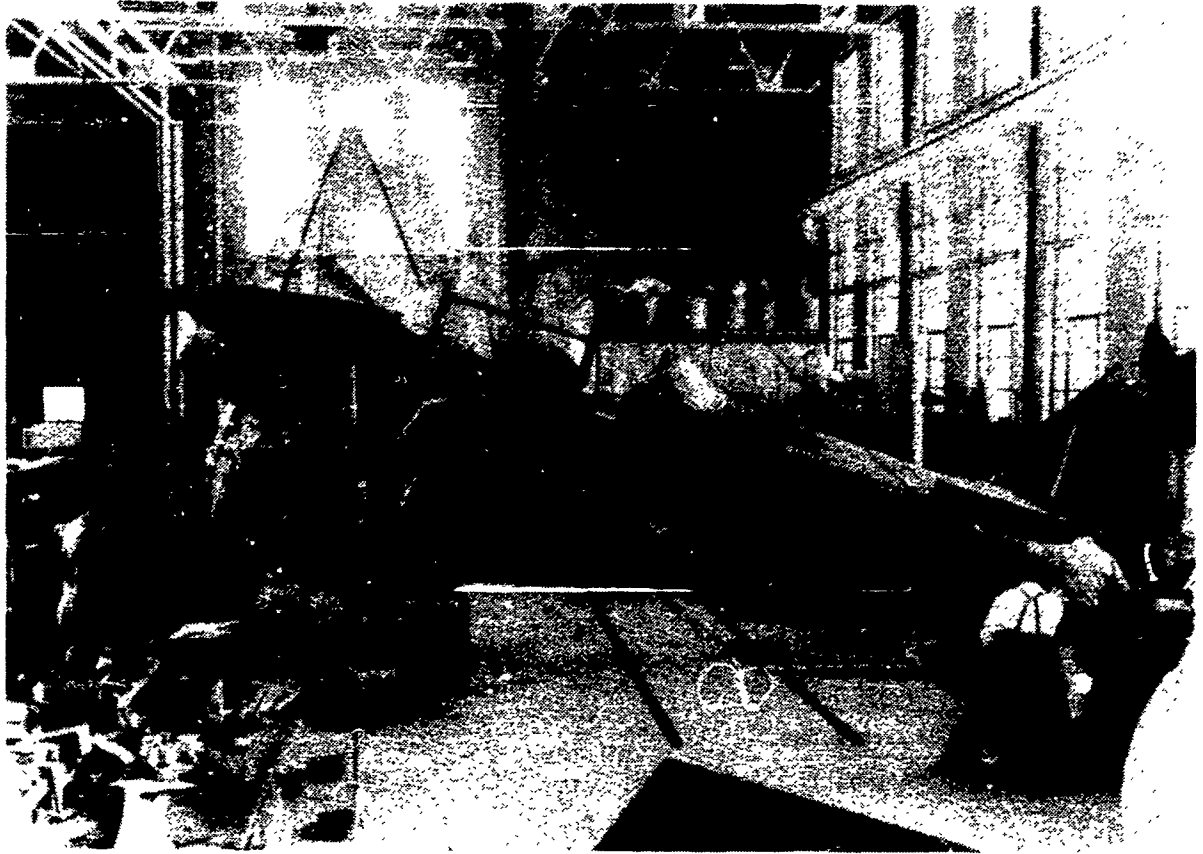
FIG. 14: DROP TEST OF A CORNELL AIRCRAFT

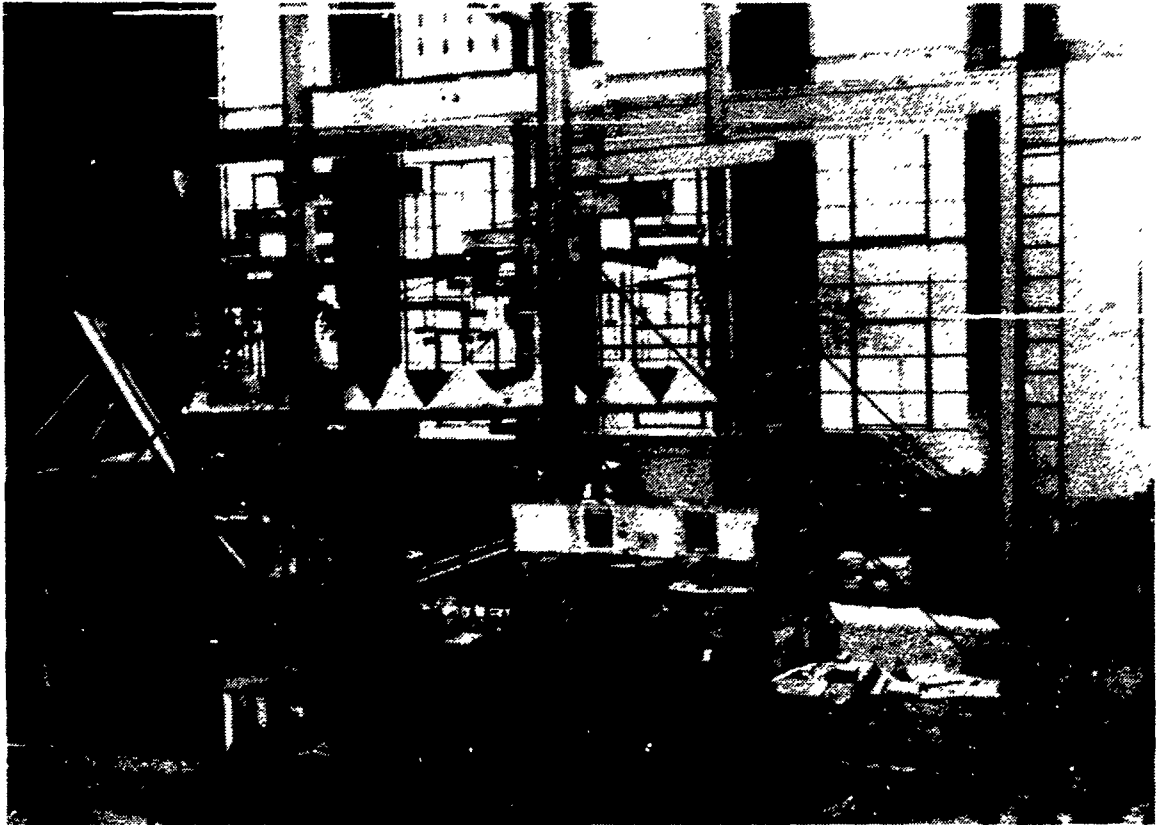
FIG. 26: AUTOMATED REPEATED LIMIT LOAD TEST ON C-100 MARK 3 OUTER WING

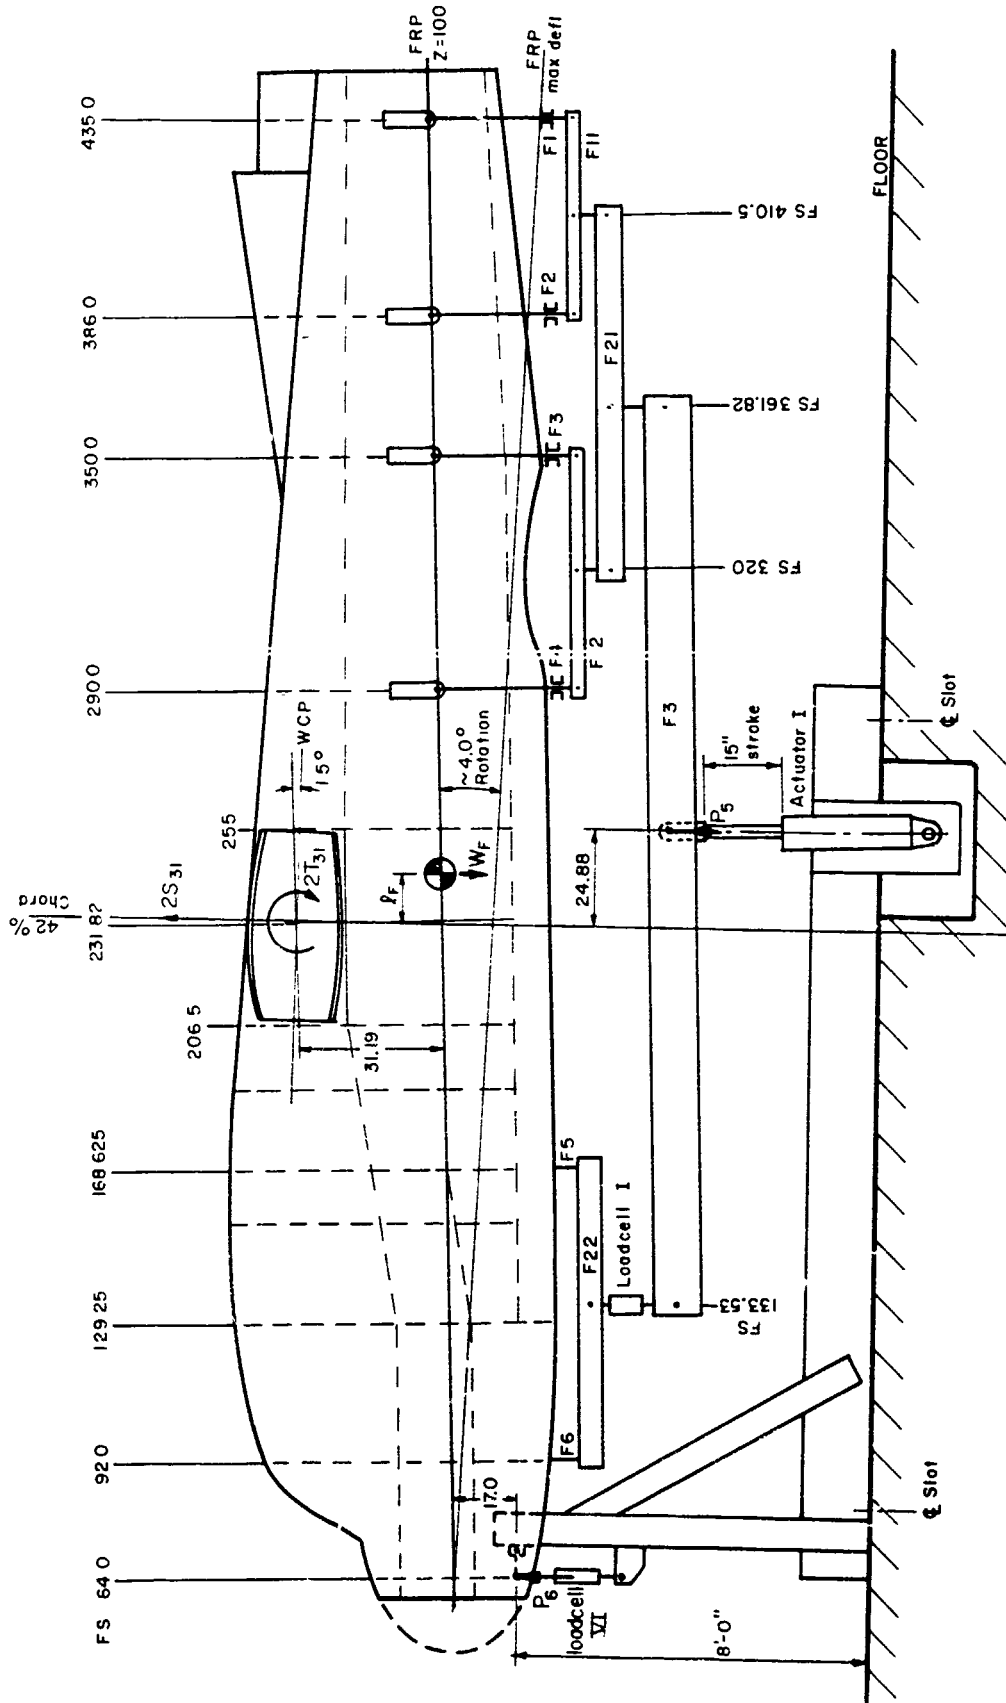
FIG. 43: UNDER FUSELAGE WHIFFLETREE SYSTEM
