TECHNICAL REPORT GL-84-13

FOUNDATION GROUTING PRACTICES AT CORPS OF ENGINEERS DAMS

FOUNDATION GROUTING PRACTICES AT CORPS OF ENGINEERS' DAMS

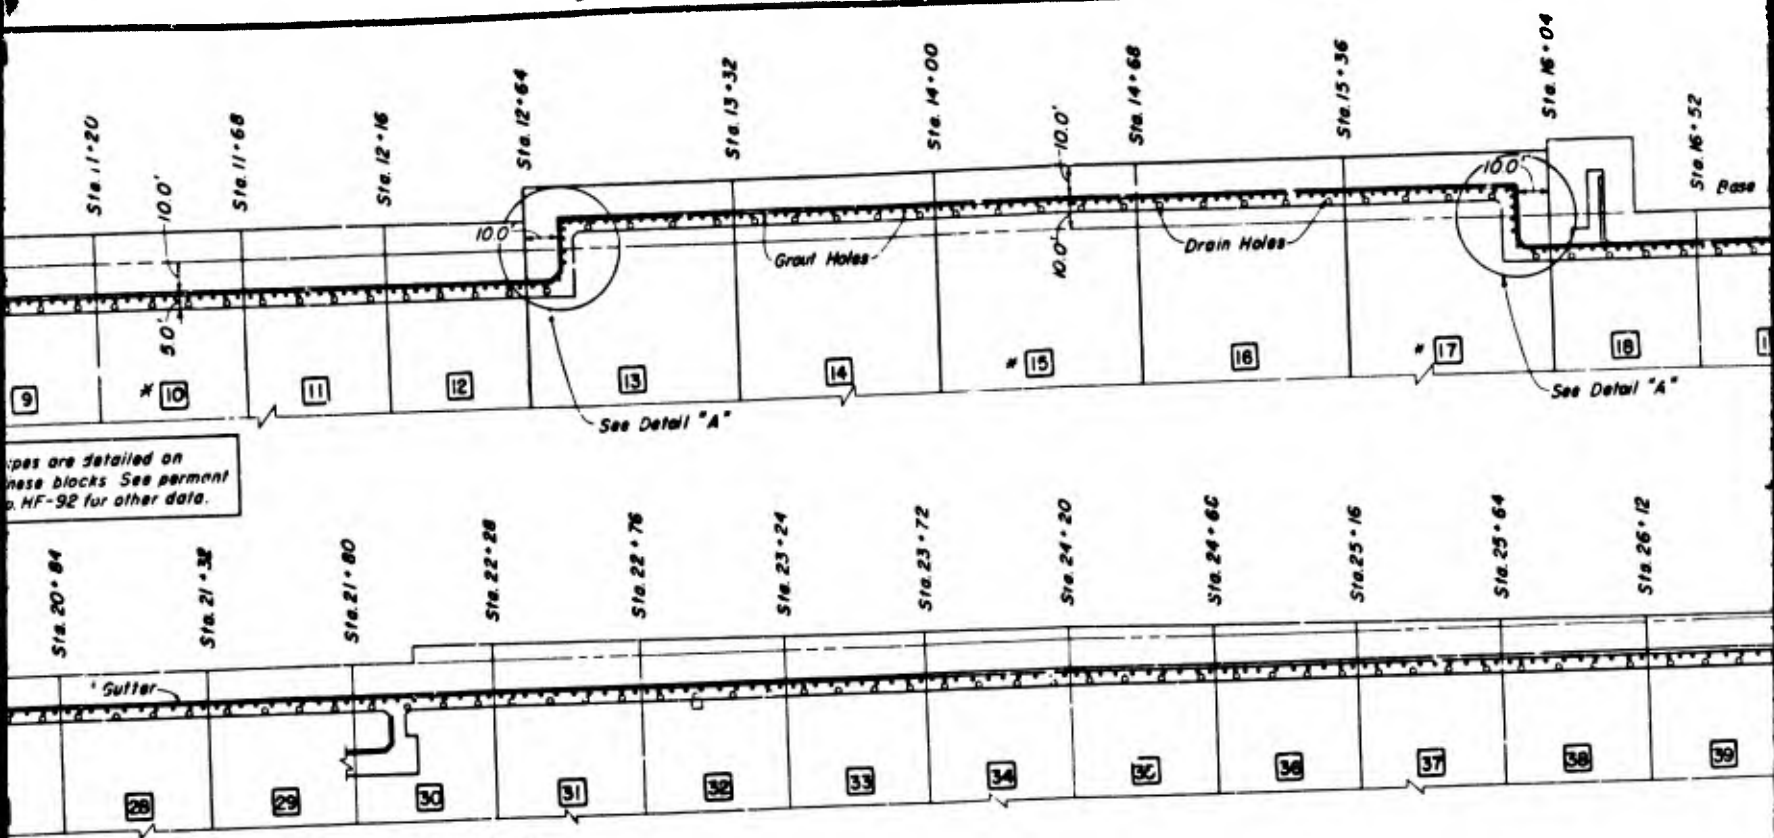
PLAN - INSPECTION GALLERY
GROUT HOLES AND FOUNDATION DRAINS
 SCALE: 1" = 30'

Need for second and third zone grouting to be determined by the contracting officer according to the field conditions encountered.

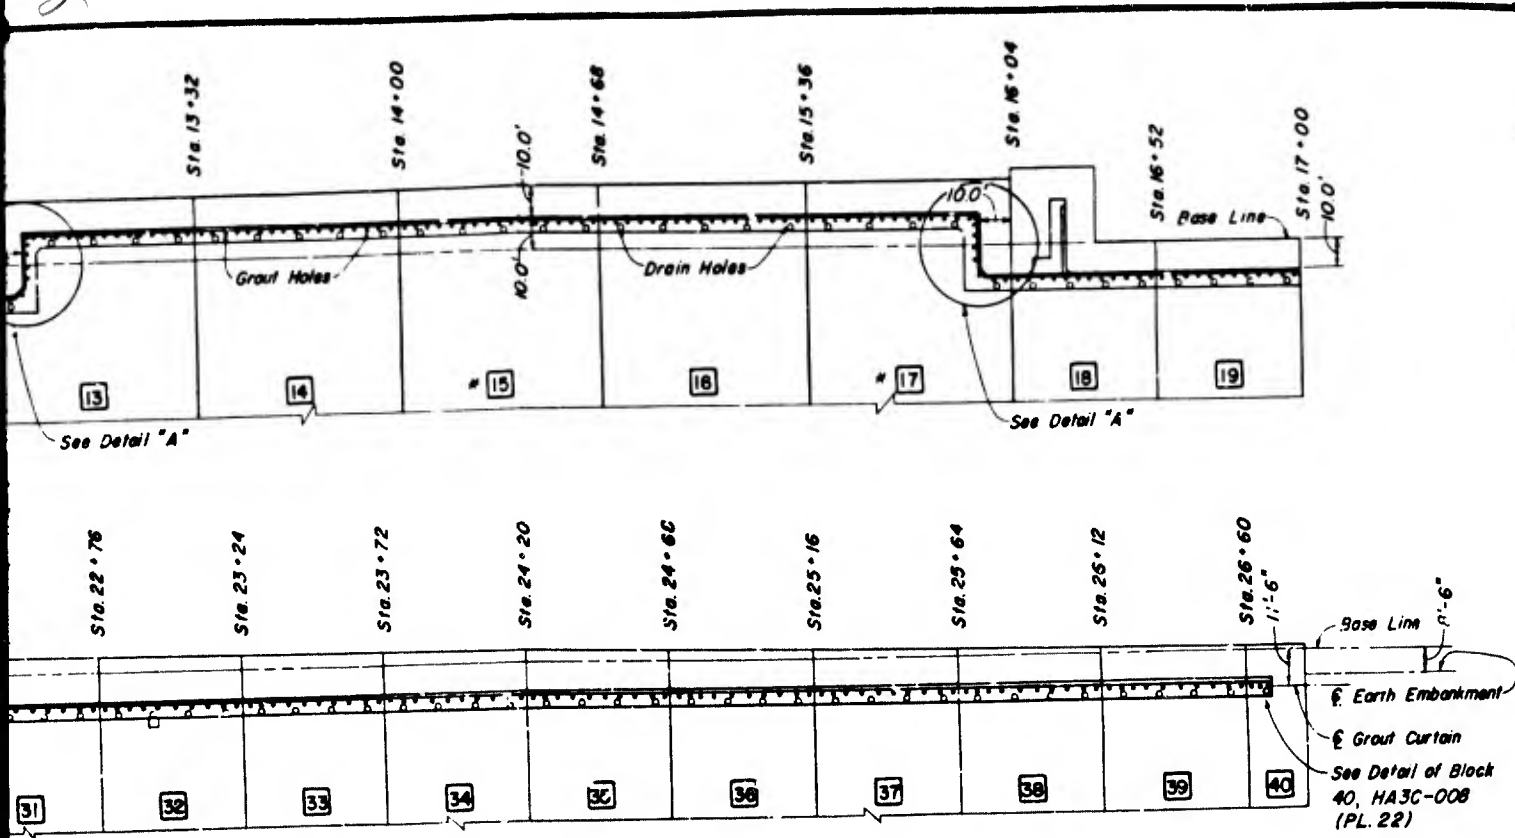
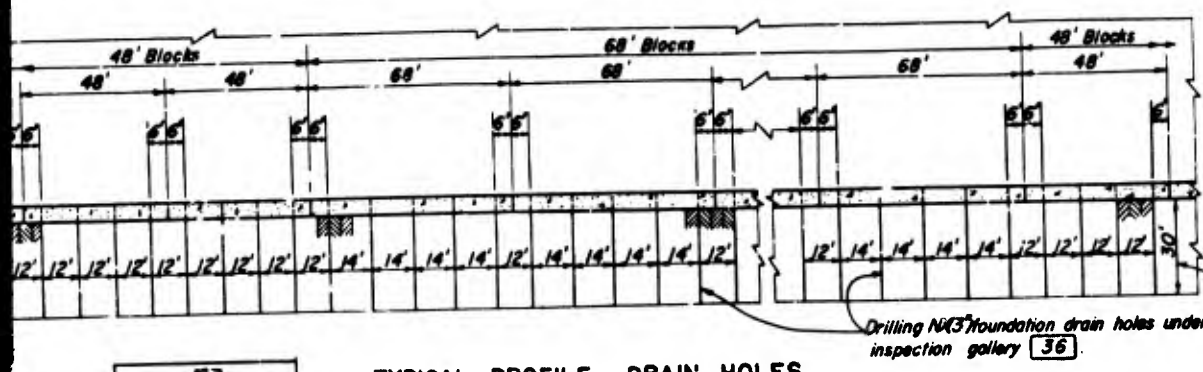
TYPICAL PROFILE - DRAIN HOLES
SCALE: 1" = 30'

NOTE:
Foundation drain holes shall be inclined downstream as shown in typical sections. Lateral deviation, if any, from approximate normality with axis of dam shall be determined in the field to meet geological conditions of the site.

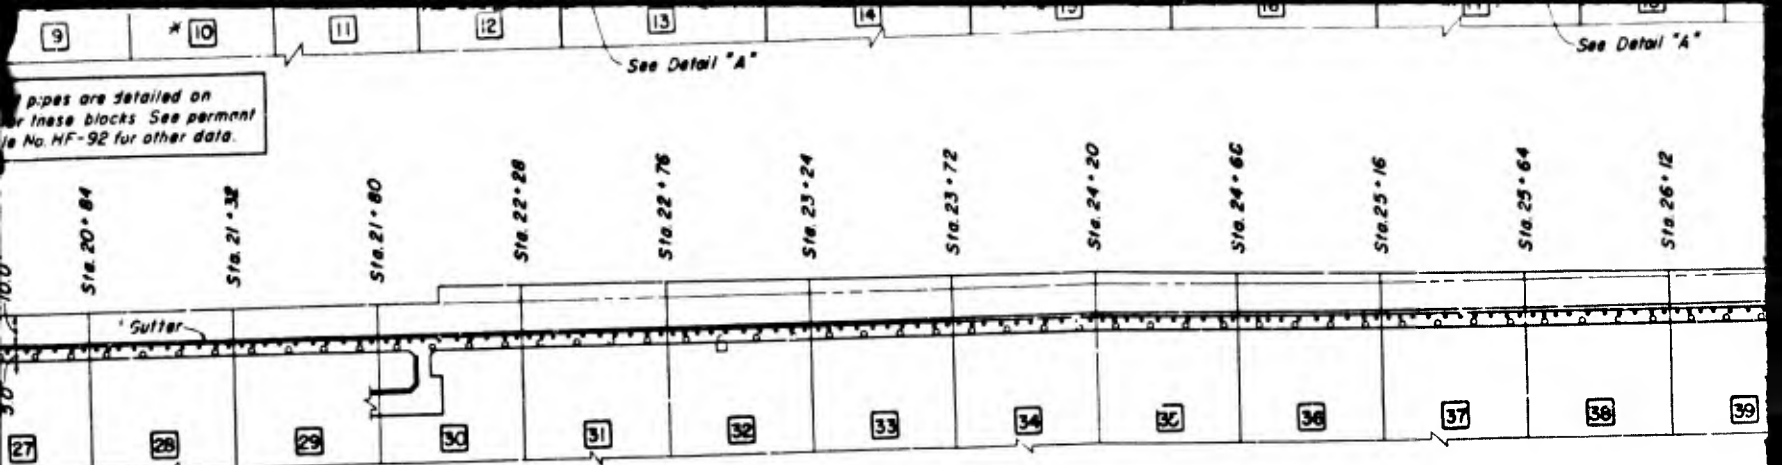
PLAN - INSPECTION GALLERY
GROUT HOLES AND FOUNDATION DRAINS
 SCALE: 1" = 30'

Need for second and third zone grouting to be determined by the contracting officer according to the field conditions encountered.

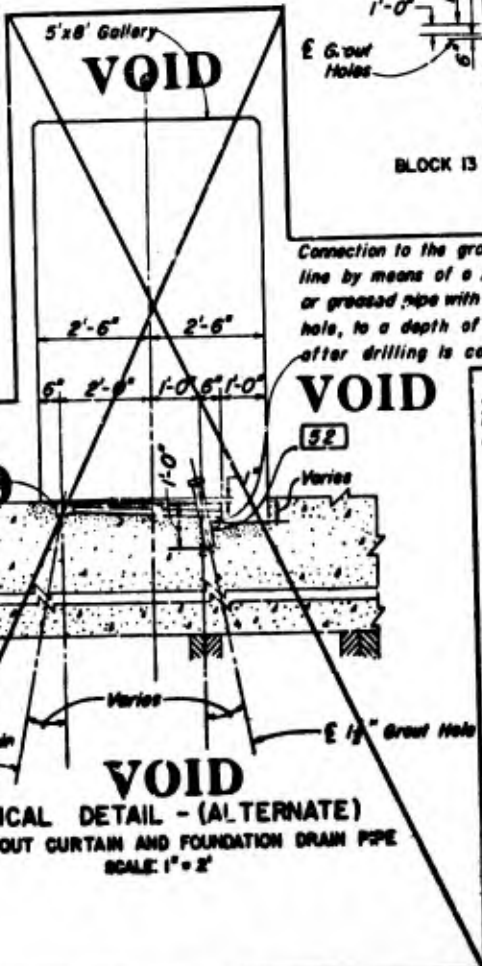
TYPICAL DETAIL - (ALTERNATE)
 FOR GROUT CURTAIN AND FOUNDATION DRAIN PIPE
 SCALE: 1" = 2'

During concrete placing great care should be taken to prevent deflecting of embedded pipes.

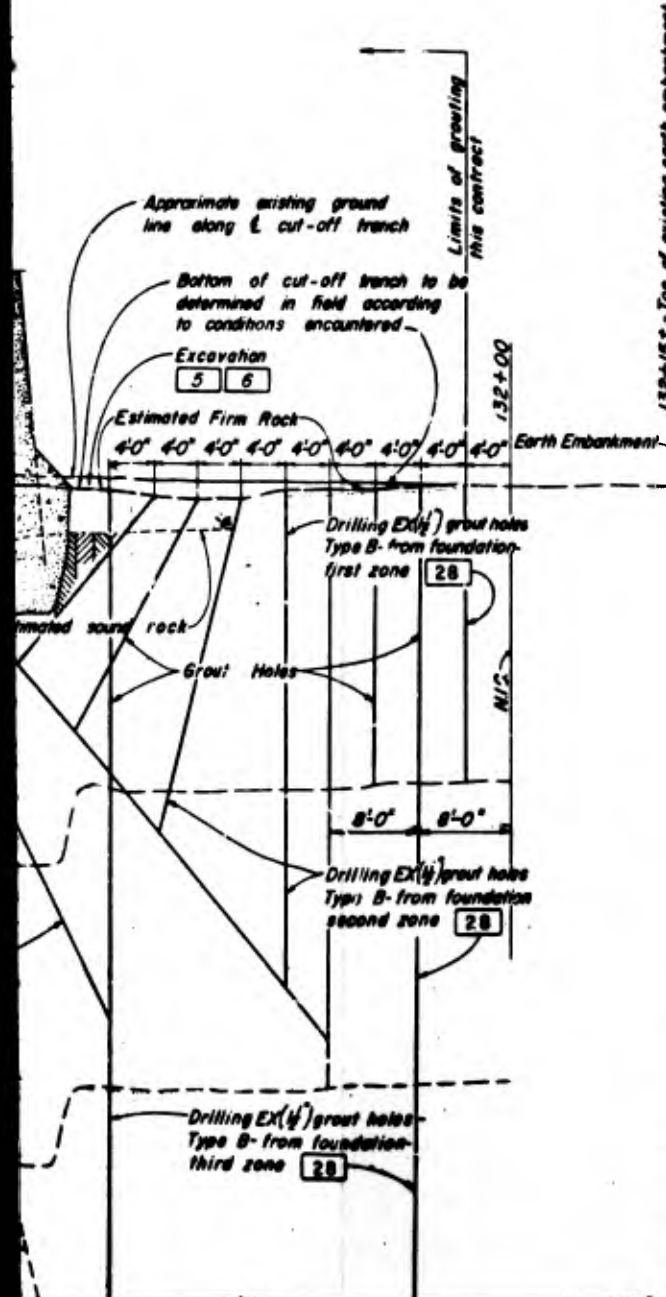
DETAIL OF GROUT HOLE
FROM SURFACE
NOT TO SCALE

- NOTES: (Continued from sheet 1)
5. Special treatment of the foundation in deeply weathered or questionable areas will be determined by the Contracting Officer after the areas have been excavated and explored.
 6. Drill foundation drain holes after foundation grouting in the affected area has been completed. Spacing, angle, and direction of holes will be determined in the field and as directed by the Contracting Officer.
 7. The Government reserves the right to have pipe for drilling and grouting installed in certain areas before placing concrete, if in the opinion of the Contracting Officer it is deemed desirable or necessary, even though the Contractor has elected to drill through concrete in lieu of the embedded pipe, as outlined in the specifications.

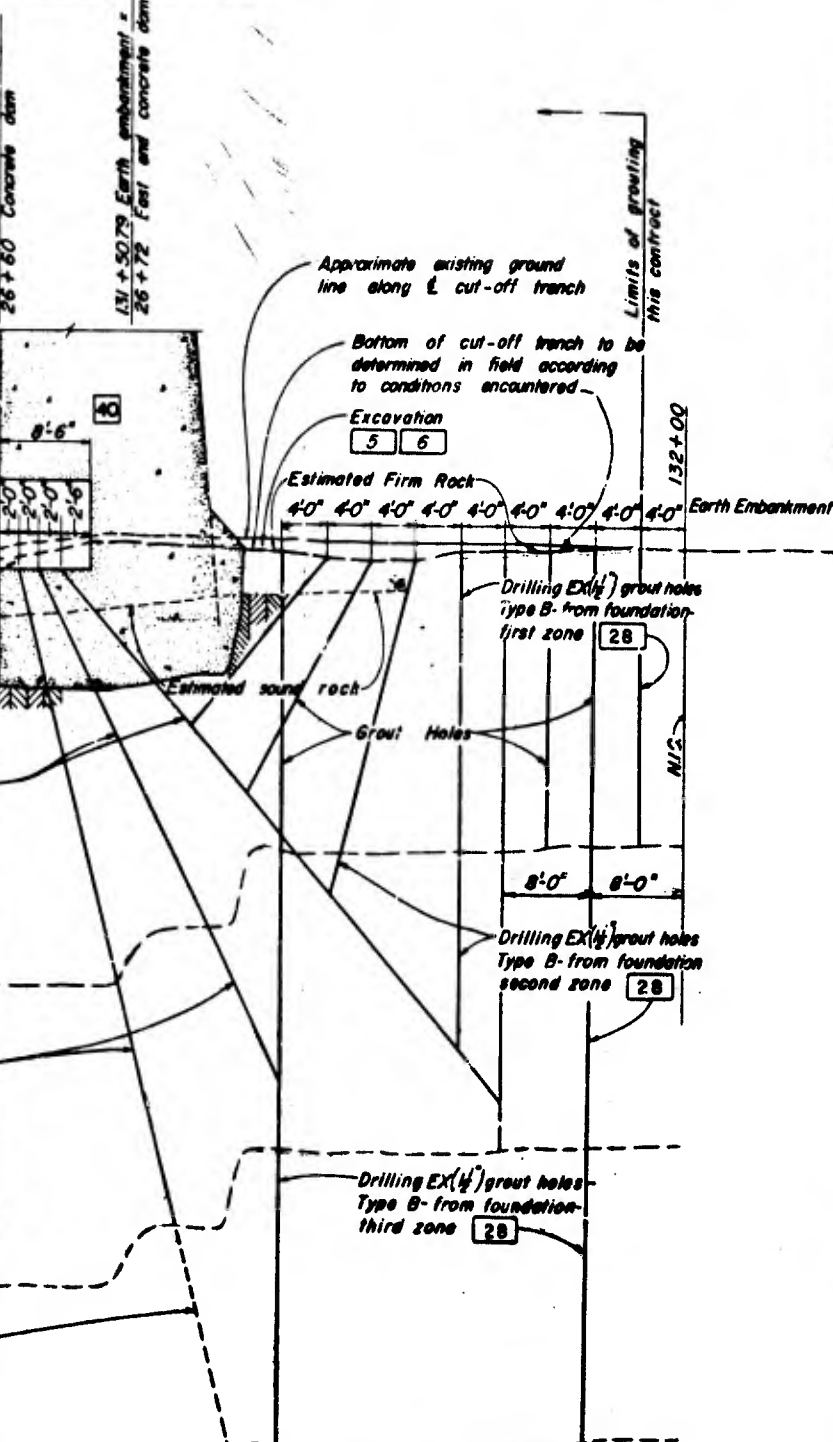
DETAIL OF GROUT HOLE FROM SURFACE
NOT TO SCALE

- NOTES: (Continued from sheet 1)
5. Special treatment of the foundation in deeply weathered or questionable areas will be determined by the Contracting Officer after the areas have been excavated and explored.
 6. Drill foundation drain holes after foundation grouting in the affected area has been completed. Spacing, angle, and direction of holes will be determined in the field and as directed by the Contracting Officer.
 7. The Government reserves the right to have pipe for drilling and grouting placed in certain areas before placing concrete, if in the opinion of the Contracting Officer it is deemed desirable or necessary, even though the Contractor has elected to drill through concrete in lieu of the embedded pipe, as outlined in the specifications.

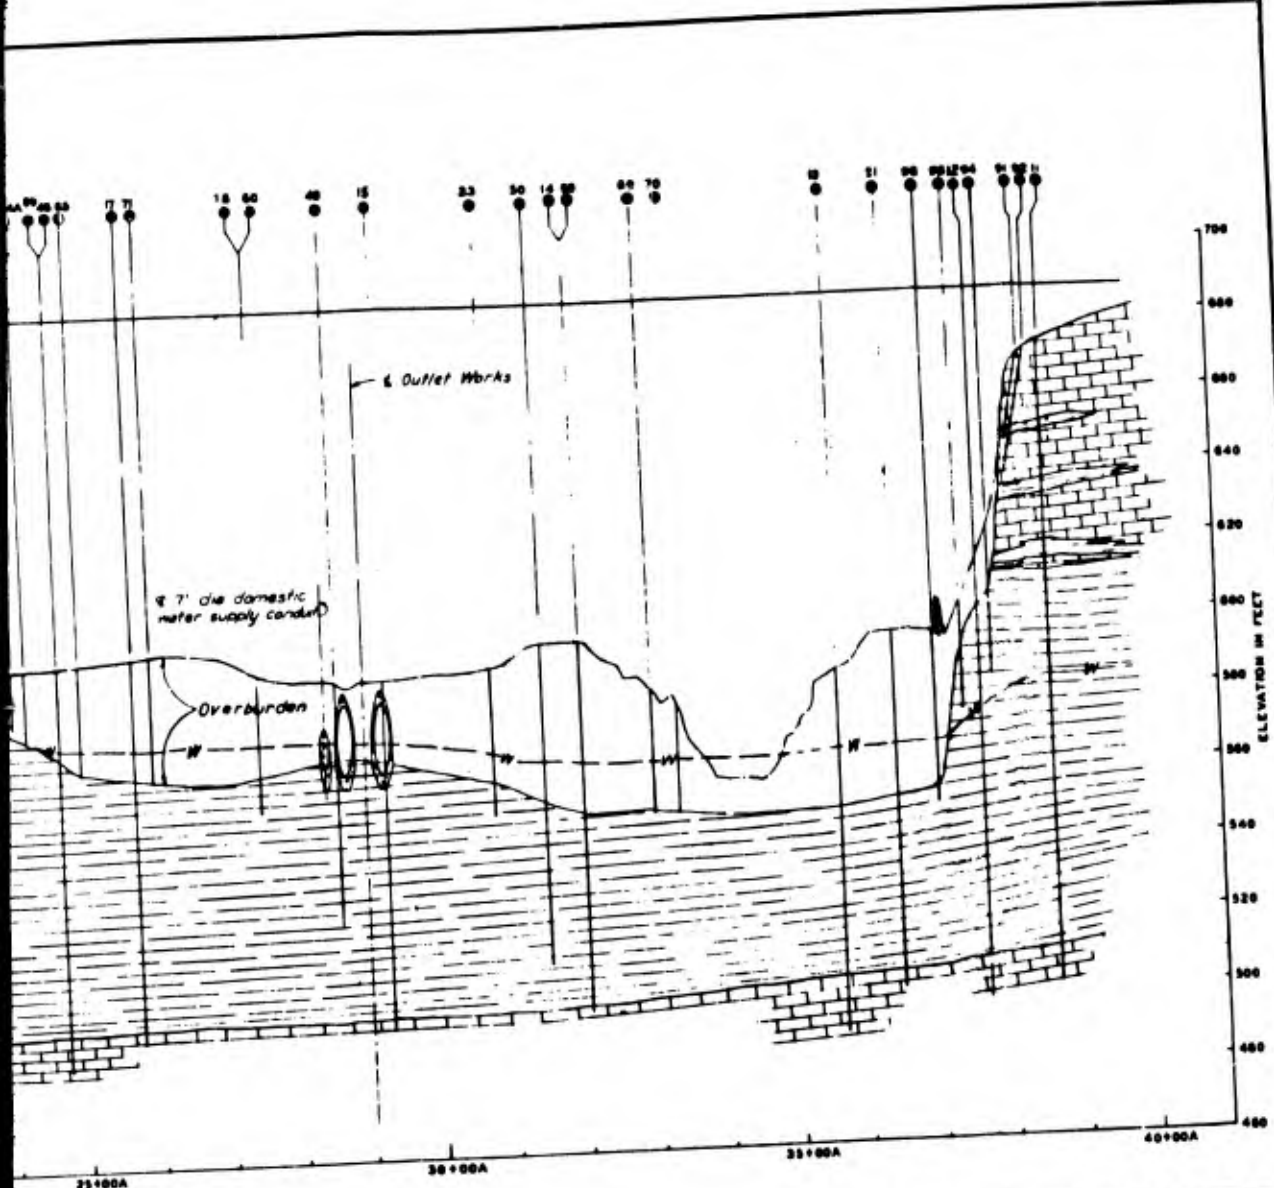
ARKANSAS RIVER WATERSHED VERMIGON RIVER, OKLAHOMA
OOLOGAH RESERVOIR
FOUNDATION PROFILE ALONG
CENTERLINE OF DAM
LOOKING UPSTREAM

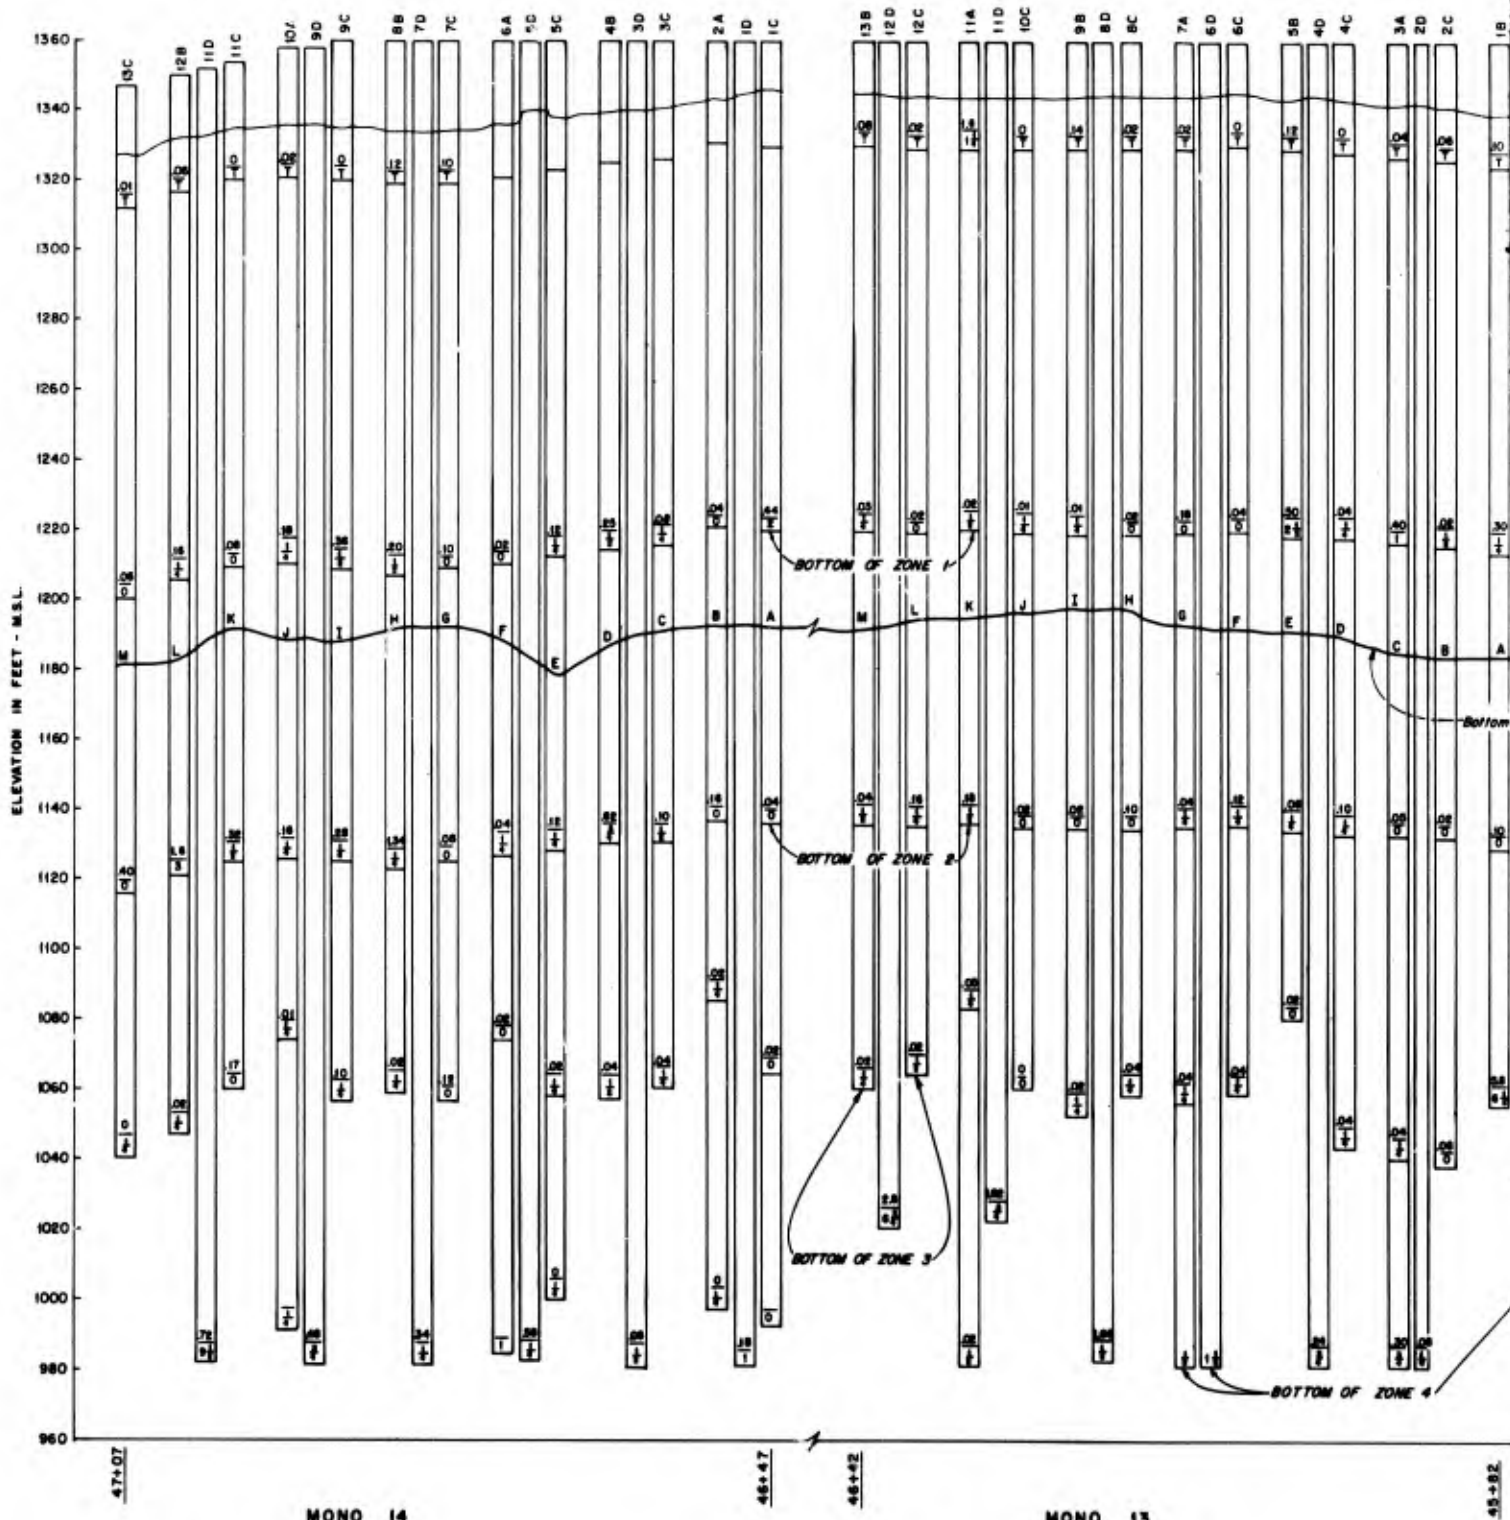
PLATE I-16

NOTE:
Tunnel plug section 3rd and 4th
zone holes not to scale
vertically. All holes this
Plate vertical.

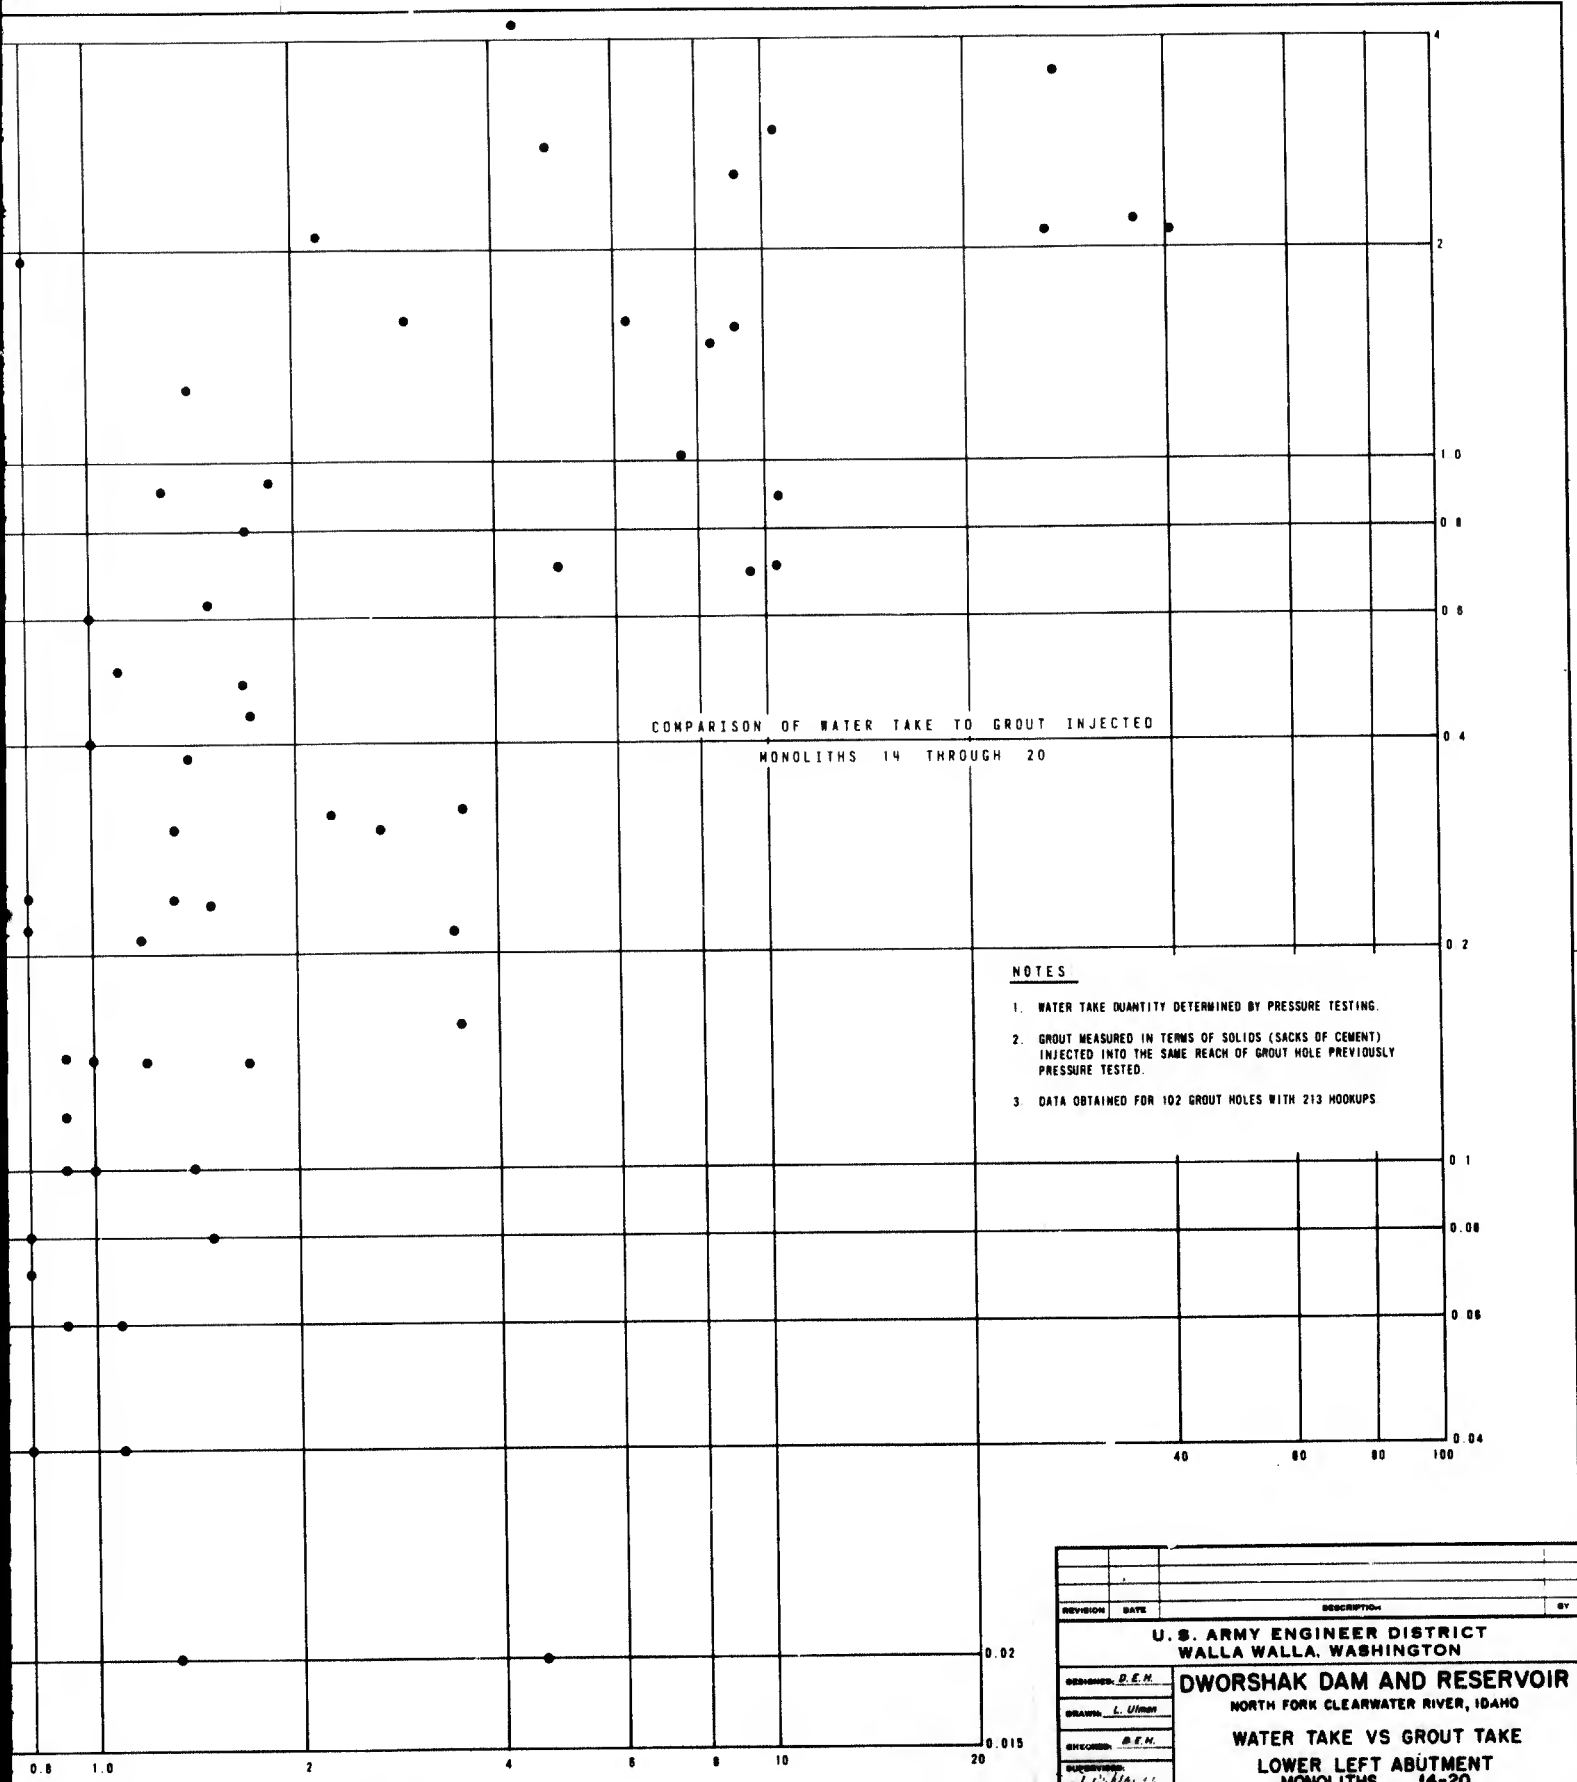
1. WATER TAKE QUANTITY DETERMINED BY PRESSURE TESTING.
2. GROUT MEASURED IN TERMS OF SOLIDS (SACKS OF CEMENT) INJECTED INTO THE SAME REACH OF GROUT HOLE PREVIOUSLY PRESSURE TESTED.
3. DATA OBTAINED FOR 102 GROUT HOLES WITH 213 HOOKUPS

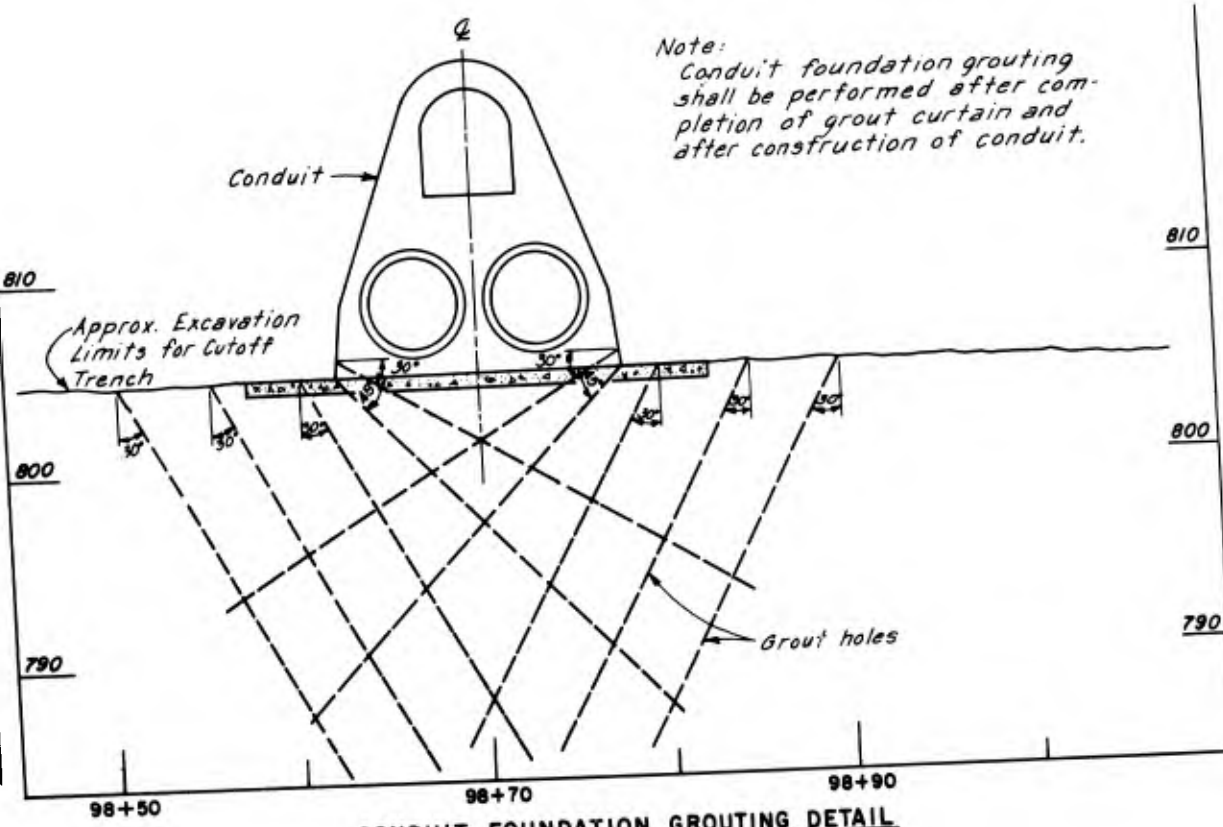
CONDUIT FOUNDATION GROUTING DETAIL
(LOOKING UPSTREAM)

Note:
Conduit foundation grouting shall be performed after completion of grout curtain and after construction of conduit.

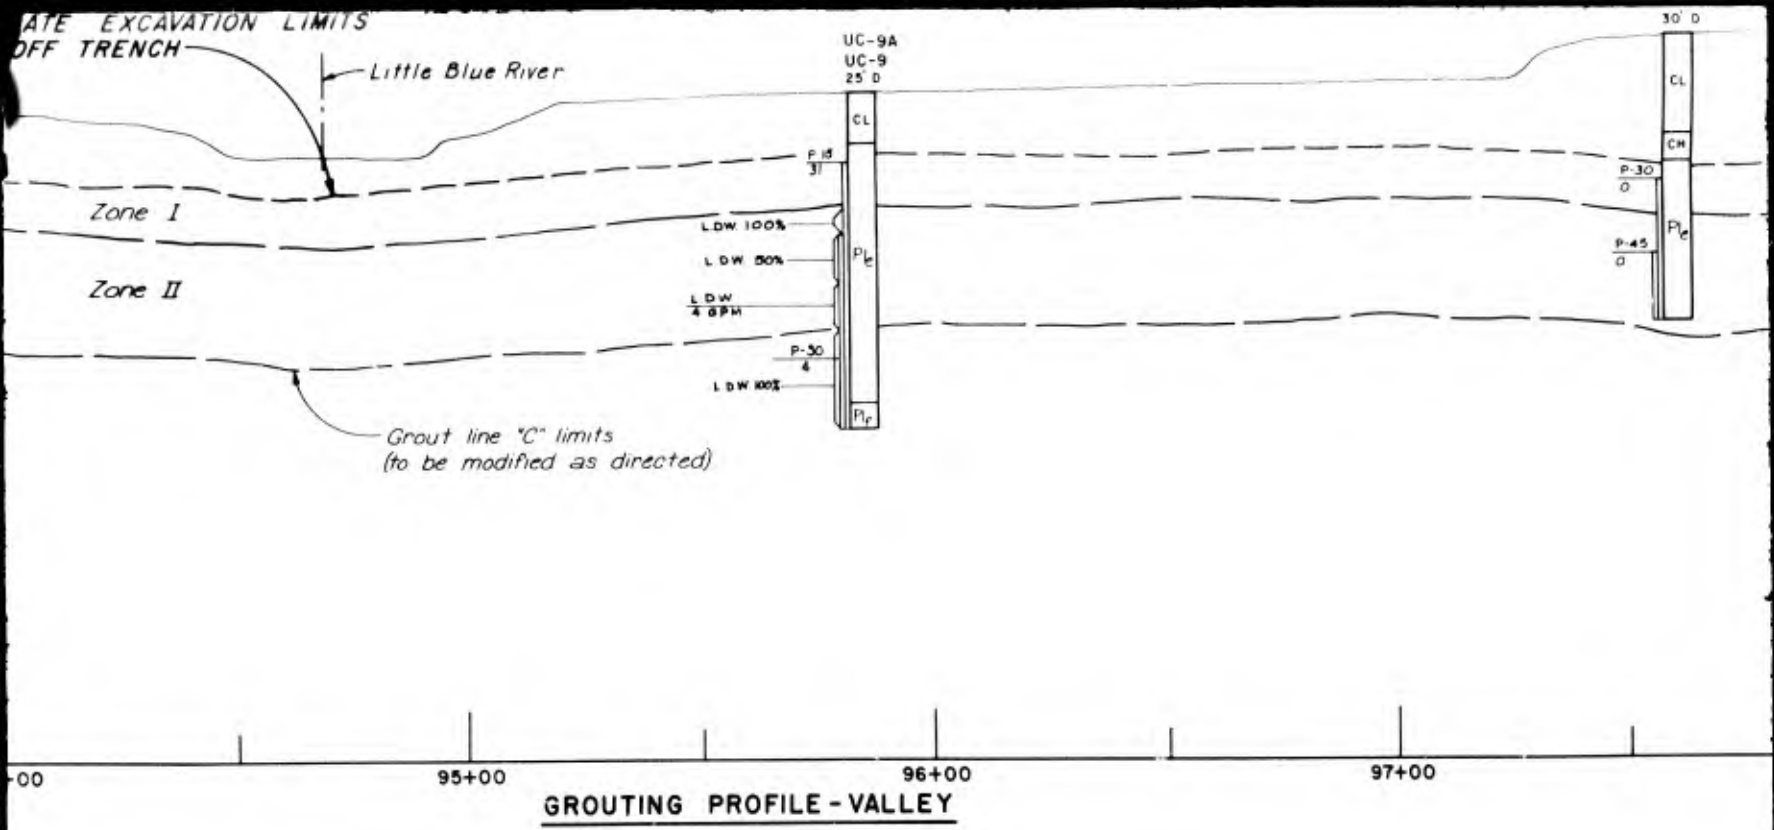
GROUTING PROFILE - VALLEY

Note:
Conduit foundation grouting shall be performed after completion of grout curtain and after construction of conduit.
