NASA  
Technical Memorandum 86881

USAAVSCOM  
Technical Report 84-C-19

# Experimental and Analytical Study of Ceramic-Coated Turbine-Tip Shroud Seals for Small Turbine Engines

January 1985

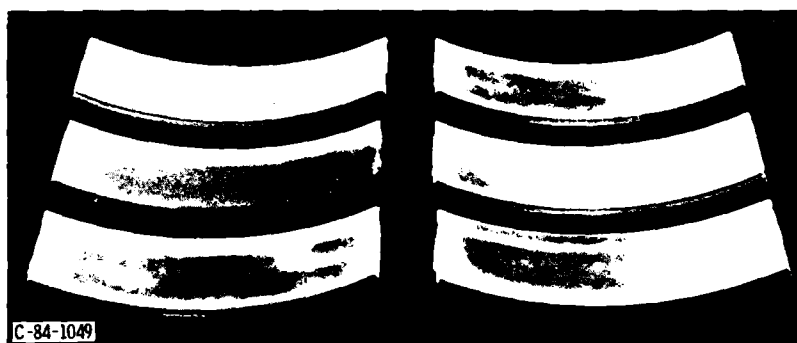
Figure 3. - Shroud segments after plasma spraying.

A photograph of the shrouds before installation in the engine is shown in figure 3. Photographs of a shroud after removal from the engine are shown in figure 12. Visual inspection reports after 4, 210, and 739 cycles are contained in appendix B. Comments on the condition of the shrouds after completion of testing are contained in ANALYSIS OF A MATERIALS SECTION, which is to follow.

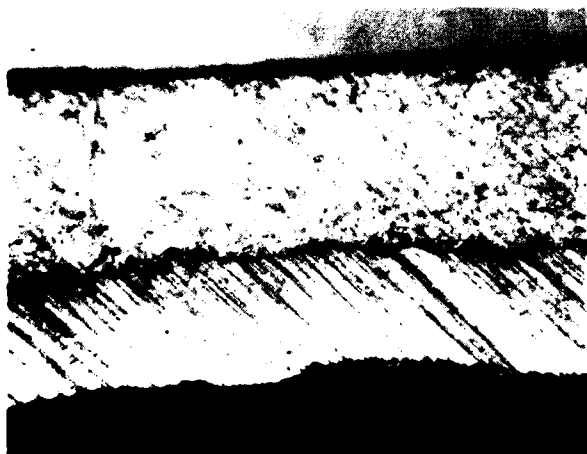
(a) Ceramic and frame crack trailing edge.

(b) Right end bond line and vertical crack.

Figure 18. - Micrographs of ceramic shroud section - trailing edge and right end.

In this evaluation, one shroud (shroud 6) and a typical cross section were metallographically examined. The front and back surfaces of a typical shroud are shown in figure 12, which indicates a reasonably smooth surface without visible defects. Some slight erosion was evident, along with a small amount of 8-wt % yttria-stabilized zirconia ceramic darkening. Macroscopic observations (figs. 17 and 18) (at 32x) showed cracking in the bond coat region along the trailing edge (fig. 18(a)), which extends back into the ceramic flow path surface. Some ceramic cracking was also evident along the leading edge (fig. 17(b)), along with some surface microfracturing (fig. 17(a)). The right end of the shroud showed both vertical and bond-line cracking (fig. 18(b)).

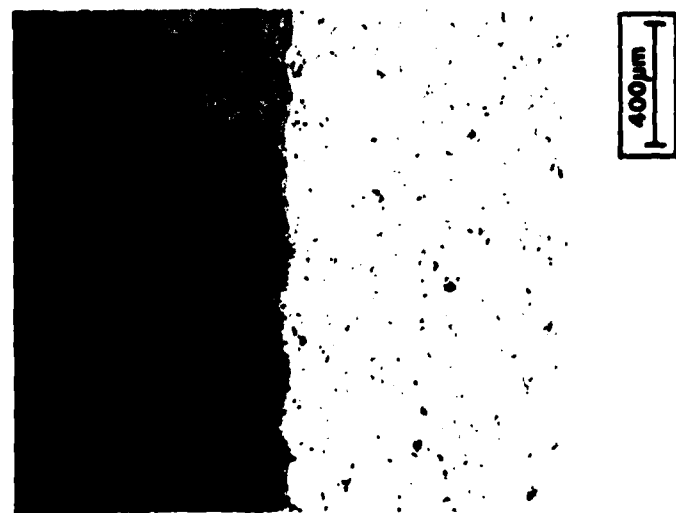
(b) Posttest microstructure; cross section A-A.

Examination of posttest ceramic coating microstructure (figs. 22(b) and (c)) revealed extensive segmentation, commonly called mud-flat cracking, and some local areas of lateral cracking and large porosity. Apparently, densification of the ceramic occurred. Caution must be exercised here, however, as observed microstructures are very dependent on metallographic polishing methods. The metallic bond layer exhibited considerable porosity, predominately due to pullout during metallographic polishing which was optimized to reveal the ceramic microstructure. The extensive porosity noted next to the leading and trailing edges was due to the geometry of the part not having been optimized for plasma spray coating. No evidence of any significant oxidation or  $\beta$ -phase (NiAl) depletion on the NiCoCrAlX bond layer was noted. Variations in the thickness of the metallic and ceramic layers found in sections AA and BB are due to impression of the process.

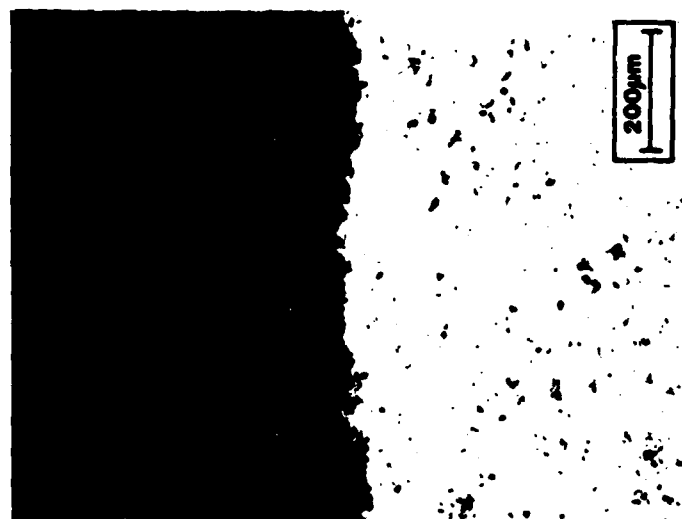
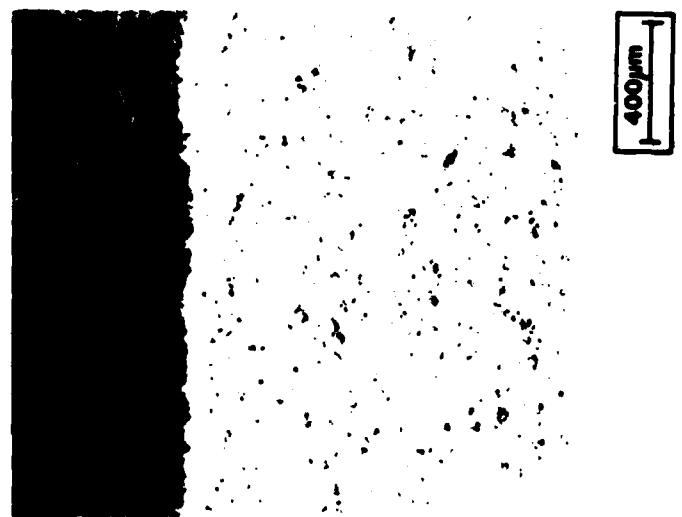
(c) Posttest microstructure; cross section B-B.
