SILICIDE CONDUCTORS RELIABILITY RESEARCH(U) RCA LABS  
PRINCETON NJ T J FAITH FEB 85 PRRL-84-CR-11  
RADC-TR-85-17 F30602-83-C-0109

**RADC-TR-85-17**  
**Final Technical Report**  
**February 1985**

# ***SILICIDE CONDUCTORS RELIABILITY RESEARCH***

**RCA Laboratories**

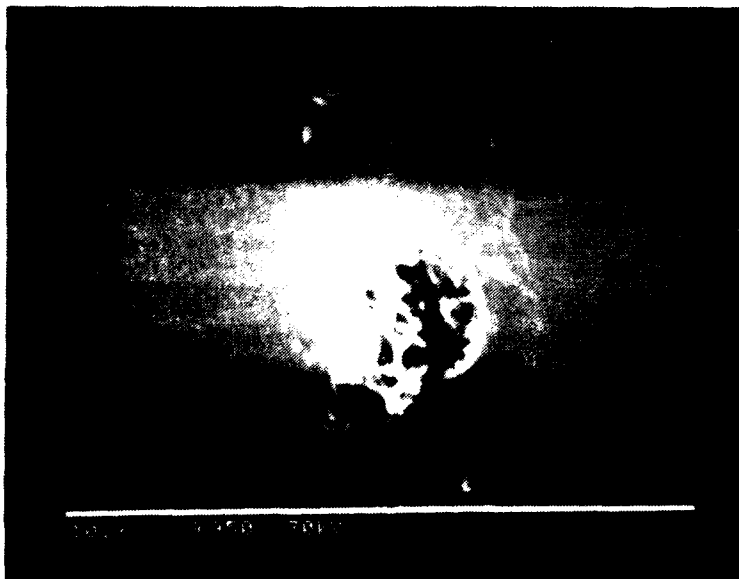
Figure 35. Scanning-electron micrograph of the same CRTV unit shown in Figure 33: contact 3 and vicinity at 10,000X magnification.

Four such photos are presented in Figs. 33, 34, 35 and 36, which show contacts 1, 2, 3, and 4, respectively, of a chip which had experienced mainstream failure in mode 2, and in which the visible failure site (under optical-microscope inspection) had extended from approximately 80  $\mu\text{m}$  to the left of contact 1 to approximately 10  $\mu\text{m}$  to the right of contact 1.
