CENTER  
LABORATORY  
TECHNICAL REPORT

NO. 13099

The Recycling and Reclamation of Used Tank Track Pins

J.F. Wallace & J.T. Snyder  
Case Western Reserve University  
Department of Metallurgy & Mat'l Sci.  
10900 Euclid Avenue  
by Cleveland, Ohio 44106

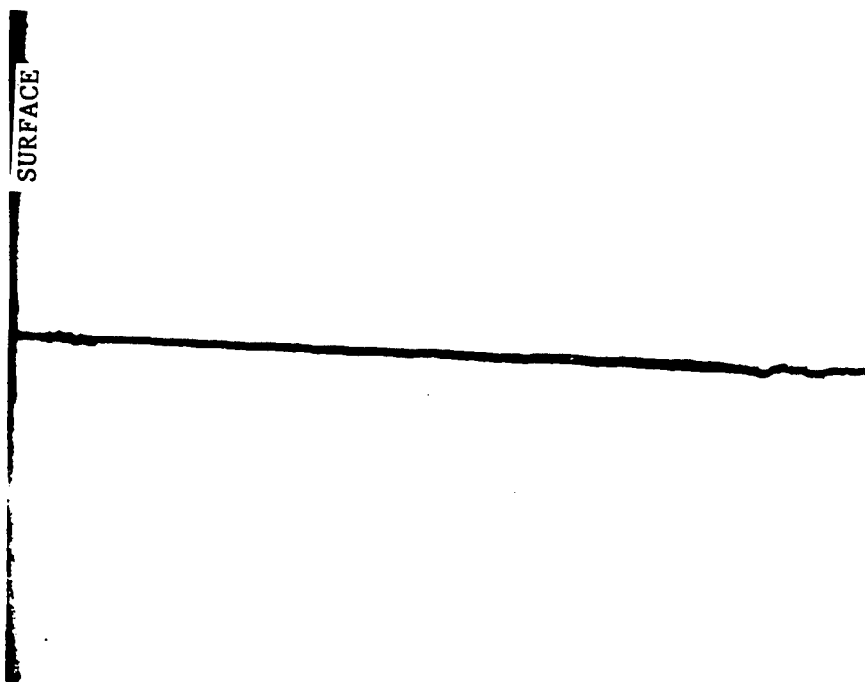
Figure 5-13. A Micrograph Showing the Cross Section of the Crack Origin of a Recycled Pin That Failed Prematurely. The Crack Propagated Perpendicularly From the Surface Indicating That the Crack Is Probably From Quenching Rather Than Fatigue Stressing. 40X. Unetched.  $N_i=200,000$  Cycles.  $N_f=54,000$  Cycles.

Although the above test results show a marked improvement in fatigue properties after reheat treatment for most fatigued pins, a few pins that contained surface cracks from previous testing or reheat treatment failed prematurely. The existence of a crack prior to the final fatigue testing was indicated by a small zone containing a dark oxide scale on the fracture surface, at the crack origin. To determine whether the crack was a result of prefatigue testing or from quenching, a metallographic section was taken through the origin of the crack. This examination showed the crack to be perpendicular to the surface which can be seen in Figure 5-13. For this reason it is believed that the crack resulted from the reheat treatment, and most probably from quenching which developed high tensile stresses in the surface. The lack of detection of these cracks by NDT is attributed to crack closure from the high compressive residual stresses from induction hardening and shot peening.
