USAAEFA PROJECT NO. 83 - 20

# LIMITED AIRWORTHINESS AND FLIGHT CHARACTERISTICS (A&FC) TEST OF THE QUICK FIX CONFIGURATION

OCTOBER 1984

FINAL REPORT

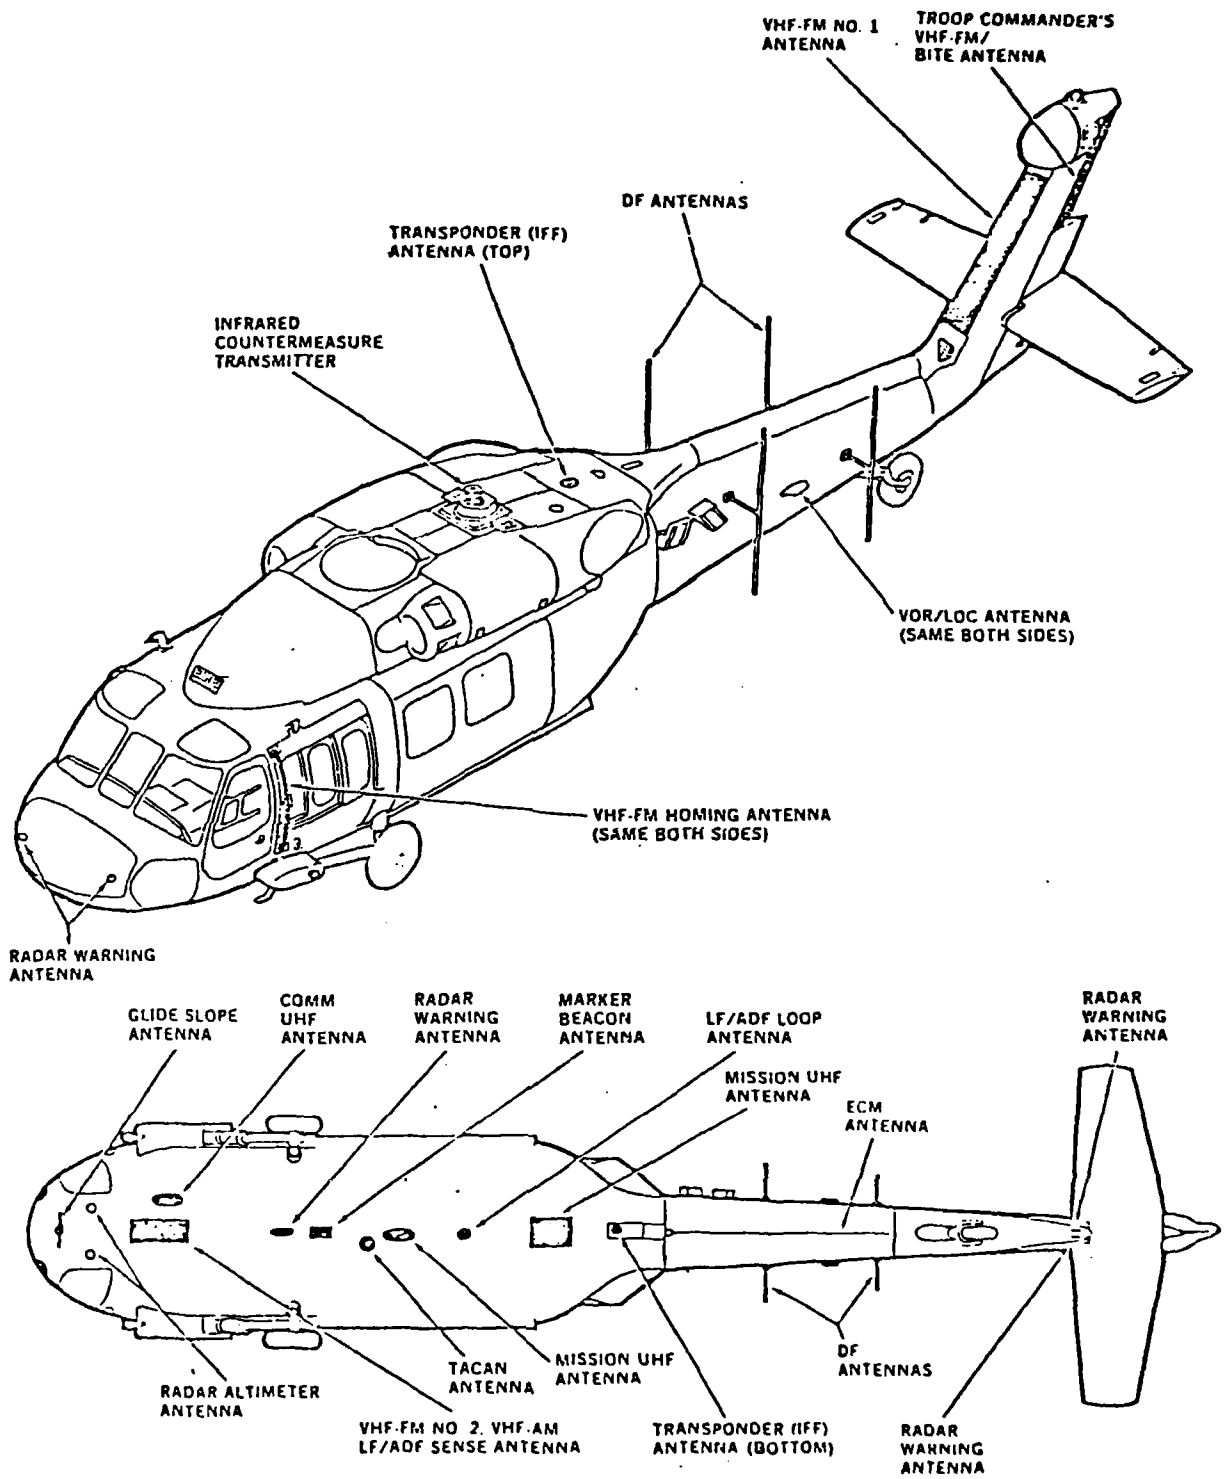
Figure 1. YEH-60A Antennas

### DF ANTENNAS

2. The YEH-60A was equipped with a DF dipole antenna set consisting of four antennas mounted on the tailcone exterior. Two antennas were mounted on each side of the tailcone at fuselage stations (FS's) 536.0 left and right and 596.6 left and right. Each antenna consisted of two monopole antenna elements; each antenna was 40.5 inches long and constructed from 1 inch diameter, 0.080 inch thick hollow aluminum tubing. These monopole elements were attached to phenolic blocks and mounted to the tailcone with a horizontal brace (photo 5). The antenna positions were numbered clockwise with the front left antenna labeled antenna #1.

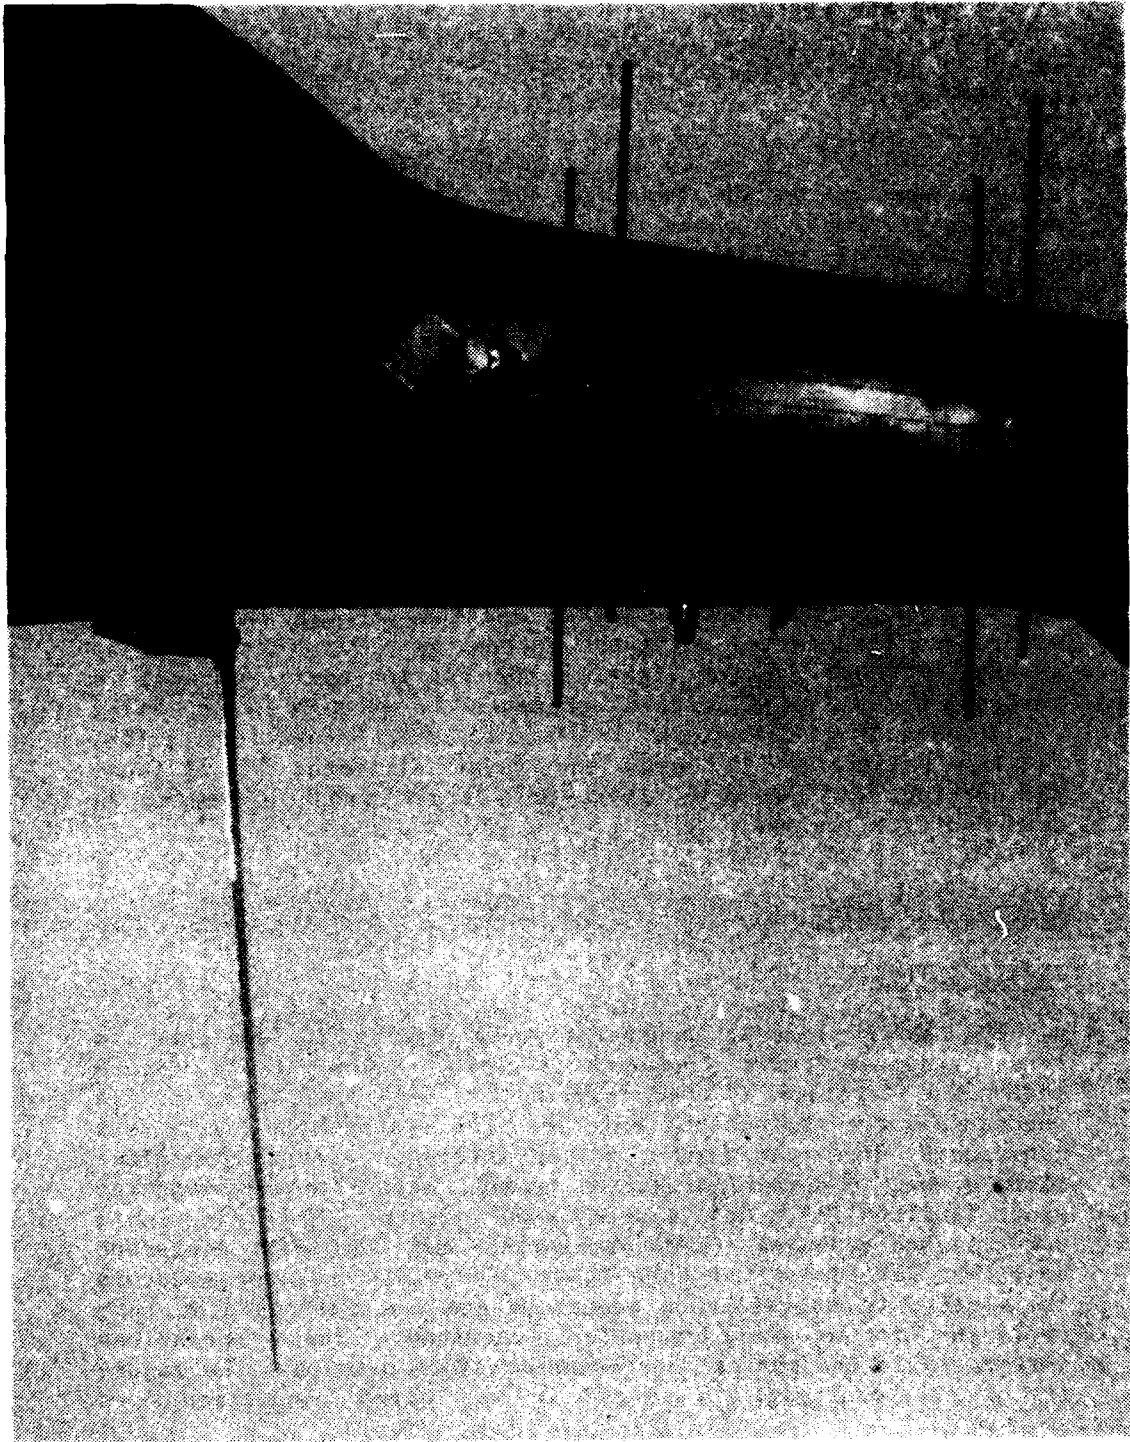
Photo 6. ECM Antenna - Extended

19. During an approach to landing with the ECM antenna in the extended position, the antenna contacted the ground and was damaged. The automatic antenna retraction provision had been disabled by setting the LO altitude bug of the radar altimeter to 0 feet while performing low-speed flight tests at 25 feet. With the automatic antenna retraction provision disabled, the pilot received no positive indication that the ECM antenna was extended. This shortcoming was previously reported (ref 10, app A). The lack of an ECM ANTENNA EXTENDED advisory light in the cockpit independent of the radar altimeter setting is a shortcoming.

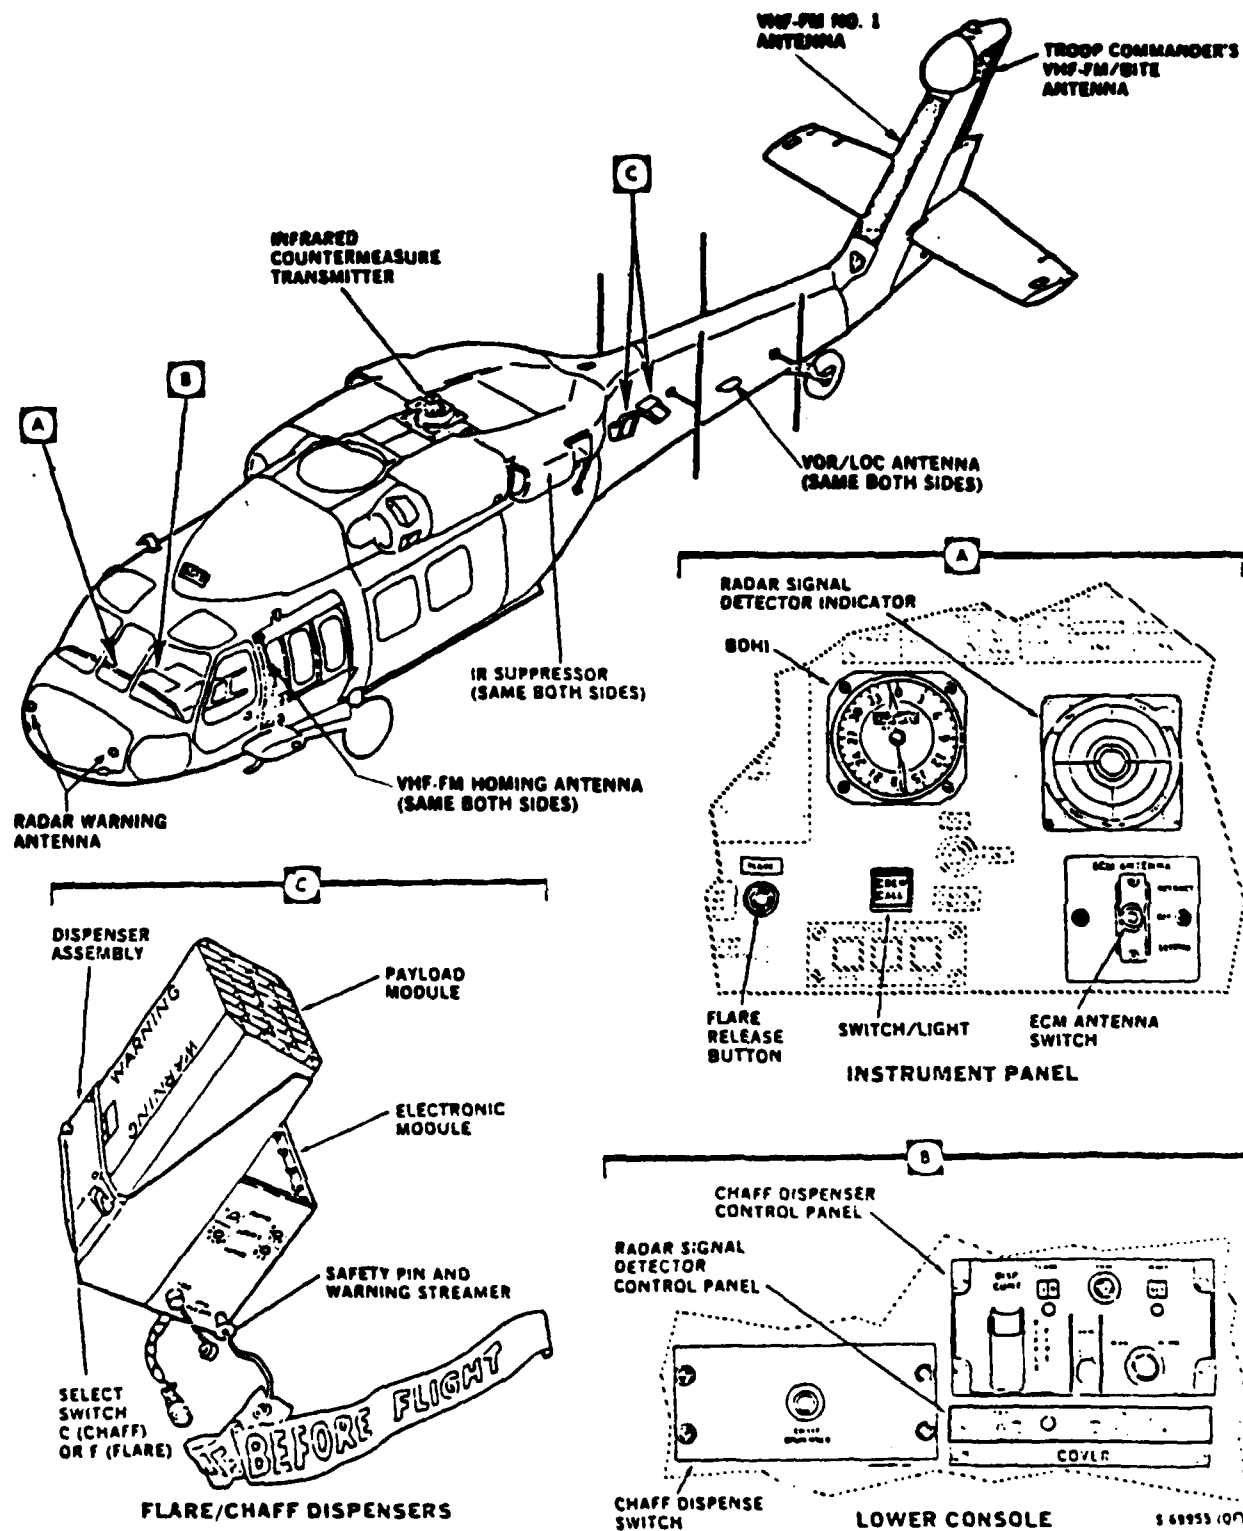
Figure 2. YEH-60A Mission Kits (Exclusive of Cabin Areas)

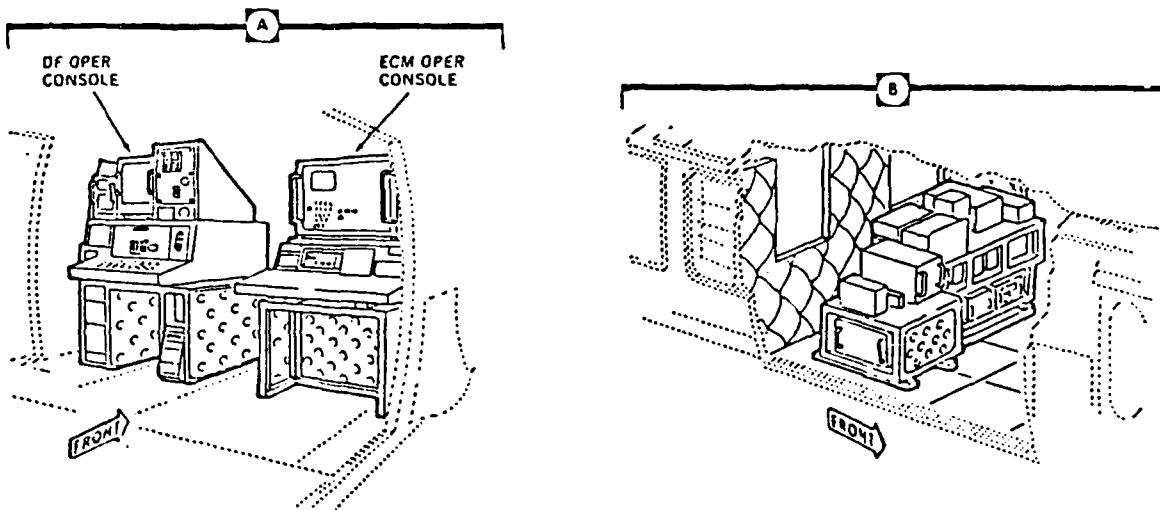
4. The AN/ALQ-151(V)2 countermeasures system is designed to detect radiated radio frequency signals, automatically referencing the location of the transmitter, and initiating active countermeasures against the emitter. The system consists of six subsystems: direction finder group, intercept group, communications group, computer/navigation group, active countermeasures group (AN/TLO-17A), and system power group. The electronic surveillance measures (ESM) equipment and the ECM equipment operate independently of each other. The ESM operator controls the electronic surveillance functions and the ECM operator controls the active countermeasures functions. These operations interface via the system intercommunications network. The majority of the equipment is housed in the cargo compartment, as

shown in figure 3. Additional equipment is located in the tail, tailcone, nose, and cockpit.

Figure 3. YEH-60A Cabin Equipment Arrangement

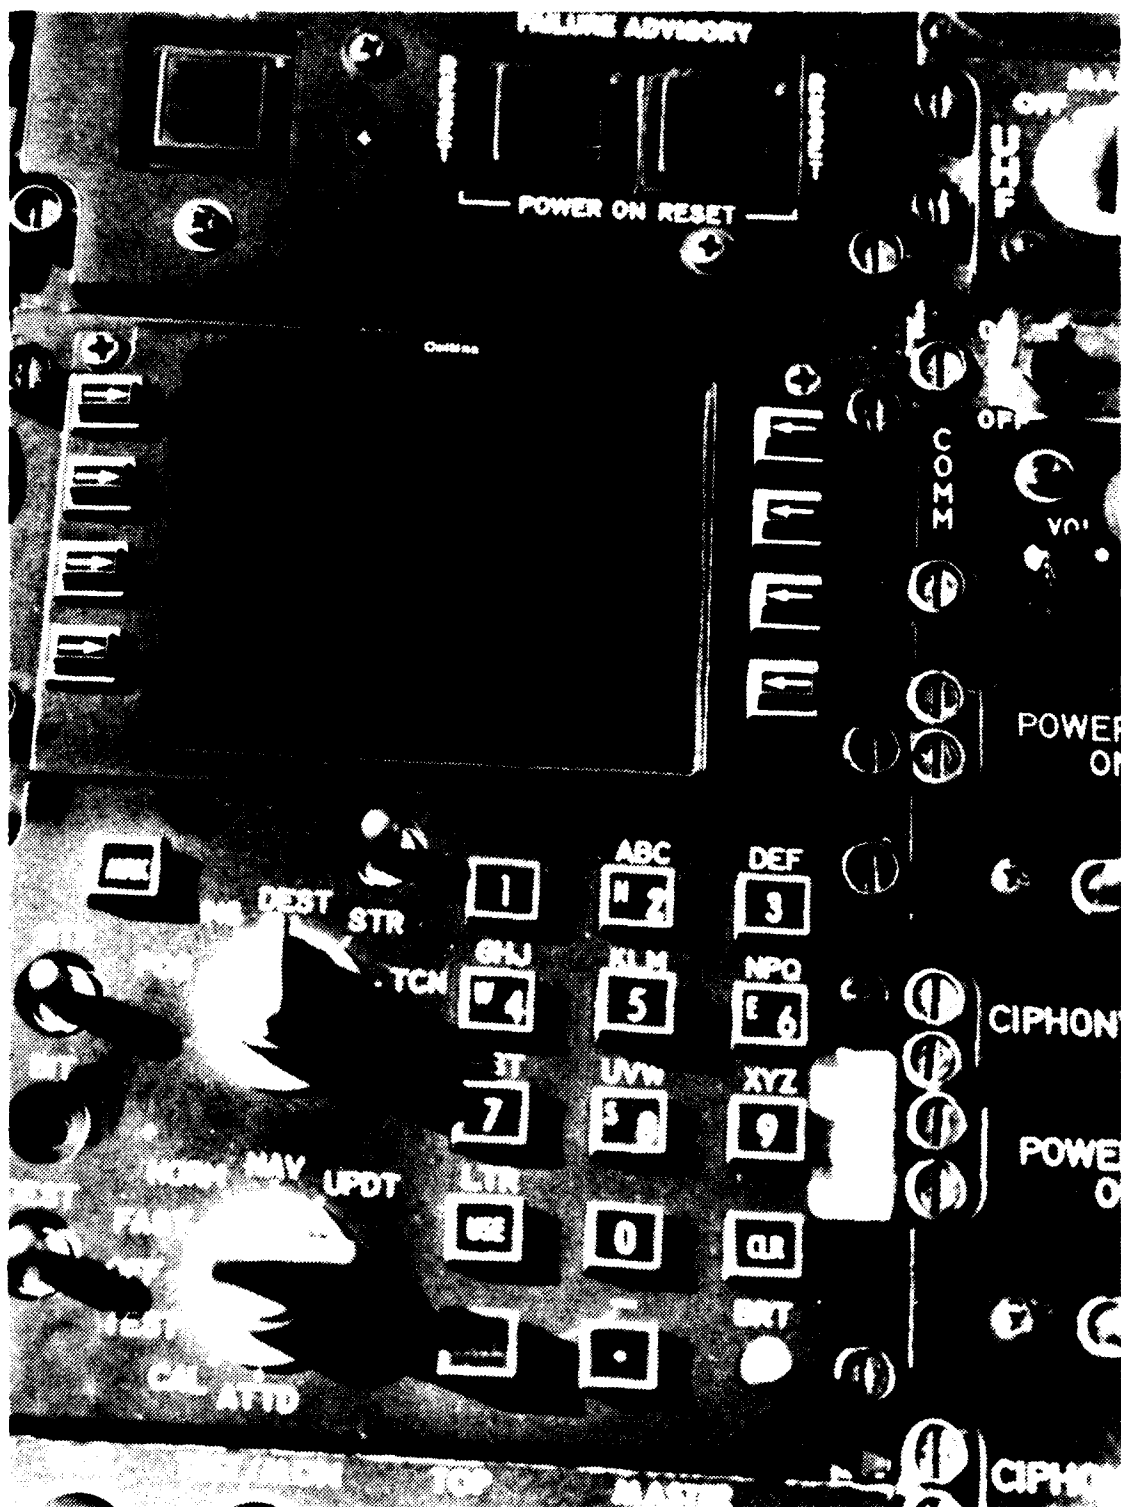
Photo 7. Integrated Inertial Navigation System (IINS)  
Central Display Unit (CDU)

21. During this program one IINS failure occurred. The Navigation Processor Unit (NPU) failed and required reprogramming by the manufacturer. The reprogramming was accomplished in 2 hours by personnel using specialized equipment. A new model Cockpit Display Unit (CDU) was installed in the aircraft on 13 June 1984. This unit was designed to protect the IINS from power transients during the hydraulic leak test. These power transients are caused by the cycling of the electrically driven backup hydraulic pump.

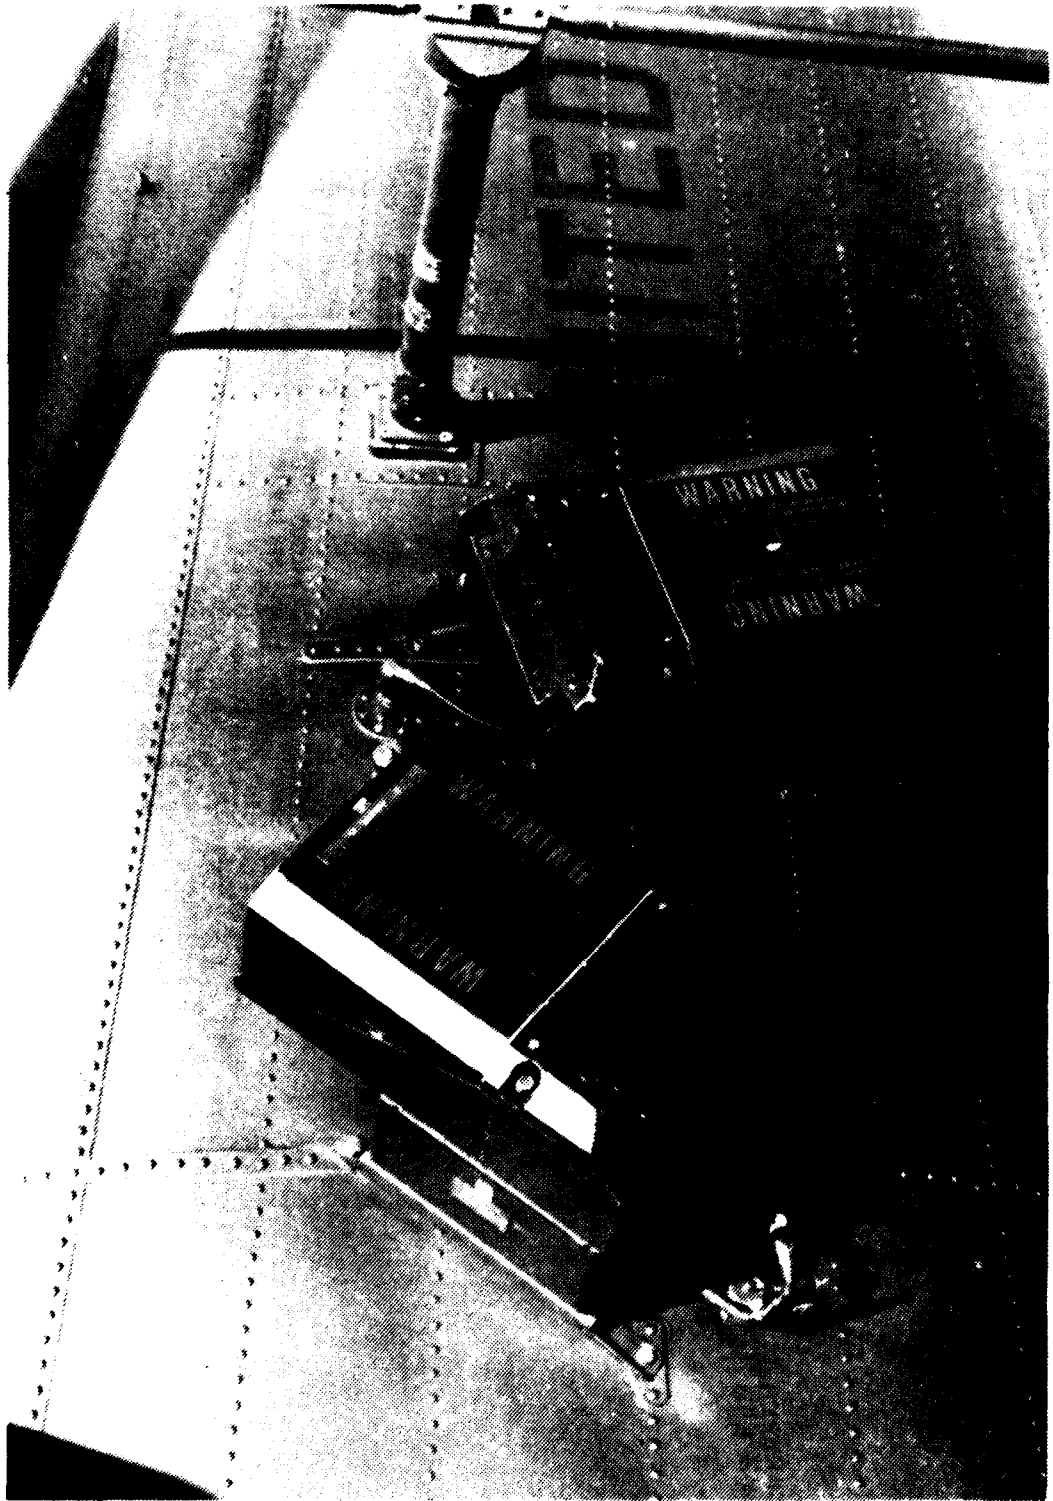
Photo 8. M-130 General Purpose Dispensers (2)

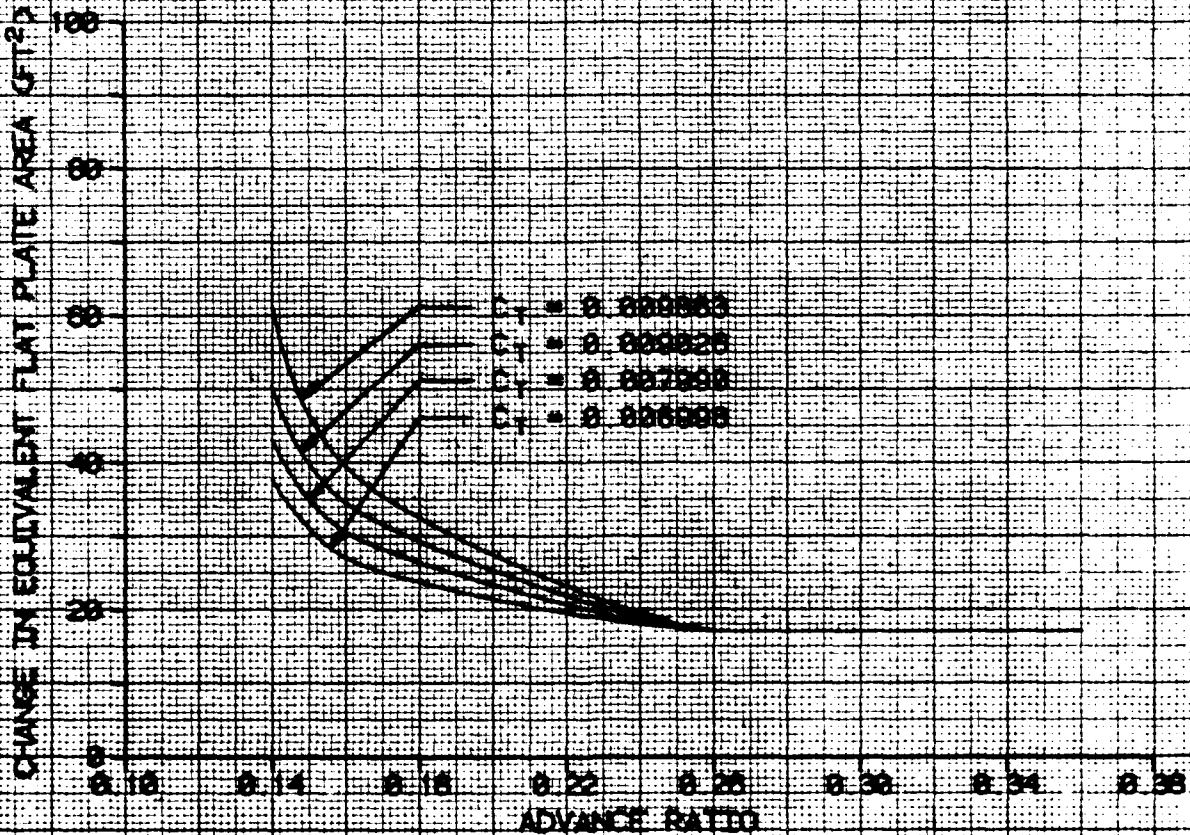
FIGURE 2  
NONDIMENSIONAL DRAG CHARACTERISTICS

- NOTES:
1. THRUST COEFFICIENT = 0.006998
  2. REFERRED ROTOR SPEED = 258
  3. ZERO SIDESLIP TRIM CONDITION
  4. AVERAGE LONGITUDINAL CENTER OF GRAVITY OF FS 359.2
  5. LATERAL CENTER OF GRAVITY OF BL 0.3 LEFT
  6. CURVE OBTAINED FROM USAAEFA REPORT NO. 77-17 WITH  $\Delta F_e$  FROM FIGURE 1 INCORPORATED

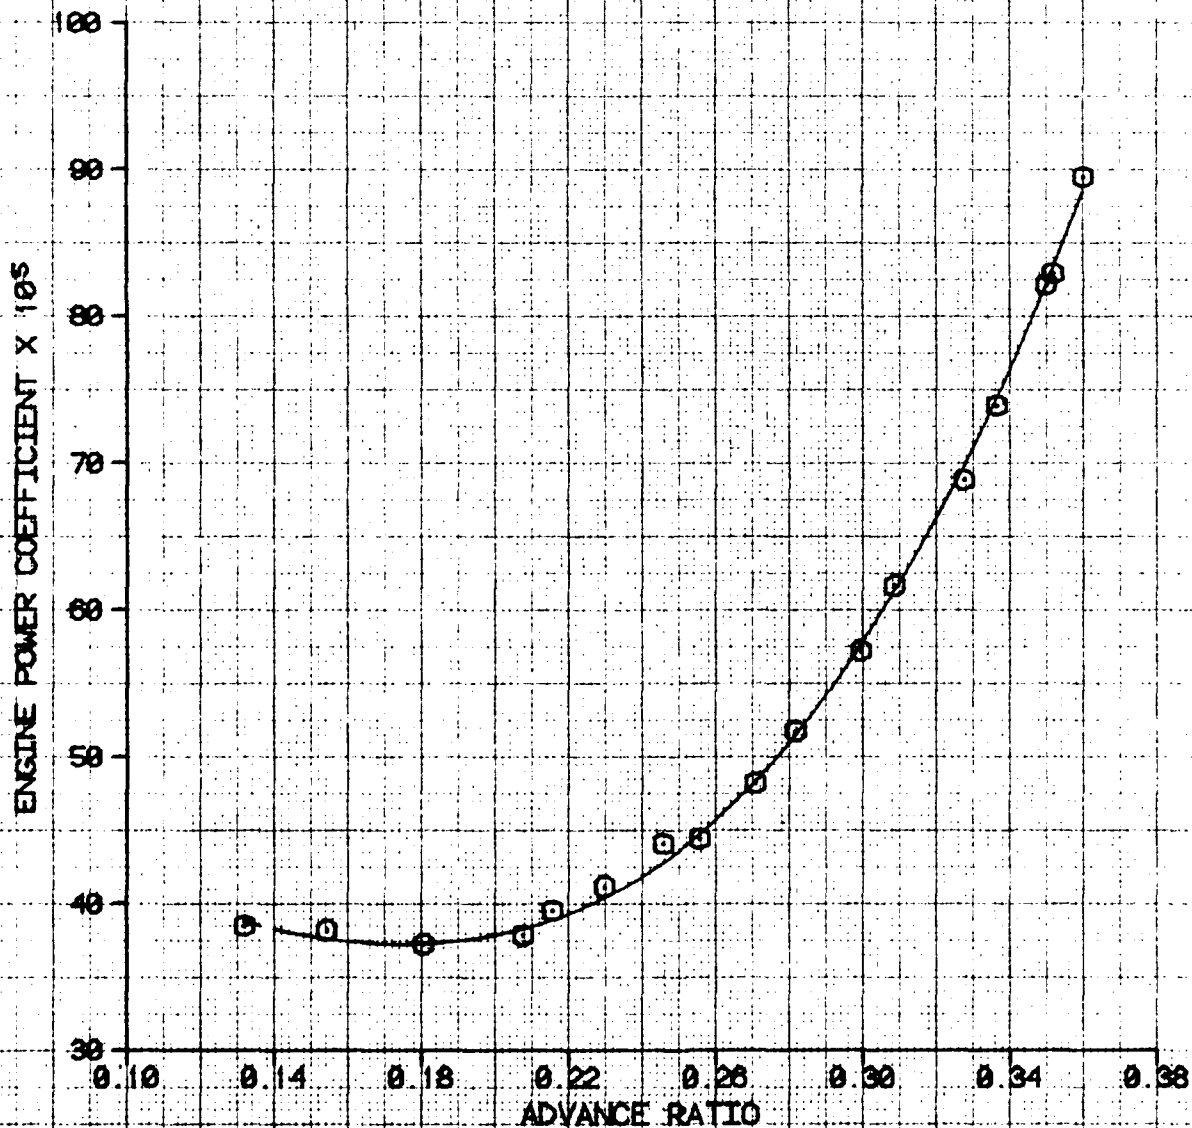
FIGURE 3  
NONDIMENSIONAL DRAG CHARACTERISTICS

1. THRUST COEFFICIENT = 0.007990
2. REFERRED ROTOR SPEED = 258
3. ZERO SIDESLIP TRIM CONDITION
4. AVERAGE LONGITUDINAL CENTER OF GRAVITY OF FS 359.2
5. LATERAL CENTER OF GRAVITY OF BL 0.3 LEFT
6. CURVE OBTAINED FROM USAAEFA REPORT NO. 77-17 WITH  $\Delta F_e$  FROM FIGURE 1 INCORPORATED

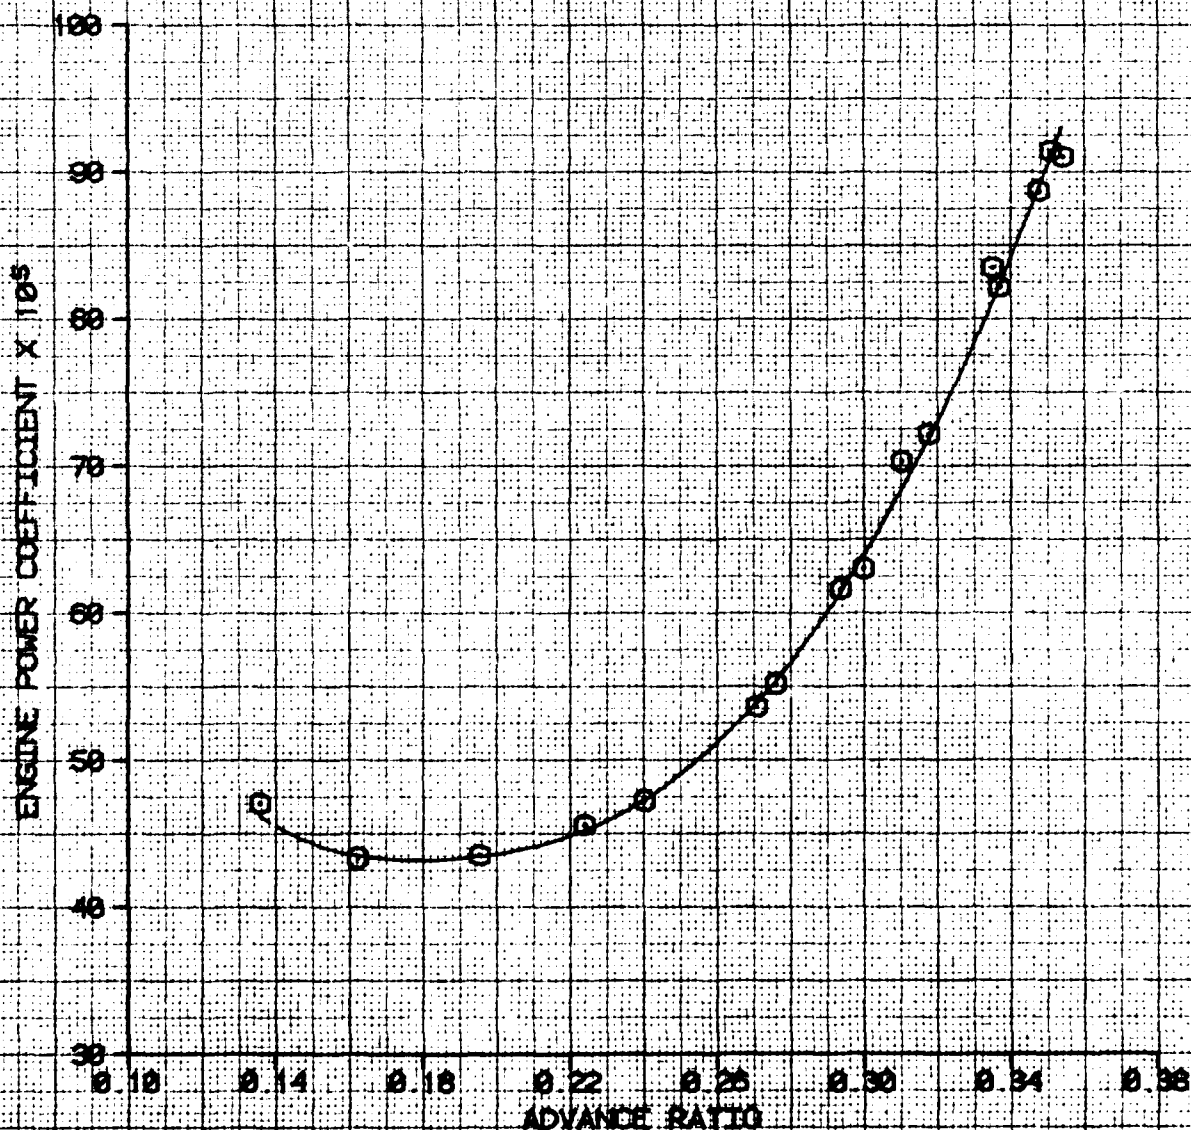
FIGURE 4  
NONDIMENSIONAL DRAG CHARACTERISTICS

1. THRUST COEFFICIENT = 0.009026
2. REFERRED ROTOR SPEED = 258
3. ZERO SIDESLIP TRIM CONDITION
4. AVERAGE LONGITUDINAL CENTER OF GRAVITY OF FS 359.2
5. LATERAL CENTER OF GRAVITY OF BL 0.3 LEFT
6. CURVE OBTAINED FROM USAAEFA REPORT NO. 77-17 WITH  $\Delta F_z$  FROM FIGURE 1 INCORPORATED

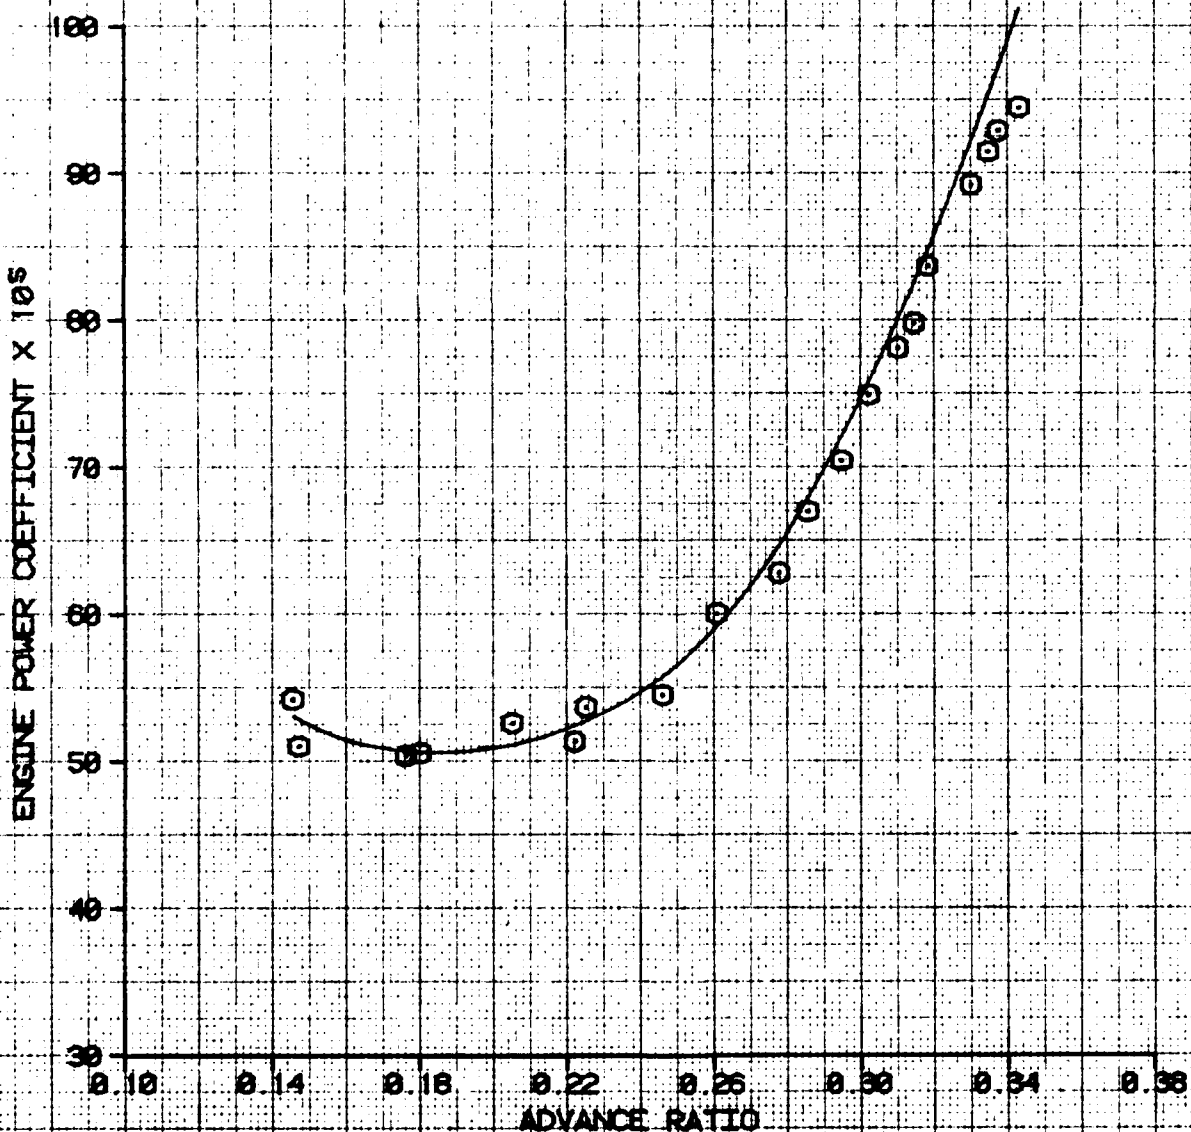
**FIGURE 5**  
**NONDIMENSIONAL DRAG CHARACTERISTICS**  
 YEH-60A USA S/N 79-23301  
 QUICK FIX CONFIGURATION

- NOTES:
1. THRUST COEFFICIENT = 0.020663
  2. REFERRED ROTOR SPEED = 258
  3. ZERO SIDESLIP TRIM CONDITION
  4. AVERAGE LONGITUDINAL CENTER OF GRAVITY OF FS 359.2
  5. LATERAL CENTER OF GRAVITY OF BL 0.3 LEFT
  6. CURVE OBTAINED FROM USAAEFA REPORT NO. 77-17 WITH  $\Delta F_z$  FROM FIGURE 1 INCORPORATED

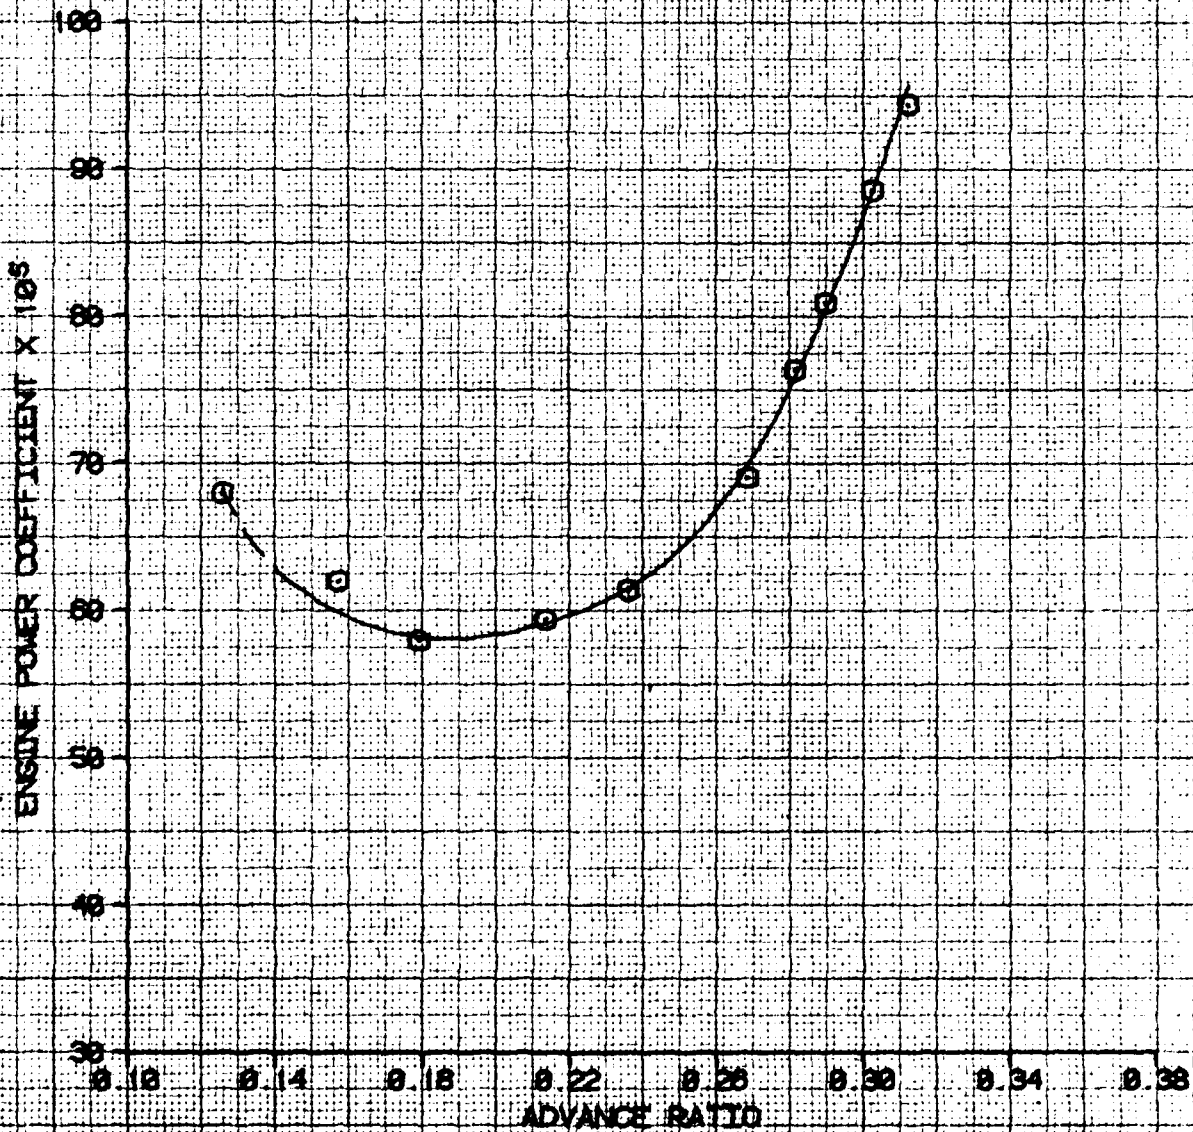
FIGURE 6  
 NONDIMENSIONAL LEVEL FLIGHT PERFORMANCE  
 YEH-80A USA S/N 79-23301  
 QUICK FIX CONFIGURATION

1. REFERRED ROTOR SPEED = 258
2. BALL CENTER TRIM CONDITION
3. AVERAGE LONGITUDINAL CENTER OF GRAVITY OF FS 359.2
4. LATERAL CENTER OF GRAVITY OF BL 0.3 LEFT
5. POINTS DERIVED FROM FIGURES 9 THRU 12

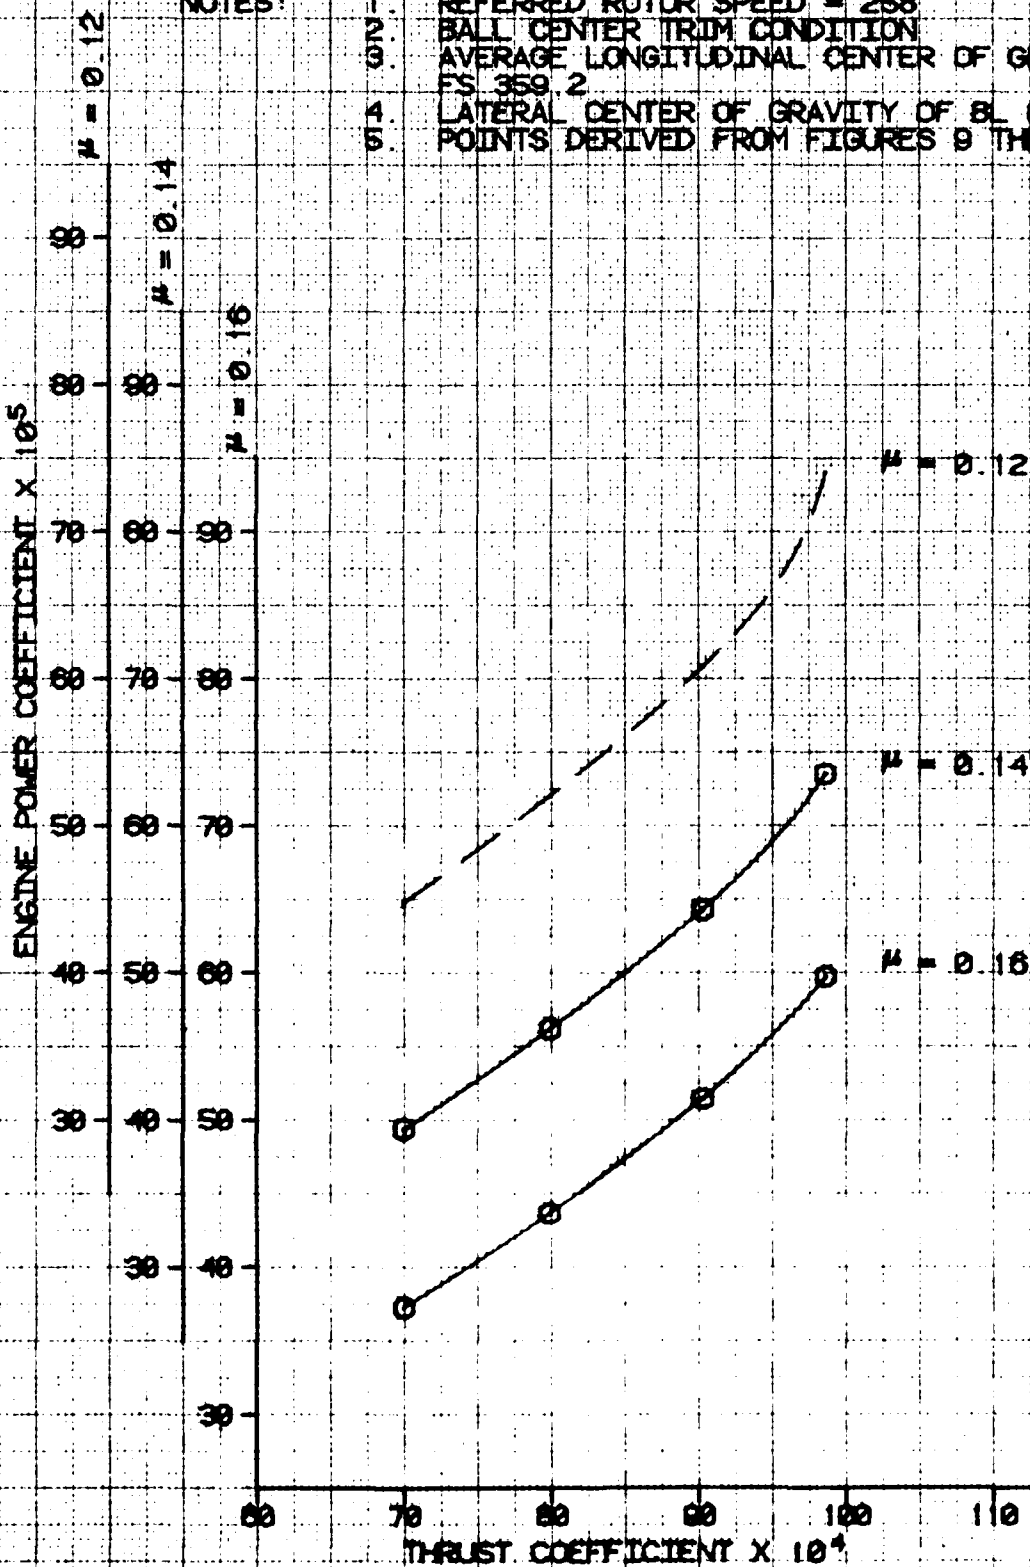
FIGURE 7  
 NONDIMENSIONAL LEVEL FLIGHT PERFORMANCE

1. REFERRED ROTOR SPEED = 258
2. BALL CENTER TRIM CONDITION
3. AVERAGE LONGITUDINAL CENTER OF GRAVITY OF FS 359.2
4. LATERAL CENTER OF GRAVITY OF BL 0.3 LEFT
5. POINTS DERIVED FROM FIGURES 9 THRU 12

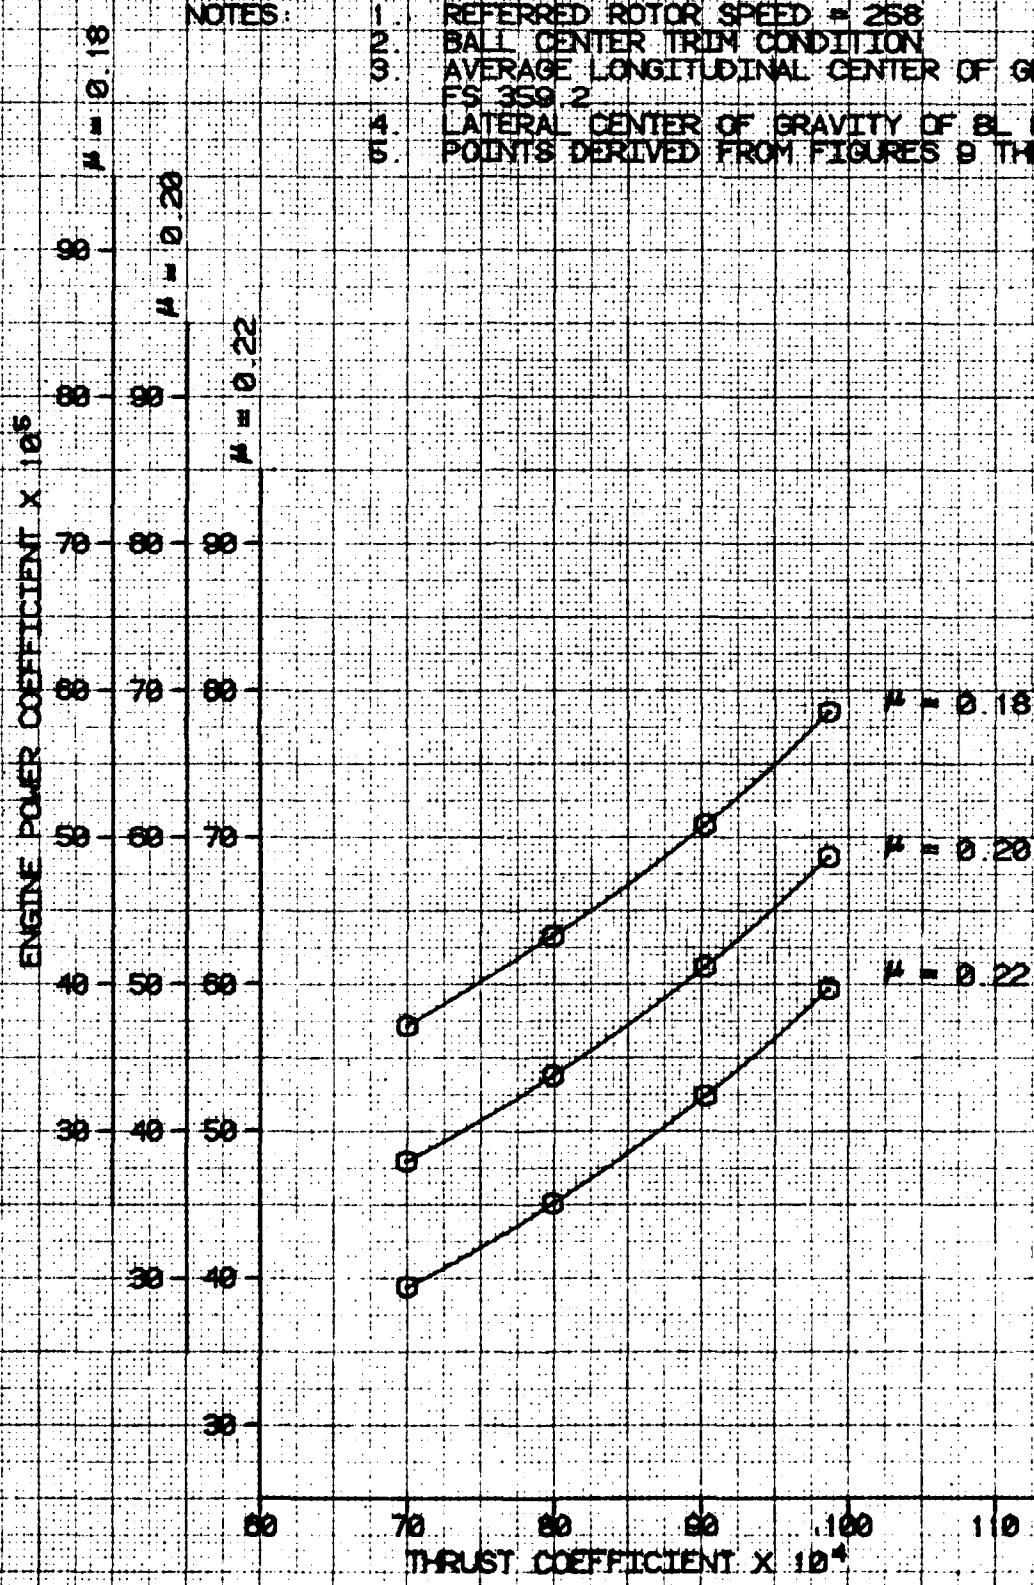
**FIGURE 8**  
**NONDIMENSIONAL LEVEL FLIGHT PERFORMANCE**  
**YB-60A USA S/N 78-23381**  
**QUICK FIX CONFIGURATION**

- NOTES:**
1. REFERRED ROTOR SPEED = 268
  2. HULL CENTER TRIM CONDITION
  3. AVERAGE LONGITUDINAL CENTER OF GRAVITY OF AS 350.2
  4. LATERAL CENTER OF GRAVITY OF B.L. 0.3 LEFT
  5. POINTS DERIVED FROM FIGURES 9 THRU 12

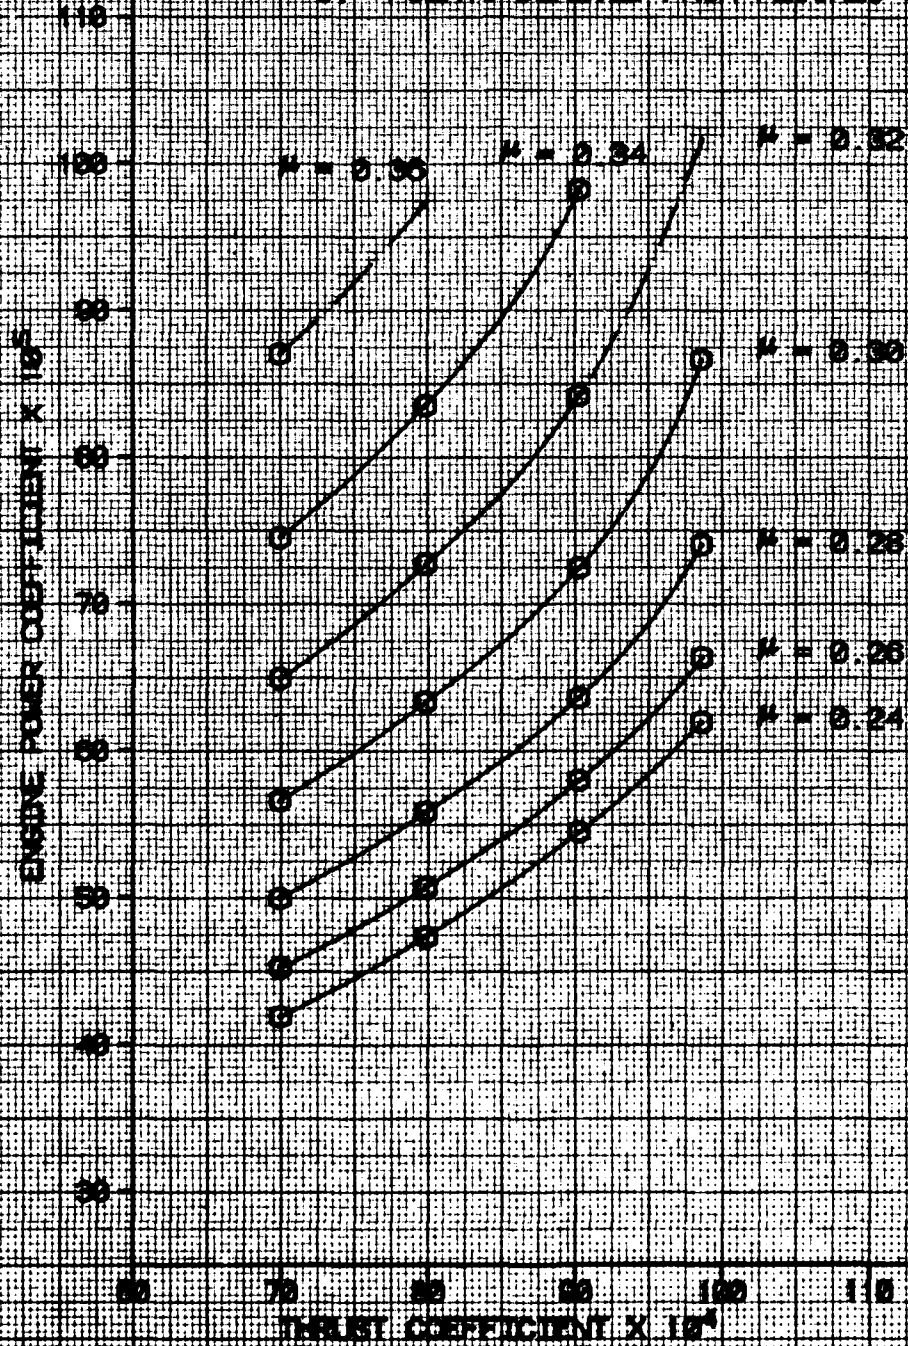
FIGURE 9  
 LEVEL FLIGHT PERFORMANCE  
 YEH-60A USA S/N 79-23301  
 QUICK FIX CONFIGURATION

AVG GROSS WEIGHT (LB)	AVG CG LOCATION		AVG DENSITY ALTITUDE (FT)	AVG OAT (DEG C)	REFERRED ROTOR SPEED (RPM)	AVG THRUST COEFFICIENT
	LONG (FS)	LAT (BL)				
15920	359.1	0.3LT	7170	14.5	258.0	0.006998

8. Level flight performance tests were conducted at the conditions listed in table 1 to determine power required and fuel flow of the YEH-60A at various airspeeds. The aircraft was tested at a longitudinal cg of fuselage station (FS) 359. Previous level flight performance testing in the normal utility configuration was conducted primarily at a cg of FS 347. A longitudinal cg of FS 359 was the alternate cg tested during the previous evaluation and a difference of 2  $\text{ft}^2$  of  $F_e$  was determined between the two cg configurations. Testing at a longitudinal cg of FS 359 closely reflects the YEH-60A mission configuration. Techniques used in obtaining and analyzing level flight performance data are described in detail in appendix D. The aircraft was flown in ball-centered flight and the data were converted to a zero sideslip trim condition for comparison to the normal utility configured UH-60A, reference 8, appendix A. All performance data were corrected for estimated drag of external test instrumentation and instrumentation electrical load. Mission equipment was not operated during level flight performance tests.

above 17 ft<sup>2</sup> with increasing  $C_T$  and decreasing  $\mu$ , a trend substantiated in reference 8, appendix A, by two of three level flight performance tests flown with IR suppressors installed indicating more power required than characterized by a constant  $\Delta F_e$  at low airspeeds. The results of incorporating  $\Delta F_e$  from figure 1 with the UH-60A nondimensional family of curves for the  $C_T$ 's flown during this evaluation, referenced to  $N/\sqrt{\theta}$  of 258 and zero sideslip trim conditions, are presented in figures 2 through 5. Nondimensional test results representing power required for the YEH-60A in ball-centered level flight are presented in figures 6 through 8. Dimensional level flight test results are presented in figures 9 through 12.
