USAAEFA PROJECT NO. 83 - 20

# LIMITED AIRWORTHINESS AND FLIGHT CHARACTERISTICS (A&FC) TEST OF THE QUICK FIX CONFIGURATION

OCTOBER 1984

FINAL REPORT

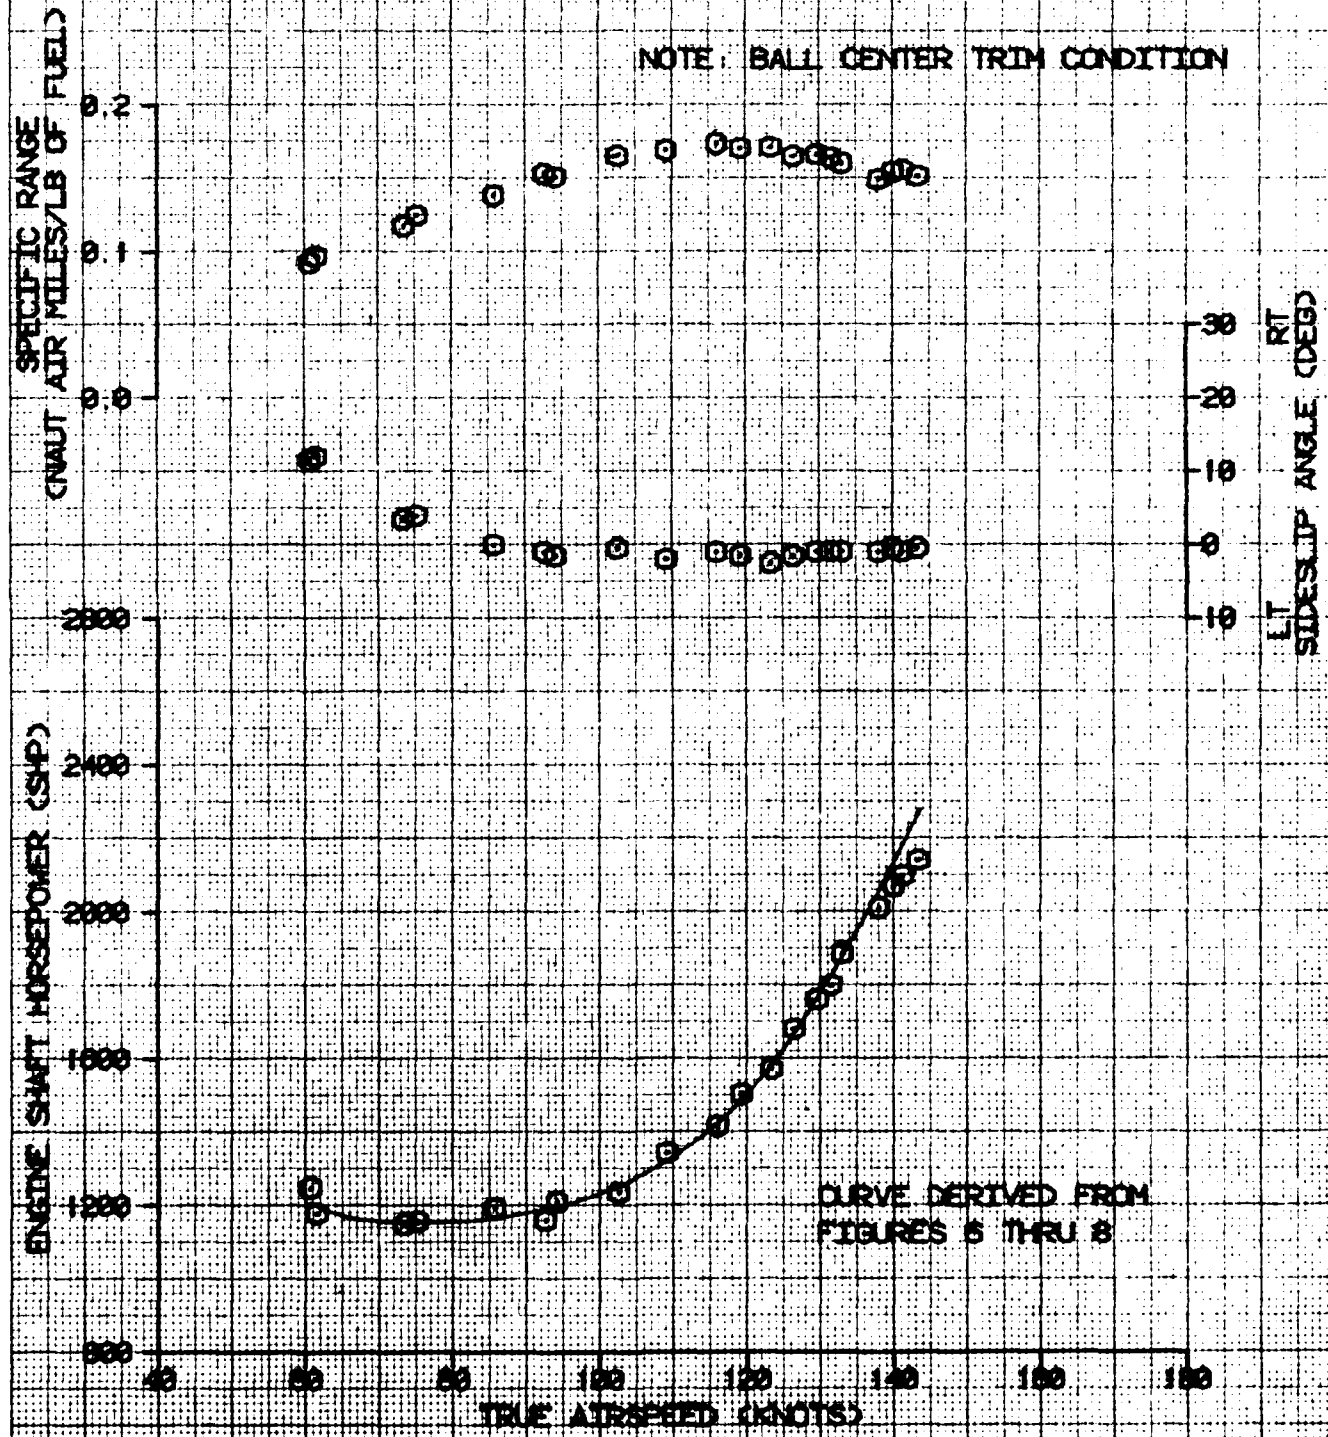
**FIGURE 12**  
**LEVEL FLIGHT PERFORMANCE**  
 YEH-60A USA S/N 79-2330  
 QUICK FIX CONFIGURATION

Avg TAS (KTS)	Avg CG Location (KFS)	Avg Density Altitude (FT)	Avg DAT (DEG C)	Referenced Rotor Speed (RPM)	Avg Thrust Coefficient
10000	358.7	0.327	15000	255.0	0.00000

above 17 ft<sup>2</sup> with increasing  $C_T$  and decreasing  $\mu$ , a trend substantiated in reference 8, appendix A, by two of three level flight performance tests flown with IR suppressors installed indicating more power required than characterized by a constant  $\Delta F_e$  at low airspeeds. The results of incorporating  $\Delta F_e$  from figure 1 with the UH-60A nondimensional family of curves for the  $C_T$ 's flown during this evaluation, referenced to  $N/\sqrt{\theta}$  of 258 and zero sideslip trim conditions, are presented in figures 2 through 5. Nondimensional test results representing power required for the YEH-60A in ball-centered level flight are presented in figures 6 through 8. Dimensional level flight test results are presented in figures 9 through 12.
