MATERIALS RESEARCH LABORATORIES

MRL-R-958

EXPLOSION BULGE TESTING  
OF AUSTRALIAN HY-80 STEEL PLATE

J.C. Ritter and B.F. Dixon

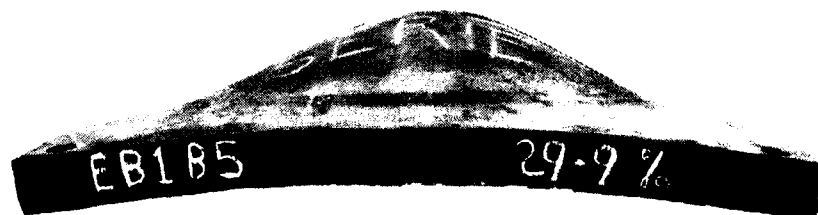
FIGURE 17 Explosion bulge plate number 1, at completion of testing.

The first plate was subjected to five blasts and achieved a total reduction in thickness of 29.9%. At this stage the plate contained one through-thickness crack along the weld and three cracks in the parent metal (Fig. 17). Since none of these cracks extended beyond the circle of contact between the test plate and die block at the moment of blasting, the plate still satisfied the specification requirements [3]. The reduction in thickness (29.9%) compares very favourably with the specified minimum of 16%.
