EFFECT OF HEAT TREATMENT ON MECHANICAL PROPERTIES  
AND MICROSTRUCTURE OF FOUR DIFFERENT HEATS  
OF ASTM A710 STEEL

September 1985

Final Report

Prepared for  
David W. Taylor Naval Ship R&D Center  
Bethesda, Maryland 20084

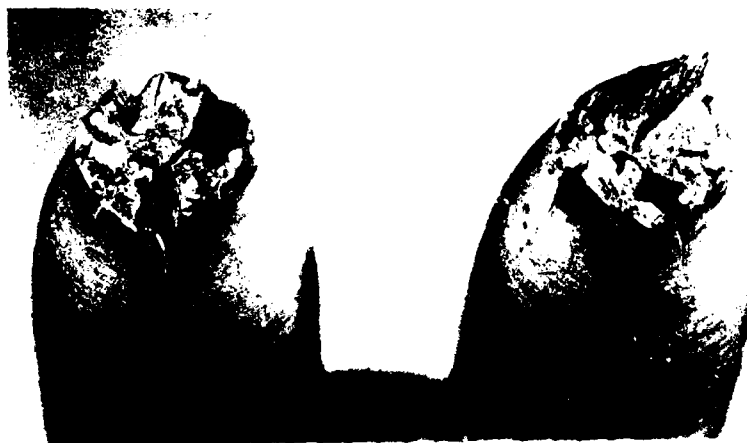
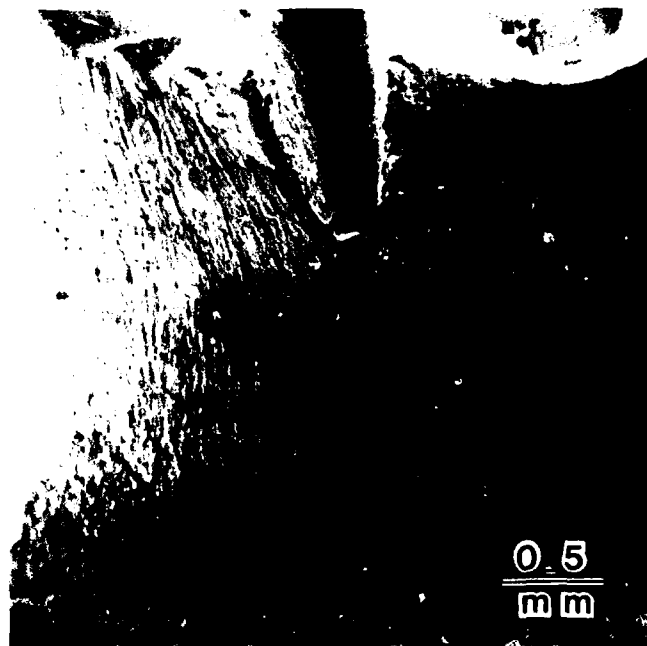
Fig. A1 Optical and SEM micrographs of splitting in A 710 tensile specimens.

It was previously observed that fractured tensile bars of A710 occasionally exhibited deep(5-10 mm) longitudinal cracks or splits (Figure A1). These cracks formed slightly before or just at the moment of fracture. These cracks were distributed radially and were not associated with rolling anisotropy. Consultation with an expert in this field (A1) indicated that these cracks were an extreme form of star fracture [also called spoke-shaped fracture (A2) or "Fraserbruche" (milling cutter fracture) (A3)]. The origin of this name can be seen in a less severely split specimen (Figure A2). Radially distributed, shear escarpments are seen which resemble a star. Since the splitting is only observed in the necked portion of the specimen, its cause could be the high triaxial stress state or the high strain state that occurs there. If the splitting were caused by a triaxial (or constrained) stress state, use of A710 might be impeded. Service stresses are usually multiaxial, and reduction in ductility by such loading would be of concern. However, if a high plastic strain state were the cause of splitting, then no concern would be warranted as the ductility is virtually exhausted when splitting finally does occur and could be regarded as an artifact of a highly ductile fracture mode.

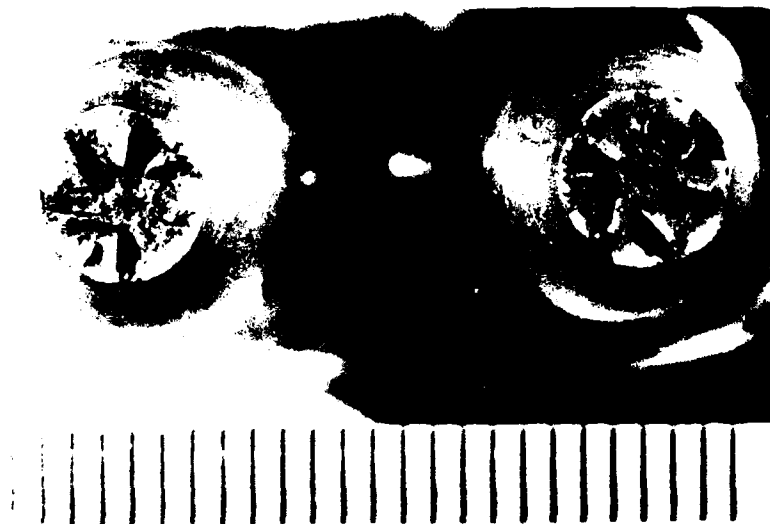
Fig. A2 Star fractures in A 710. Also known as spoke-type or milling cutter fractures.

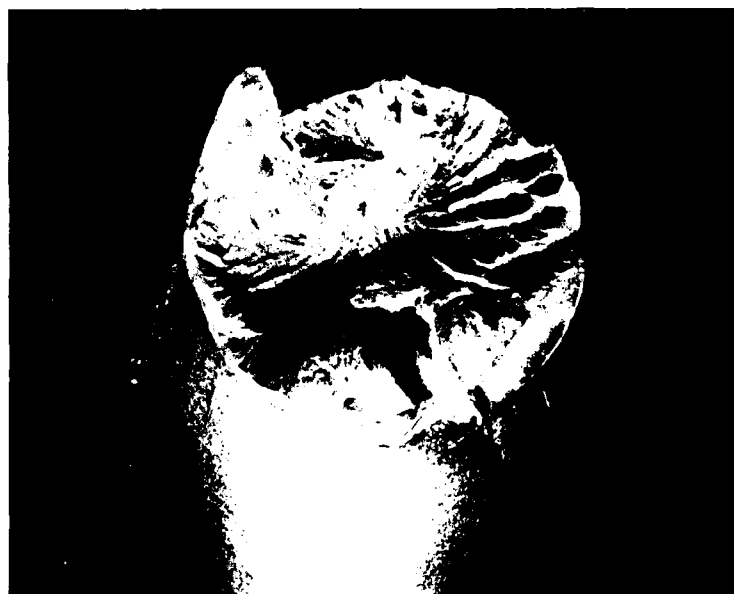
Fig. A3 Splitting observed in oversized ( $3/4$ " diameter gage) tensile specimen.

To investigate this phenomenon further, a plate of A710 was heat treated to the condition found to be prone to splitting in this investigation 899°C (1650°F), 30 min, WQ precipitation hardened - 538°C (1000°F) for 90 min and AC). Oversized tensile specimens [19 mm (3/4 inch) diameter gage sections] were machined from this plate. At fracture, these exhibited splitting (Figure A3).
