INVESTIGATE LASER INDUCED DAMAGE IN OPTICAL COATINGS USING TIME RESOLVED RAMAN SPECTROSCOPY

Gregory J. Exarhos

Pacific Northwest Laboratory
Richland, Washington 99352

Final Report

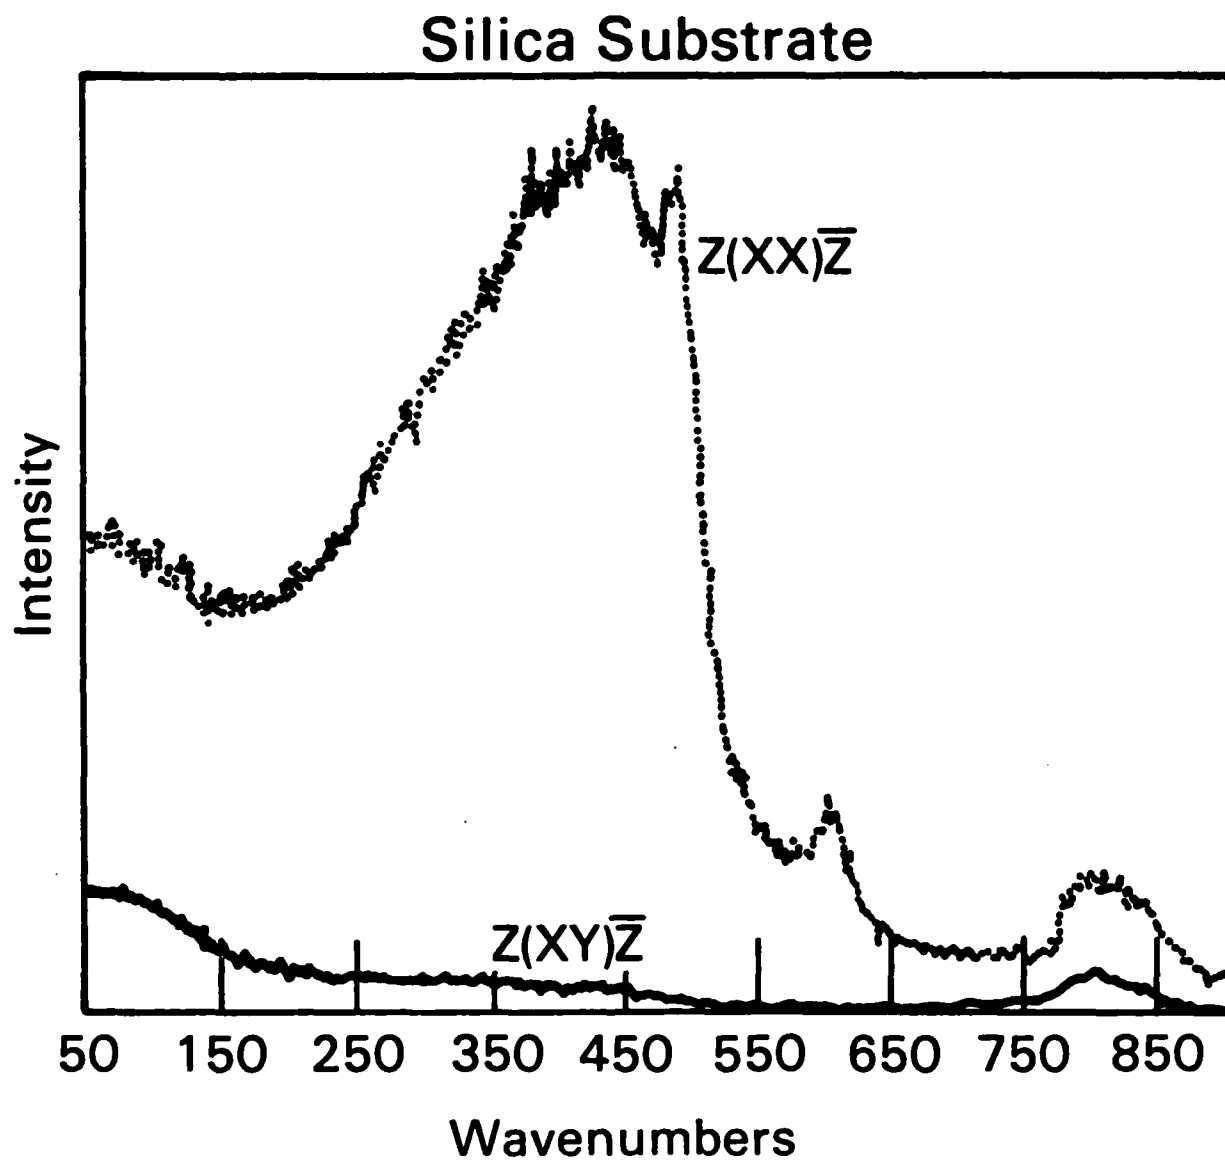
Figure 2. Raman spectra of an uncoated vitreous SiO_2 substrate. The standard scattering geometry designation is based upon a coordinate system defined at the sample where Z and \bar{Z} are the incident and scattered laser directions and X and Y define which component of the electric field is transmitted by the analyzer.

In this investigation, all coatings evaluated were deposited onto fused silica (SiO_2) substrates. For thinner coatings, the weak substrate Raman scattering can be appreciable relative to scattering from the thin film and can obscure Raman lines attributed to the coating. To minimize this substrate interference, a technique has been employed which takes advantage of the contrasting polarization properties of Raman scattering from the fused silica substrate and the fine grained coating. Inherent molecular disorder present in the fused silica results in marked polarization anisotropy in the Raman scattered radiation while scattering from the individual randomly orientated grains is isotropic. Therefore, analysis of the perpendicular component of the scattered light will consist almost entirely of Raman scattering attributed to the optical coatings. This effect is illustrated dramatically for thin TiO_2 coatings on silica in Figs. 2, 3 and 4.

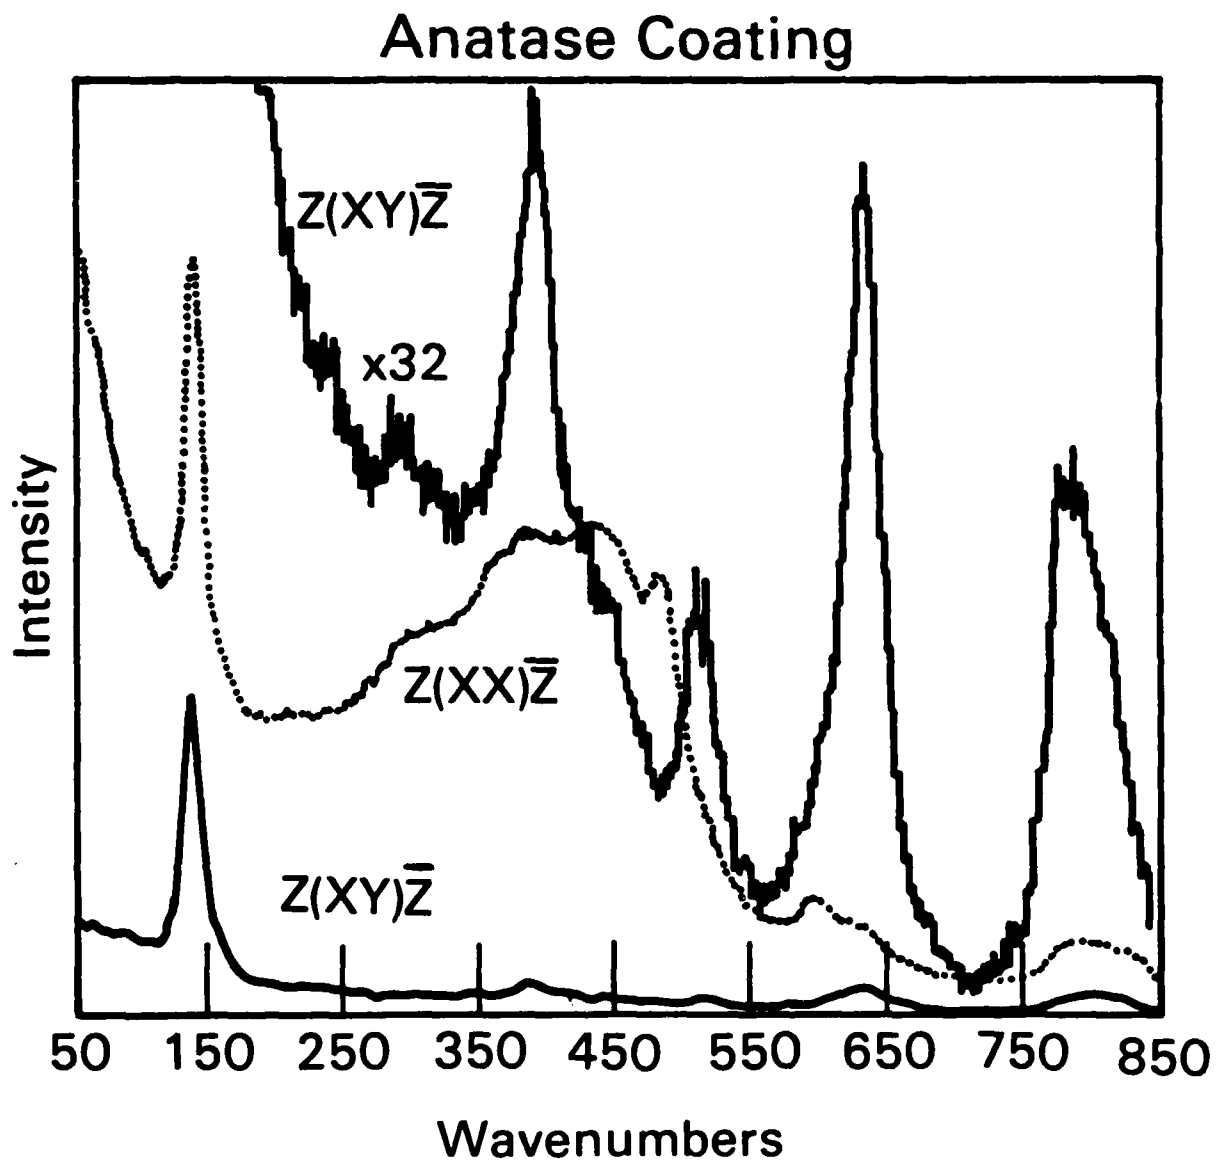
Figure 4. Raman spectra of a 1811°A thick anatase (TiO₂) coating on SiO₂.

The primary candidate coating material chosen for this project is TiO_2 deposited on silica substrates in both single layer and multilayer designs although some preliminary data from studies of ZrO_2 will also be discussed. These oxides were chosen for investigation not only because they are technologically important, but because they exhibit relatively high Raman scattering cross sections and can exist in several stable crystalline phases that are readily discernible from measured Raman spectra (Figs. 3 and 4).

Thin film TiO_2 optical coatings have been characterized with regard to phase identity and homogeneity by Raman spectroscopy. The Raman spectrum of a thin anatase film on silica is depicted in Fig. 4. By analyzing the $Z(X Y)\bar{Z}$ component of the scattered radiation, Raman scattering from the silica substrate is markedly attenuated at frequencies below 800 cm^{-1} . The broad feature at ca 800 cm^{-1} is, however, assigned to Raman scattering from the glass substrate. For the other scattering geometry $Z(X X)\bar{Z}$ substrate features overwhelm Raman lines from the thin optical coatings. Therefore, in all subsequent measurements, the $Z(X Y)\bar{Z}$ scattering geometry was used. The major anatase lines at 145, 199, 398, 517 and 639 cm^{-1} and rutile features at 244, 440 and 610 cm^{-1} previously assigned clearly distinguish the two crystalline phases (Refs. 11 and 12).

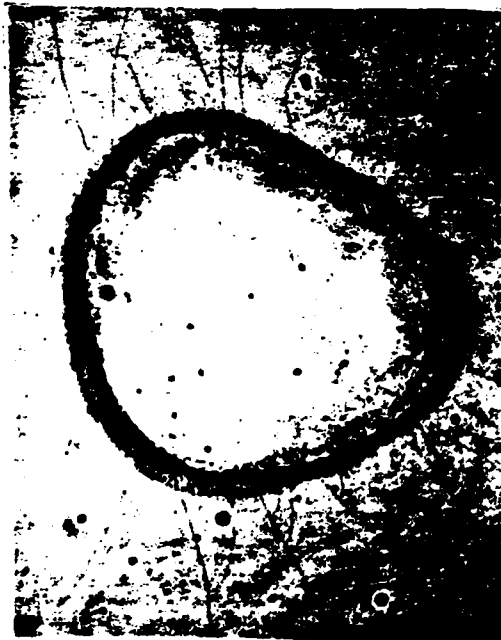
Single layer anatase coating
(0.8 μm). 1 shot.

Multilayer anatase coating.
1 shot.

Single layer anatase coating.
Multiple shot damage.

Multilayer anatase coating.
Multiple shot damage.

Figure 8. Photomicrographs of TiO_2 coatings subjected to pulsed 532 nm irradiation above damage threshold (100X magnification).

Optical coatings which have incurred irreversible laser damage exhibit features similar to those seen in micrographs of single and multilayer anatase coatings that have been subjected to intense pulsed 532 nm radiation (Fig. 8). Evidence for coating ablation and recrystallization is apparent in each picture; however, more homogeneous damage centers are produced following multiple laser shot exposure over the same area. Damage is fairly uniform over the irradiated areas which have average diameters which range from 250 to 750 μm . With proper optics, a Raman probe laser beam can be focused to a 1 μm spot size enabling surface profiling of the damaged region with regard to identification of crystalline phases, decomposition products, and coating thickness measurements. Results of such spatially resolved measurements in addition to in situ Raman measurements obtained in a time resolved mode are discussed below.

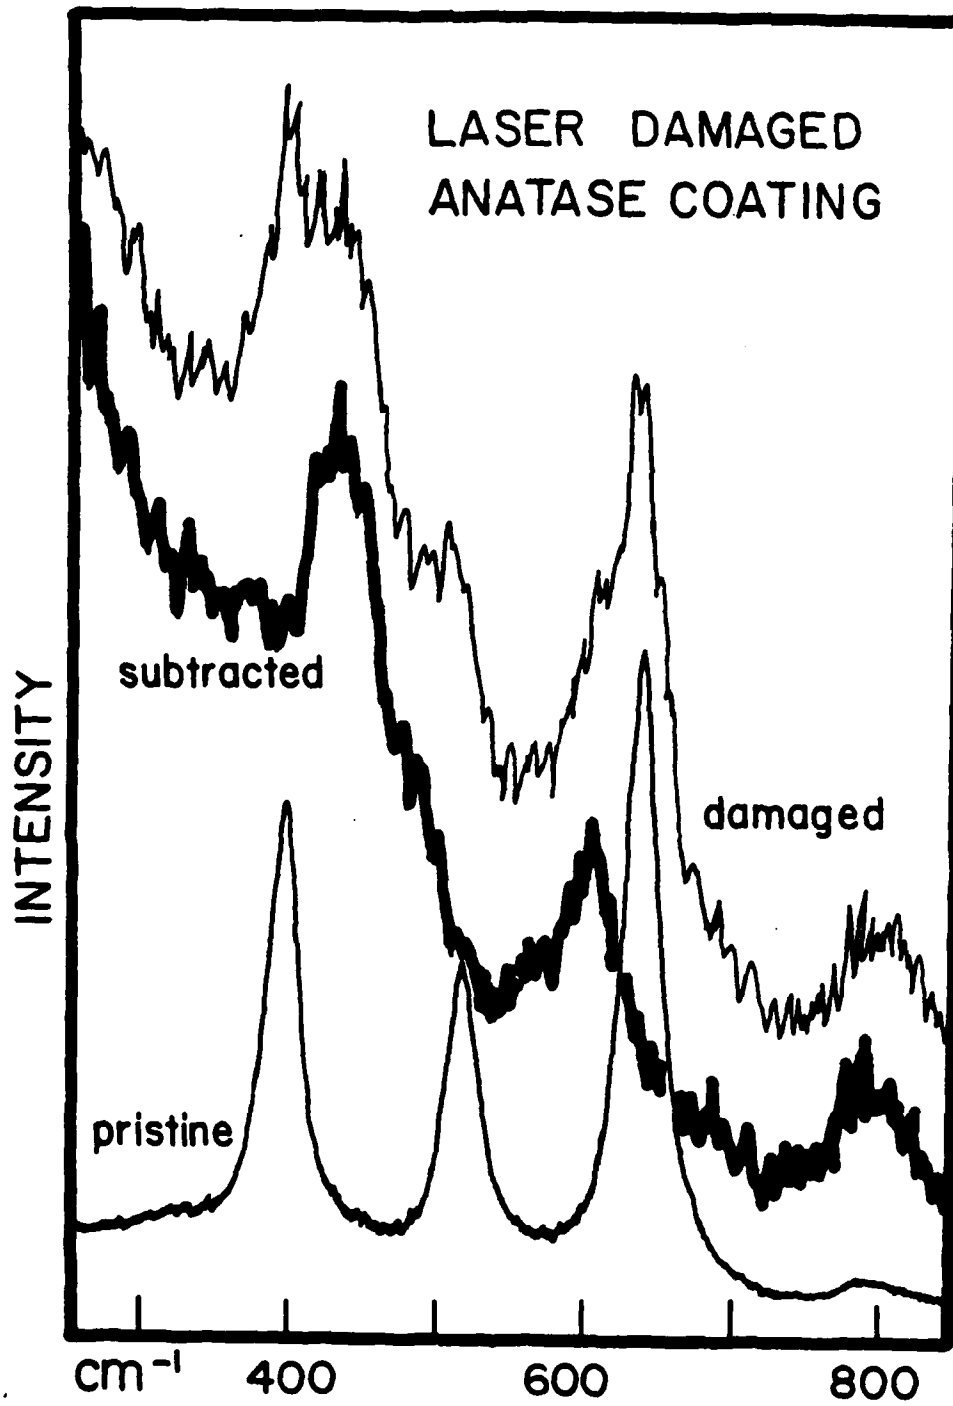
Figure 11. Raman characterization of multiple laser pulse damage to a 9587°A single layer anatase coating.

The 145 cm^{-1} band has been observed to increase in frequency as a function of increased hydrostatic pressure (Ref. 13). An increase in frequency for this mode is also observed following damage by a single 532 nm pulse near threshold damage energy. Based on pressure dependent measurements, the observed frequency shift can be correlated with an imposed pressure of 10 kbar. Therefore, results can be interpreted in terms of a laser induced pressure wave which distorts the crystalline lattice, thereby, locking in the high pressure (higher density) phase. Continued laser damage at this damage zone is eventually expected to form a stable high density phase of TiO_2 . Figure 11 shows substantial rutile content in the damage zone following multiple laser pulse damage to the same area.

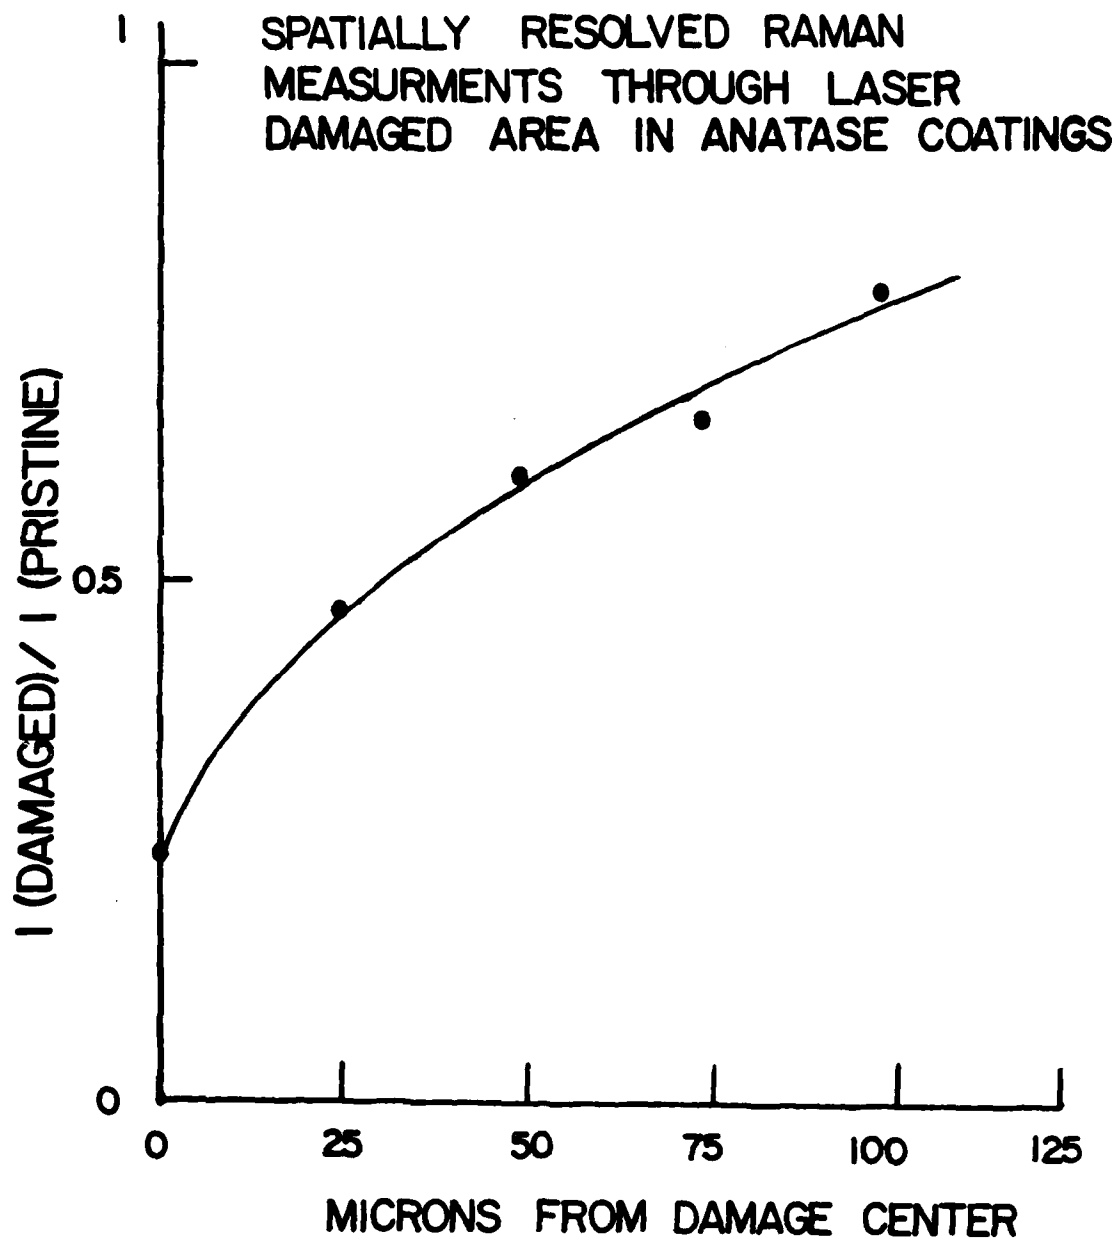
Figure 12. Raman characterization of multiple laser pulse damage to a 9587 \AA single layer anatase coating.

Finally, the applicability of using Raman spectroscopy to spatially profile the laser induced damage zone is demonstrated in Fig. 12. The intensity ratio of the 145 cm^{-1} band before and after damage is plotted as a function of distance from the damage zone center. For this measurement, the probe laser spot size was 25 μm in diameter and the damage zone had a diameter of 500 μm . Higher resolution is possible (1 μm) with proper focusing optics. The intensity ratio corresponds to a relative coating thickness measurement; however, the technique could also be used to profile the phase composition across the damage zone in cases where multiple crystalline or amorphous phases are known to exist.

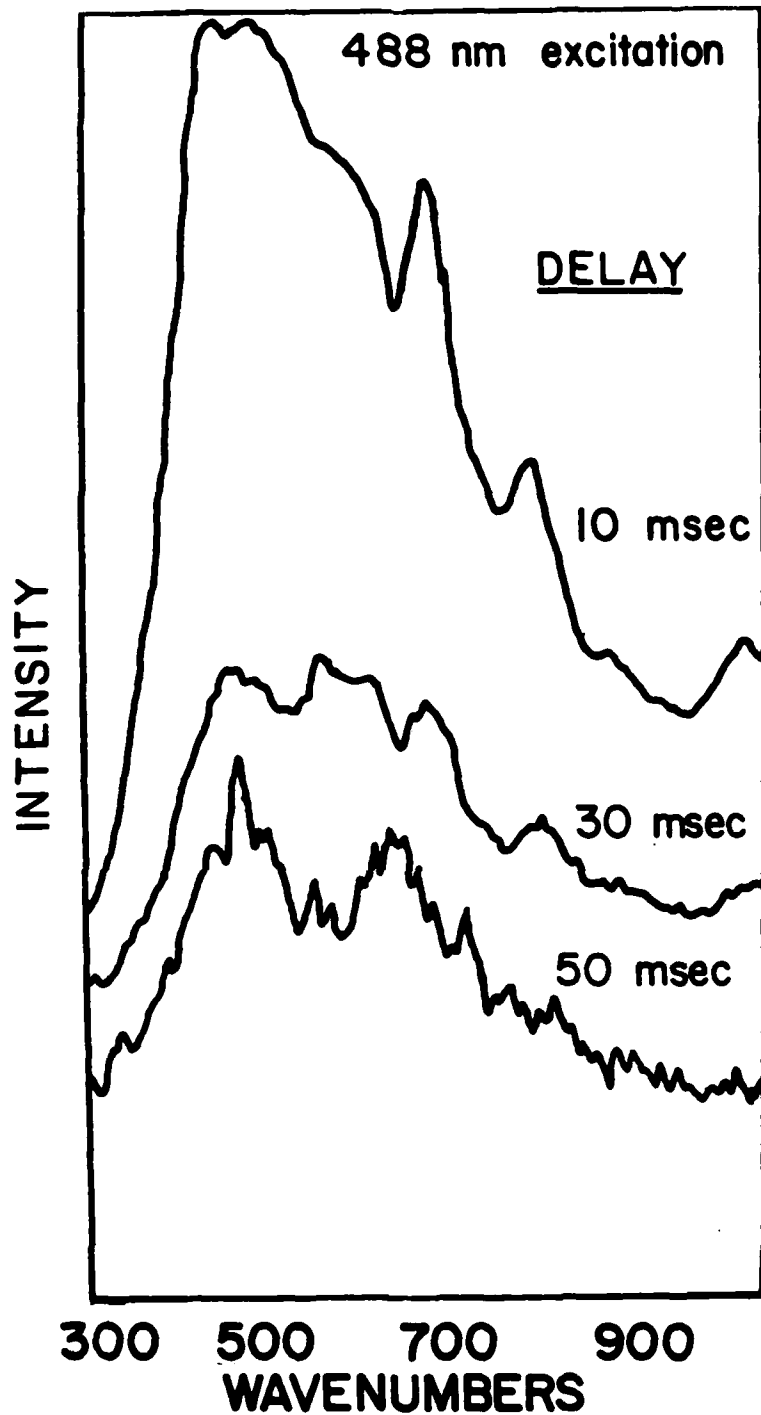
Figure 16. Time resolved raman spectra of a rutile coating subjected to a high energy laser damage pulse showing reversible transformation to an anatase-like phase. Spectra were acquired under CW Ar+ excitation on a millisecond time scale.

The Raman experiments discussed previously were designed to characterize equilibrium damage to optical coatings induced by pulsed high energy laser irradiation. A second group of experiments was performed to characterize the nonequilibrium state immediately following irradiation by a high energy laser pulse in a regime where equilibrium thermodynamics does not apply. The first series of experiments involved measuring Raman spectra separated in time by increments of 10 ms following the 532 nm Nd:YAG laser damage pulse. The 488 nm CW Ar+ laser line was used as the Raman probe. Below damage threshold for any coating Raman spectra acquired at 10 ms intervals are identical. When anatase coatings incur damage, a rapid intensity rise near the exciting line is observed; however, the major anatase lines are still evident albeit at lower intensity in all subsequent spectra. Results for rutile coatings are shown in Fig. 16. At 10 ms following the damage pulse, the low frequency intensity rise is evident. However, the rutile vibrational lines are not seen. Rather, the $640\text{ cm}^{-1} e_g$ anatase line is observed. At longer times, the rutile spectrum recovers, again at a lower intensity than the undamaged coating. An apparent reversible phase transition to an anatase-like phase has occurred.

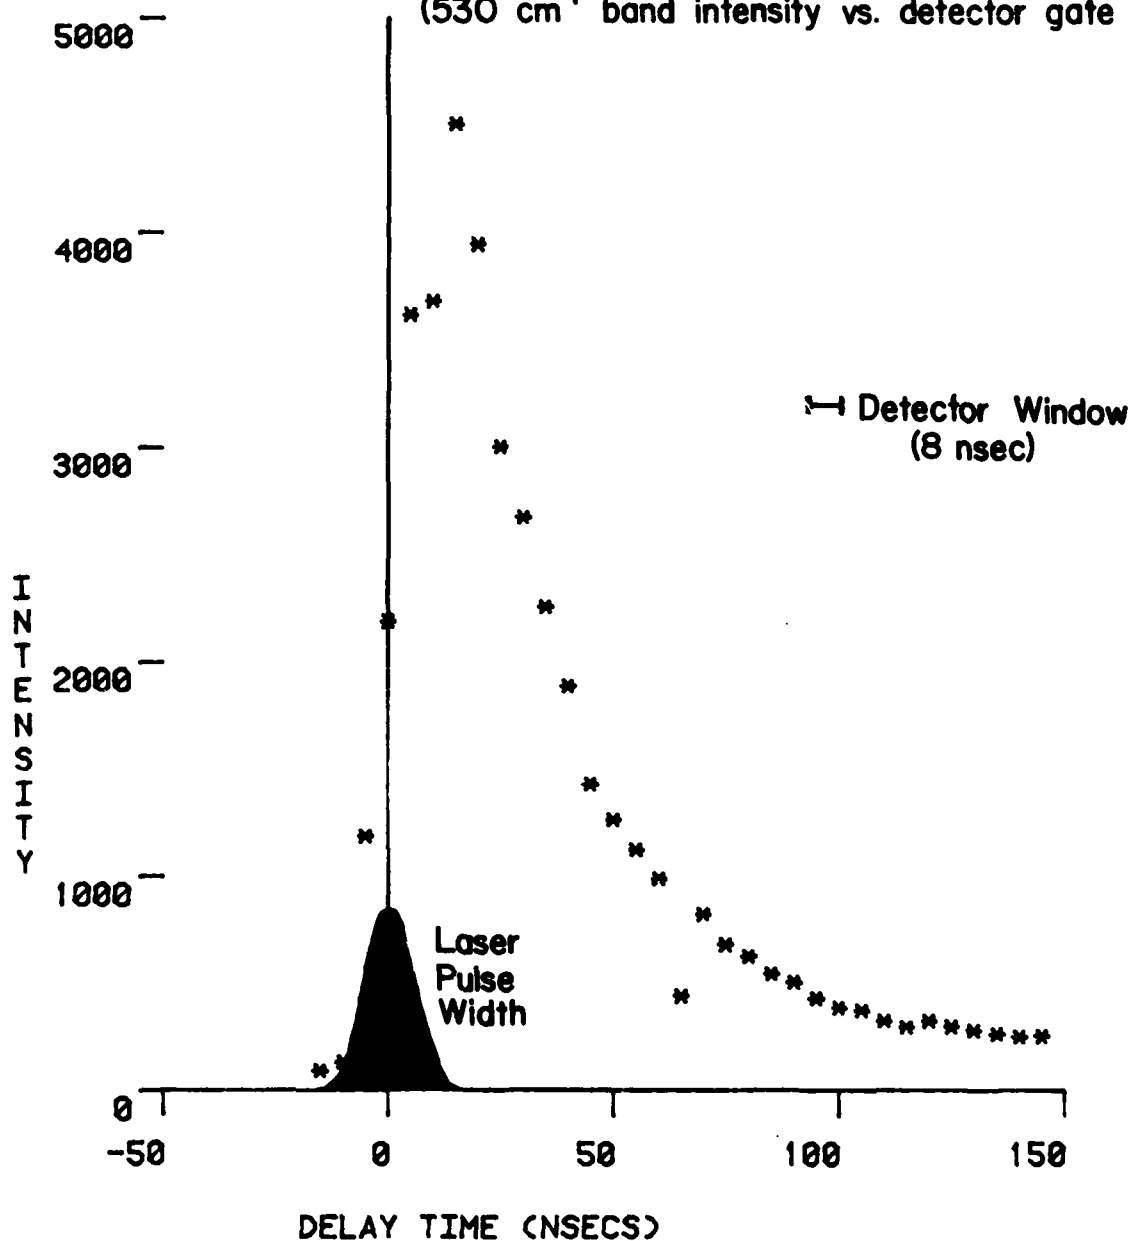
RUTILE COATING ON SILICA

(530 cm^{-1} band intensity vs. detector gate delay)

Figure 18. Intensity variation of the 530 cm^{-1} anatase-like band in a rutile coating during laser induced damage (532 nm) as a function of detector delay time,

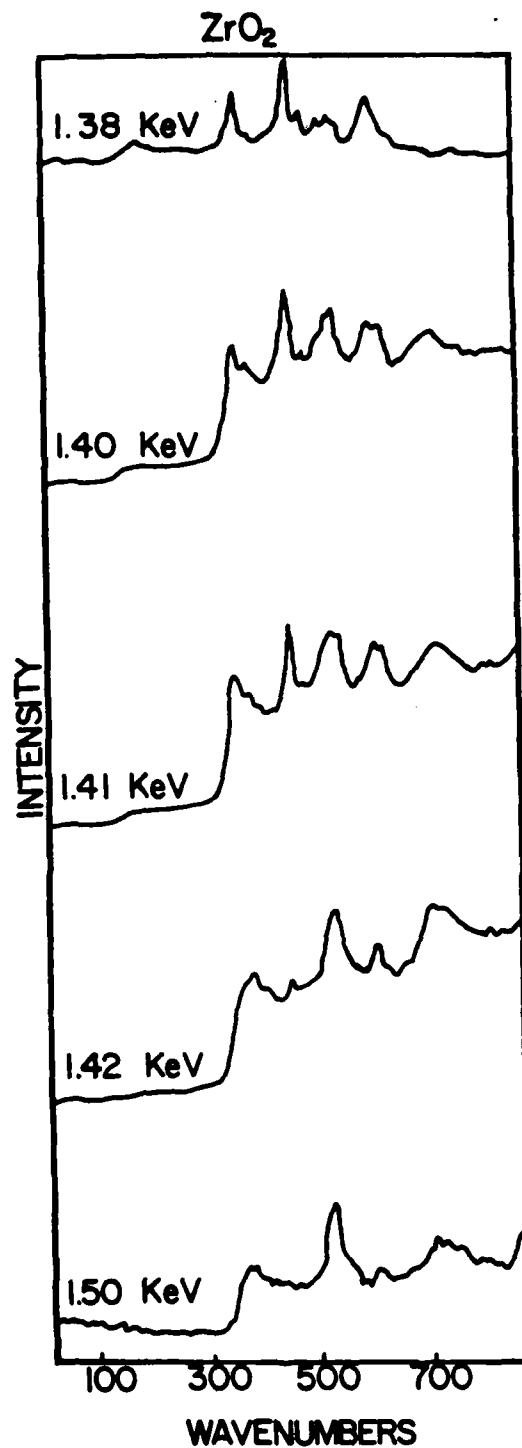
Figure 20. Raman spectra of single layer ZrO_2 on a metal substrate as a function of laser pulse energy. (The voltages refer to laser power supply settings and are proportional to laser output power.)

Preliminary measurements for single layer ZrO_2 coatings on metal substrates are shown in Fig. 20. Raman spectra are recorded as a function of relative laser pulse energy at 532 nm. As the pulse energy increases, reversible transformation from monoclinic ZrO_2 to tetragonal ZrO_2 to cubic ZrO_2 (a single Raman line near 550 cm^{-1}) can be discerned. The existence of multiple phases suggests similar failure mechanisms as observed for TiO_2 coatings but further work is necessary to confirm these ideas.
