NAVAL POSTGRADUATE SCHOOL  
Monterey, California

THESIS

DETERMINATION OF THE DUCTILE TO BRITTLE  
TRANSITION TEMPERATURE OF  
PLATINUM-ALUMINIDE GAS  
TURBINE BLADE COATINGS

September 1985

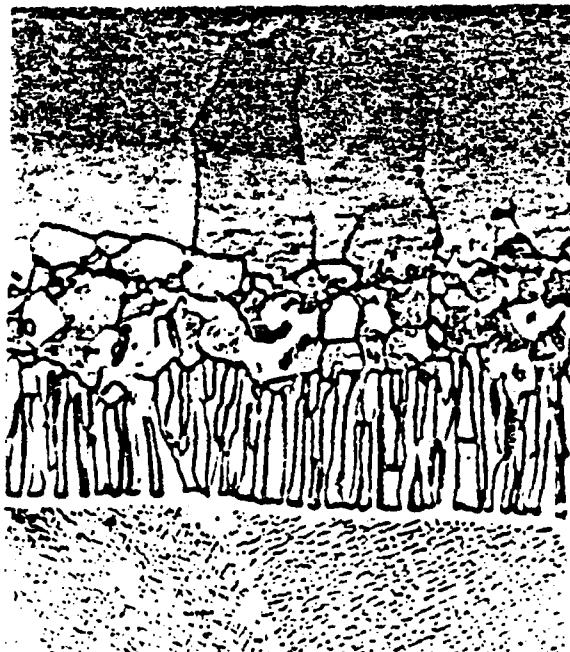
Figure 2. Outward Nickel-Aluminide Coating (1000x)

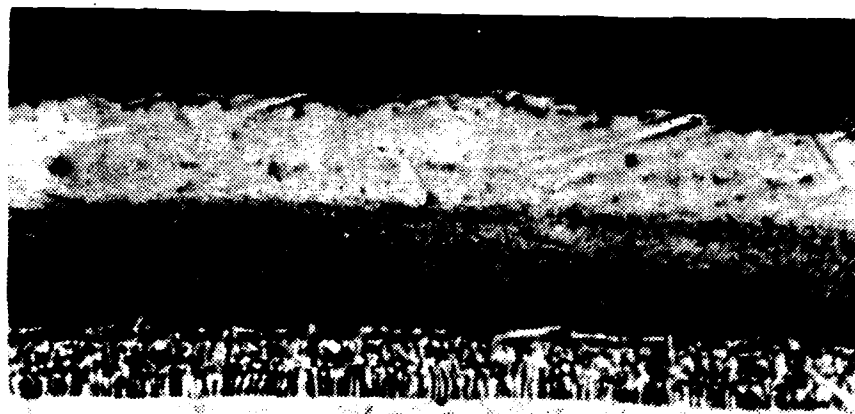
Figure 5. Coating No. 1 - Low Pt Diffusion, Inward Al, Etched (425x)
