Report No. CG-D-33-85

**FIRE RESISTANCE TESTING OF BULKHEAD AND DECK PENETRATIONS**

D.E. BEENE, JR.  
and  
J.H. HOWES

U.S. COAST GUARD RESEARCH AND DEVELOPMENT CENTER  
AVERY POINT, GROTON, CONNECTICUT 06340-6096

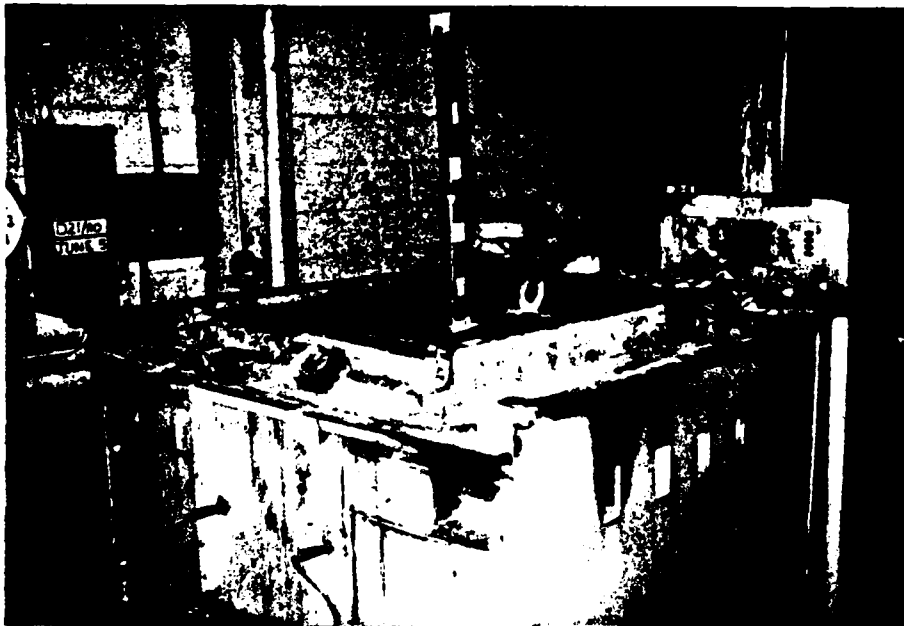
**Figure 3. Test Furnace**

Furnace Controls and Data Recording Equipment

Penetration Sample Being Tested in Furnace
