## MICROSTRUCTURAL CHARACTERIZATION OF LPCVD TUNGSTEN INTERFACES

D.C. PAINE\*, J.C. BRAVMAN\*, AND K.C. SARASWAT\*\*

## ABSTRACT

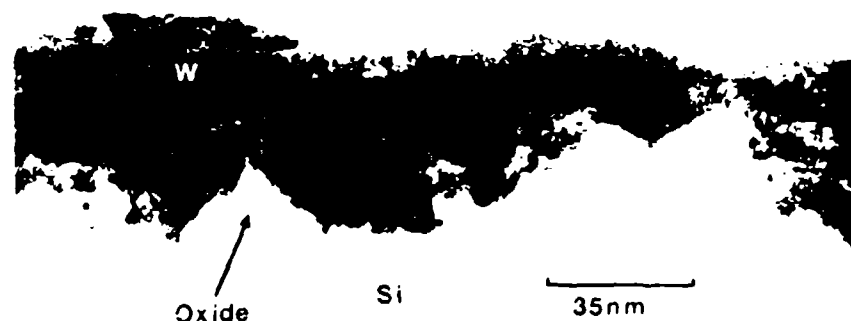
Fig. 4. Tungsten/silicon interface region. Most of the tungsten has been milled away during sample preparation.

The tungsten/silicon interface region is seen in Figure 4. While most of the tungsten overlayer has been milled away during TEM specimen preparation, the remaining tungsten shows an interface roughness of approximately  $20\text{nm}$ . The origin of interface roughness appears to be due to two mechanisms. For large scale roughness, native oxide patches can be seen to be present at the interface. The presence of oxide protects the underlying silicon during the silicon reduction stage of the deposition of tungsten from  $\text{WF}_6$ . Consequently, only those regions exposed to the  $\text{WF}_6$  will be consumed during the

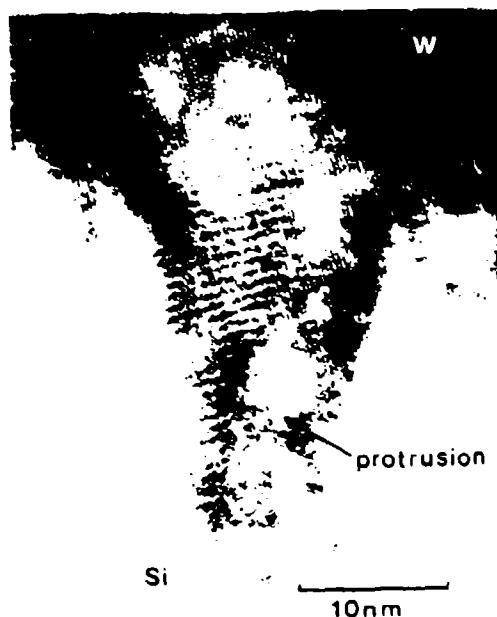
Fig. 5. Protrusion into the silicon substrate originating in the tungsten overlayer. Moiré fringes are clearly visible as light and dark bands running part way across the width of the protrusion.

bands known as Moire fringes running approximately across the width of the protrusion. Moire fringes result from the interaction of two overlaid diffracting crystals which are misoriented with respect to each other and/or have different interplanar spacings. The planes that form the Moire pattern must lie in the zone defined by the incident electron beam. In Figure 5, one of the crystals involved in the formation of the Moire pattern is the silicon substrate which is oriented in the [110] zone. The possible planar spacings of the second, unknown, crystal can be readily determined by the relationship  $g = g_1 - g_2$ , where  $g_1$  is the silicon reciprocal lattice vector and  $g_2$  is the reciprocal lattice vector of the plane in the unknown crystal. The orientation and fringe spacing from the Moire pattern defines  $g$ . All the possible  $g_1$  vectors for silicon oriented in the [110] zone and  $g$  of the moire pattern is known, hence, it is easy to determine the various  $g_2$  vectors which are consistent with  $g_1$  and  $g$ . An optical bench is used to obtain a high degree of accuracy for  $g_1$  and  $g$ . The analysis, even with a generous allowance for measurement error, shows that there are no low index planes in either tungsten or silicon which could have caused these Moire fringes. Higher index silicon reflections such as 331 could, in principle, interact with tungsten to cause these fringes. These higher order reflections, however, were dismissed because diffraction patterns from the silicon in the region of interest showed that the higher order reflections are of low intensity. The Moire pattern shown in Figure 5 is very well defined. This indicates that it was formed from strongly diffracting planes (i.e. low index planes) in both crystals. This seems to suggest that the protrusion is not tungsten but rather one of the tungsten silicides, all of which have low index planes which would fit this data.
