TECHNICAL REPORT D-86-2

THE DUWAMISH WATERWAY CAPPING
DEMONSTRATION PROJECT: ENGINEERING
ANALYSIS AND RESULTS OF
PHYSICAL MONITORING

by
Clifford L. Truitt

Environmental Laboratory

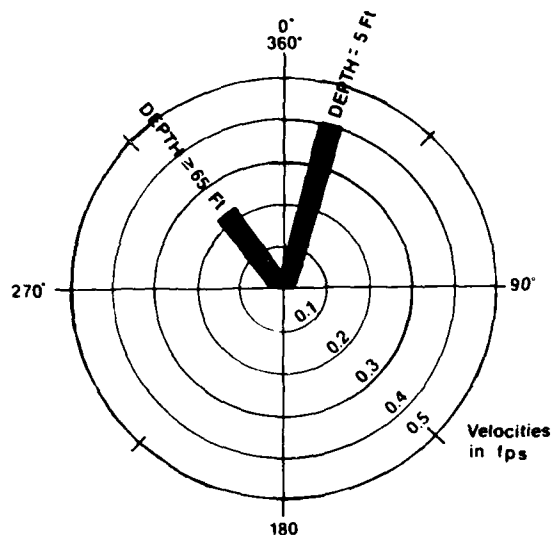
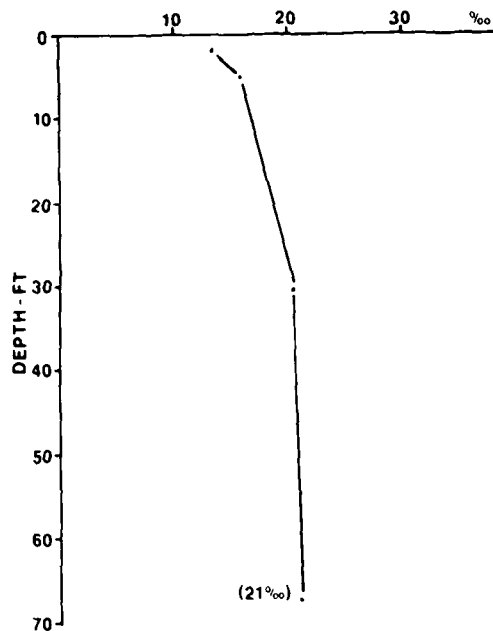
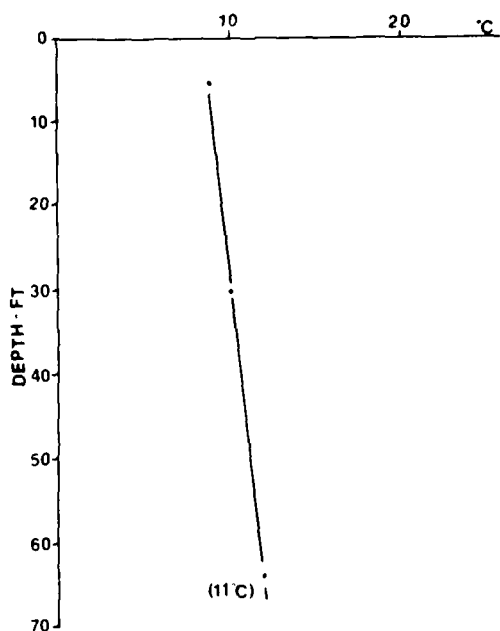
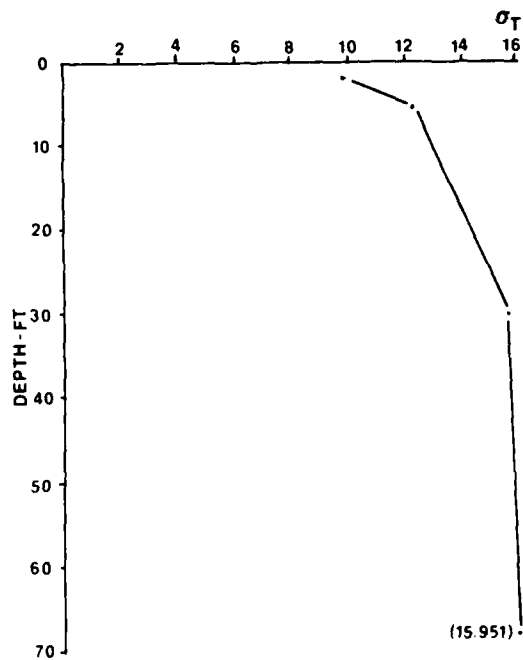
Figure 4. Physical parameters measured at disposal site

**CURRENT SPEED
AND DIRECTION**

NOTE: Channel axis runs approximately north-south. 0°/360° is north.

SALINITY

TEMPERATURE

DENSITY

10. The highest current velocity measured during the fieldwork was a single value of 1.4 fps just beneath the water surface. Sustained maximum values in the upper third of the water column were more typically 0.4 to 0.8 fps. Sustained maximum values near the bottom were approximately 0.2 fps. The recording current meters showed frequent periods during which current velocities were less than the instrument threshold value of approximately 0.05 fps. Figure 4 presents a current rose representative of site conditions at the actual time of the disposal.

11. Ambient salinity, temperature, and density data are also presented on Figure 4. Bulk samples of the water at both the dredge site and the disposal site were obtained two days prior to the start of dredging for analysis of background chemical constituents and for use in elutriate tests. Results of these chemical analyses are shown in Table 1 as background values.

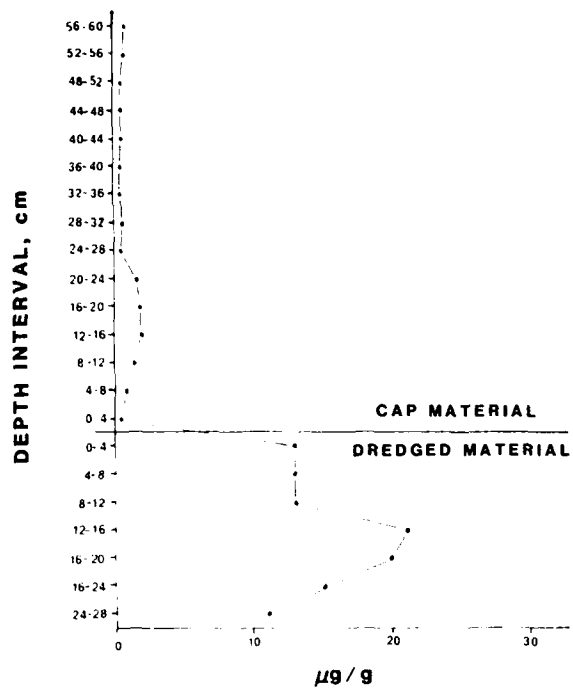
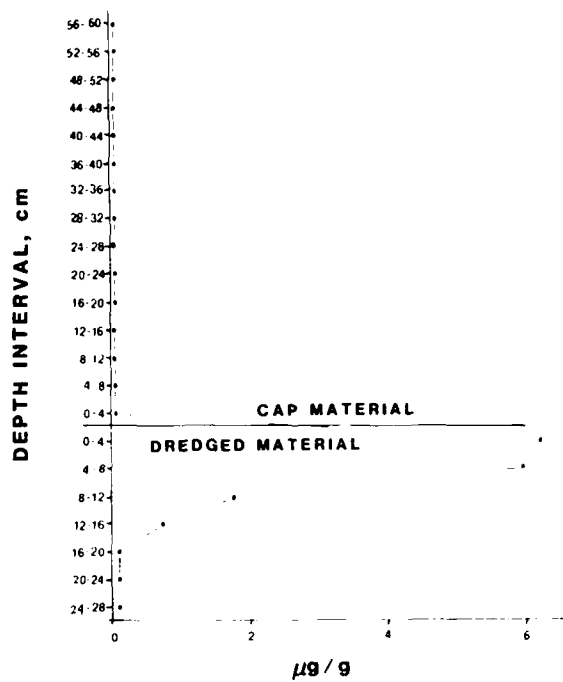
Figure 19. Chemical profile through the cap

LEAD

AROCHLOR 1242

82. Results of chemical analysis of initial core samples indicated that the dredged and cap materials formed a sharp, relatively unmixed interface. This is illustrated in Figure 19, which presents Pb and Arochlor 1242 PCB concentrations in a core at the Duwamish capping site. Both Pb and PCBs were initially either absent or present in low concentrations in the cap materials. Below the cap/dredged material interface, however, high concentrations of Pb and PCB relative to those in the cap material were noted.

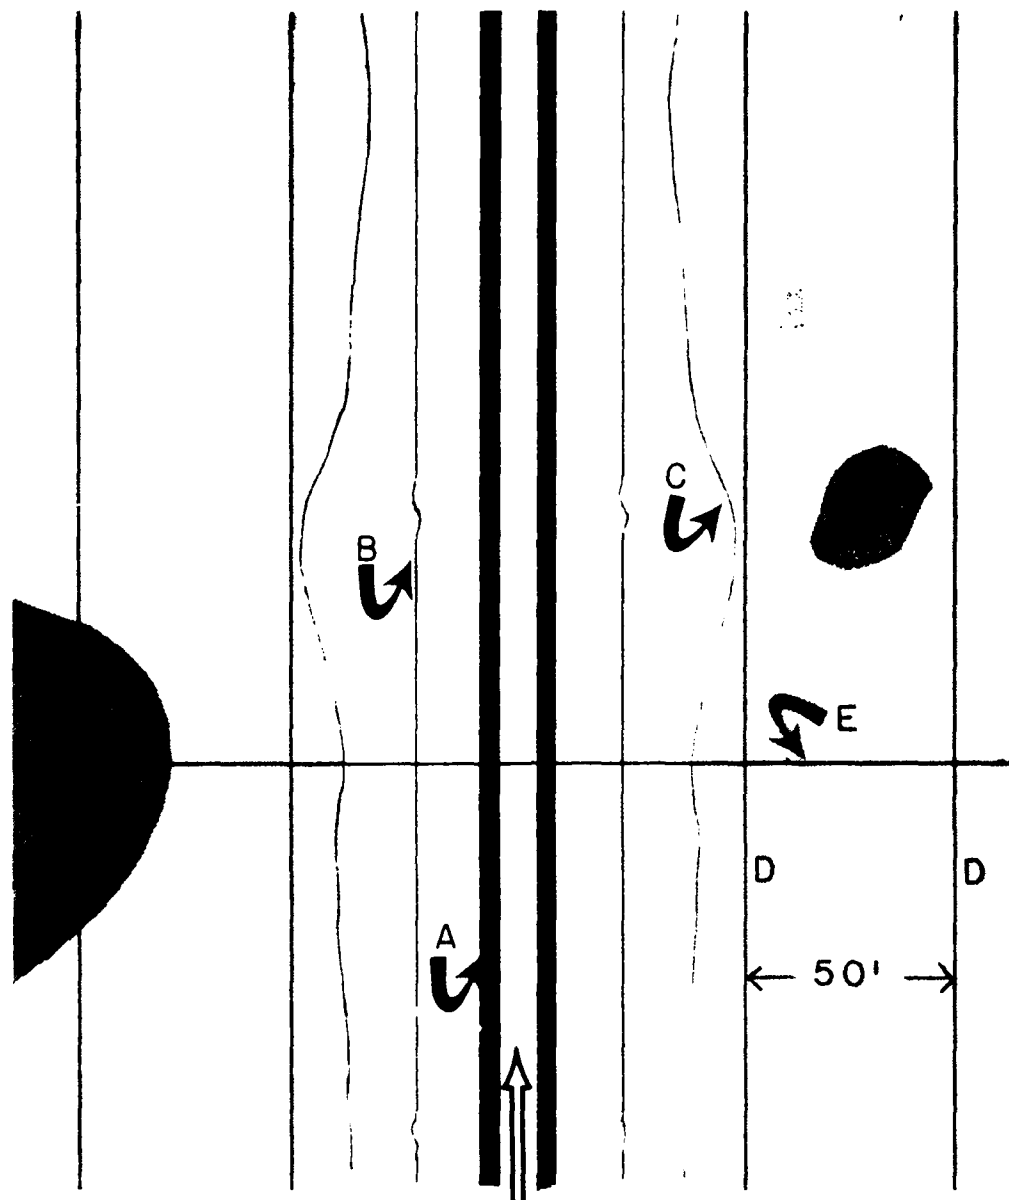
Figure B1. Example SSS record

DIRECTION OF FISH MOVEMENT

6. The following discussion applies to Figure B1. The dark parallel lines (A) running down the center of the sonograph are the starting points of
