SALVAGE AND DEMOLITION  
OF  
TWO NAVY OFFSHORE PLATFORMS

FPO-1-84(32) OCTOBER, 1984

STAGES I & II

NAVAL COASTAL SYSTEMS CENTER

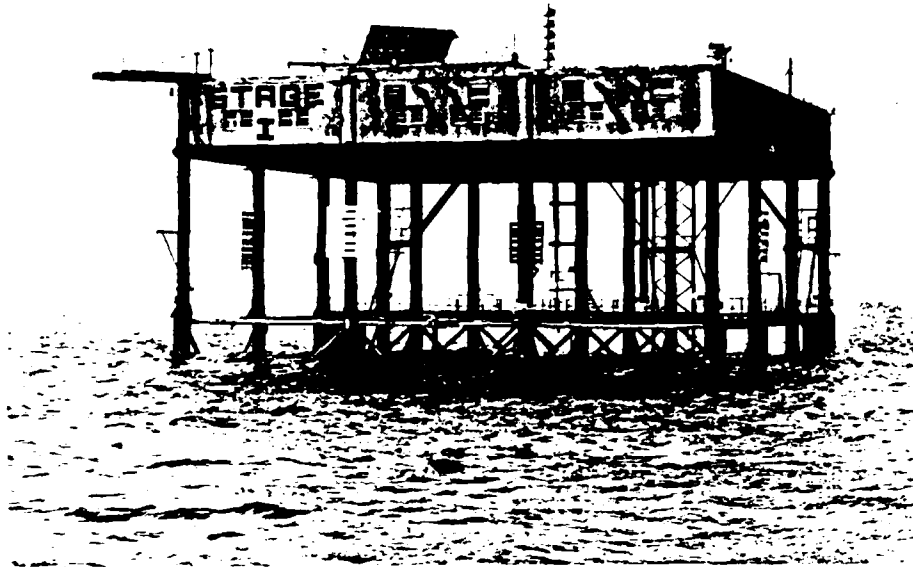
Figure 1. Offshore Platforms Salvaged/Demolished

a) STAGE I (3 July 1984)

b) STAGE II (3 August 1984)

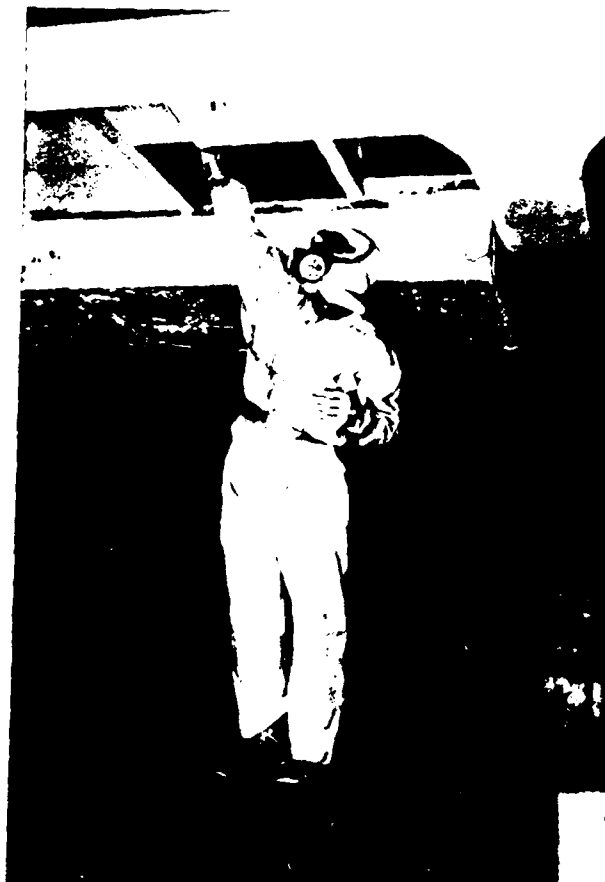
Figure 13. Photos Showing Asbestos Removal

a) Removing Non-Friable  
Ceiling Tiles

b) Sampling Friable Asbestos  
Covering Mufflers  
(friable material was removed  
using the glove-bag method)

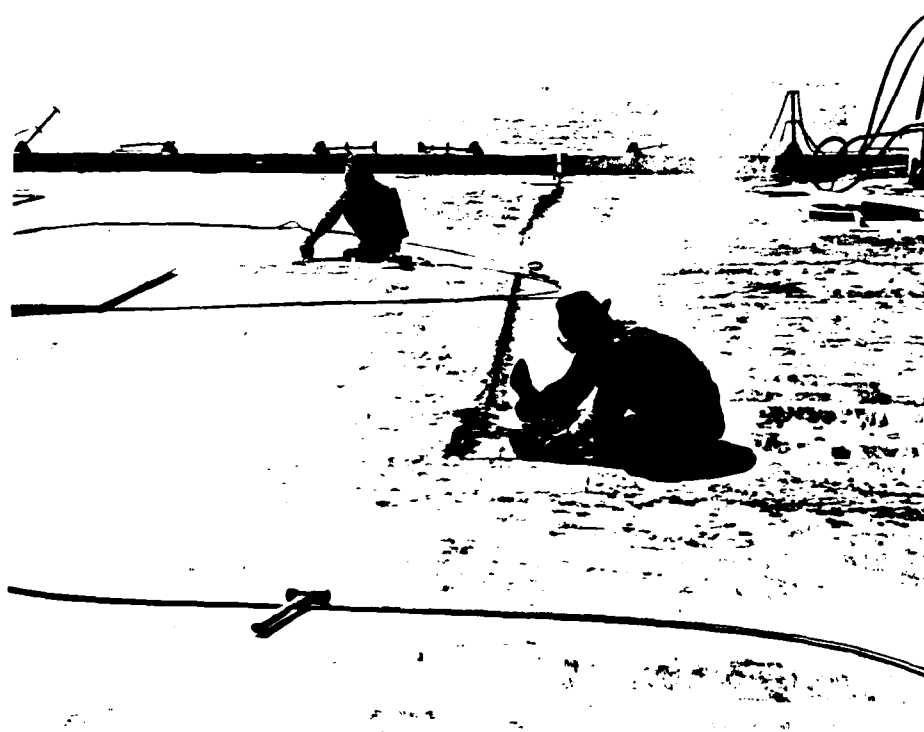
Figure 15. Precutting the Decks of Stage I  
(all but several key beams were cut)

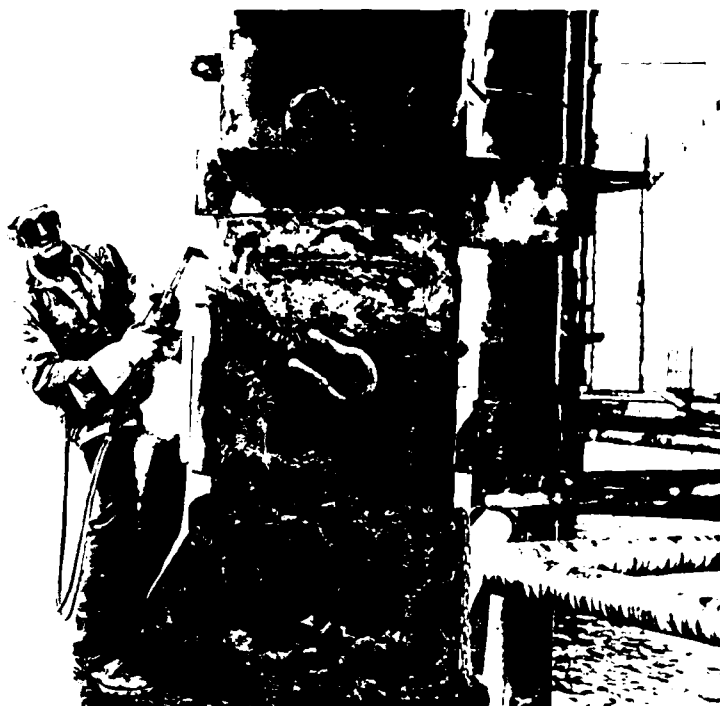
Figure 18. Supporting Legs are Last Items Cut Before a Lift is Made  
(A 6" long section of circumference is not cut by the welders  
on one pile; this "hangover" is torn off during lifting)

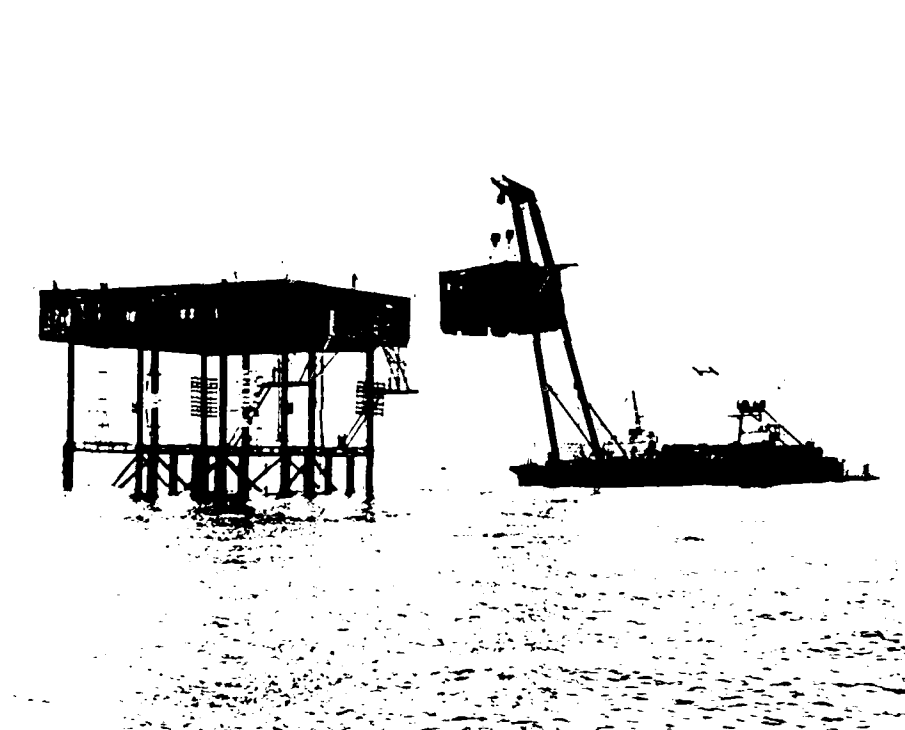
Figure 28. Section I (Upper Two Decks) Being Removed from  
Stage II (5 August 1984, weight = 60 tons)

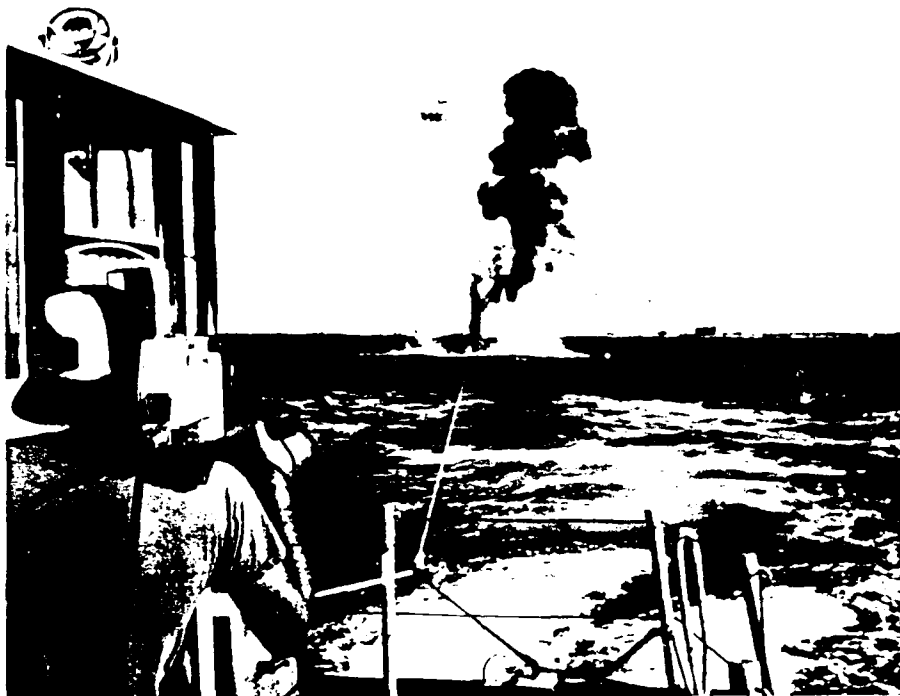
Figure 44. Demolition Shot on Stage II

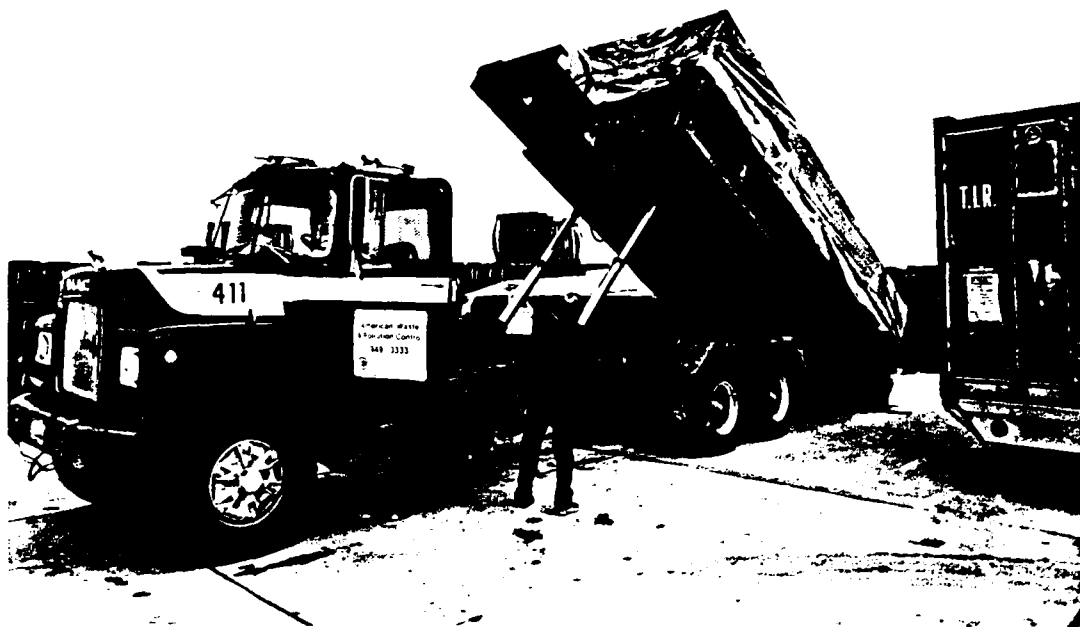
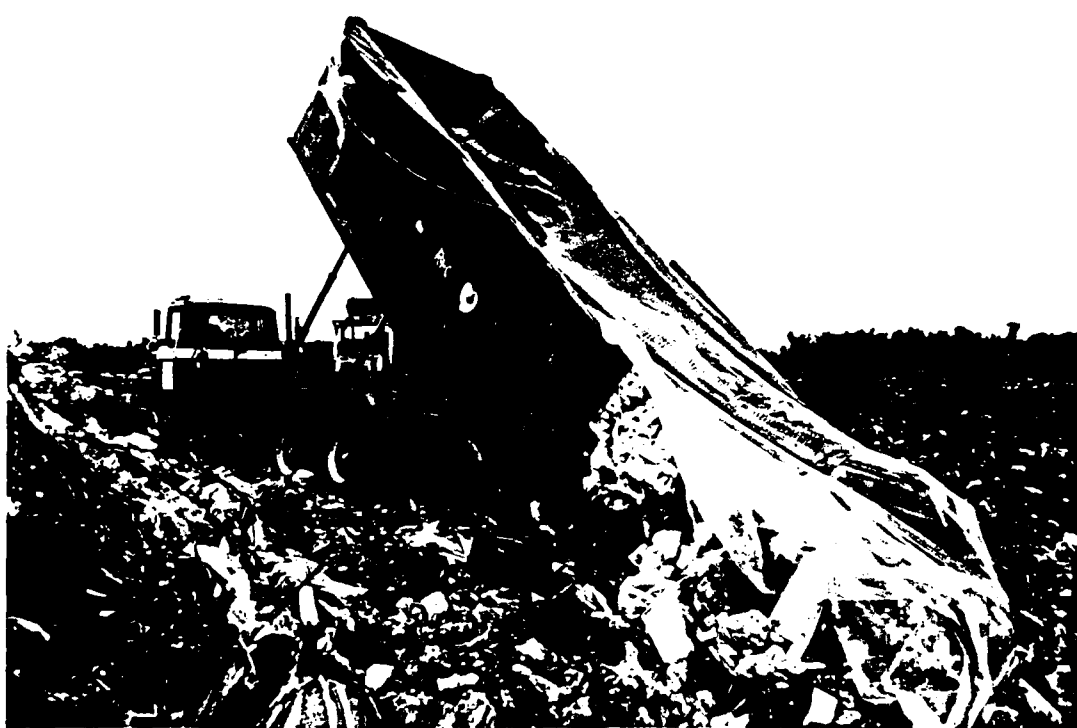
Figure 47. Disposal of Asbestos Waste
