N-1750

May 1986

Technical Note

## EVALUATION OF INSTALLED SOLAR SYSTEMS AT NAVY, ARMY AND AIR FORCE BASES

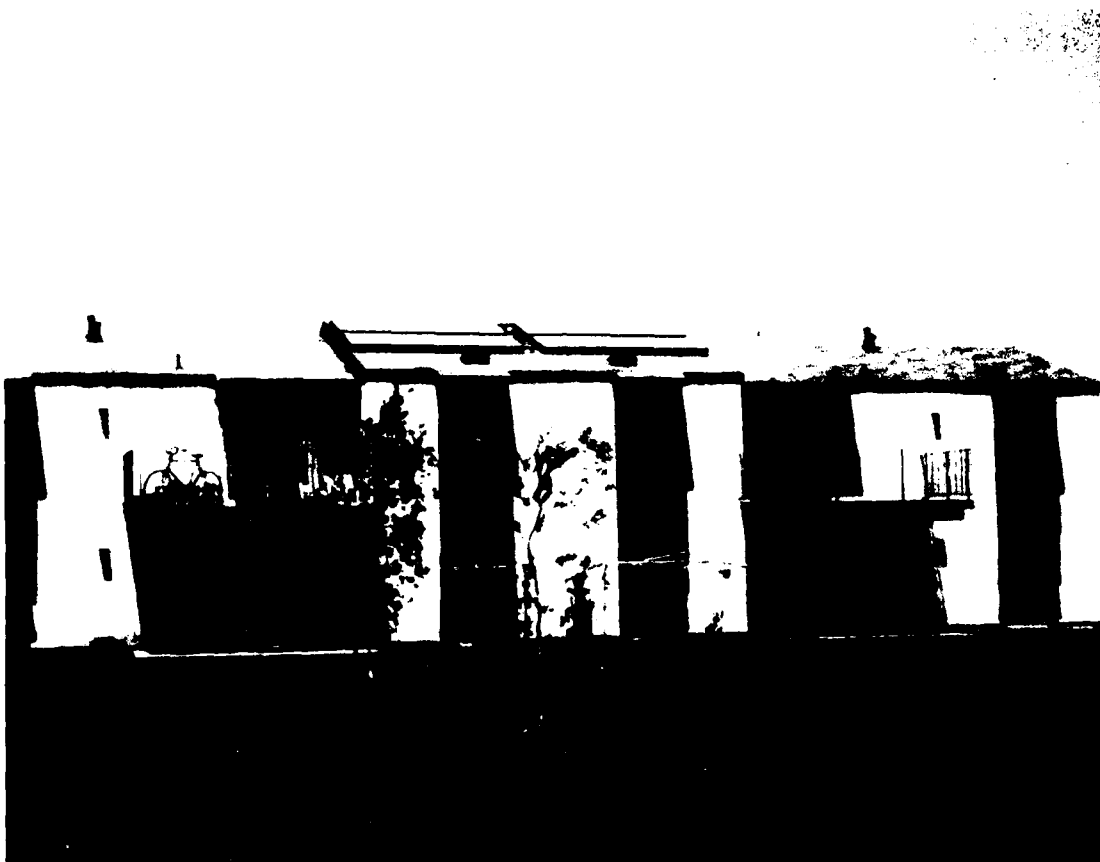
Figure 1. Four-plex units, El Toro, Calif.

1. Visual inspection showed no visible corrosion or leaks.
2. Systems appeared adequately designed and installed, however, the final design and installation was different from that on the original drawings.
3. About 40% of the systems had poor performance due to inadequate charge of glycol solution in the solar loop. Systems need closer monitoring or a routine PM to correct this problem.
4. The controller and tank are located in a shed outside the unit. The controller was "locked" in a shed requiring the disassembly of many screws to open the door which was time consuming and not conducive to quick maintenance checks. Once inside the shed a convenient gage showed the state of charge of the glycol solar loop and a fill valve was readily accessible. It appeared as if special equipment from the manufacturer would be required to recharge the system.

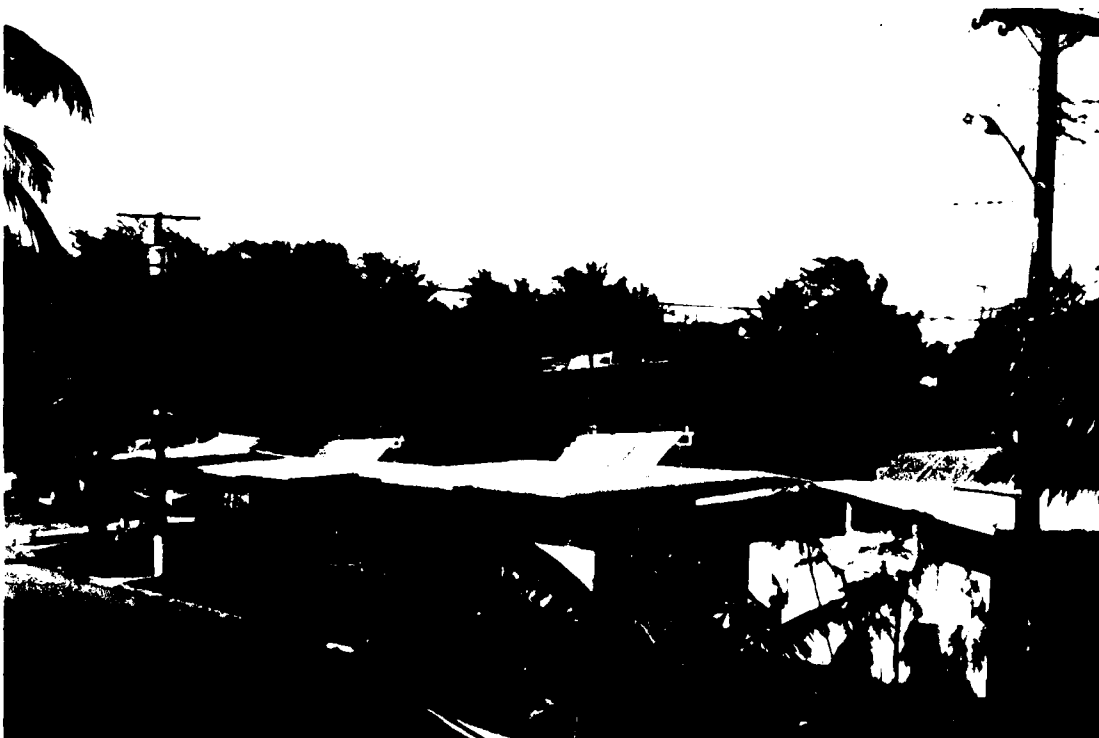
Figure 5. Active DHW units, NAVSTA Puerto Rico.

1. About a dozen active units were inspected at random. About half the units were not working for a variety of reasons including controller/pumps unplugged (occupant tampering), pump failure, and sensor failure.
2. The solar collectors are in good condition.
3. A variable speed pump/controller combination is used which has been shown to be less reliable than a nonproportional combination. No action is recommended unless parts are being replaced.
4. No regular maintenance was performed on systems.

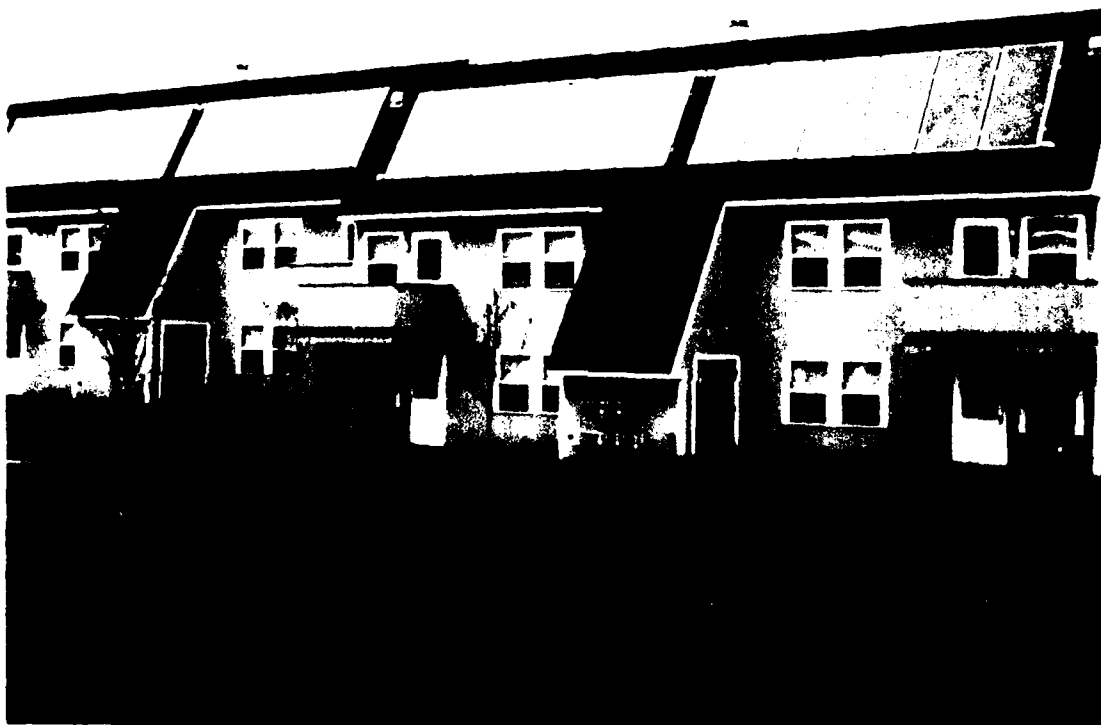
Figure 6. Four-plex units, Ballston Spa, N.Y.

1. The solar collectors and tanks appeared to be in good condition.
2. There was a lack of accurate system drawings, hence no adequate preventive maintenance was performed.

3. There were a number of items that related to the initial system installation:
  - Insulation was missing from a number of pipes and joints.
  - There were some poorly soldered joints resulting in small leaks of the glycol solution.

- No dielectric unions were used resulting in dissimilar metal contacts which could cause problems in the future.
4. A design weak point is the lack of a circulating pump between the preheat storage tanks and main storage tanks. Standby losses are high and heat is transferred only when a demand is placed on the system. Performance could be improved if a pump were installed.

5. The majority of systems did seem to be operating normally and the rest of the design appeared adequate.
6. Each house had monitored the natural gas consumption; however, there were no baseline houses without solar that were also monitored. An estimate was made on how much gas would be used on similar houses adjusted for the difference in heating degree days of the climate. From this estimate it appears that the Ballston Spa houses use about 35 to 40% of comparable gas usage of houses without solar.

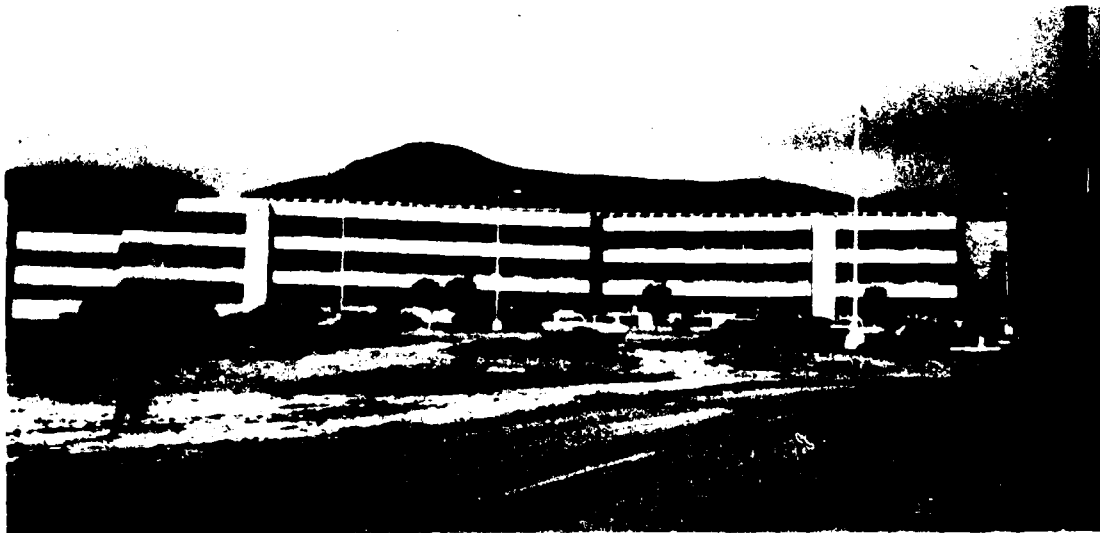
Figure 9. BEQ, Camp Pendleton, Calif.

1. The piping runs were overly complicated which could contribute to poor flow distribution through the system.
2. One pump was not running due to control problems and one pump needed repair work.
3. The glycol in the system was low.
4. The solar collectors where fine and no major corrosion was noted.
5. The solar collectors were plumbed together with silicone hose and screw type hose clamps. They have had some leaks. NCEL has already recommended that constant tension hose clamps be used in place of screw type or that this method not be used at all.
6. During the first year of operation, several collector cover glazes cracked due to suspected thermal stresses. This problem is not recurring.

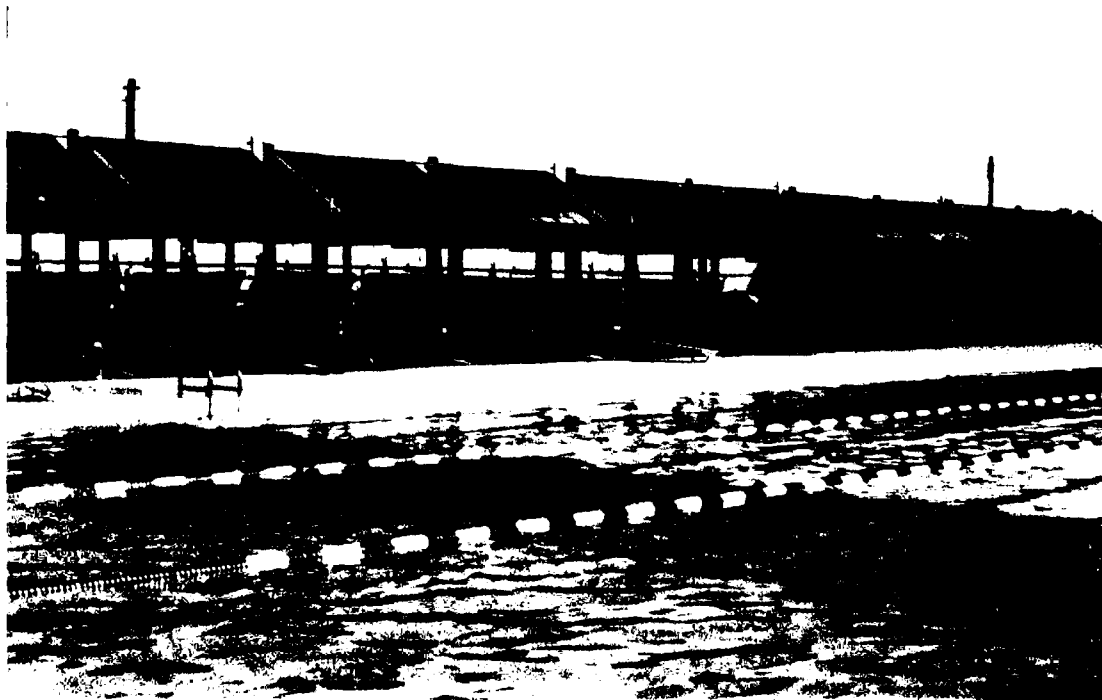
Figure 10. Swimming pool, Camp Pendleton, Calif.

The swimming pool in the "14" area of Camp Pendleton is a 500,000-gallon pool used for recreation and combat training. The solar system consists of 152, 4 feet by 8 feet unglazed solar collectors mounted on a ground rack alongside the pool (Figure 10). The unglazed collectors use a copper tube on an aluminum absorber plate for heat collection. Due to the problems explained next, these collectors are scheduled to be replaced. All further comments address only the old system.

1. The system was not operational due to a combination of control problems, air in the system, and numerous system leaks.

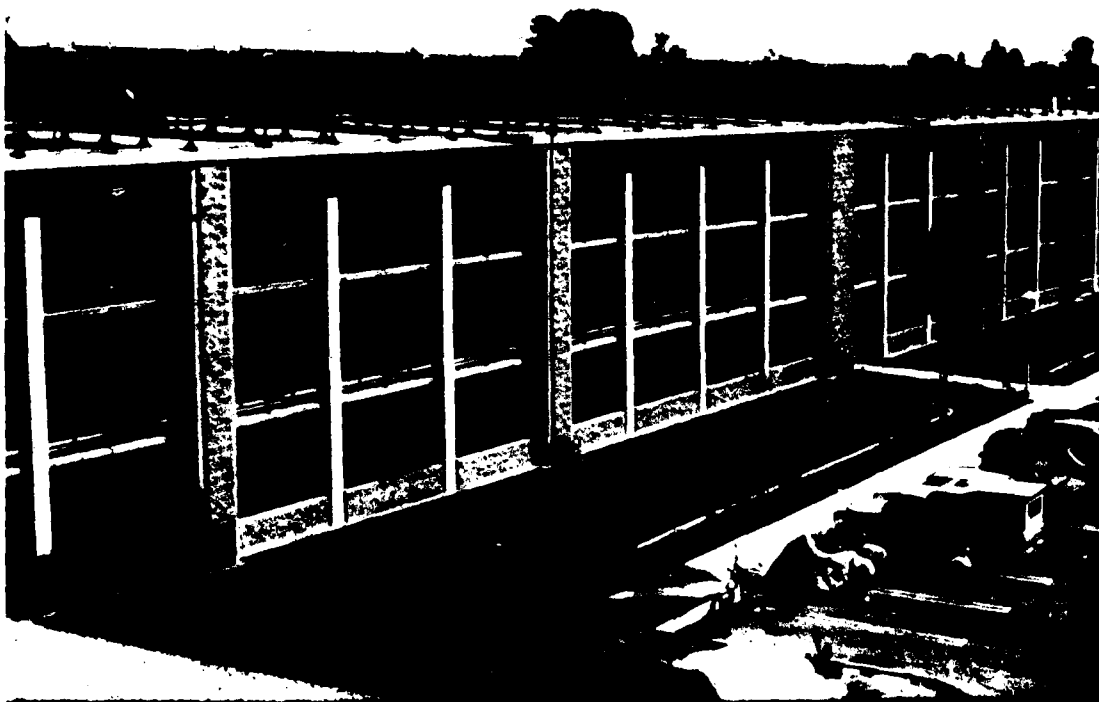
Figure 12. BEQ, MCAS El Toro, Calif.

1. There were problems found with the control system due to non-functioning equipment, some unconnected controls, and poor sensor placement. The sensor was located in the collector box rather than in the fluid outlet of collector.
2. Sensors placed outside near the buried storage tank were not protected from the weather and need to be replaced.
3. New controls and sensors were recommended.
4. Overall installation was professional and collectors are in good shape.
5. Flow balance needs to be done on the system. The balance valves are already installed. Flowrates were recommended.
6. The storage volume is slightly undersized. A procedure was recommended that would not require any more storage tanks.
7. There was no O&M manual for this complicated system.
