**KACHINA TEST SERIES: DYNAMIC ARCH TEST  
THREE (DAT-3) ANALYSIS REPORT**

March 1986

Final Report

**AIR FORCE WEAPONS LABORATORY**  
**Air Force Systems Command**  
**Kirtland Air Force Base, NM 87117-6008**

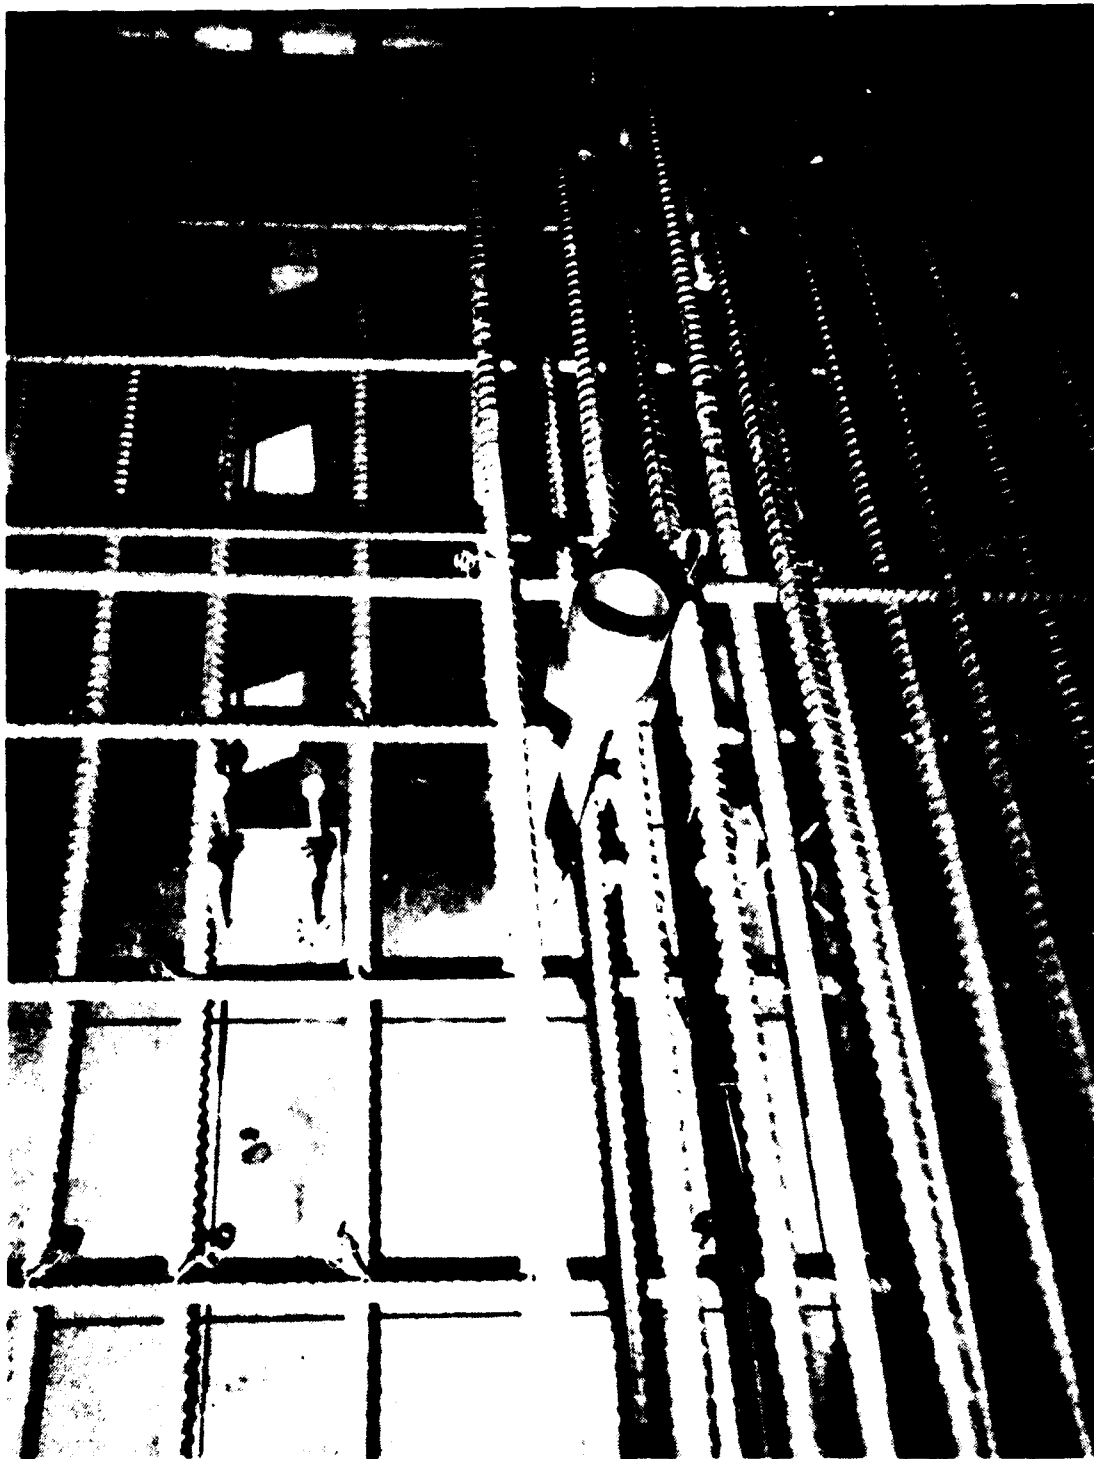
Figure 5. Cast-in-place instrumentation hardware.

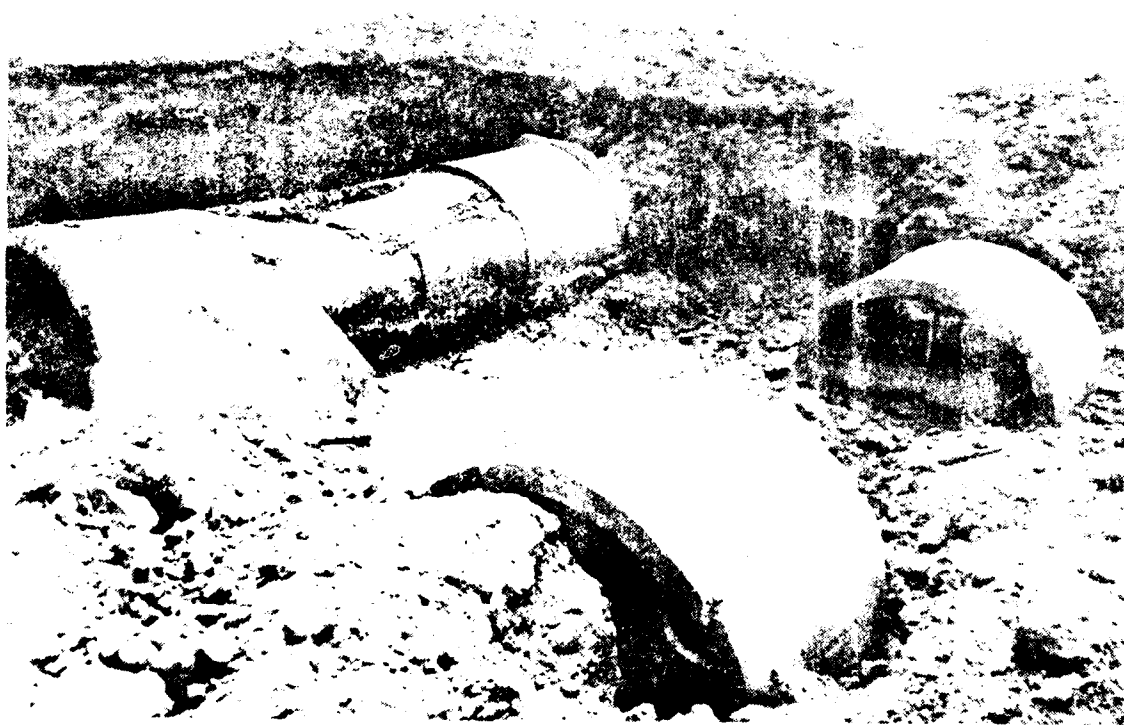
Figure 28. Excavated test-bed and structures.

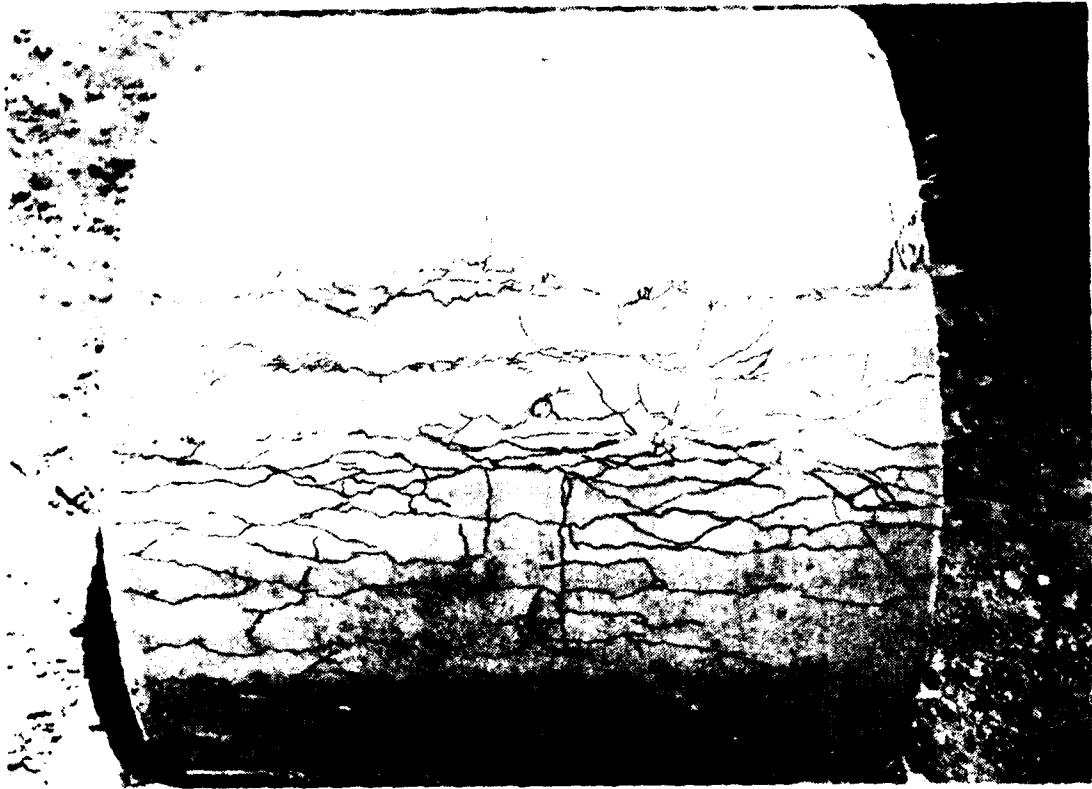
Figure 29. North side A6.

Arch segments A5-1, A5-4, A6 and A7 displayed similar types of damage. (See Figures 29 through 35 and the photographs and drawings in Appendix C.) The floors of the structures buckled inward because of the downward movement of the arch walls. Extensive cracking in the floor occurred in the central portion, starting at approximately 152 to 228 mm (6 to 9 in) from the interior corner or chamfer. After the arch walls had moved sufficiently to compact the underlying soil, a longitudinal crack developed on both sides of each arch. Each crack began at the end point of the circumferential splice hook cast in the corner of the wall and ran along the outside of the arch, approximately 530 mm (20.9 in) above the base of the structure.

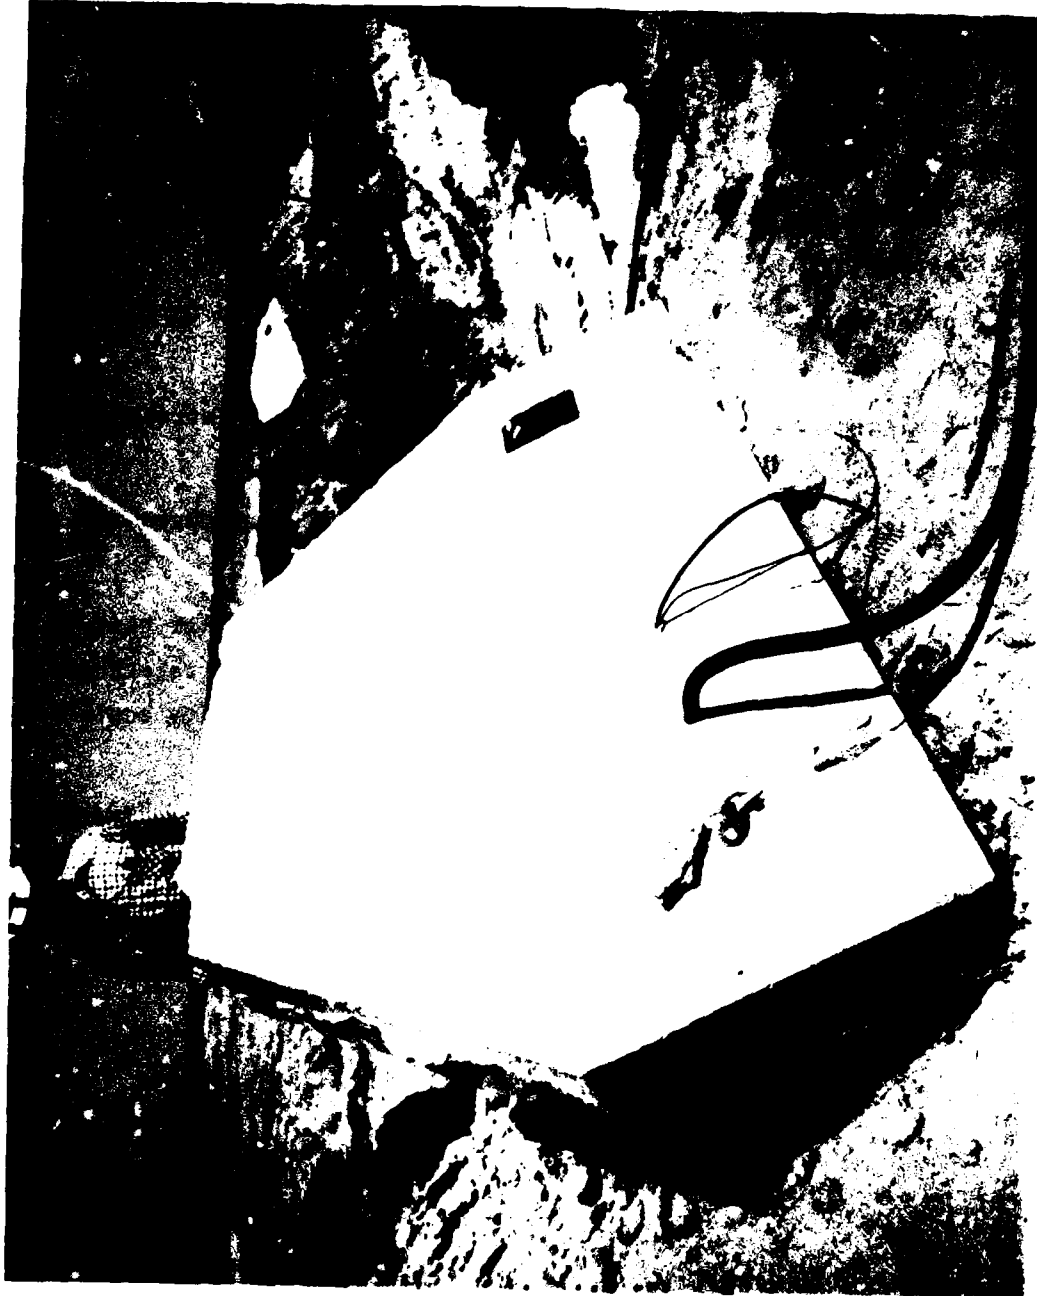
Figure 61. Posttest bulkhead inspection.

The postmortem inspection showed that, at the bulkhead (outside), no damage was visible where it was most expected, at the unprotected exit. The cables were also intact at the outside exits from both pipes and hoses. All cables had continuity from the exits to the instrumentation shelters.

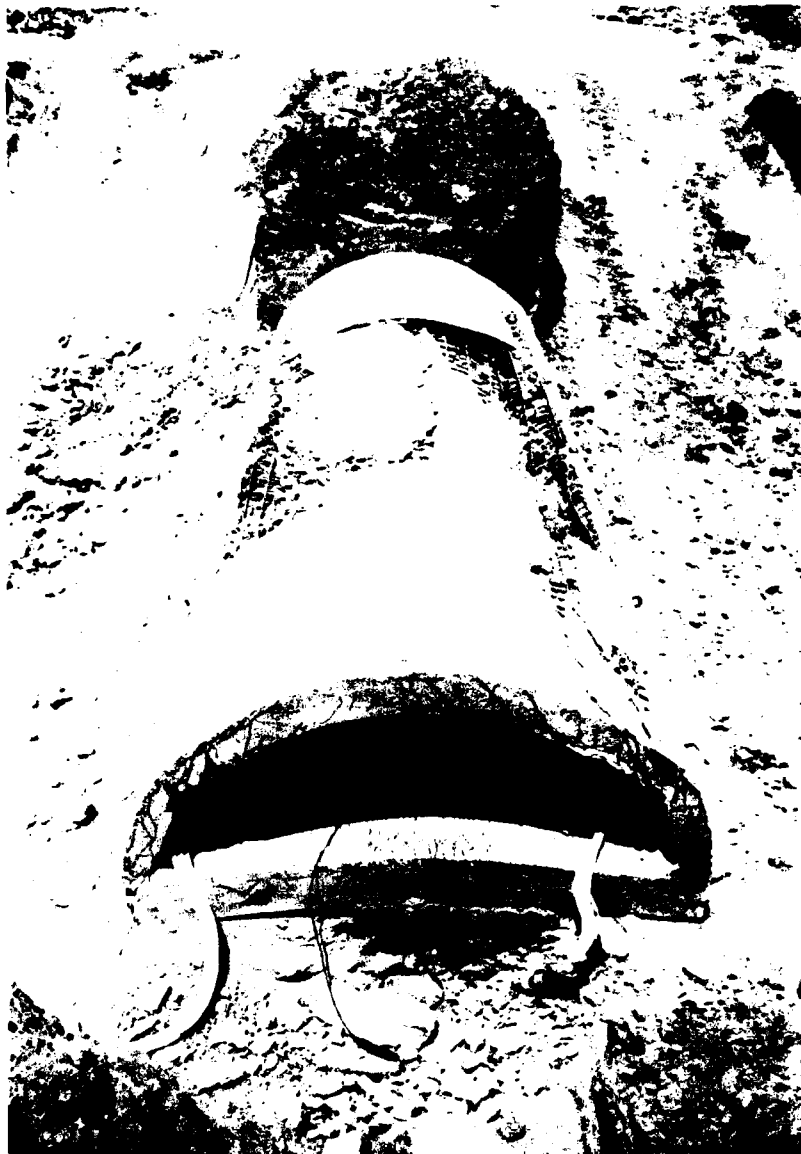
Figure 65. View of Arch A5 from south side (upstream is left).

Arch A5--Figures 64 and 65 present end-on views of A5, highlighting the fairly symmetric failure of the arch in the middle sections. The upstream and downstream sides of the arch do not appear to differ as to the location or severity of the main fracture zone, with the exception of the south end segment of A5 which shows more failure on the downstream side. Each end cross section shows the focusing of the severe cracking at about  $\pm 60$  deg of angle from the crown of the arch and at the floor center. Unlike the KED

short arches, joint shear and beam shear cracking at the floor edges was not a major failure mode on DAT-3. The chamfer is intact, and relative deformation between the wall just above the floor and the floor is not apparent.

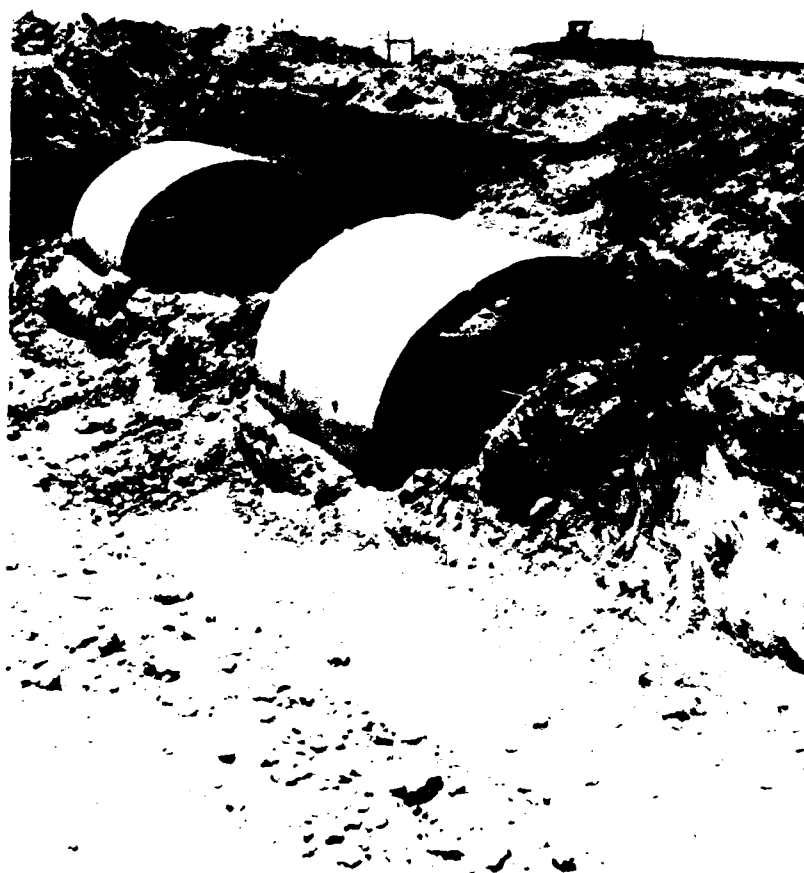
Figure 75. View of Arches A6 and A7 (foreground) from downstream north side.

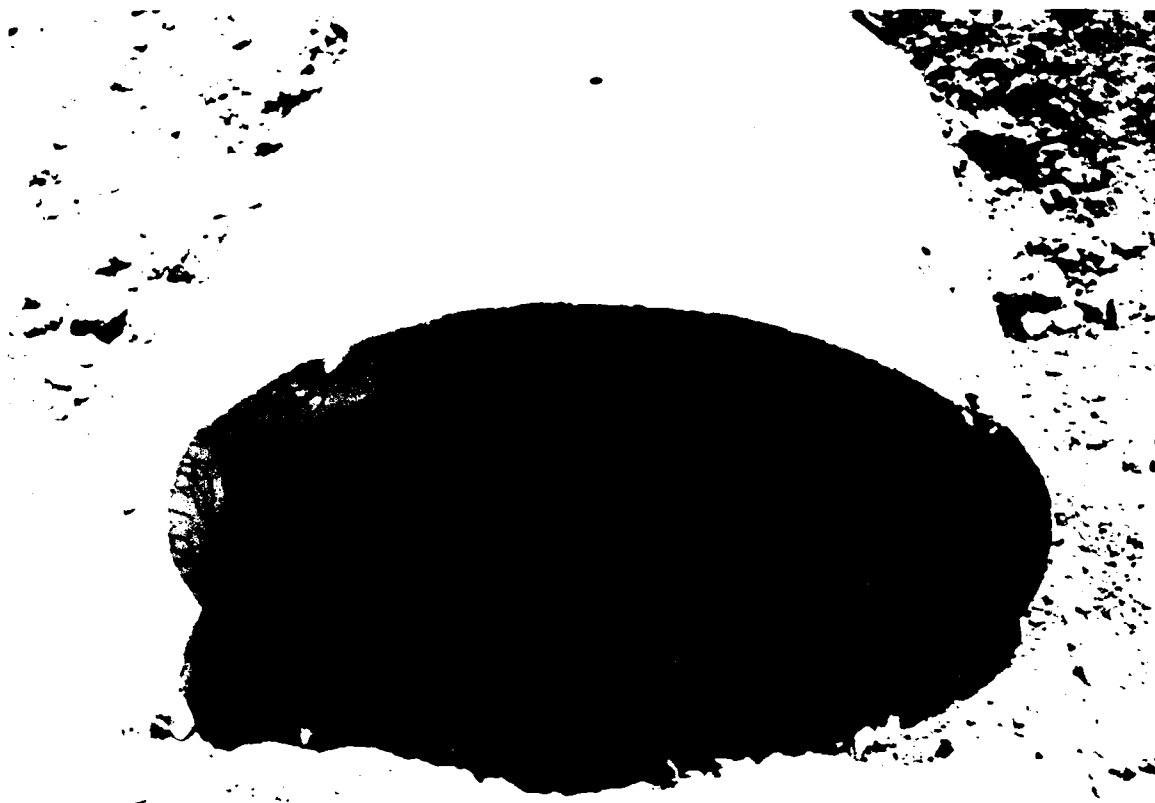
Figure 84. North end of Arch A7 (upstream is right).

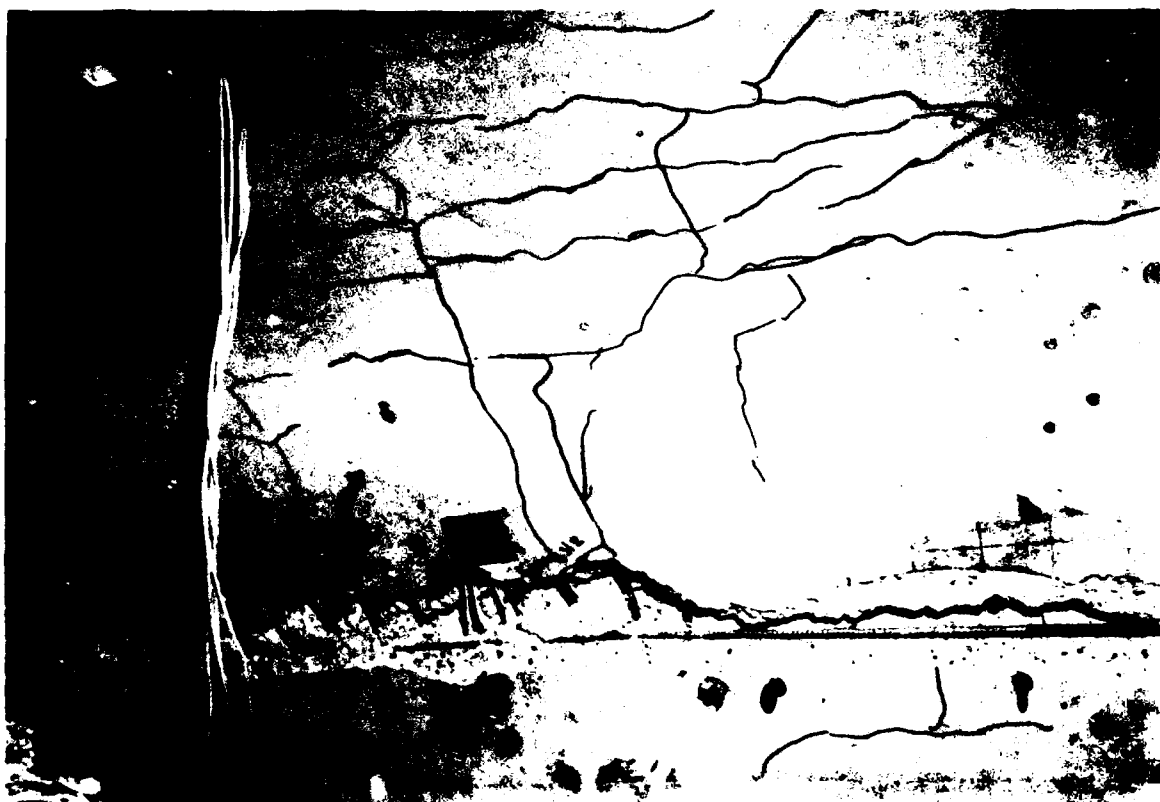
Figure 90. Closeup of Arch A7 downstream interior wall.

Interior walls show spall zones similar to those in A5 and A6. Figures 88 through 90 show the spall regions, which extend from 45 to 60 deg from the crown, with a minor spall zone on the upstream wall just above the floor seen in Figure 88.

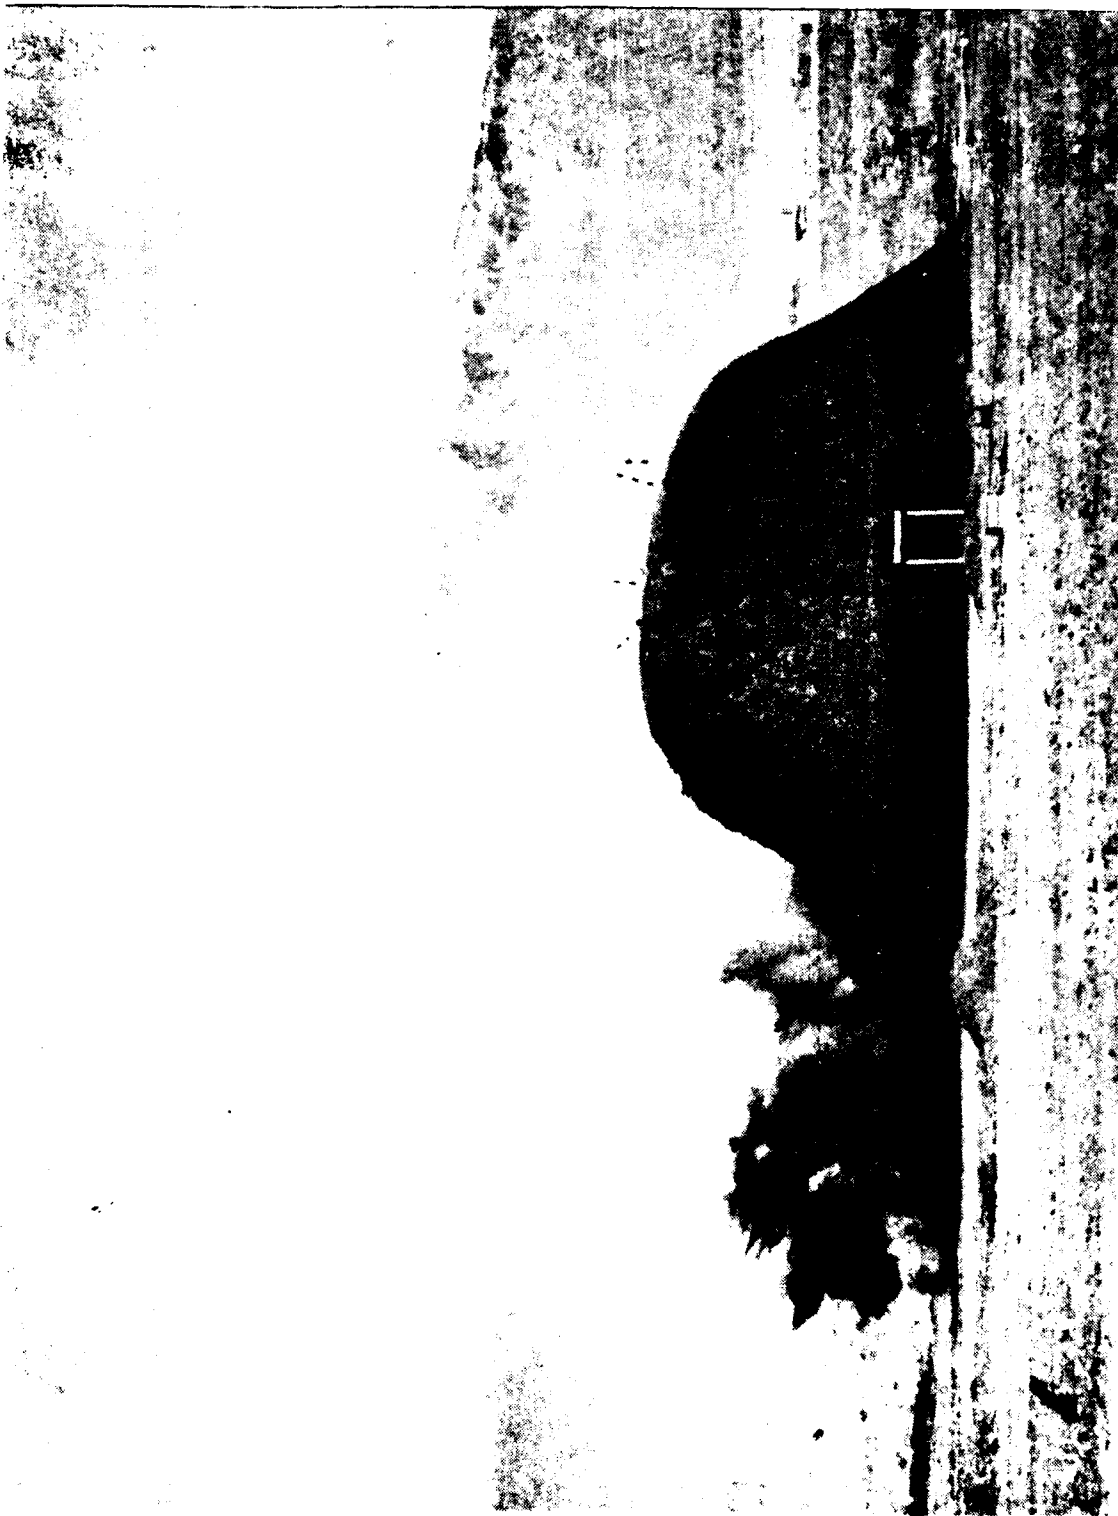
HEST detonation.

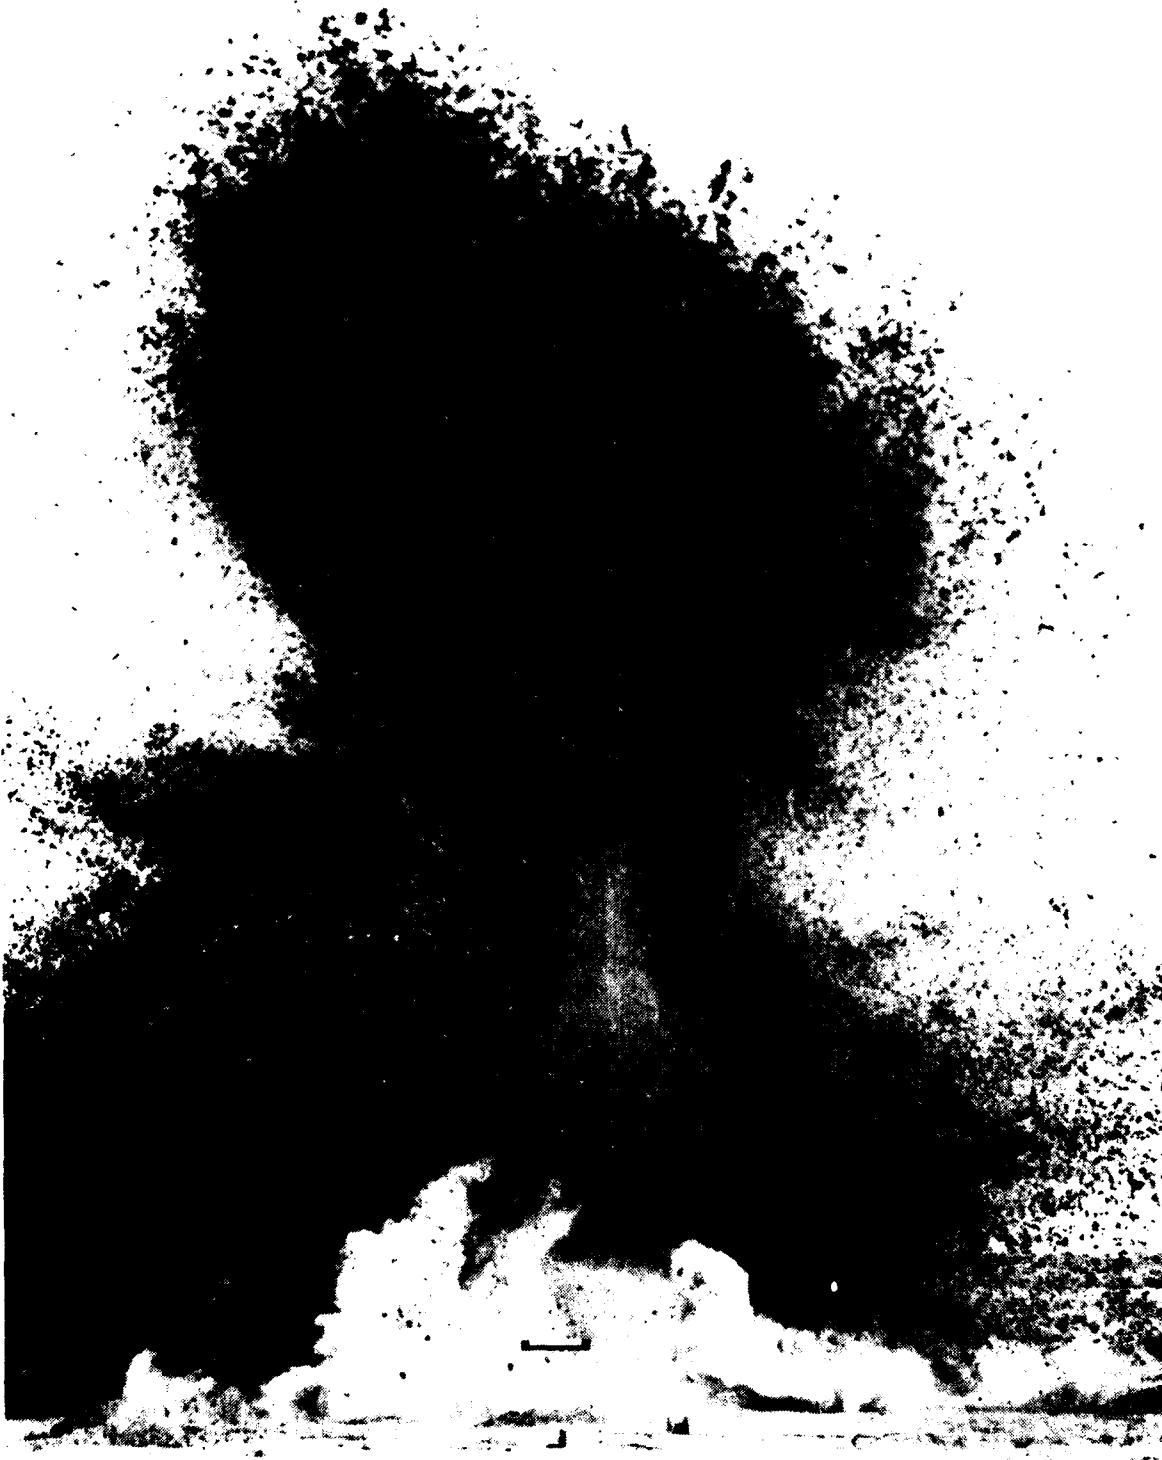
HEST detonation continued.
