**CORROSIVE-WEAR OF BUOY CHAIN**

Craig A. Kohler, Daniel R. May,  
Thomas H. Briggs, Richard Brown

U.S. COAST GUARD RESEARCH AND DEVELOPMENT CENTER  
AVERY POINT, GROTON, CONNECTICUT 06340-6096

INTERIM REPORT  
July 1986

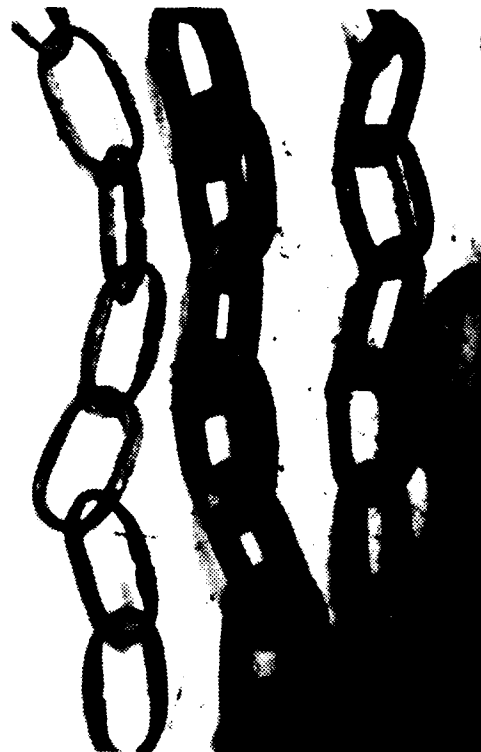
**FIGURE 3. ABRADED BUOY CHAIN**

**FIGURE 4. ABRADED BUOY CHAIN**

**FIGURE 5. ABRADED BUOY CHAIN**

**FIGURE 6. ABRADED BUOY CHAIN**

**FIGURE 7. ABRADED BUOY CHAIN**

**FIGURE 8. ABRADED BUOY CHAIN**

**FIGURE 9. ABRADED BUOY CHAIN**

The degradation of buoy chain occurs in the same fashion. As the chain is moved about the ocean bottom, the soft porous layer on the links is removed by the abrasive surface of a sandy or rocky bottom and falls away from the steel links. The newly exposed metal area is then subject to a direct abrading process with the sand or rock particles. When the chain does become stationary, a new surface layer will form.
