# PLASTIC STRAIN LOCALIZATION IN SUPERALLOY SINGLE CRYSTALS

## FINAL REPORT

JULY 31, 1986

**UNITED  
TECHNOLOGIES  
RESEARCH  
CENTER**

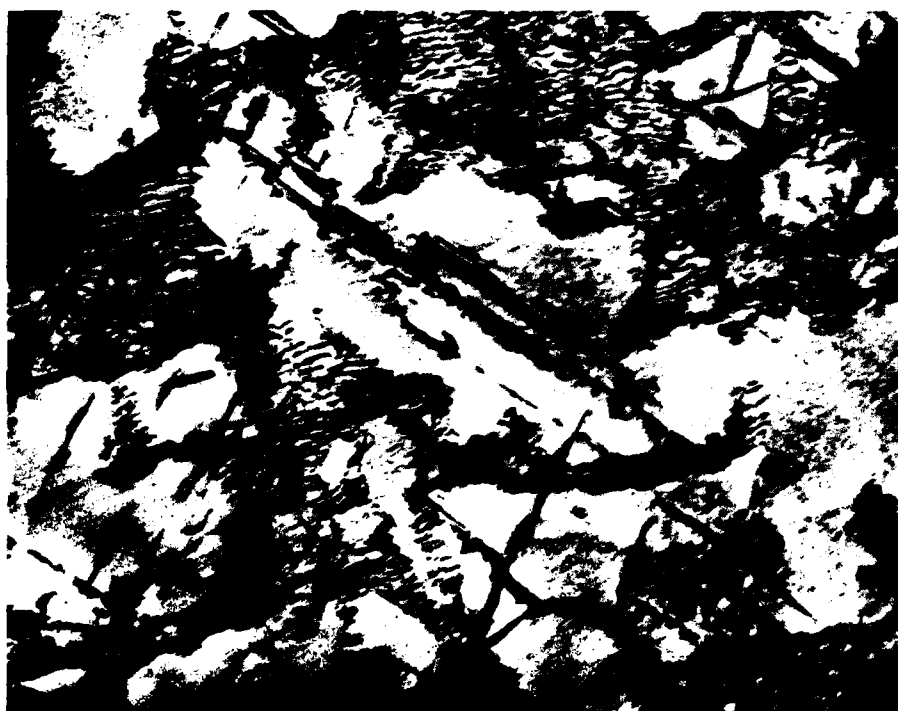
REPLICA OF UNDEFORMED U-700

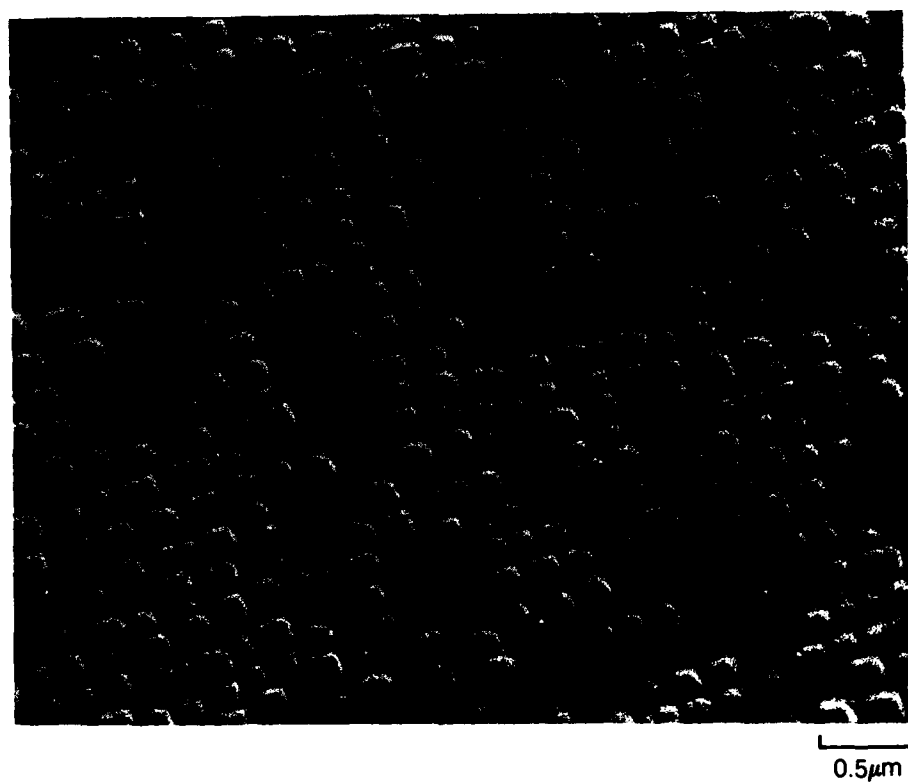
**SURFACE REPLICA OF U-700 COMPRESSION SPECIMEN AFTER  $\epsilon_p = 0.25\%$   
REVEALING TEARING AT SURFACE SLIP OFFSETS**

After a plastic compression strain of 0.25%, very fine and discrete slip lines were observed throughout the sample surface. Figure 19 shows three of these slip lines on the  $90^\circ$  side. The replica film failed along these very sharp slip lines causing the large white bands where the replica has separated.

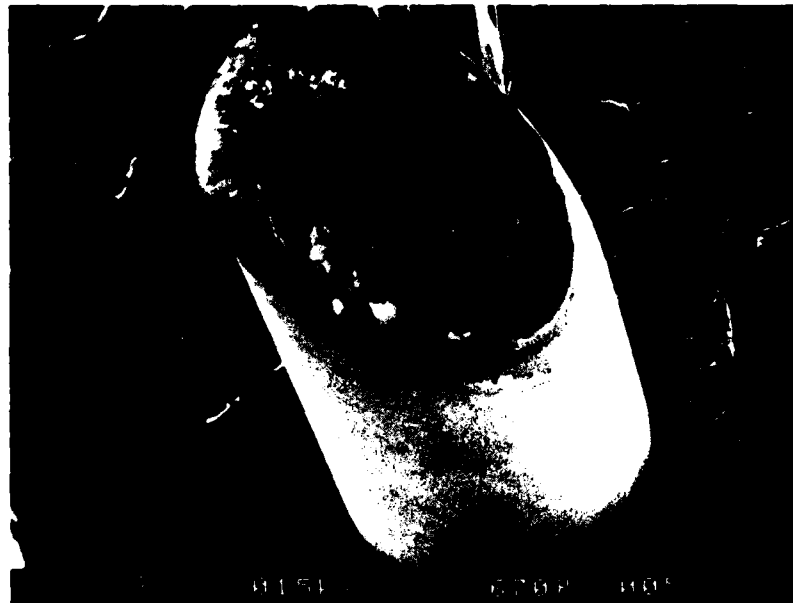
**FRACTURE SURFACE ILLUSTRATING SURFACE SLIP INITIATED  
FATIGUE FAILURES**

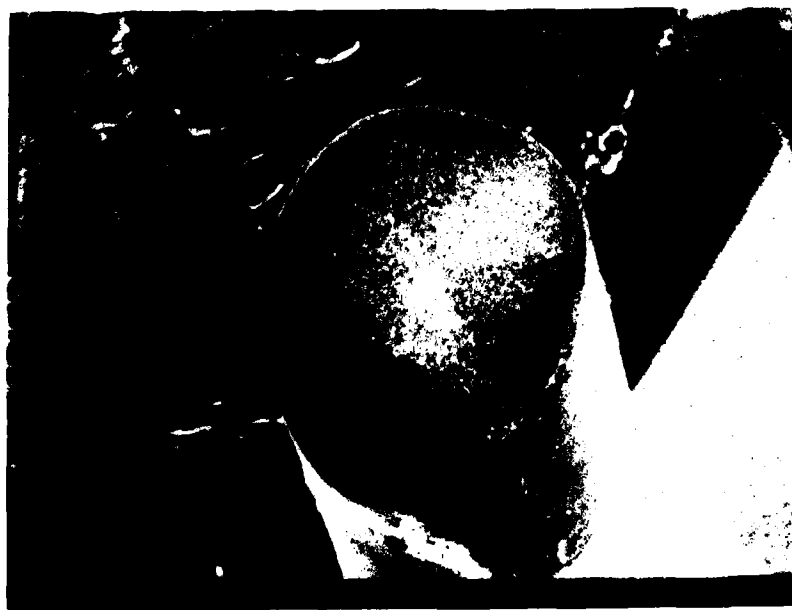
**FRACTURE SURFACE ILLUSTRATING SUB-GRAIN BOUNDARY INITIATED  
FATIGUE FAILURES**
