# Special Report 86-28

September 1986

## *Engineering surveys along the Trans-Alaska Pipeline*

Randy N. Godfrey and Robert A. Eaton

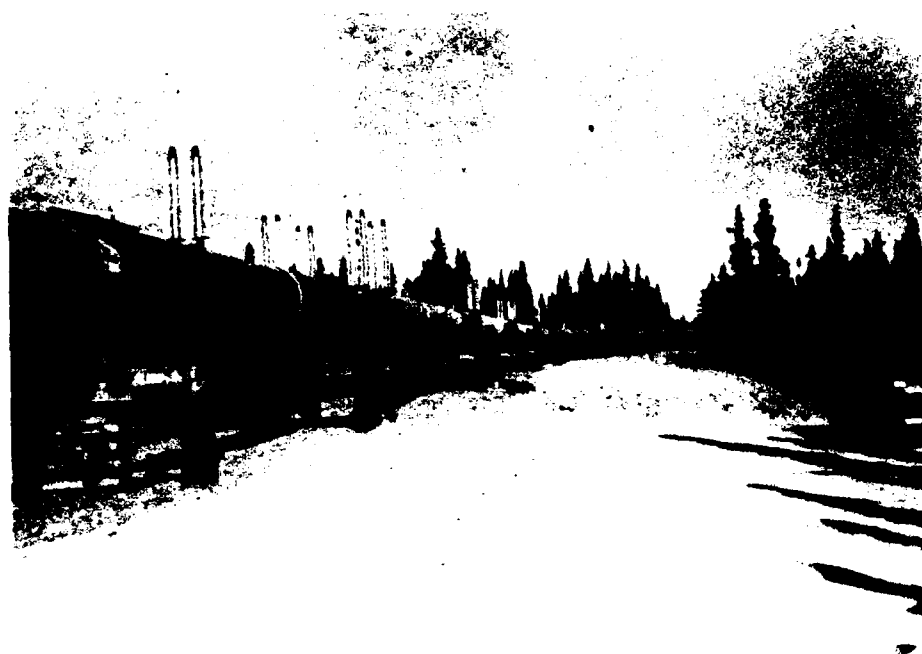
Figure 5. Willow Creek site, September, 1977.

a. Looking north along the east side of the workpad from the centerline at VSM #49. Note the stones left on the surface after grading.

b. Looking north along the west shoulder of the workpad from VSM #49. Note the wood planking used to support the horizontal strut of the VSM.

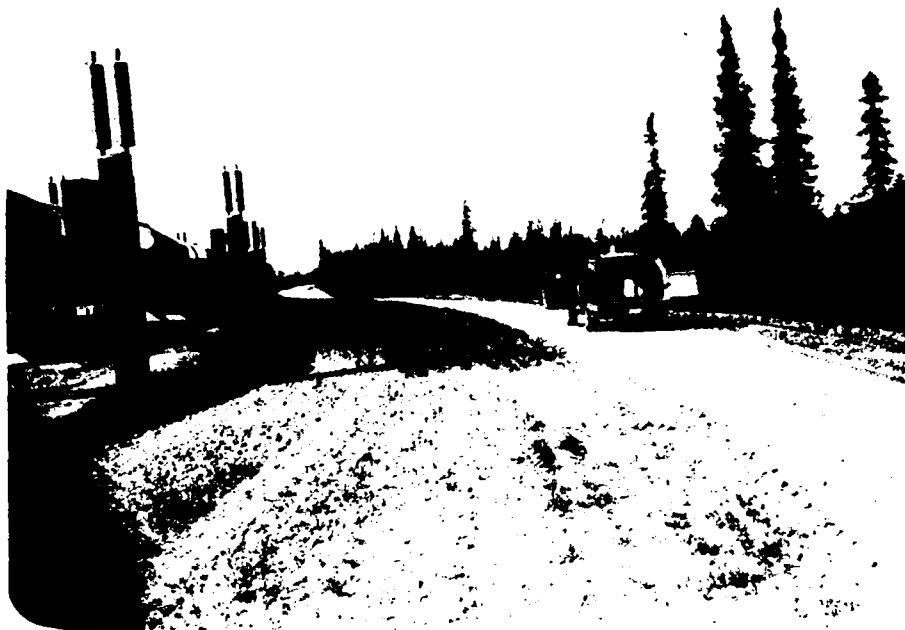
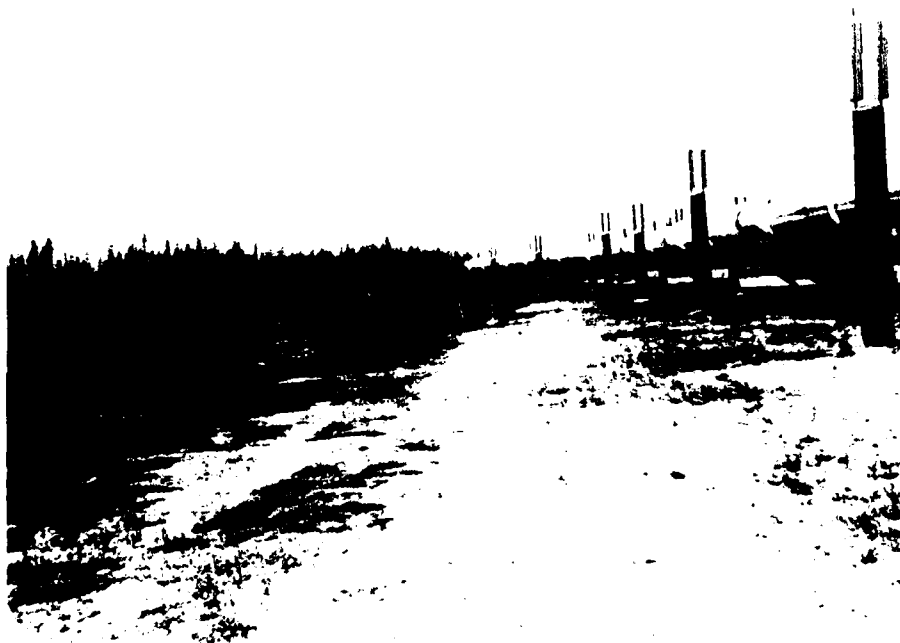
a. Looking north from VSM Bent #62 along the east side of the workpad.

b. Looking north from VSM Bent #62 along the west side of the workpad.

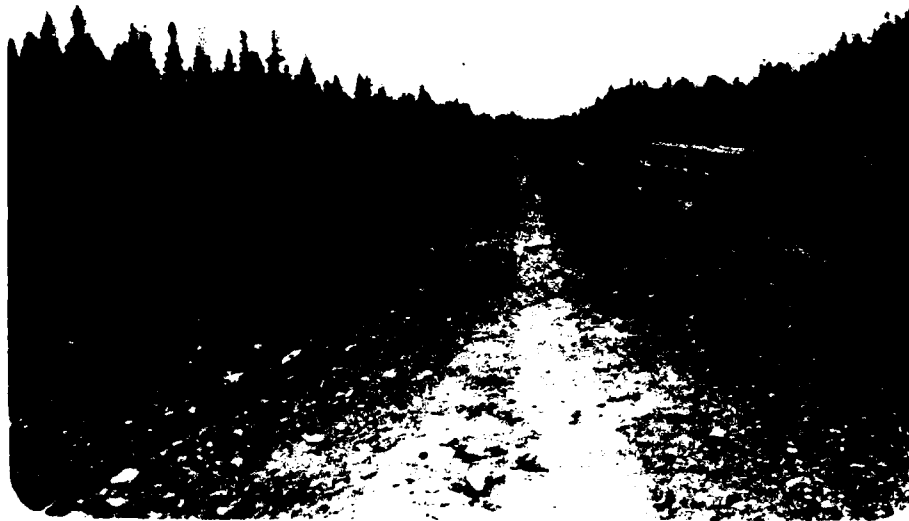
a. Looking north along the centerline of the pipe from about 90 m south of centerline station 0+30. The post and sign (marking the temperature sensors) are at station 0+30.

b. Looking east along the workpad 90 m south of centerline station 0+30. Grader tracks are visible in the lower right, indicating that the surface was reworked before the 1977 survey.

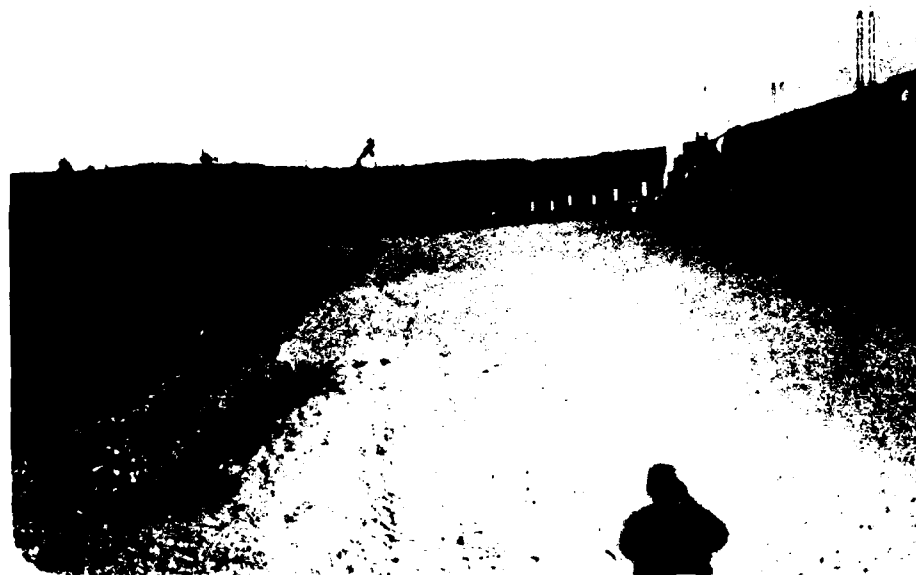
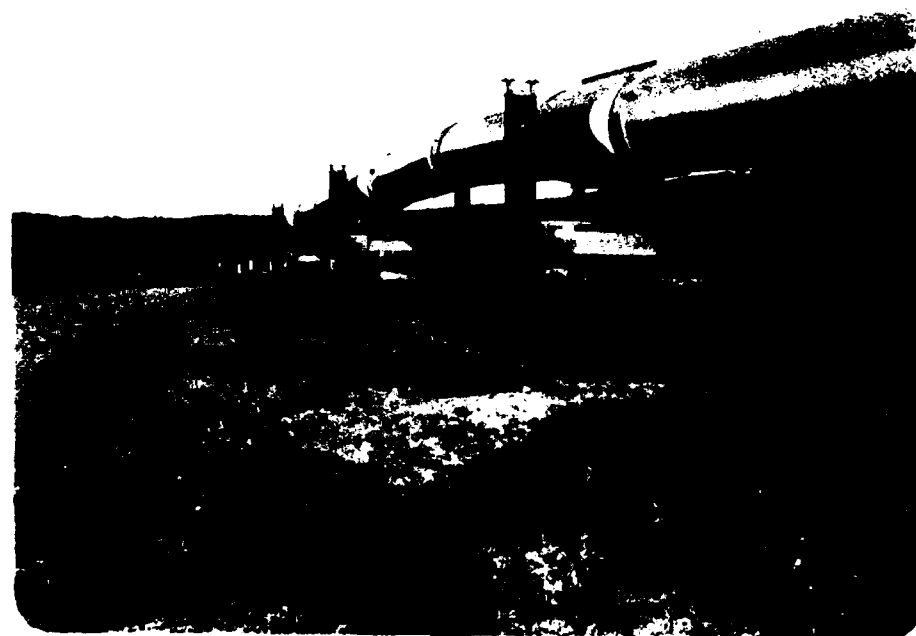
a. Looking east along the north side of the workpad from near VSM #48.

b. Looking east from near VSM #48 on the north side of the pipe.

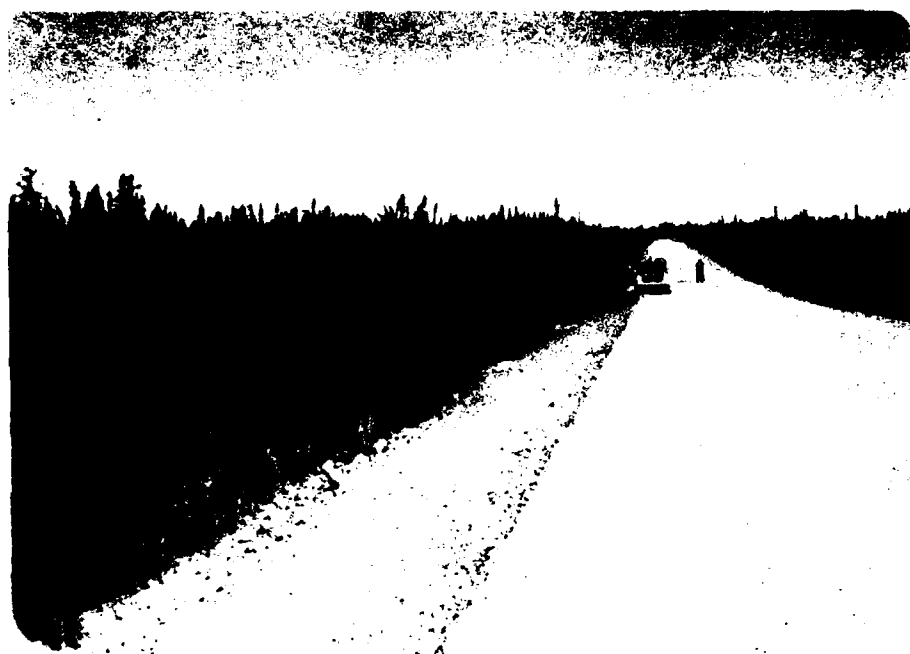
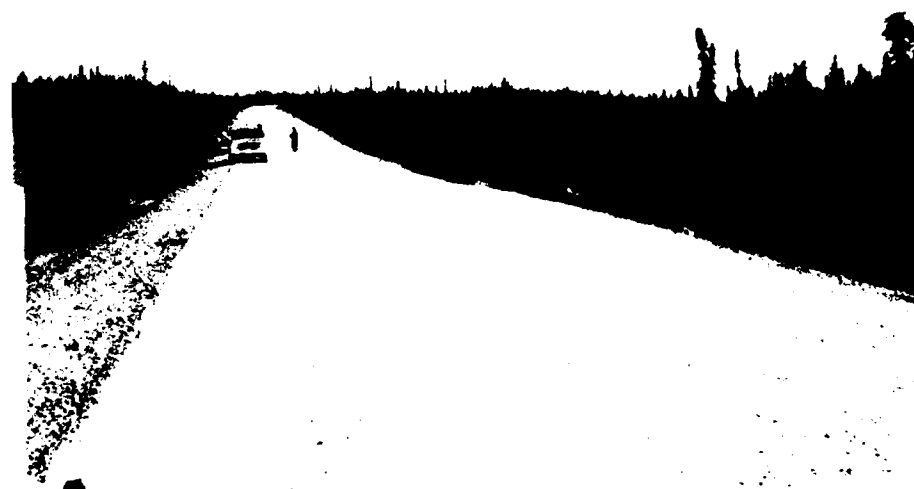
a. Looking north along the west side of the road. Note the shallow berm along the roadside created during grading.

b. Looking northeast along the west shoulder of the road.

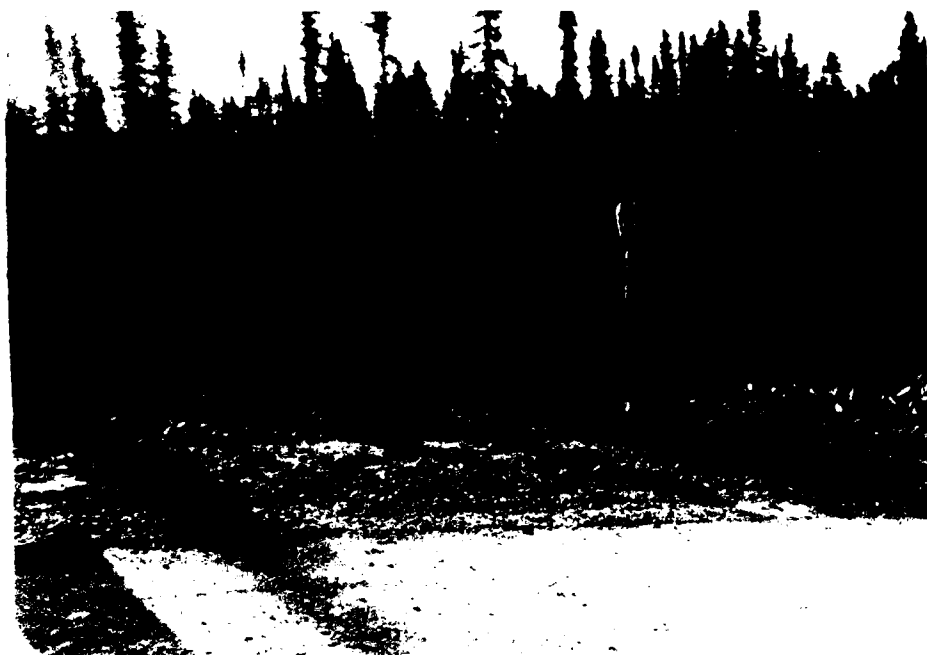
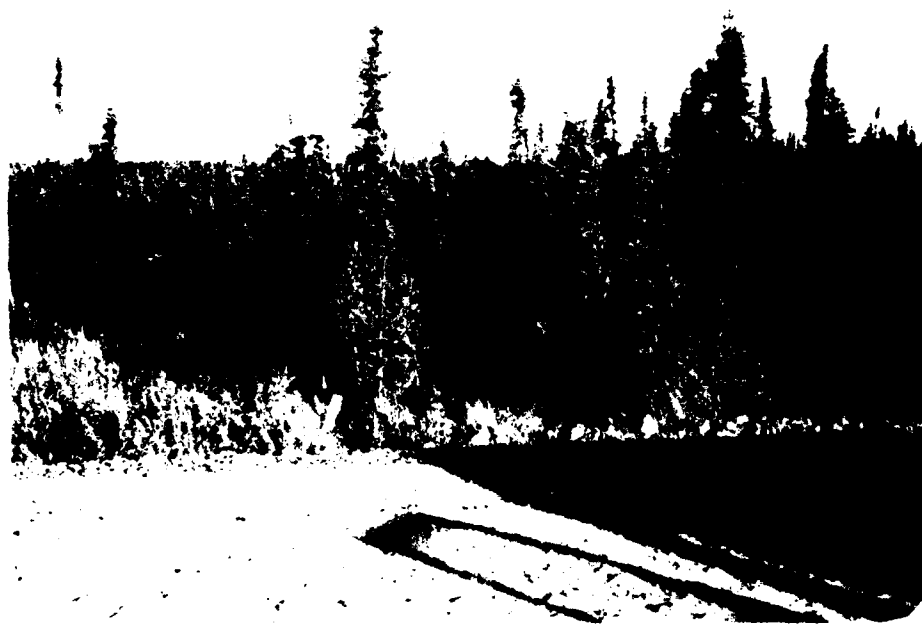
a. Looking toward the south side of the road from the centerline. Note the stones along the edge.

b. Looking toward the north side of the road from the centerline. Note the gravel berm along the edge resulting from grading.

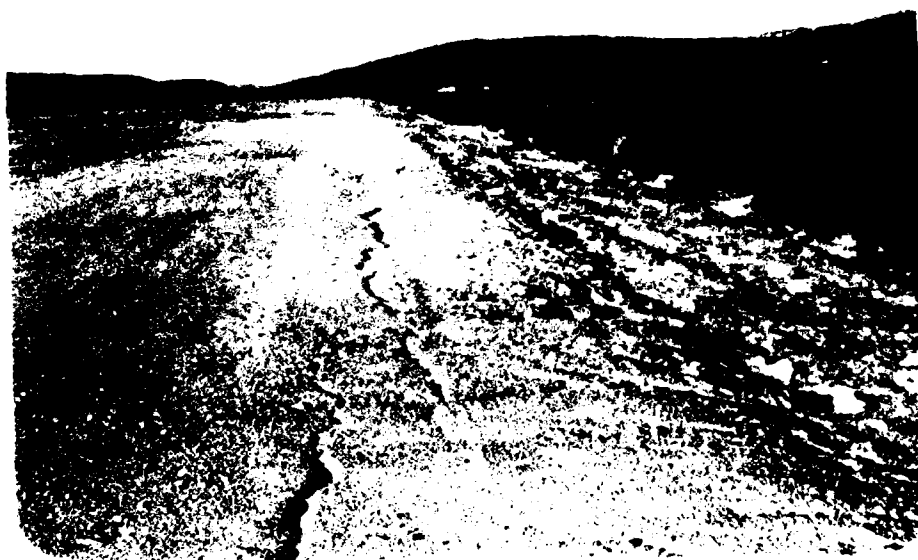
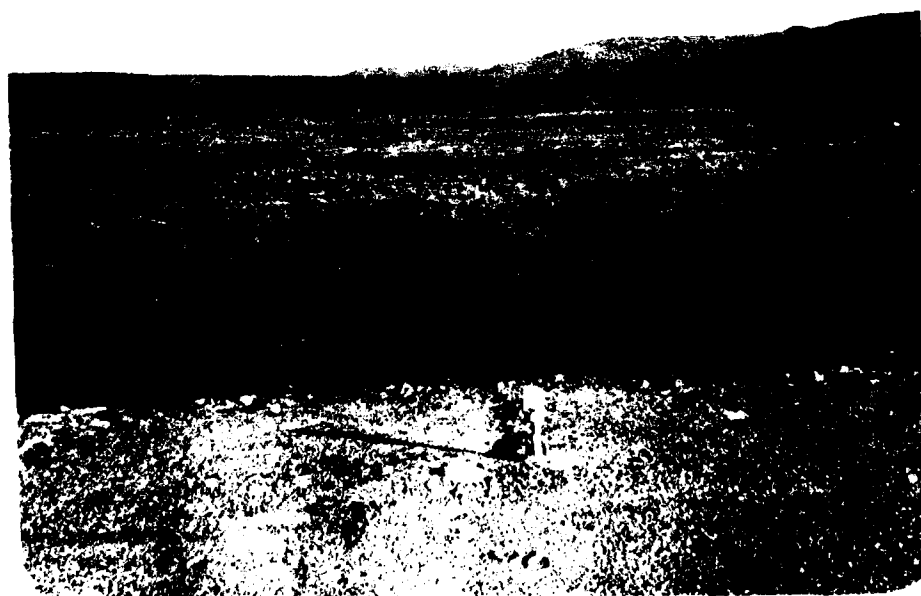
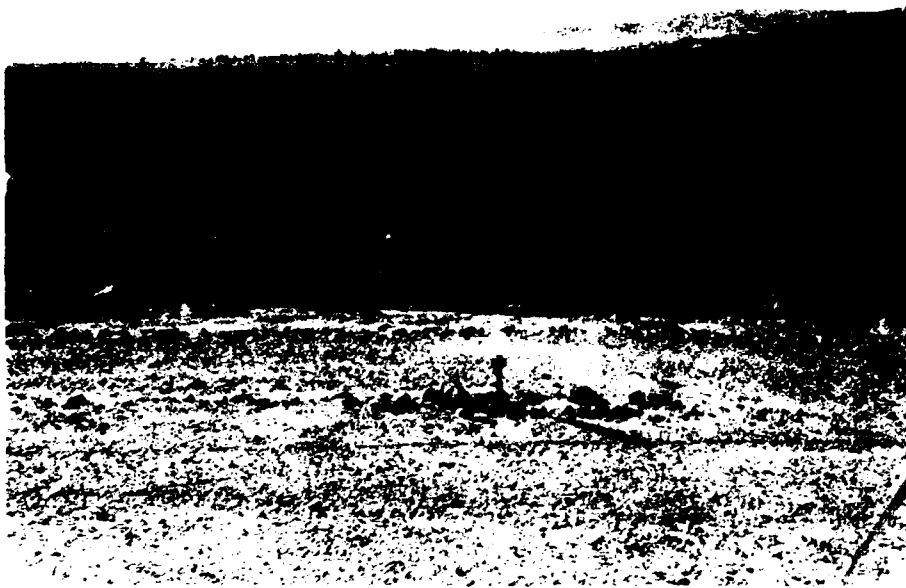
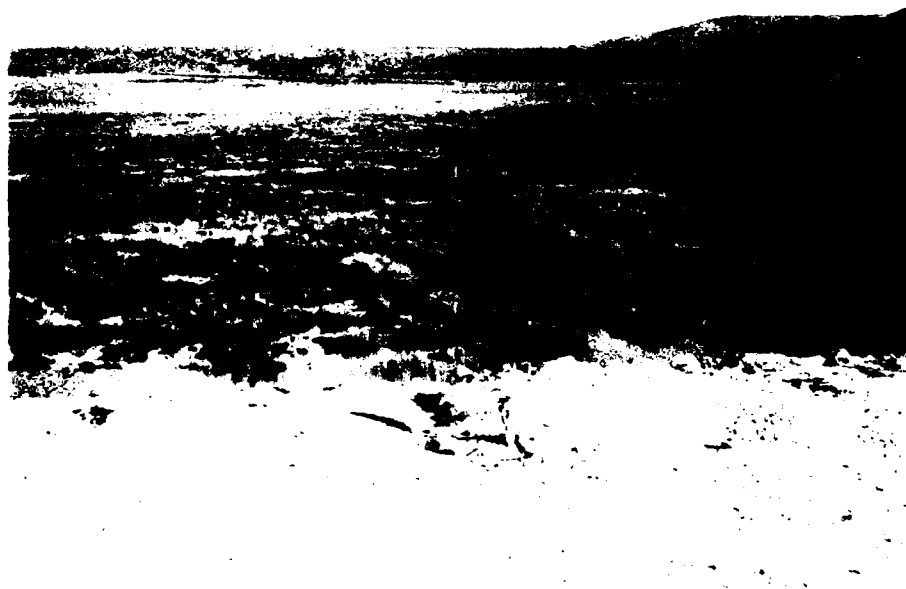
Figure 39. Old Man Airfield east and west sites.

a. East site, looking south from the south side of the runway along the cross section. Note the gravel berm at the edge created by regrading. The pipeline is visible at the upper right.

b. East site, looking west from the cross section along the north side of the runway. Note the cracks along the runway edge, probably caused by the settlement at the toe area. Also note the surface water along the toe.

c. East site, looking north from the north side of the runway along the cross section. Surface water is visible at the toe.

d. West site, looking south from 6 m north of the runway edge on the cross section line.

e. West site, looking north from 6 m south of the north edge of the runway on the cross section line. Note the surface water at the toe.

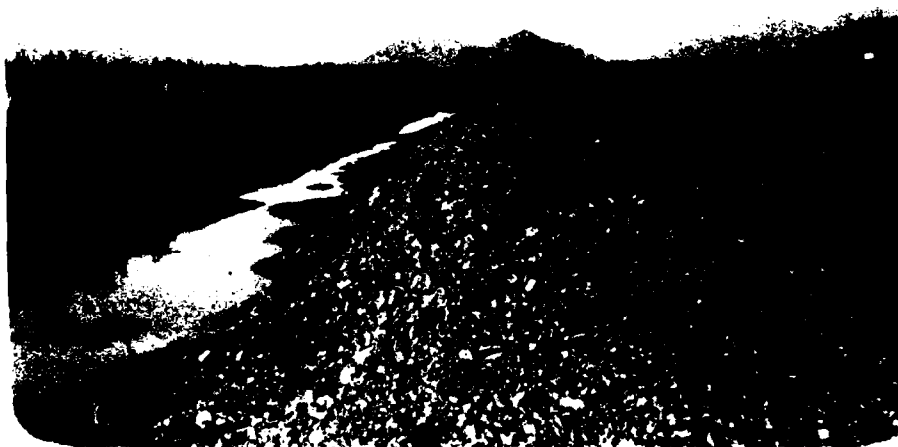
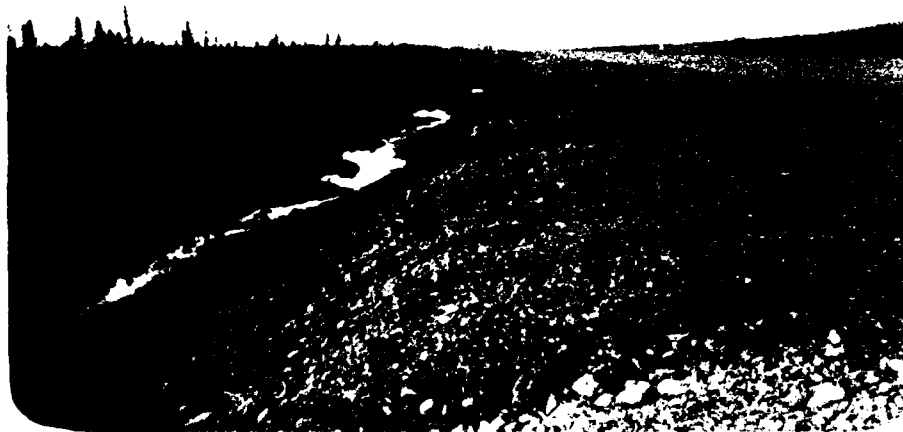
Figure 44. Prospect Airfield north and south sites.

a. North site, looking north along the east side from the cross section of the site.

b. North site, looking north along the west side from the cross section of the site.

c. South site, looking north along the west side from the cross section of the site. Note the minor amount of water in this ditch, though some erosion and sloughing of the shoulder has occurred.

d. South site, looking north along the east side from the cross section of the site. Note the isolated pools of water in the ditch and the relatively little sloughing or erosion of the shoulder.

e. Large depression in the runway shoulder on the east side about 50 m south of the south site caused by an uncorrected drainage problem.

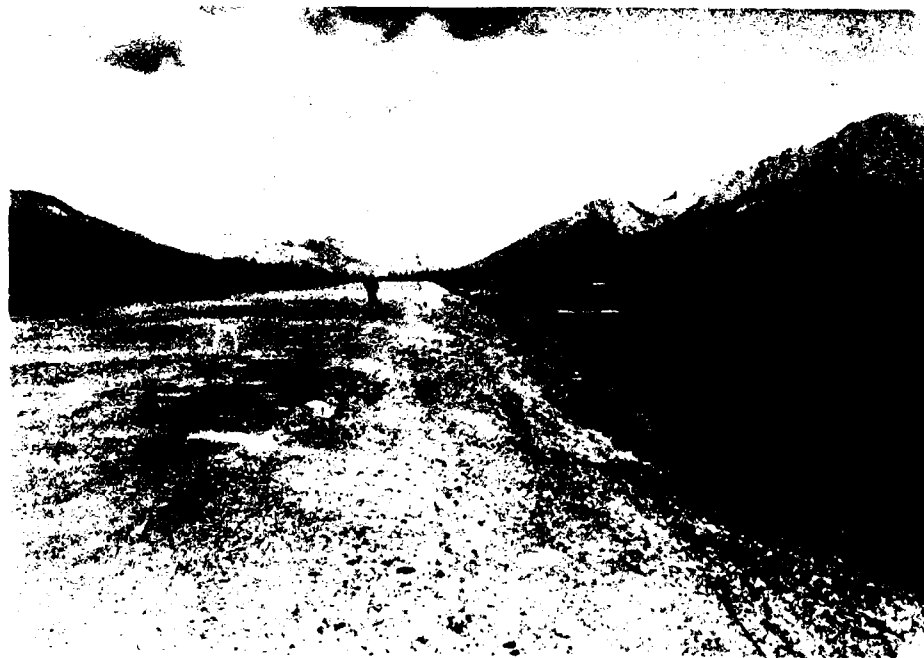
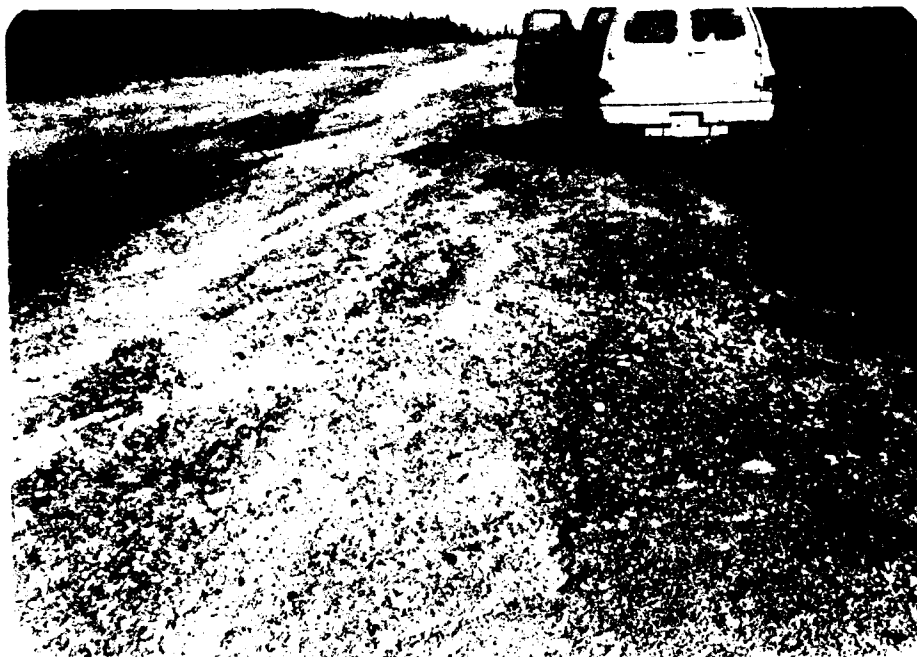
Figure 49 (cont'd).

a. North site, looking north along the east shoulder of the runway. Note the shoulder cracks.

b. North site, looking north along the west shoulder. Note the shoulder cracking and the service road adjacent to the runway.

c. North site, looking north along the runway centerline from the southernmost point of the centerline profile.

d. South site, looking east from the runway centerline along the cross section. Note the pipeline (about 170 m from the runway edge) and the Haul Road visible beneath the pipe (about 250 m from the runway edge).

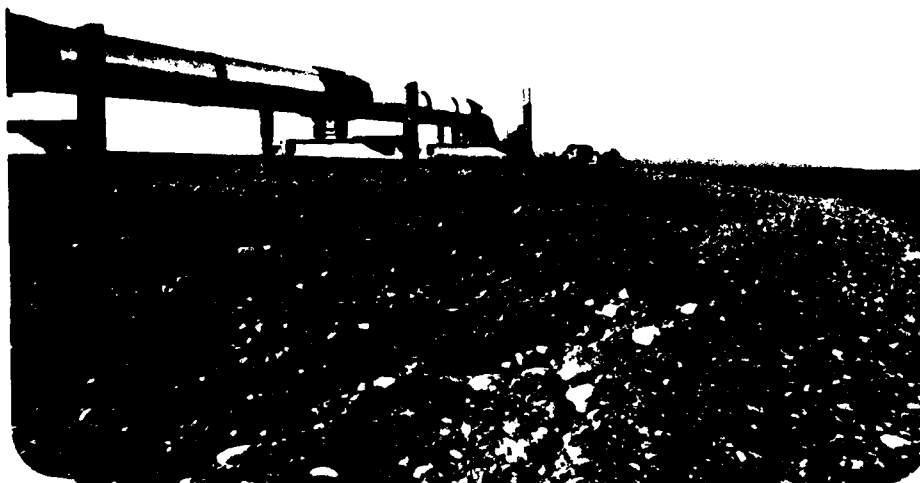
a. Looking north along the centerline of the workpad.  
Note the wheel ruts in the gravel surface.

b. Looking north on the east side of the workpad.

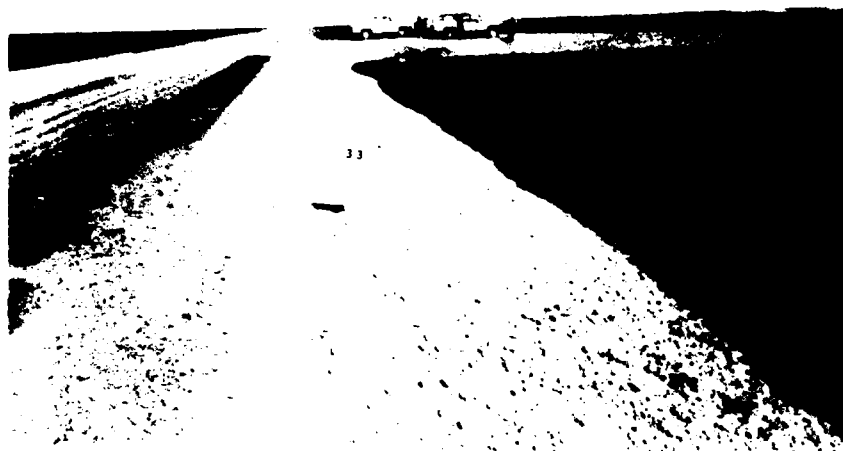
Figure 68. Access Road 133-APL-1 site, 17 August 1976. Looking north from the Haul Road toward the intersection with the access road.
