MRL-TN-503

TECHNIQUES FOR THE FIELD REPAIR OF  
ARMOUR BATTLE DAMAGE

N.M. Burman and C.G. Killoh

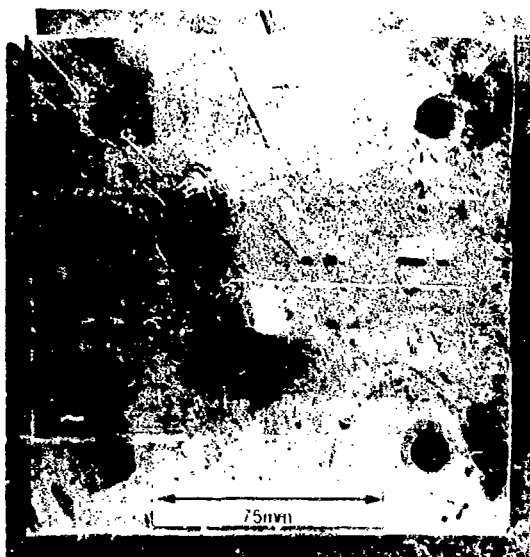
FIGURE 9     Aluminium and steel ballistic test patches showing .30 and .50 calibre AP round penetration.

The results of the .30 and .50 calibre armour piercing trials on the Ramset patch repair system are shown in Figure 9. Both AP rounds penetrated the steel and aluminium patches, however, the integrity of the patch fastening system was not diminished.
