MISCELLANEOUS PAPER GL-86-34

# EVALUATION OF ASPHALT RUBBER AND ENGINEERING FABRICS AS PAVEMENT INTERLAYERS

Geotechnical Laboratory

Final Report

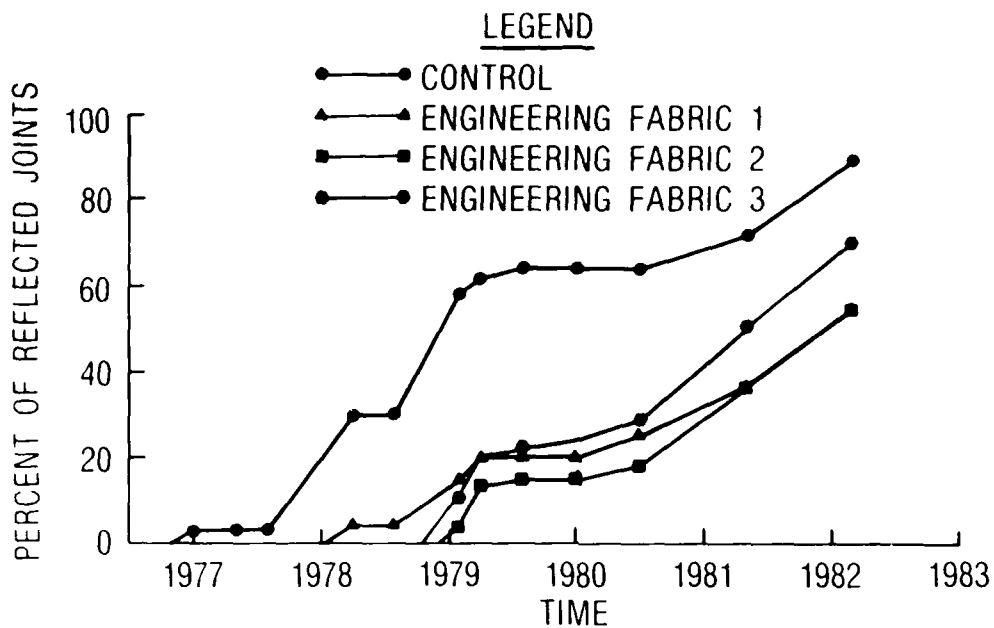
INTERSTATE 85—ATLANTA, GEORGIA  
(PCC PAVEMENT—4 IN. AC OVERLAY)

Figure 2. Percent of reflected joints versus time, 4-in. AC overlay

11. The Georgia Department of Transportation (DOT) has done an extensive amount of work using these methods to rehabilitate PCC pavements in its interstate system. Several projects have been constructed comparing the full-width application of an engineering fabric and a single waterproofing strip, a woven or nonwoven fabric embedded in a thick layer of self-adhesive rubberized asphalt, to a control section. The Georgia DOT also used these projects to compare overlay thicknesses of 2, 4, and 6 in. (5.08, 10.16, and 15.24 cm). These projects showed the benefit of thicker overlays and that retardation of reflective cracking can be obtained with the use of fabrics. The percentage of cracks reflecting through an overlay as a function of time for a project located in Gwinnett County on Interstate 85 is shown in Figures 1 through 3 (Gulden and Brown 1983). The number of cracks reflecting through the 2- and 4-in. overlays is much greater in the control test section than that for the sections containing fabric interlayers. The figures show that in the control sections, 60 percent of the joints in the original pavement has reflected through the pavement in 1 to 3 years and that in the engineering fabric sections, 60 percent reflection takes two to six times as long.

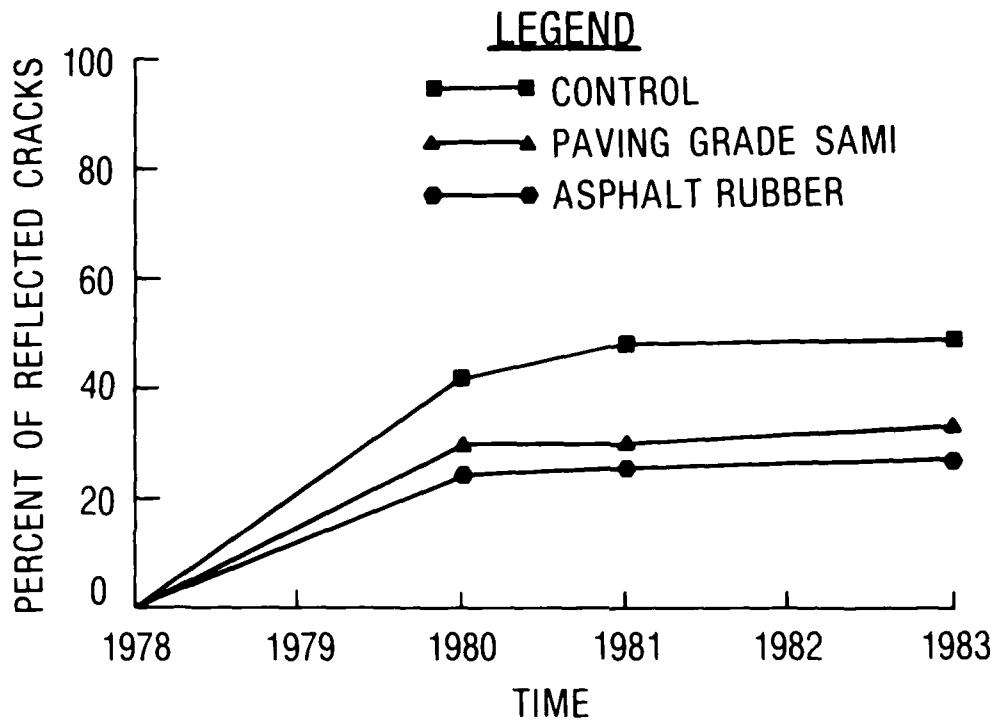
INTERSTATE 90-MOSES LAKE, WASHINGTON  
(AC PAVEMENT—3.0 IN. AC OVERLAY)

Figure 6. Percent of reflected cracks versus time,  
Interstate 90

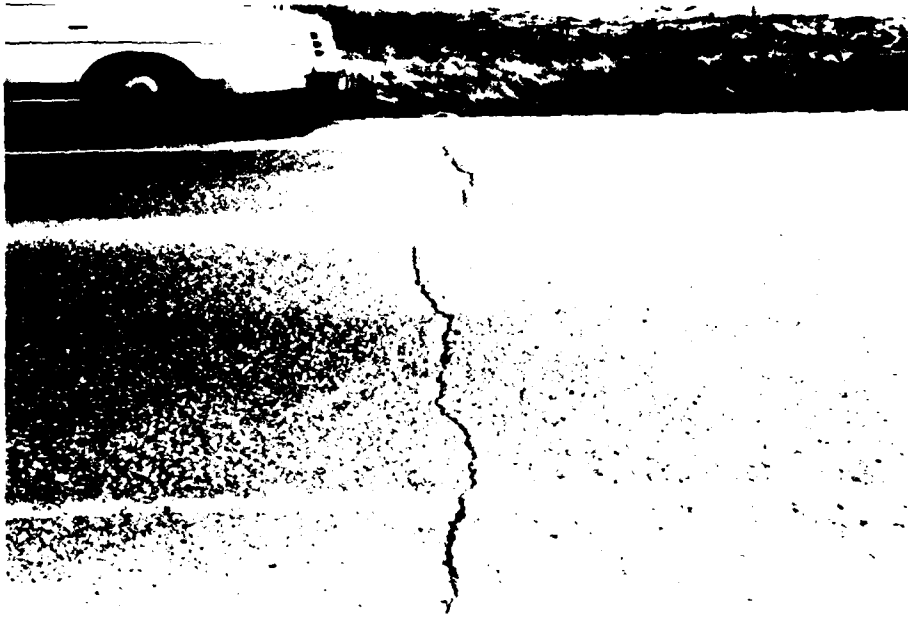
Figure 20. Typical transverse crack over original PCC pavement, US 2, Spokane County

35. The field inspection was conducted in April 1984, 6 years after the installation of the reflective crack treatment. At the time of inspection, the interlayer was functioning very well controlling reflection cracks from the underlying pavement. The cracks in the test section over the PCC pavement were reflecting through approximately every 30 ft (9.14 m) while transverse cracks were appearing every 100 ft (30.48 m) in the AC portion. Typical cracking of this pavement is shown in Figures 20 and 21. According to the Washington State DOT, the asphalt-rubber interlayer has been a success.

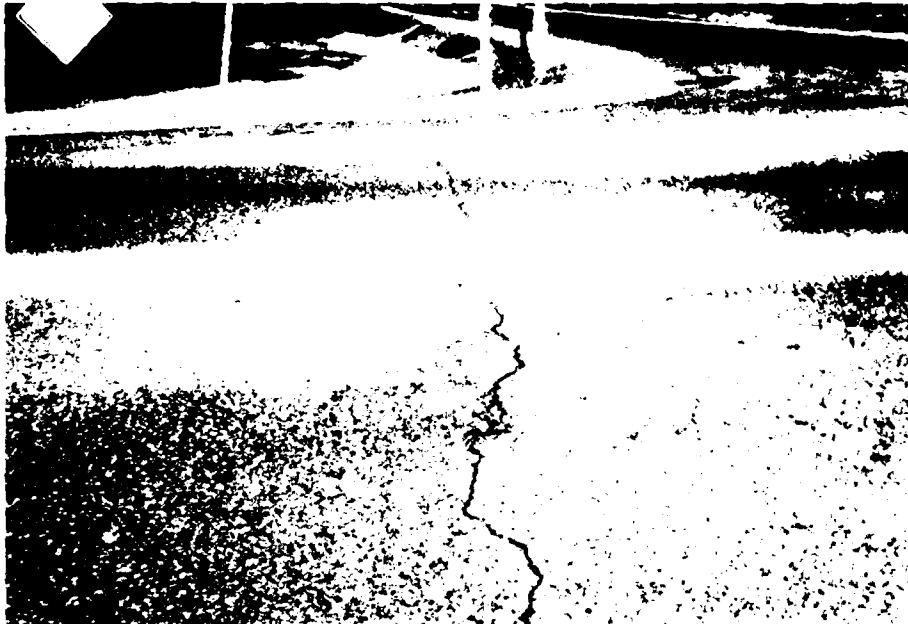
Figure 21. Typical transverse crack over original AC pavement, US 2, Spokane County

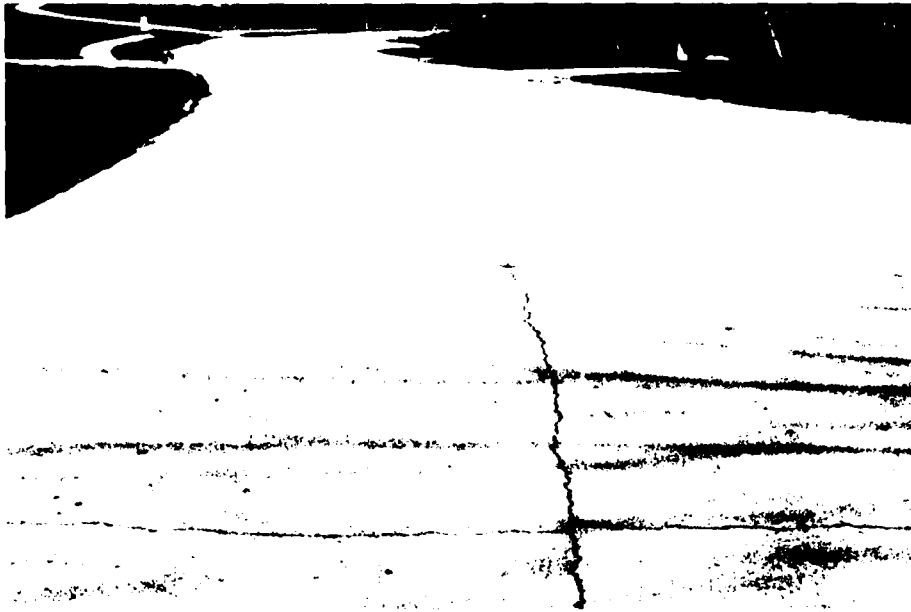
Figure 22. Longitudinal crack in engineering fabric section, Cottage Grove Road, Urbana

38. The visual inspection was conducted in April 1984, 9 years after the installation of the engineering fabric. The roadway as a whole was in good condition. Although there were a large number of cracks in the pavement (Figures 22 and 23), the pavement structure was sound. It appeared that the engineering fabric interlayer had reduced and retarded some of the cracking and had also aided in waterproofing the subgrade.

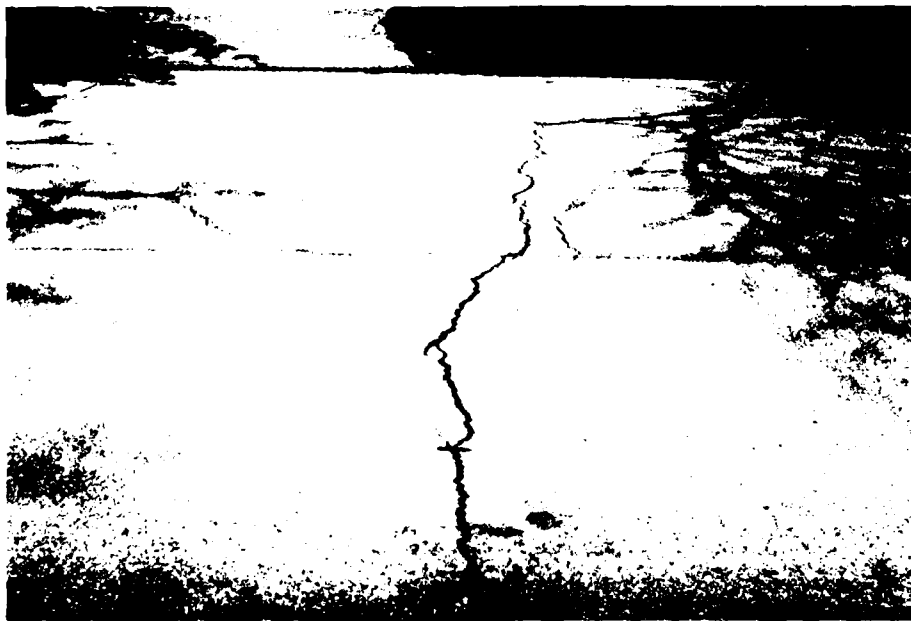
Figure 23. Wide transverse crack in engineering fabric section, Cottage Grove Road, Urbana
