Final Report

# IMAGE SENSOR DATA BASE FOR THE DARPA ALV PROGRAM

C.D. MILLER  
Sensor Systems Division  
OCTOBER 1986

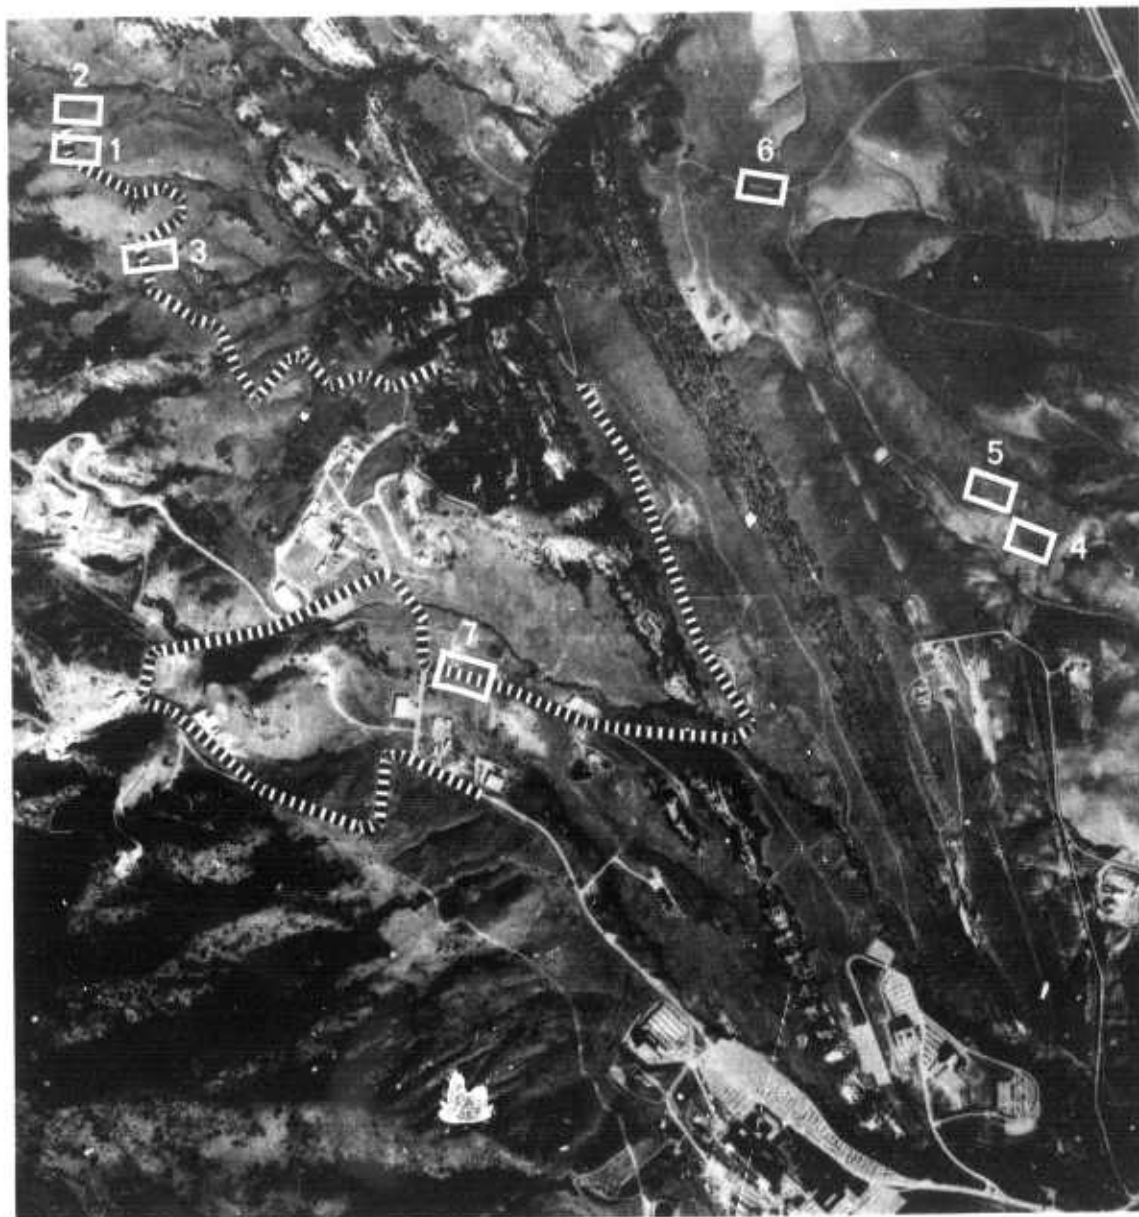
Figure 3-3. Measurement Test Sites - July 1985

----- Indicates Road Areas Traversed

□ Indicates MSS Sites

The MSS data cannot be acquired with the van moving since it takes approximately 10 seconds to acquire a frame of data and movement would cause unacceptable distortions in an image. Sites were selected such that the sun would be behind the van. Measurements were made usually in a sequence of 4 or 5 frames (positions) at each location. The initial frame would be taken and then the van with sensors moved ahead 30-50 feet and the process repeated. The 3D sensor and TV system were also operated simultaneously with the MSS. Seven locations were imaged in two days of operation, resulting in 42 runs of MSS data. It was not possible to operate during evening hours due to cloud build-up over the site. As can be seen from the data logs in Appendix B, morning data acquisition was performed from approximately 06:30 until 09:30. Figure 3-3 indicates the locations of the road networks and the selected MSS sites over which data was taken.

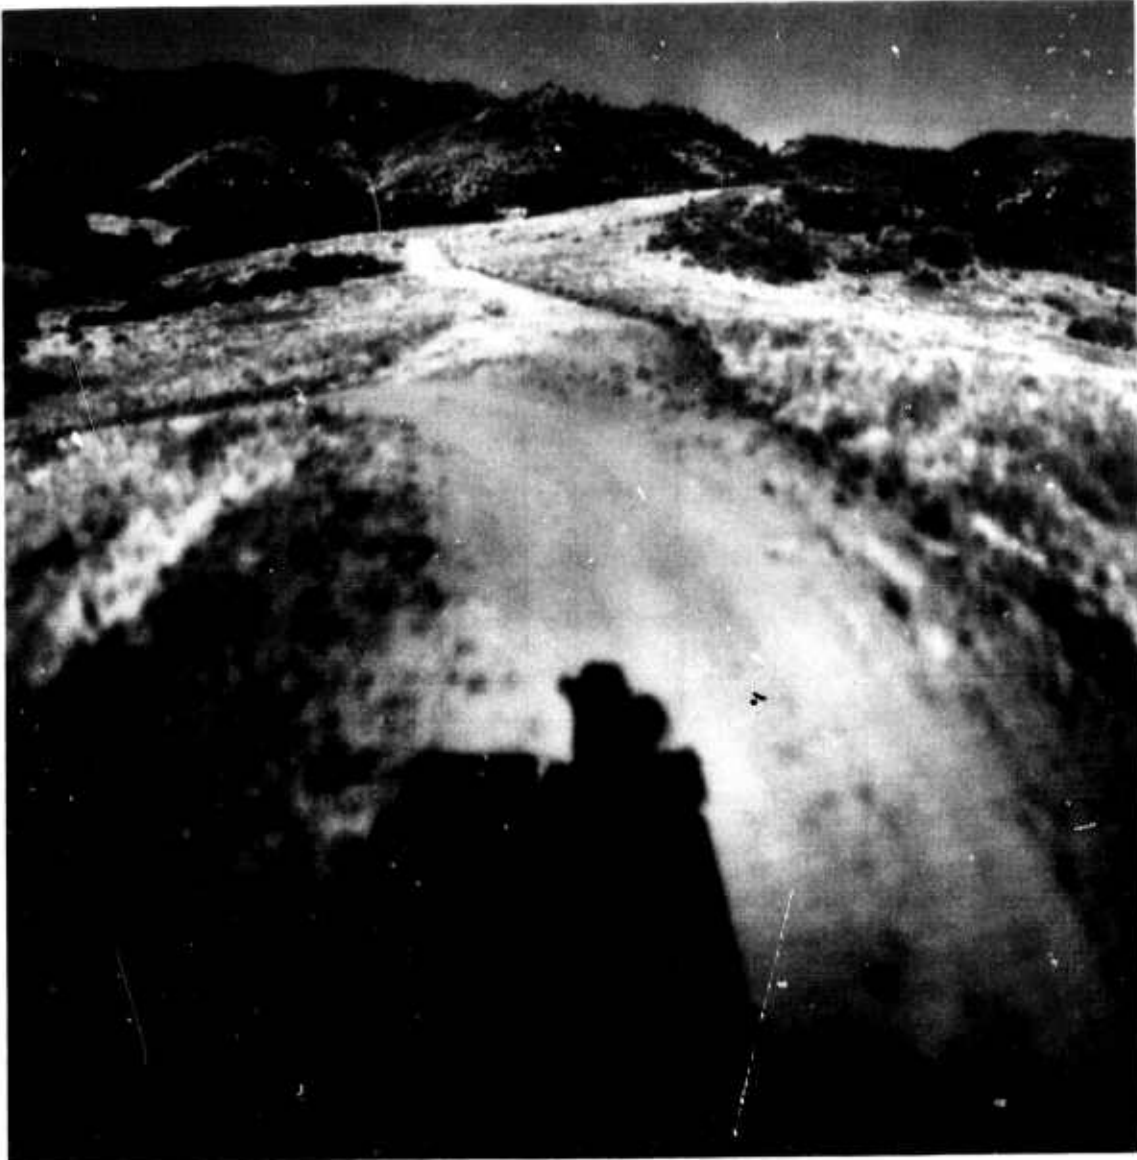
Figure 4-2. Multi Spectral Image, July 1985, Run 12, Band 2

The multispectral system scans horizontally  $\pm 50^\circ$  with an instantaneous field of view (IFOV) and sampling rate such that 803 pixels are generated across the field of view (FOV). See Figure 4-1. The vertical scan is manually controlled by an operator switching the nodding mirror beneath the sensor. The vertical scan is at a constant angular rate and is set to provide proportionate horizontal and vertical scale, ie, the correct perspective of the imaged scene. Vertical scans are typically made  $\pm 45^\circ$  with respect to the horizon, resulting in approximately 800-900 scan lines for a given frame. When reformatting the data, each scene was viewed on a display and only 512 lines of data selected with the top of the frame positioned such that a portion of the sky was contained in each image. the horizontal FOV was also reduced by extracting only 512 pixels from the center of the image. The resulting frame, therefore, consists of 512 scan lines with 512 pixels per line. Note, the near-field image, i.e., that portion of the terrain close to the van, is out of focus as the MS sensor is designed for airborne use and has the focus preset to infinity. See Figure 4-2 for a typical MSS image at the Denver ALV test site. Note the shadow of the van and defocused image in the foreground.
