DOT/FAA/PM-86/12  
Program Engineering  
and Maintenance Service  
Washington, D.C. 20591

# Performance of Recycled Asphalt Concrete Airport Pavement Surfaces

G. D. Cline  
M.C. Hironaka

October 1986

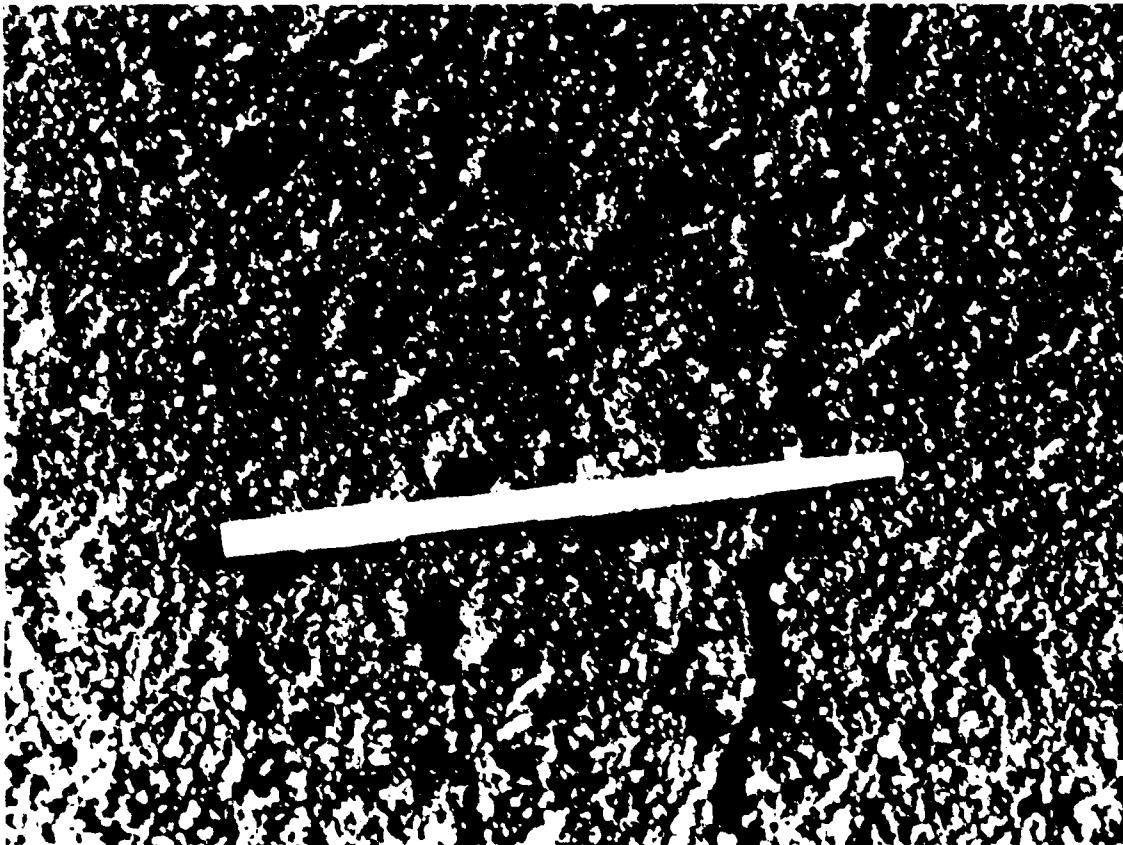
Figure 7 illustrates the layout of Runway 2-20 and location of condition survey sample units and test cores. Seventeen of the 72 sample units were surveyed. PCI values ranged from 80 to 88 with the average being 85 (see Table 2). The overall rating of the pavement is classified as very good in accordance with FAA Guidelines<sup>2</sup>. The major distresses observed at Needles Airport were longitudinal and transverse cracking and raveling both of low severity. A typical view of the defects is shown in Figure 8. The primary distress mechanism is climatic effects on material durability.

FIGURE 8. TYPICAL PAVEMENT DEFECTS (CRACKING AND RAVELING OF LOW SEVERITY) AT NEEDLES AIRPORT, NEEDLES, CALIFORNIA.
