ESL-TR-85-37

**ALTERNATE LAUNCH AND RECOVERY SURFACE
TEST SECTION, DESIGN, CONSTRUCTION, AND
EVALUATION, NORTH FIELD, SOUTH CAROLINA**

**U.S. ARMY ENGINEER WATERWAYS
EXPERIMENT STATION
P.O. BOX 631
VICKSBURG, MISSISSIPPI 39180-0631**

FINAL REPORT

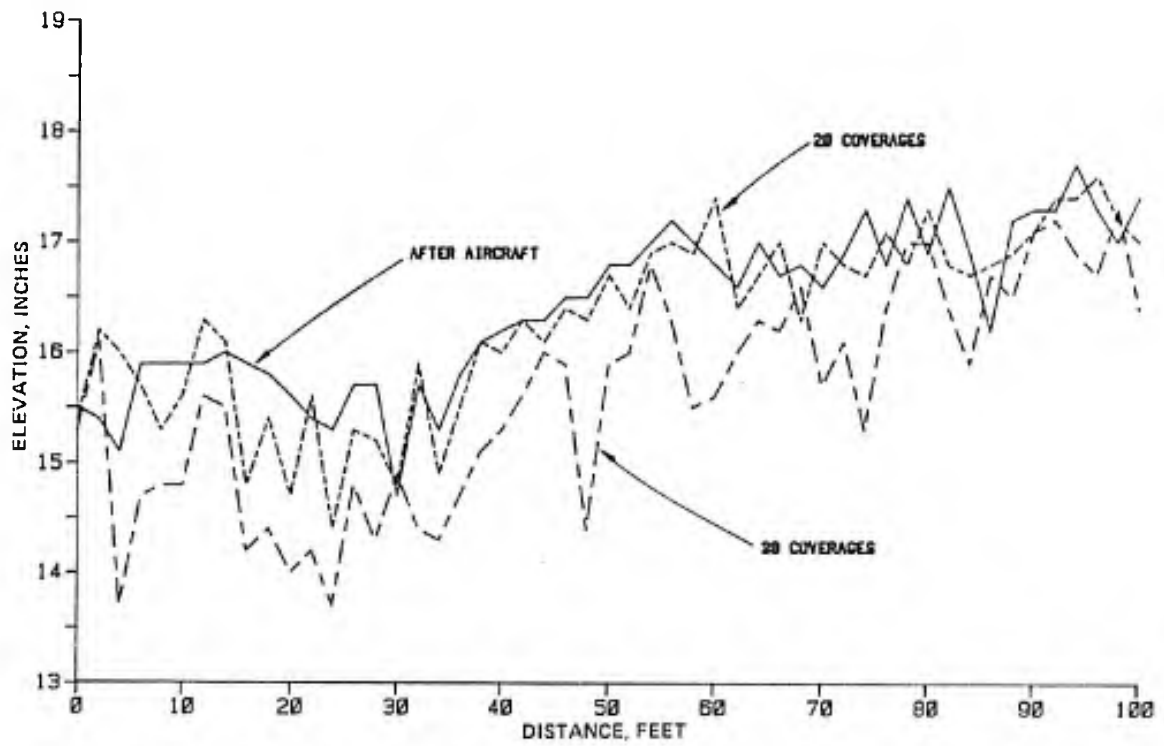
Figure 19. Profile, F-15 Traffic Lane, Stabilized Soil Test Item.

the rain-dampened loose stabilized soil had dried. Between 30 and 33 coverages, the load cart generated dust from the loose stabilized soil. Traffic was stopped at 38 coverages when a 3.25-inch maximum rut was measured. Photo 31 shows the traffic lane when traffic was stopped. Typical cross sections for the F-15 traffic lane, stabilized soil test item, after the F-4 aircraft (0 coverages F-15), after 20 coverages, and after 38 coverages are shown in Figure 18. Profile for the centerline of the F-15 traffic lane, after the F-4 aircraft (0 coverages), 20 coverages, and 38 coverages are shown in Figure 19.

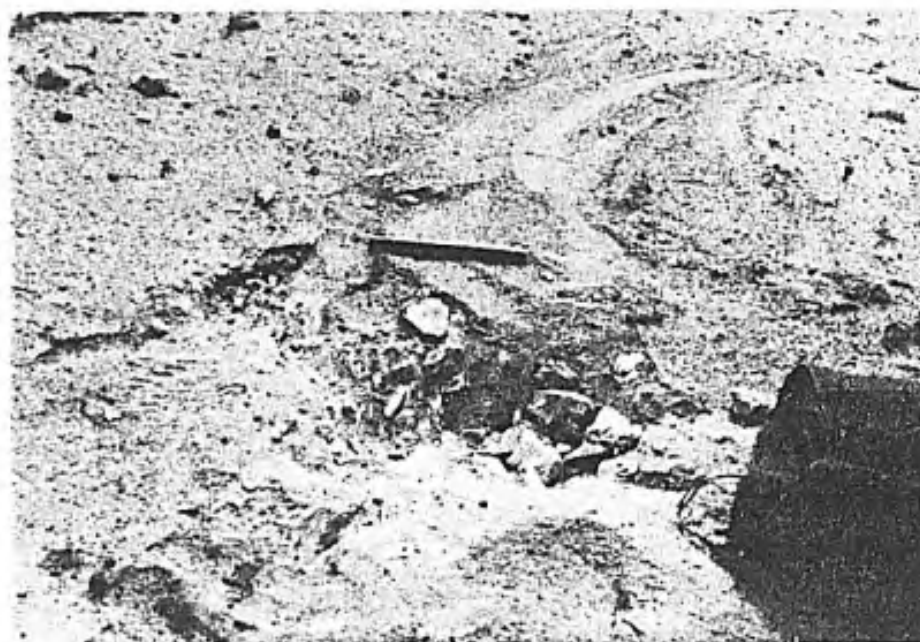
Photo 2. Damage to a Slab From a 3.5-pound Charge of TNT.

This procedure was repeated on six slabs with the 3.5-pound charges. The damage to the slabs was essentially the same (Photo 2) as the trial blasting.

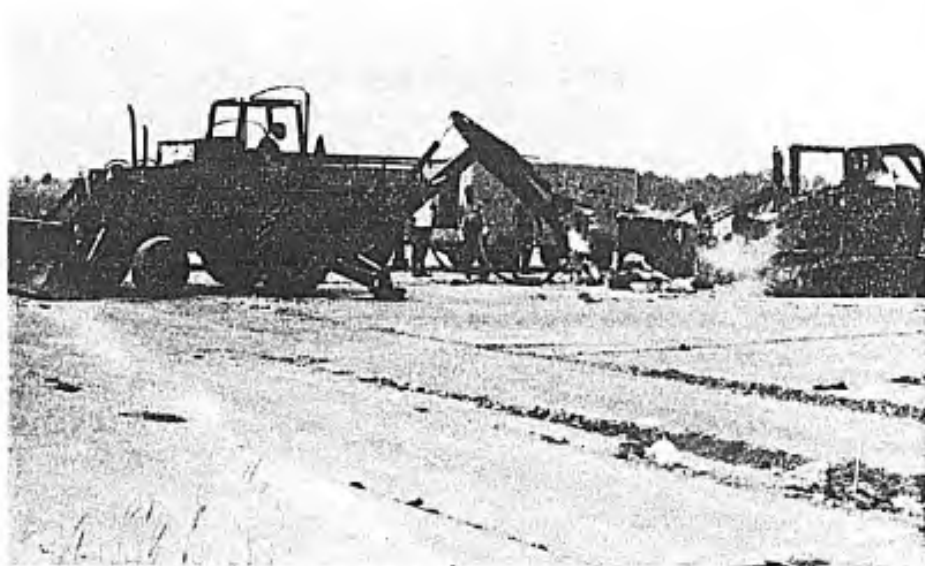
Photo 4. Removal of PCC With Pavement Breaker and Front-end Loader.

A 1,100-pound pneumatic pavement breaker was mounted on a Case 680E backhoe and was used to break up the PCC. The pavement breaker broke the slabs into pieces of sufficient size to be handled by a tracked front-end loader with a 4-way bucket (Photo 4). The broken PCC was removed from the runway to a preselected disposal site.

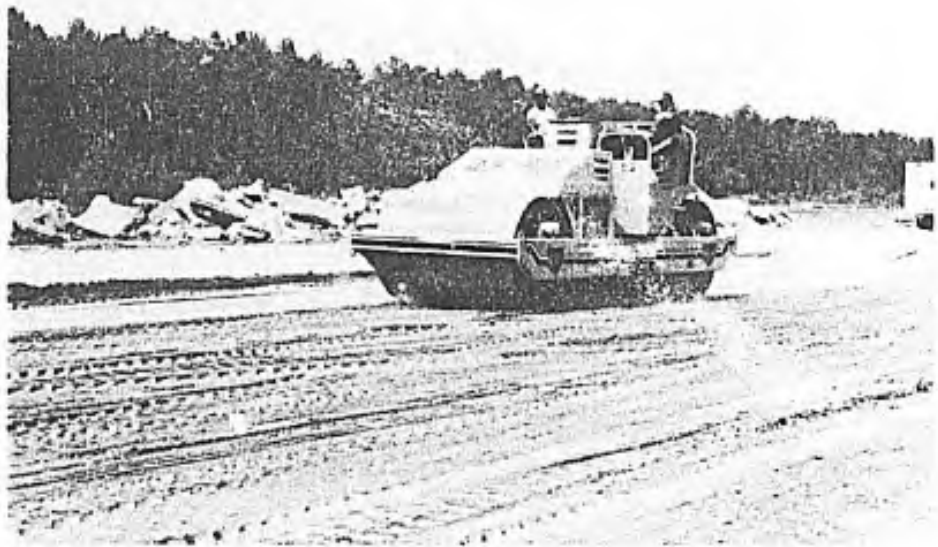
Photo 5. Compacting the Subgrade With a Tandem Vibratory Roller.

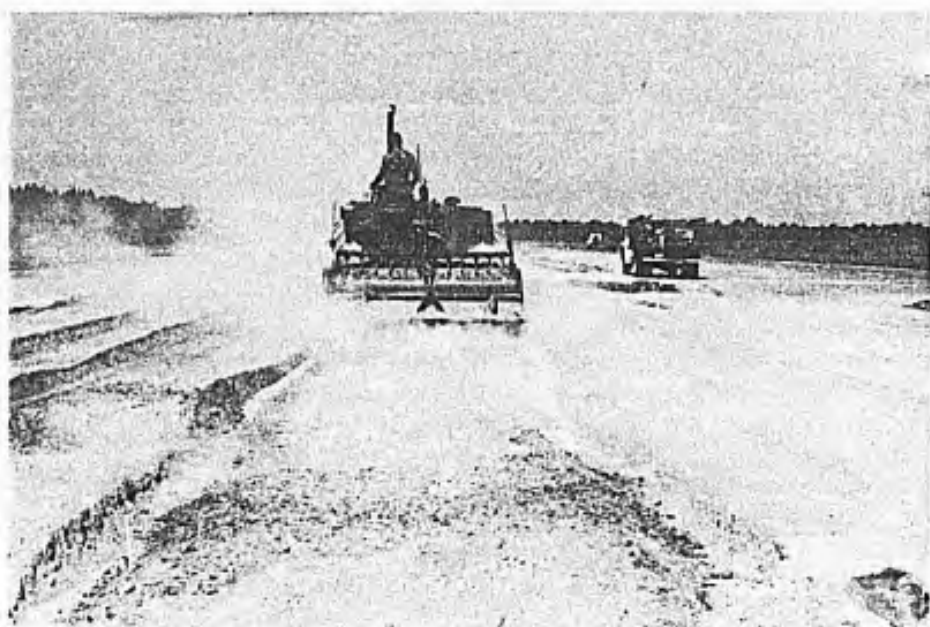
Photo 9. Blending PC and Silty Sand with a Pulvimixer.

The material to be used in the first lift had an initial water content of 7.8 percent. Prior to adding PC the stockpile was sprayed lightly with water. The PC was placed on the stockpile by positioning the tractor-trailer PC transporter on one side of the stockpile and then backing down the stockpile, discharging the PC through an 8-foot spreader bar attached to the rear of the trailer. When the tractor-trailer reached the end of the stockpile, it was stopped and then driven forward in the same wheel path, discharging the PC. At the end of the stockpile the tractor-trailer was shifted over 8 feet (the width of the spreader bar) and driven backward and forward in the same path, discharging the PC. This was repeated until the entire width of the stockpile had been covered. Four trips across the stockpile were required to discharge all the PC (47,340 pounds) from the trailer. Photo 8 shows the PC being placed on the stockpile. After the PC was placed on the stockpile, it was blended into the silty sand with a pulvimixer (Photo 9). Six passes with the pulvimixer were used to blend the PC with the silty sand. One pass consisted of the pulvimixer starting on one side of the stockpile and blending the soil and PC from one end of the stockpile to the other end. At the end of the stockpile the pulvimixer turned around and returned through the stockpile, moving over the width of the pulvimixer. This was repeated until the width of the stockpile had been covered. After mixing, the stockpile was piled using two front-end loaders (Photo 10). The bottom of the stockpile was turned over when the material was placed in the pile. Turning over and piling the material helped to further mix the soil and PC. To ensure a thorough mixing, the material was respread on the runway into a workable stockpile, approximately the same size as before. After respreading of the material, blending of the PC and soil was continued with the pulvimixer. During this time the water content of the material was checked with a nuclear moisture-density gage and found to be lower than optimum for the CE-12 moisture-density relations (Figure 5). Water was sprayed onto the stockpile from fire truck and mixed into the material as the pulvimixer continued the blending of the PC and soil. After the PC and soil were thoroughly mixed, the material was piled again with the two front-end loaders.

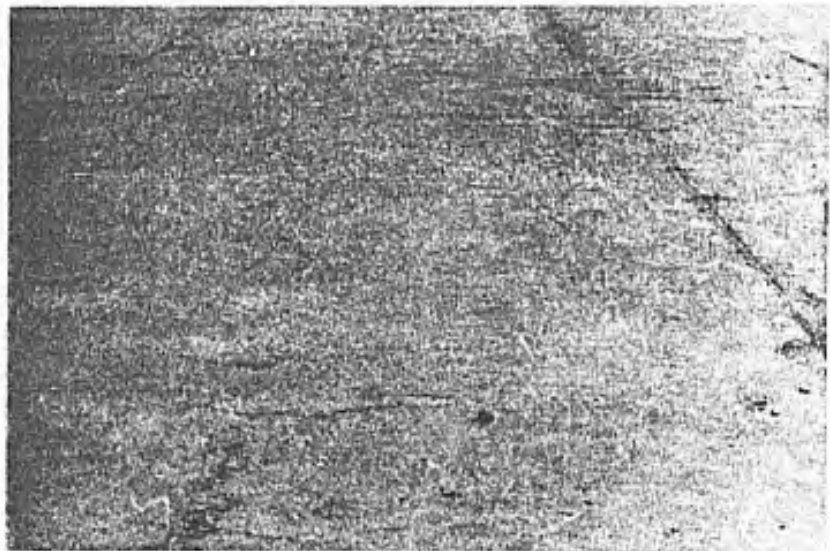
Photo 14. Stabilized Soil after Compaction.

After placement of the stabilized soil, compaction was applied using the tandem vibratory roller. The same roller pattern used on the first lift was used for the second: the front drum operating at the high-force level and the rear drum operating statically, traveling in the forward direction the length of the test item, stopping, and reversing, returning in the same track with both drums operating statically. The roller drums produced bow waves in the stabilized soil in front of each of the drums and created transverse tears in 80 to 90 percent of the length of the roller path. Photo 12 illustrates the transverse tears. During the roller compaction, the edge of the drums produced shoving (lateral movement) in the stabilized material almost the entire length of the roller path, where the roller drums overlapped with the previous roller path (Photo 13). This produced loose material approximately 3/8 inch deep extending approximately 12 inches into the last roller path. Compaction of the stabilized soil with roller in the vibratory mode was stopped after the fourth pass because of a drop in the density of the material between the third and fourth passes of the roller. Dry density determinations with a nuclear moisture-density gage were as follows: 106.6 pcf after two passes, 108.2 pcf after three passes, and 107.7 pcf after four passes. The 107.7 pcf density is 87 percent of the laboratory density shown in Figure 6. The initial four passes were applied with the roller in the vibratory mode and the final pass was in the static mode. The additional compaction effort removed most of the loose material from the surface of the stabilized material (Photo 14). The final pass in the static mode did not remove any of the transverse tears. Photo 15 shows a closeup view of the transverse tears in the surface of the stabilized soil after all roller operations. These tears may have been prevented by using a multiple-wheel rubber-tired roller.

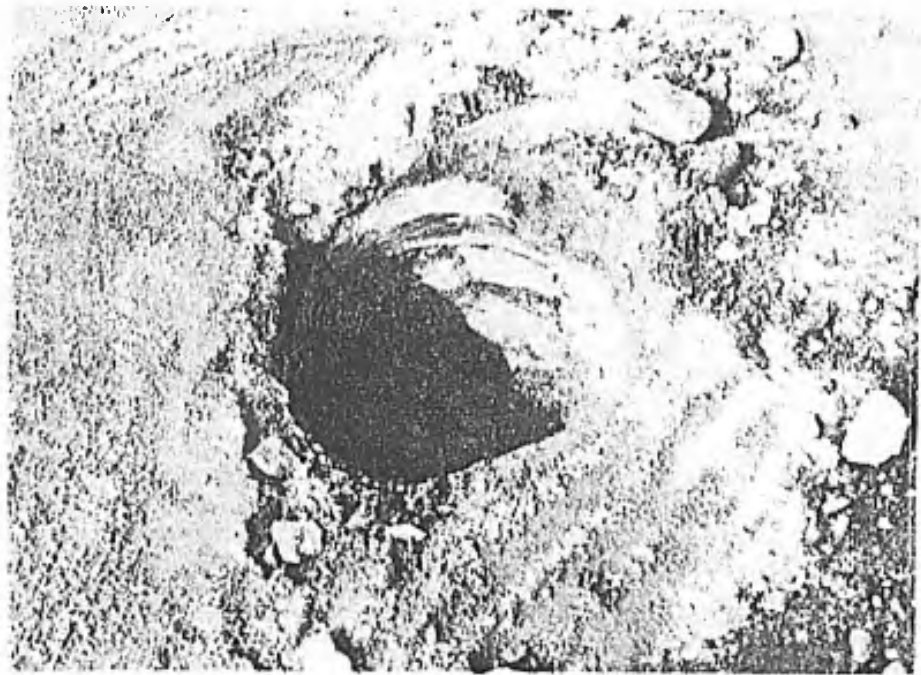
Photo 16. Top Layer (Second Lift) of the Stabilized Soil Through a Core Hole.

The top lift of the stabilized soil was in layers (Photos 16 and 26) and not a single uniform 5- or 6-inch-thick lift as it should have been. This should be considered a construction failure. Jet blast from the F-4 aircraft probably would not have dislodged the stabilized soil at the surface and the breakup or abrasion of the stabilized soil under load cart traffic would have been at a slower rate had the top lift of stabilized soil been in one uniform lift. As stated earlier in this report, the layering was probably caused by the vibratory roller used in compacting the stabilized soil. The F-15 and F-4 load cart traffic showed that the test item as constructed, with the layers, would support 38 and 80 coverages of traffic, respectively. However, the F-4

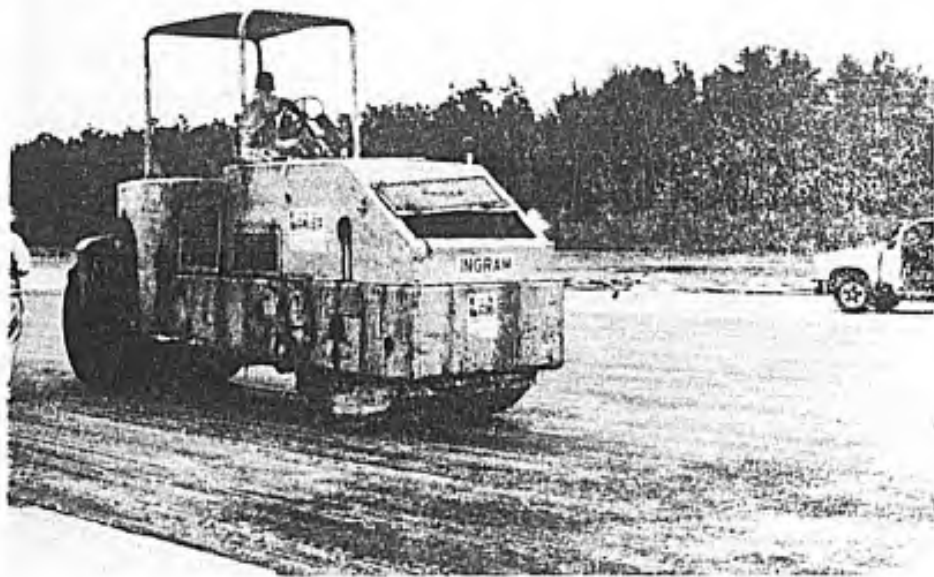
Photo 19. Final Compaction of the AC with a Tandem Steel-Wheel Roller.

The AC was placed with an asphalt finisher placing a 10-foot-wide paving lane. The placement of the AC was started on the north side of the test item at the end of the stabilized soil test item. The AC was tied into the stabilized soil to form a smooth transition between the two test items. The paving contractor placing and supplying the AC used four trucks in transporting the AC from the batch plant to the test item. The AC contained in the four trucks was just enough to place four and one-half paving lanes; five paving lanes were required to complete the test item. There was a 45-minute downtime before AC could be supplied to finish the test item. The temperature of the AC mix at laydown was 290° F. Initial compaction was applied with the 25,000-pound tandem vibratory roller operating statically (Photo 18). The temperature of the AC was 185° F at the start of compaction. Two passes were applied to the AC with the roller in the static mode. An attempt was made to compact one paving lane at the high-force level (33,500 pounds total applied force per drum). This effort produced tears in the AC surface. The force level was reduced to 25,000 pounds per drum. The compaction effort was applied by vibrating while moving forward and operating statically while in reverse. The roller operating at the low-force level reduced the number of tears in the AC. A 20,000-pound tandem steel-wheel roller with 54-inch-wide drums was applied to the AC immediately behind the vibratory roller for final compaction (Photo 19). The tandem steel-wheel roller mended (closed) the tears produced by the vibratory roller. While the compaction operation was under way, placement of the AC (one-half of a paving lane) was completed in the test item. This material was compacted but with extensive tearing.
