AFWAL-TR-86-4031

MODIFICATION OF LUBRICANT TRACTION  
MEASURING DEVICE

Final Report for Period October 1983 - July 1984

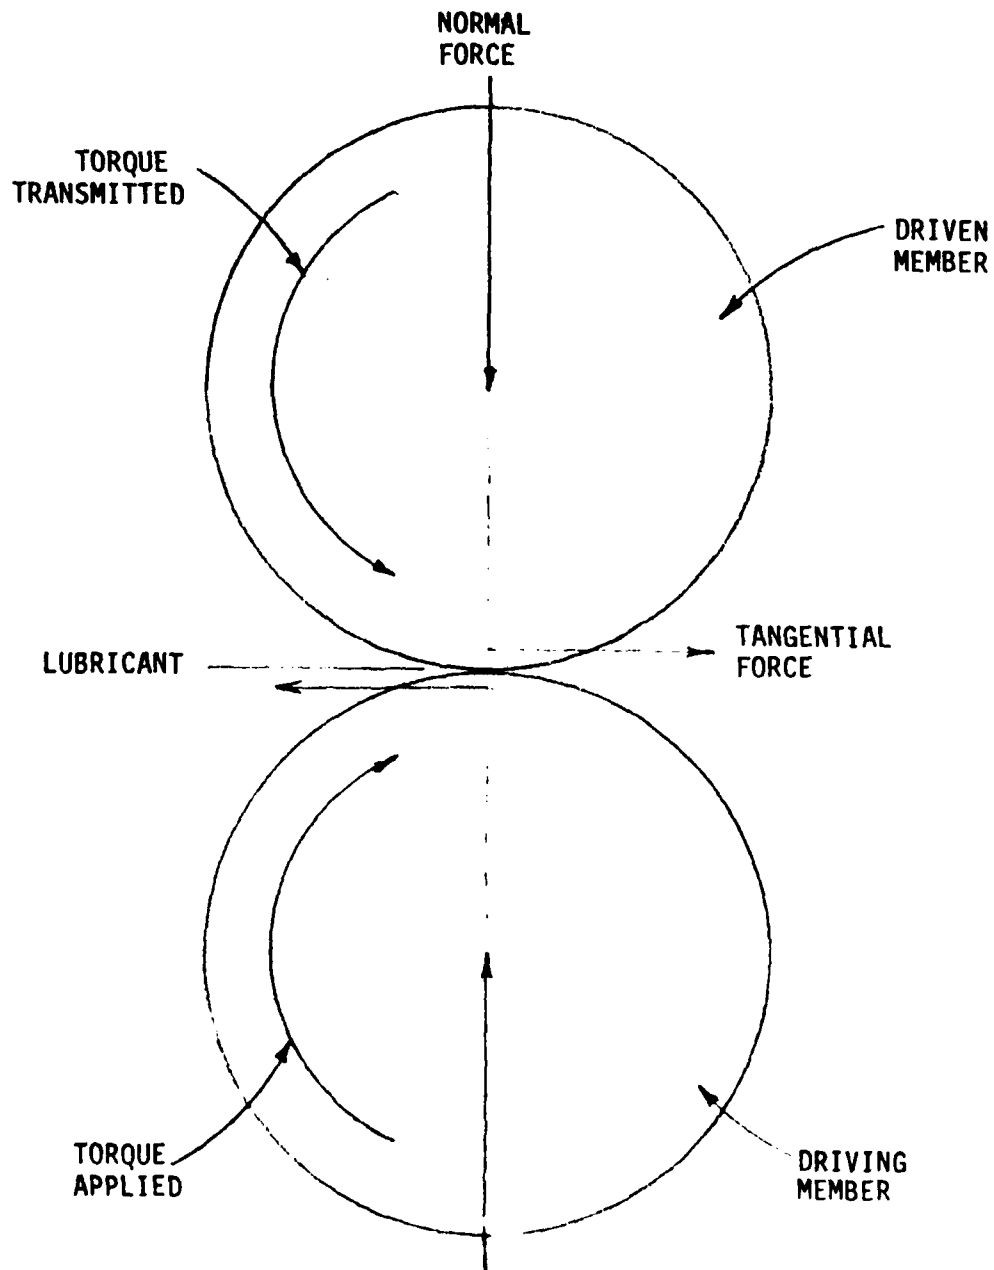
$$\text{TRACTION COEFFICIENT} = \frac{\text{TANGENTIAL FORCE}}{\text{NORMAL FORCE}}$$

Figure 2.1. Simple Two-Disk Design for the Study of Lubricant Characteristics

Traction Rig is designed around the use of two independently driven crowned cylindrical discs to impinging parallel spin axis, as shown schematically in Figure 2.1.

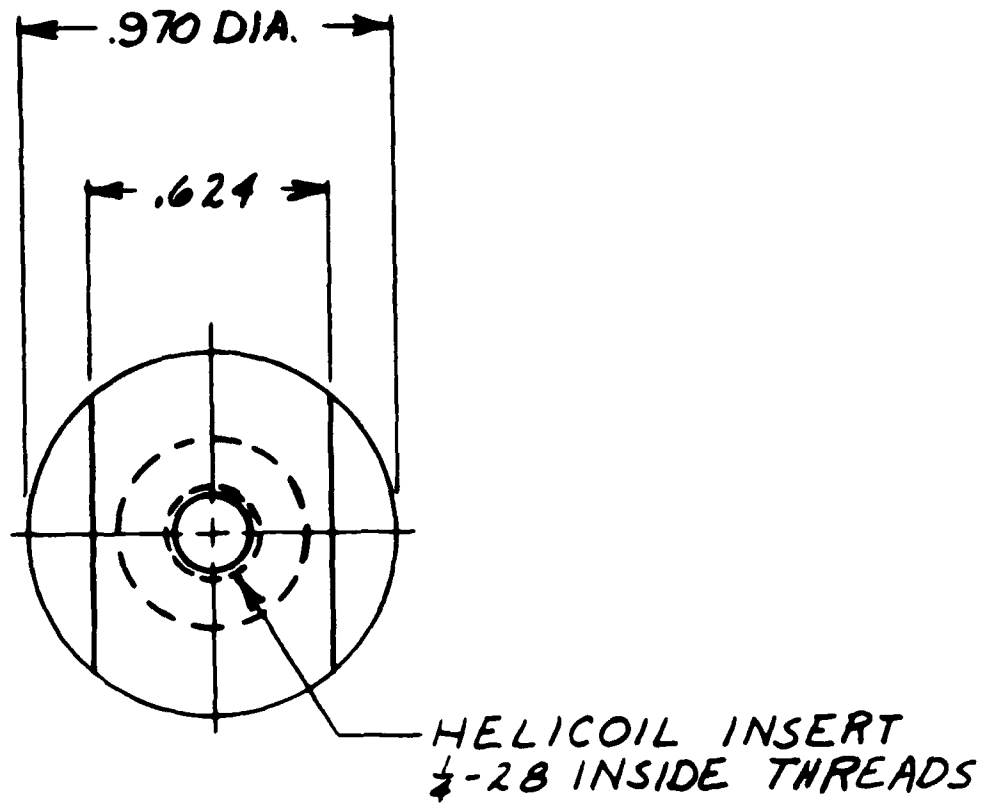
(1) Helicoil threads in the Retaining Nut (Figure 3.3) on the Translating Spindle and Fixed Spindle damage.

MATERIAL - ALUMINUM

Figure 3.3. Test Disc Retaining Nut, Original.

(1) Helicoil threads in the retaining nut on the translating spindle were damaged due to over tightening, reduced thread engagement and absence of any locking mechanism.

Since no torque wrench was used to tighten the retaining nut, these could have been easily overtorqued. Recommended torque for this helicoil insert (per Helicoil bulletin 1000) is only 30 in-lb. The Tie bolt is made out of 4340 Alloy Steel Rc28-32, for which minimum tensile strength is approximately 120,000 psi (Figure 3.2 and 3.7). Catalog recommended torque for 1/4 - 28 threads for such material is 90 in-lb (see Unbrako Catalog page 9). A gross mismatch between the strengths of tie bolts threads and the retaining nut threads is clearly evident.

The length of the helicoil insert in the retaining nut should have been 1.50 x diameter instead of hardly 1 x diameter as designed.

(2) New retaining nuts were made for both spindles, using 17-4 PH-H1100 stainless steel (Figure 3.4).

(3) We recommend that during mounting of retaining nut onto the spindle, the threads on the tie bolt and retaining nut should be thoroughly cleaned and a drop of Loctite 290 be applied to the tie bolt threads. The retaining nuts should be torqued to 80-90 in-lb.

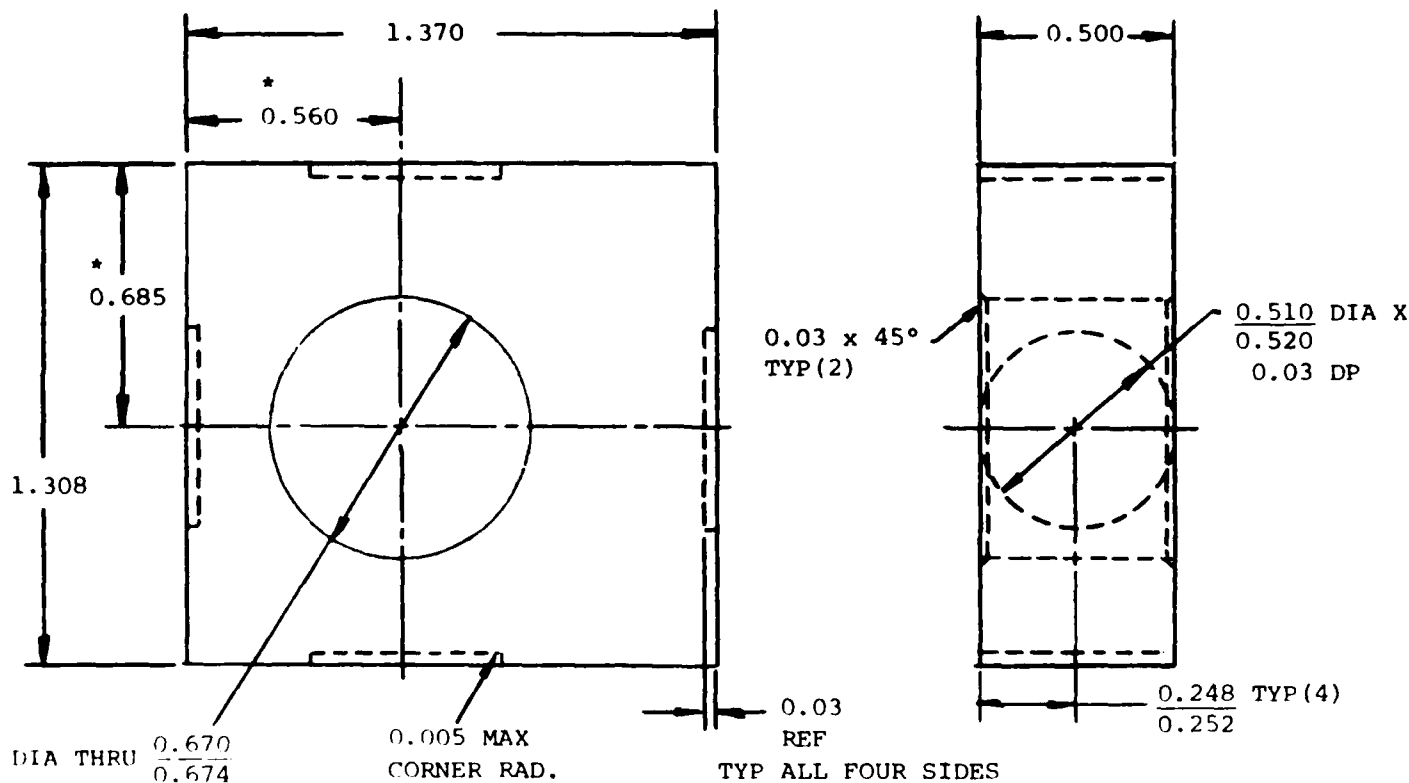
the test blocks. Nonimal gap between the faces of test blocks was 0.130 in (due to the space occupied by disc load cell). Data were taken with spindles' center distances of 1.250 in, 1.375 in and 1.500 in, which was achieved by using '\*' dimensions (Figure 4.7 and 4.8) .560, .623 and .685 respectively on the test blocks facing each other.

- Notes:
1. Scale 2X
  2. All Dimensions in Inches
  3. Material SST
  4. All sides Parallel to  $\frac{0.670}{0.674}$  Dia Within 0.002.
  5. Surface Finish 63  $\mu$ in all over

Figure 4.7. Test Block (Fixed Spindle).
