NSWC TR 86-412

CORROSION BEHAVIOR OF P/M MECHANICALLY ALLOYED IN-9052.I, AN ELECTRO-CHEMICAL INVESTIGATION

BY P. A. STONE J. F. McINTYRE R. K. GARRETT

1 DECEMBER 1986

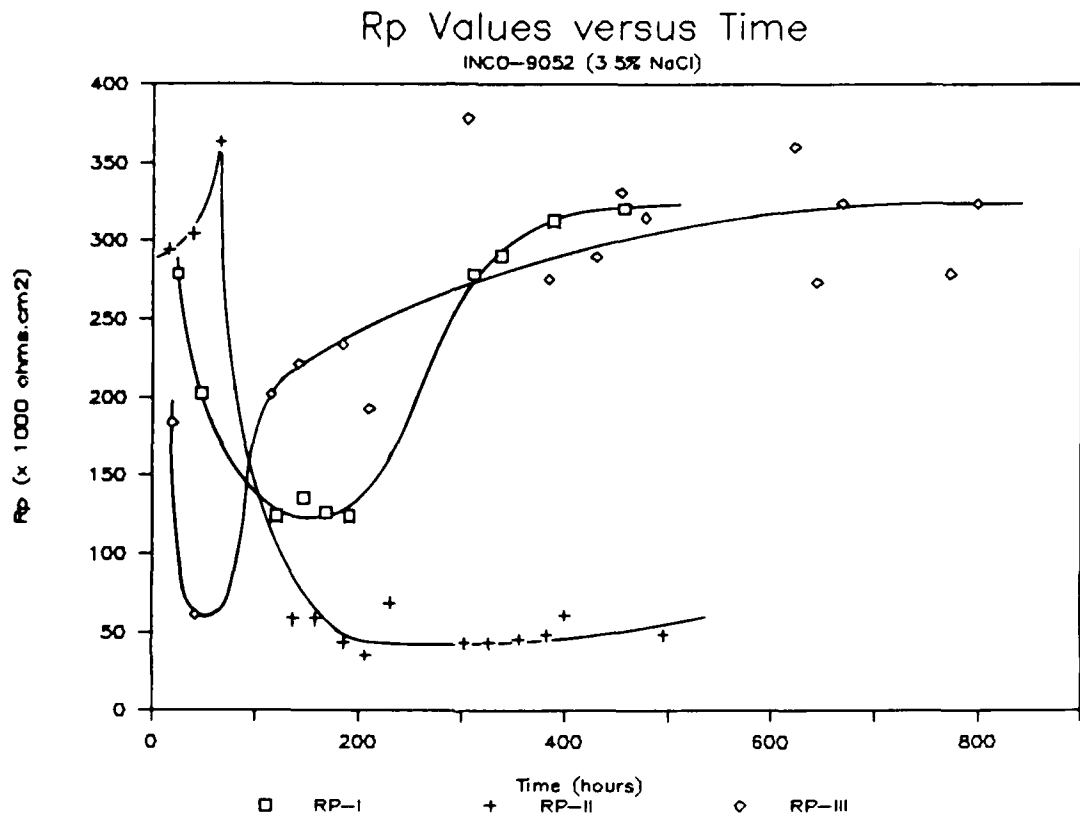
FIGURE 6. Rp - TIME PLOTS FOR IN-9052 EXPOSED TO 3.5% NaCl

The uniform corrosion of IN-9052 and AA-6061 exhibited different behavior. (See Figures 6-7.) The corrosion rate for IN-9052 increased with time at early stages of corrosion and then decreased to a final "steady-state" corrosion rate.* (See Figure 6.) On the other hand, the corrosion rate of AA-6061 decreased initially; however, at later times the corrosion rate accelerated, and eventually reached a "steady-state" value. (See Figure 7.) The steady-state corrosion rate for IN-9052 was lower than the steady-state rate for AA-6061 as shown by R_p values of 14,000 ohms.cm² and 15,000 ohms.cm² respectively.

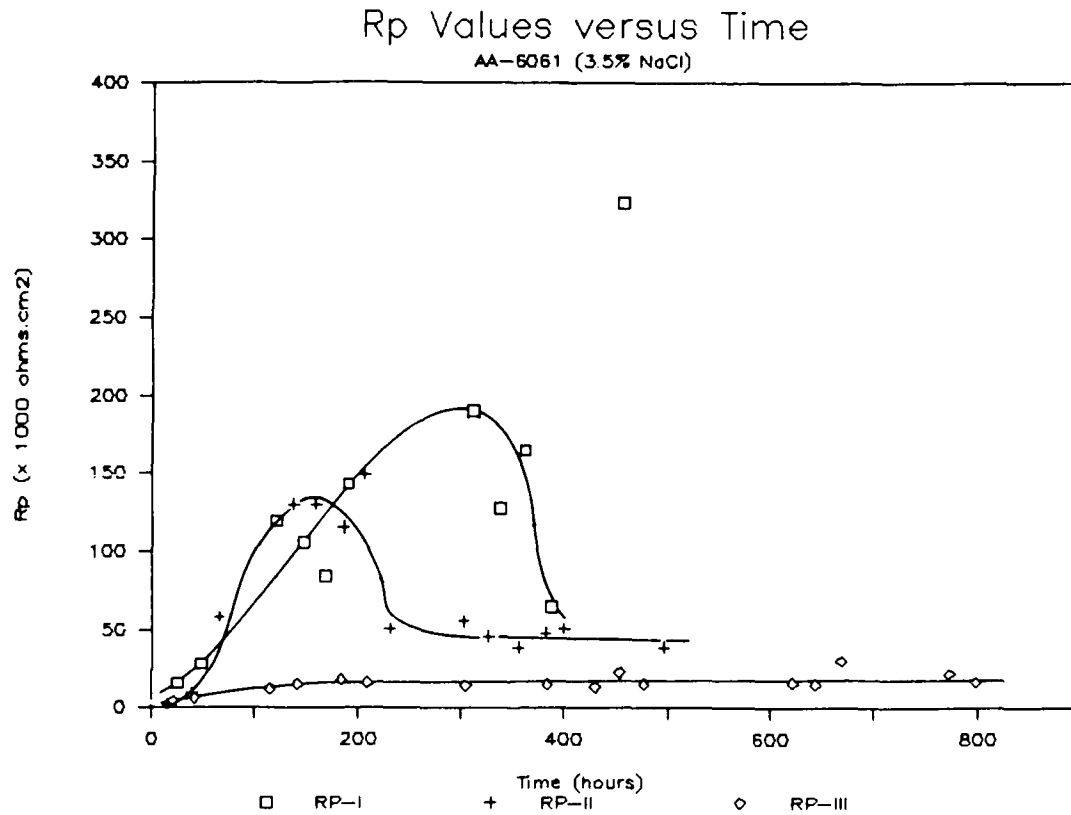
FIGURE 7. Rp - TIME PLOTS FOR AA-6061 EXPOSED TO 3.5% NaCl

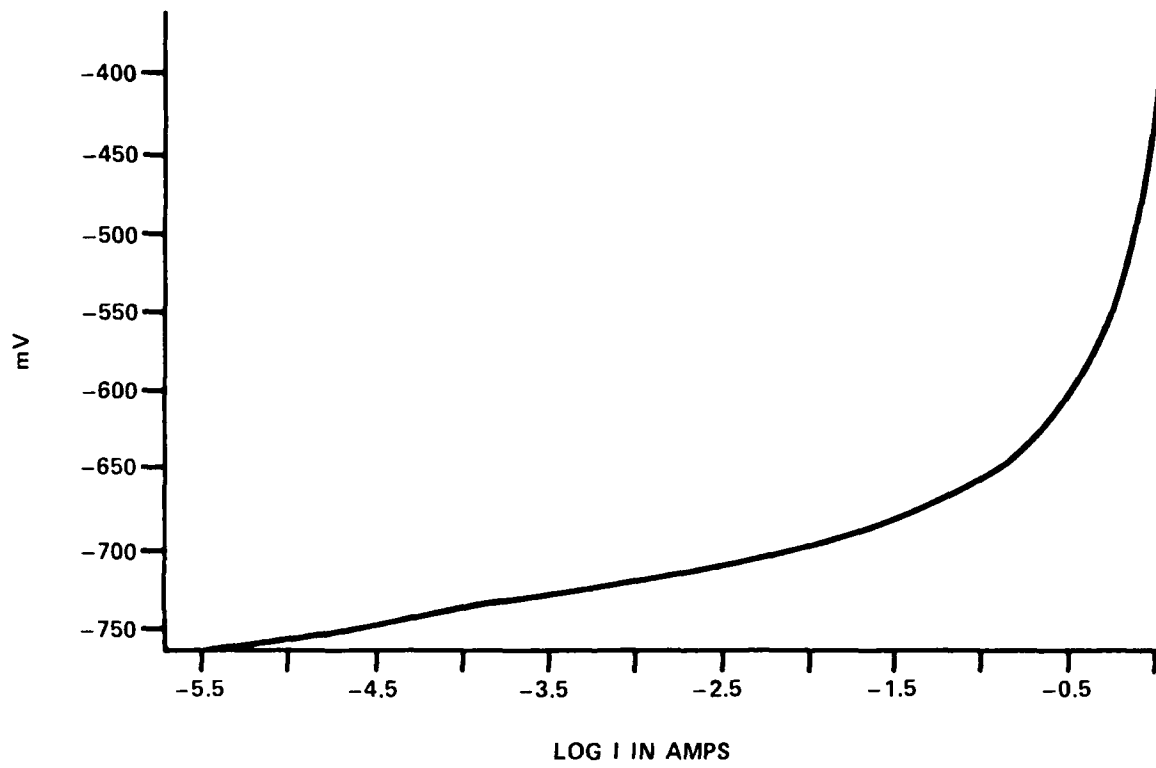
FIGURE 9. POTENTIODYNAMIC ANODIC POLARIZATION CURVE FOR AA-6061 EXPOSED TO 3.5% NaCl

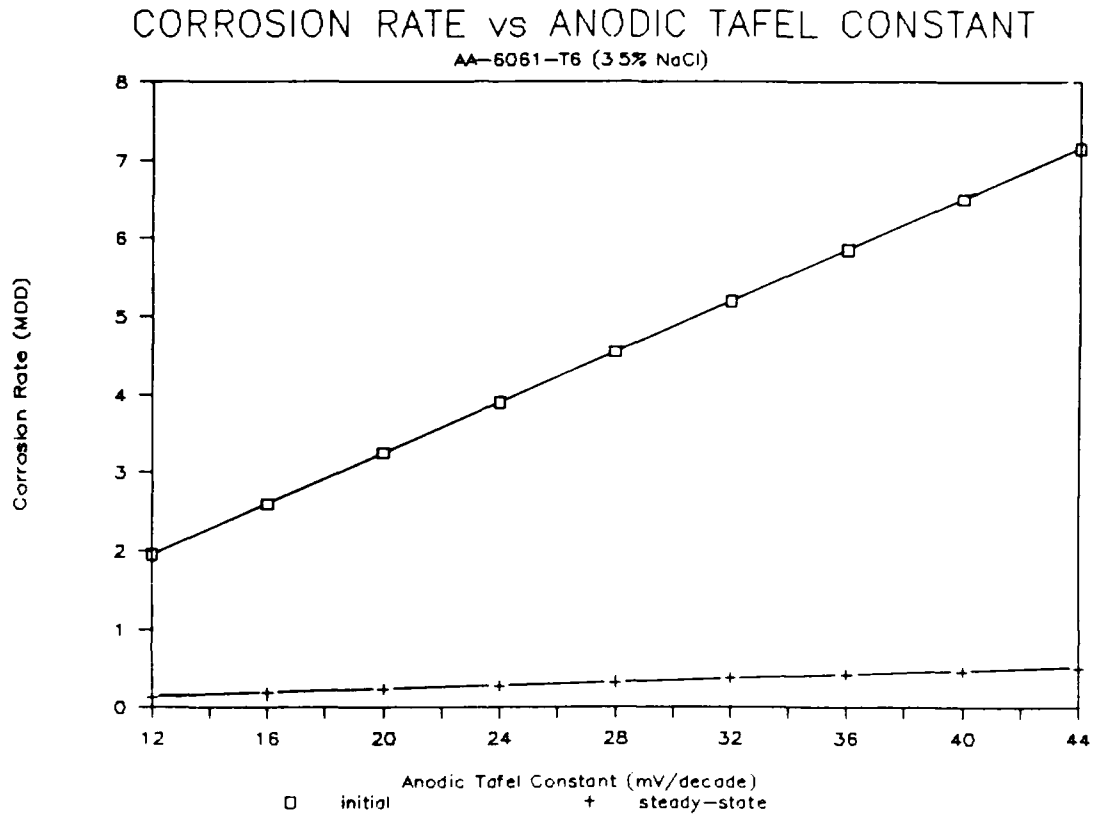
FIGURE 11. CORROSION RATE - ANODIC TAFEL CONSTANT PLOT FOR AA-6061 EXPOSED TO 3.5% NaCl

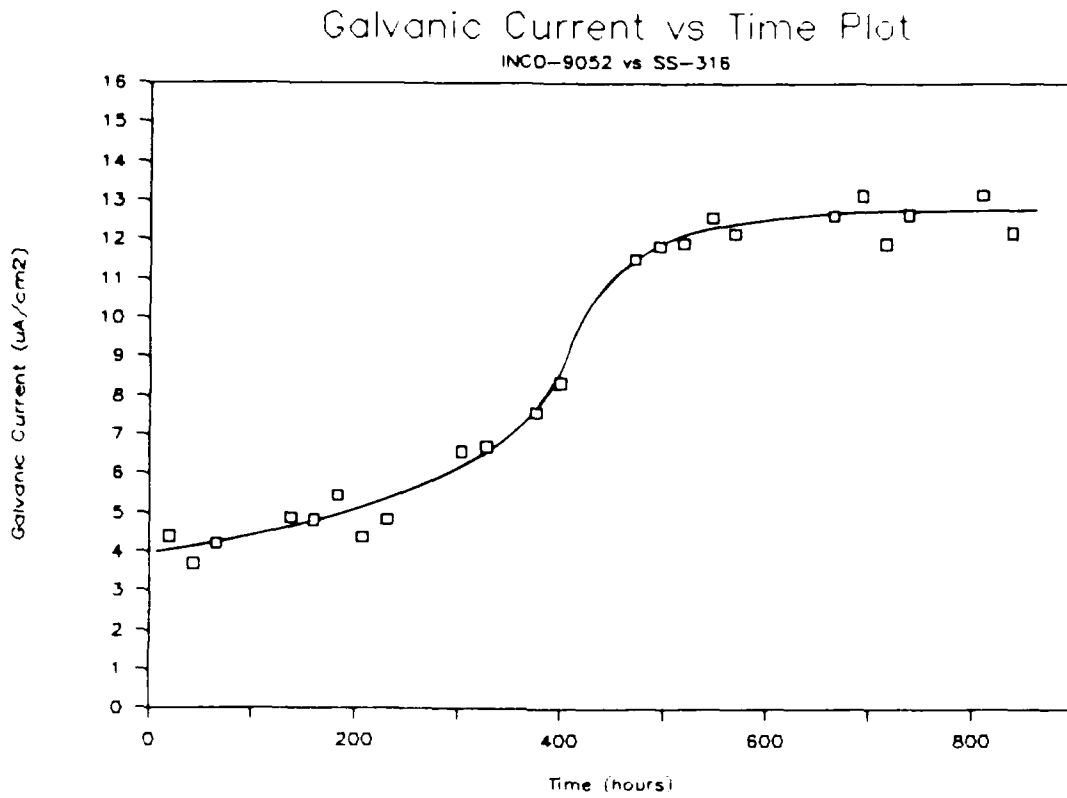
FIGURE 14. GALVANIC CURRENT DENSITY - TIME PLOT FOR A IN-9052/SS-316 COUPLE EXPOSED TO 3.5% NaCl

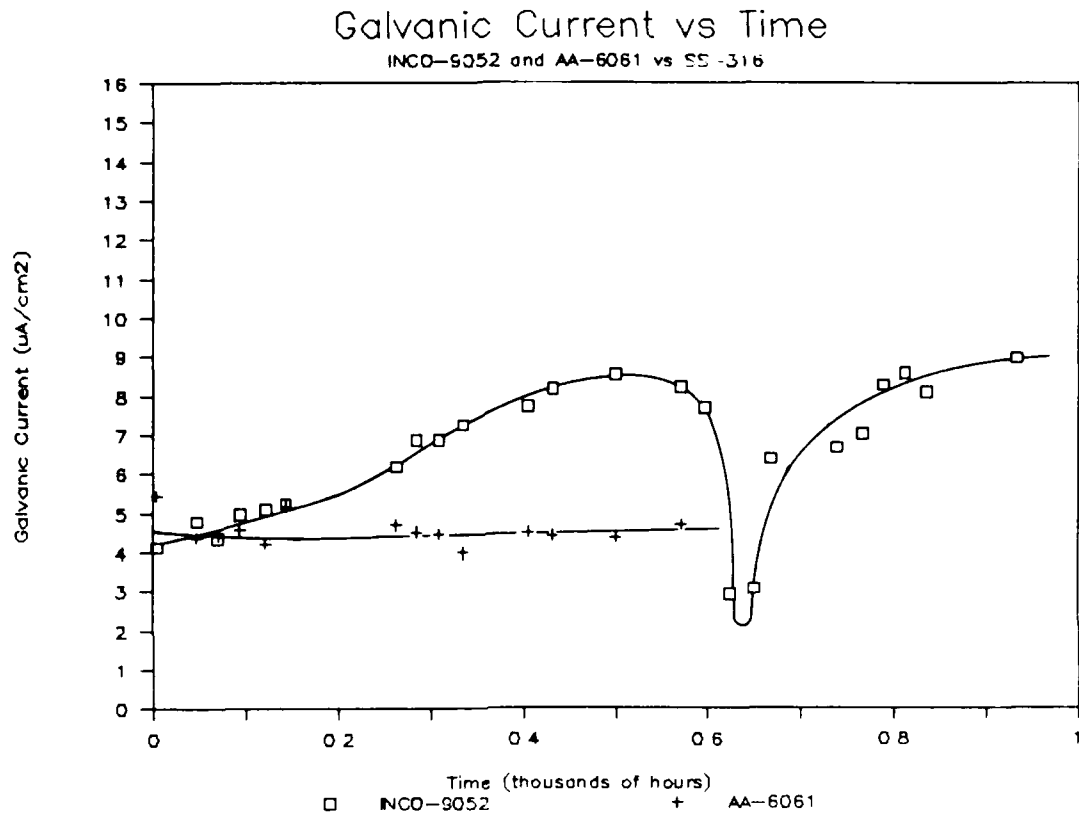
FIGURE 15. GALVANIC CURRENT DENSITY - TIME PLOT FOR IN-9052/SS-316 AND AA-6061/SS-316 COUPLES EXPOSED TO 3.5% NaCl

In comparison, the galvanic current for SS-316/AA-6061 was small and remained constant for the duration of the test period. (See Figure 15.) AA-6061 exhibited only localized pitting with the build-up of some corrosion products. In fact, the galvanic corrosion rates at initial times and final times were nearly the same. (See Table 2.) Predicted corrosion rates were slightly lower than observed for coupled IN-9052 but values were also two orders of magnitude higher than observed for uncoupled AA-6061. This indicated that galvanic corrosion may be slightly greater for IN-9052 when coupled to SS-316 but both galvanic couples gave corrosion rates that were at least two orders of magnitude higher than observed for uncoupled IN-9052 or AA-6061. It might be argued that crevice interaction for the IN-9052/SS-316 couple contributed to the observed higher corrosion rates for IN-9052 compared to those predicted for AA-6061.

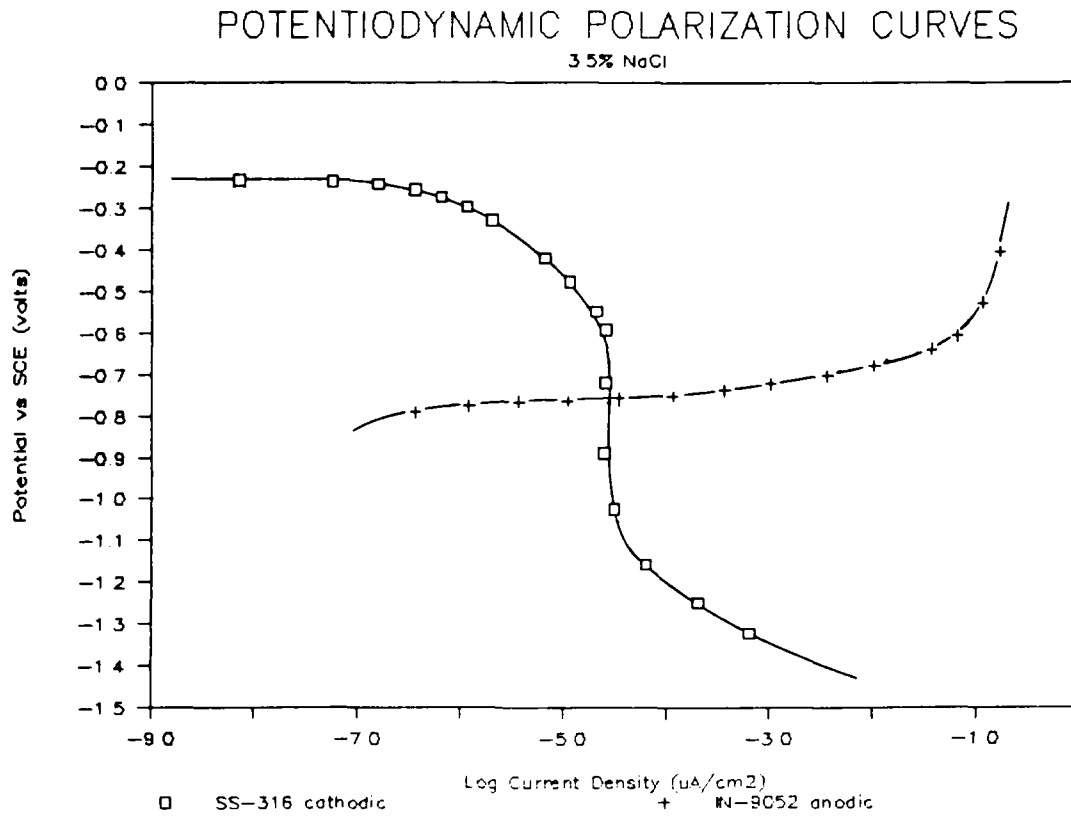
FIGURE 16. OVERLAY OF ANODIC POLARIZATION CURVE OF IN-9052 AND CATHODIC POLARIZATION CURVE OF SS-316, EXPOSURE TO 3.5% NaCl

Because a small SS-316 surface area was used, the generated galvanic currents were small. For example, if equivalent surface areas had been studied, the initial galvanic current densities would have been about 25.1 and 28.2 $\mu\text{A}/\text{cm}^2$ for SS-316/IN-9052 and SS-316/AA-6061 respectively. The initial galvanic currents were obtained from the overlay of the cathodic polarization curve for SS-316 and the anodic polarization curves for AA-6061 and IN-9052, the intersection of these curves was taken to be equivalent to the initial galvanic current densities. (See Figures 16-17.)

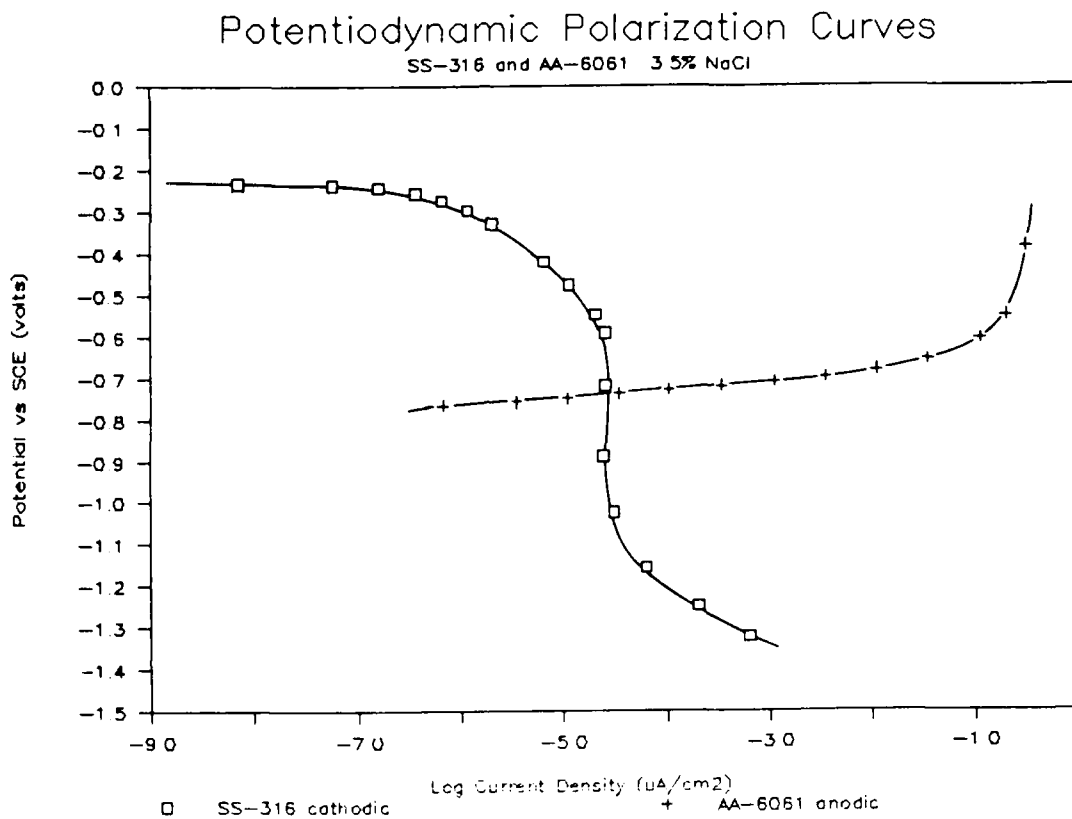
FIGURE 17. OVERLAY OF ANODIC POLARIZATION CURVE OF AA-6061 AND CATHODIC POLARIZATION CURVE OF SS-316, EXPOSURE TO 3.5% NaCl

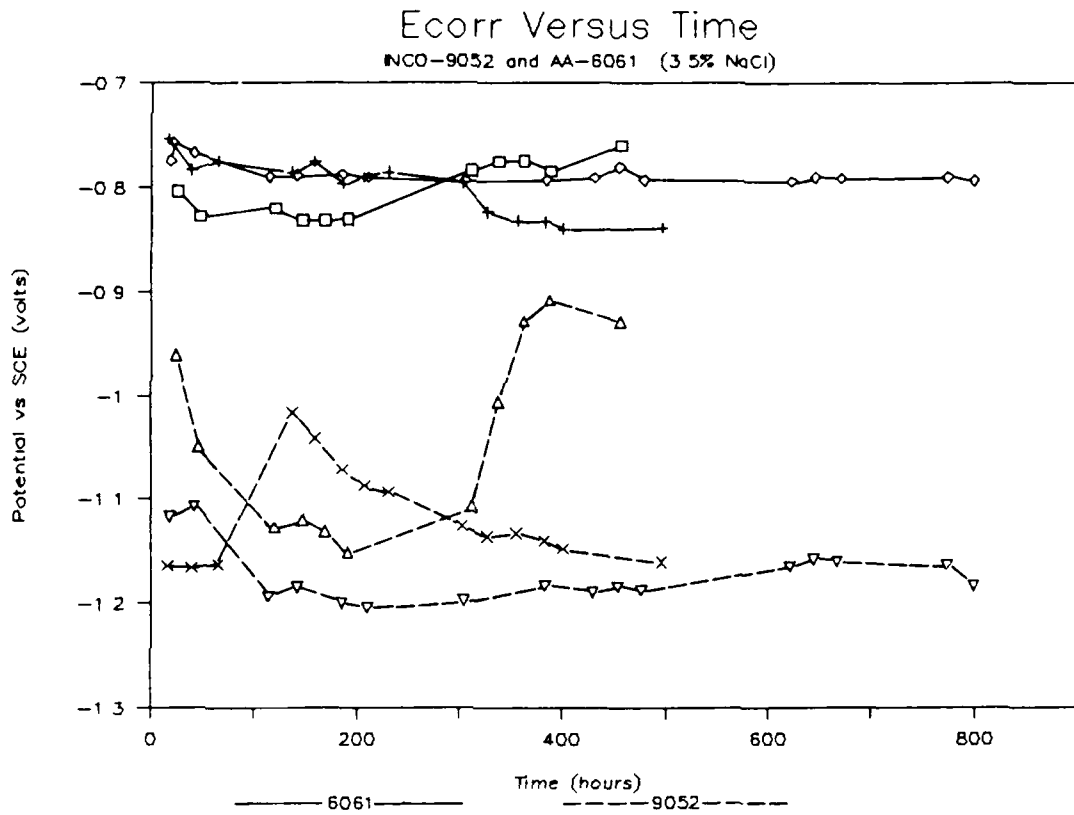
FIGURE 18. E_{corr} - TIME PLOTS FOR IN-9052 AND AA-6061, EXPOSURE TO 3.5% NaCl
