TECHNICAL REPORT GL-87-18

# COST-EFFECTIVE SURFACING FOR TRACKED-VEHICLE TRAFFIC

Geotechnical Laboratory

August 1987

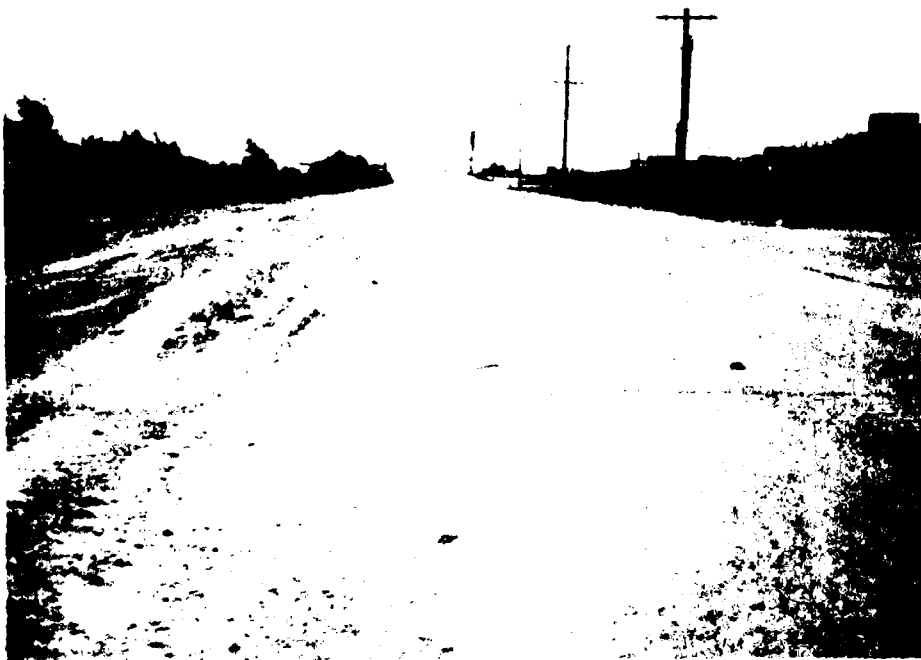
Photo 2. Rounded pavement edge caused by tracked-vehicle traffic, Fort Hood

6. Intersections and along pavement edges were the problem areas for tracked vehicles on pavements. Wherever a tracked vehicle had turned, problems with scuffing or shoving occurred. Tracked vehicles, because of their width and speed, normally travel with their inside track on the middle of the traffic lane and the outside track on the shoulder or gutter causing distress to these structures (Photo 1). This traffic caused the outer edge of the pavement to wear faster than other areas, resulting over a period of time in the edge rounding (Photo 2).

12. Fort Hood had many PCC and asphalt concrete pavements that appeared to be in good condition except for the edges rounding off (Photo 2). This was

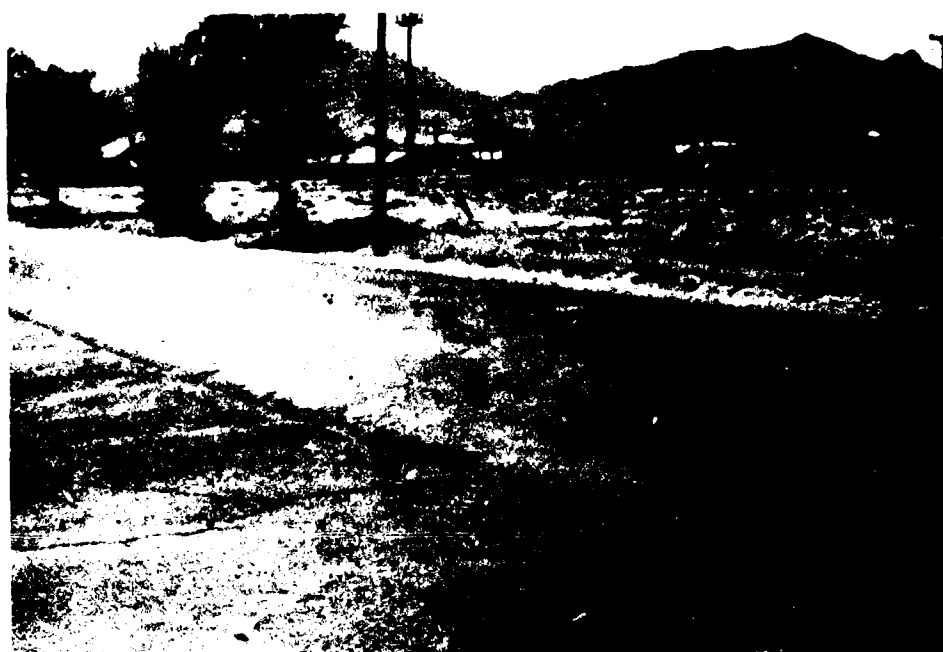
Photo 5. Pavement damaged by turning tracked vehicles

10. The asphalt pavement distresses found at Fort Bliss were similar to those found throughout this study. The major damage to asphalt pavements occurred at intersections or in areas where turns were made (Photo 5). At Fort Bliss, this problem was being solved by replacing the damaged asphalt pavement with reinforced PCC (Photo 6). The straight sections of asphalt pavements were generally in good shape except for some slight corrugation (Photo 7). On roads with a curb-and-gutter system, the tanks rode in the gutter or on the curb and caused severe damage to both (Photo 8).

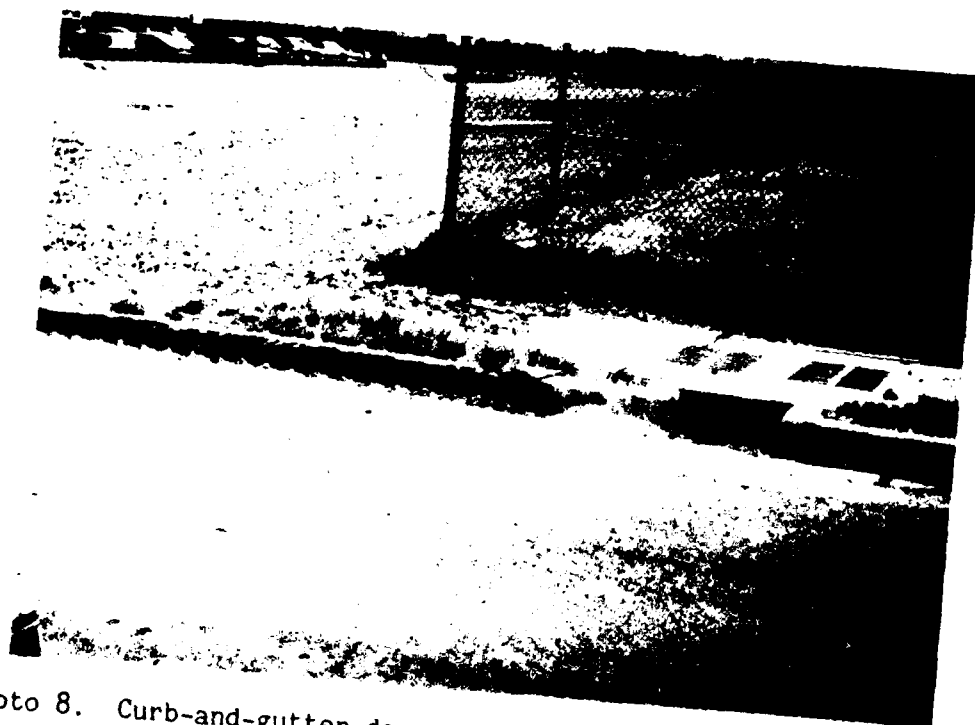
Photo 8. Curb-and-gutter damage caused by tracked-vehicle traffic

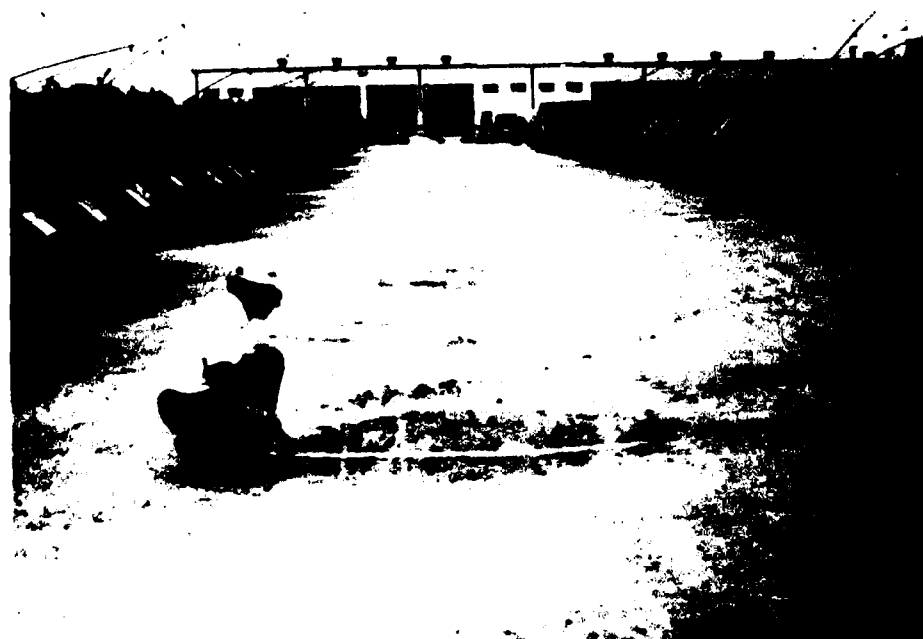
Photo 10. Parking area damaged by fuel spills

caused by the tracked vehicles running on the shoulder and the edge of the pavement. The PCC pavements are more difficult to repair and Fort Hood is currently seeking to replace the pavements with asphalt pavements to simplify repairs when they become necessary. Fort Hood also had many PCC pavement sections at tank crossings on asphalt roads. A problem had been encountered over the years as the asphalt pavement was overlaid, resulting in the formation of a dip at the PCC crossing (Photo 9). These dips had become severe. To alleviate this situation, concrete ramps were built up to these crossings and asphalt pavement was placed continuously throughout the road. These concrete ramps solved the major problem in crossing asphalt pavements--edge cracking. Fort Hood was increasing the use of asphalt concrete, which should have increased the amount of maintenance required while simplifying the repairs. Fort Hood had several parking and loading areas overlaid with asphalt pavement. These areas had received repeated fuel spills and had experienced damage from traffic (Photo 10).

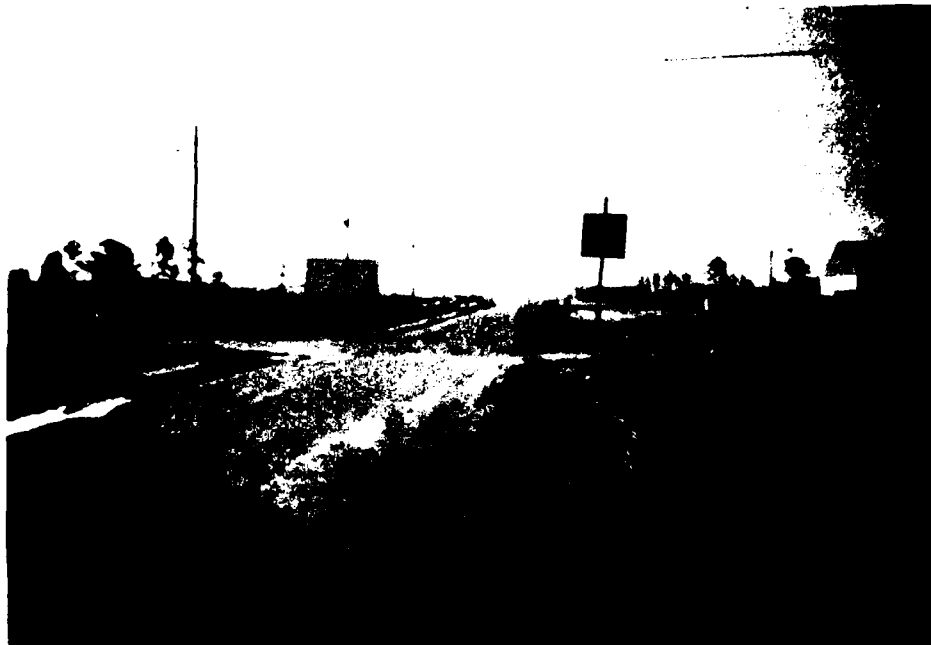
Photo 11. Damage to road and shoulders caused by tracked-vehicle traffic

14. The survey of the pavements at Fort Stewart revealed distress similar to that observed at the other locations visited. Damage had occurred most frequently at intersections or wherever turns were made. Also, damage had occurred at the road edge, shoulders or gutters, or where there was heavy tank traffic (Photo 11).

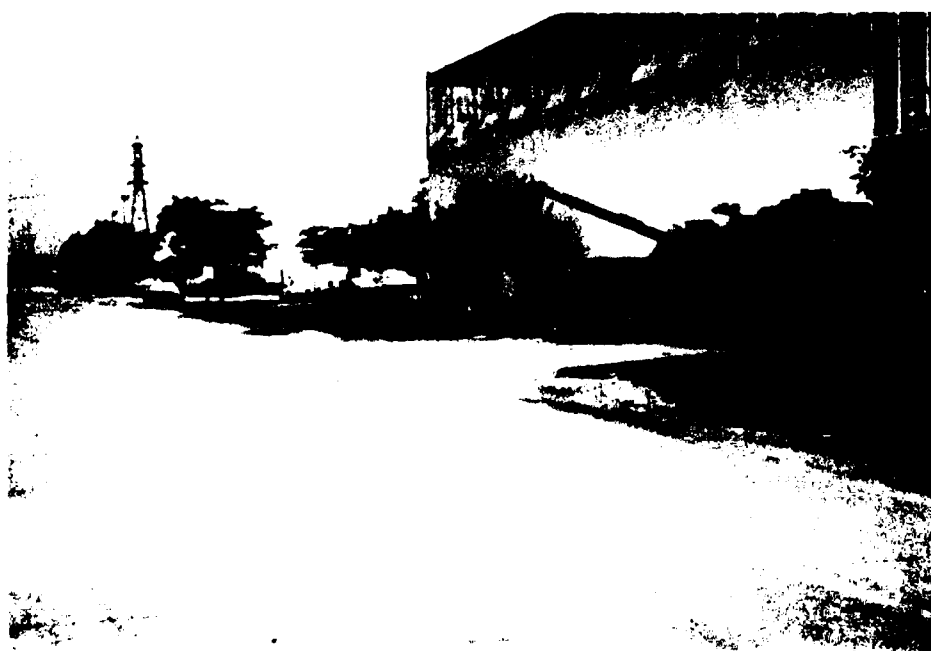
Photo 14. Surface scuffing from turning tracked vehicles

16. The pavement was in good condition with only a few surface defects (Photo 13). There was some surface scuffing where tracked vehicles had turned (Photo 14). This asphalt pavement was placed over PCC pavement and the underlying contraction joints had reflected through (Photo 15). These cracks were small and had not raveled. During construction, a problem was encountered with the slag aggregate in that the specific gravity of the slag varied so much that it was difficult to maintain the proper void content in the mix.

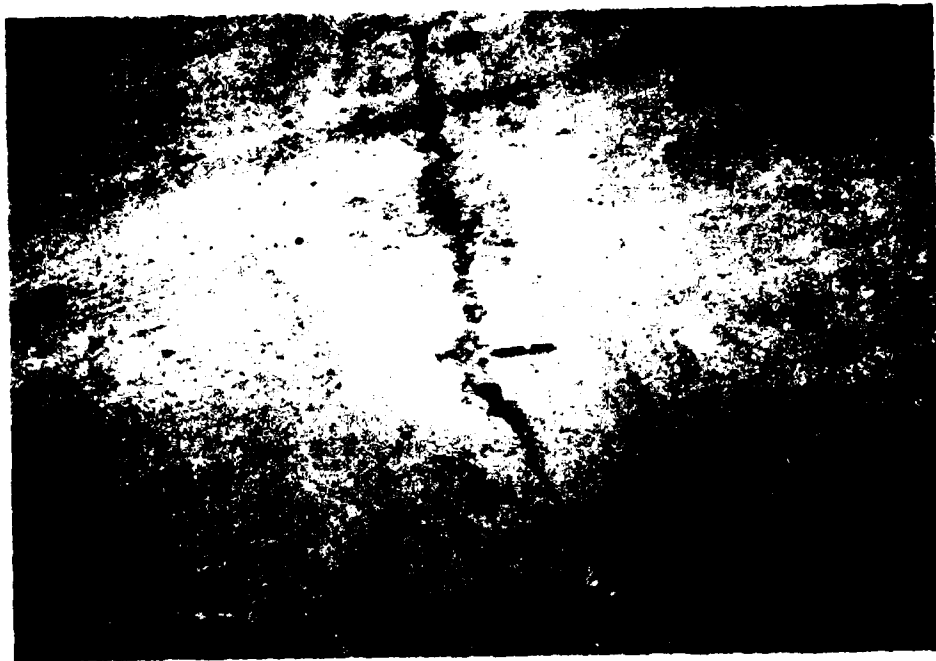
Photo 41. Shrinkage crack, Item I

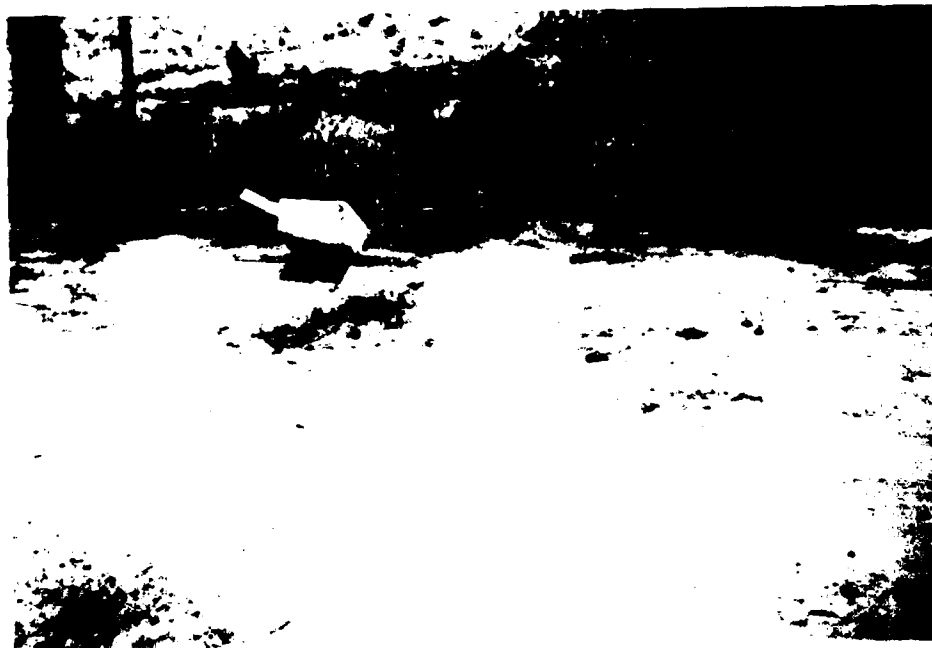
Photo 42. Shrinkage crack, Item J

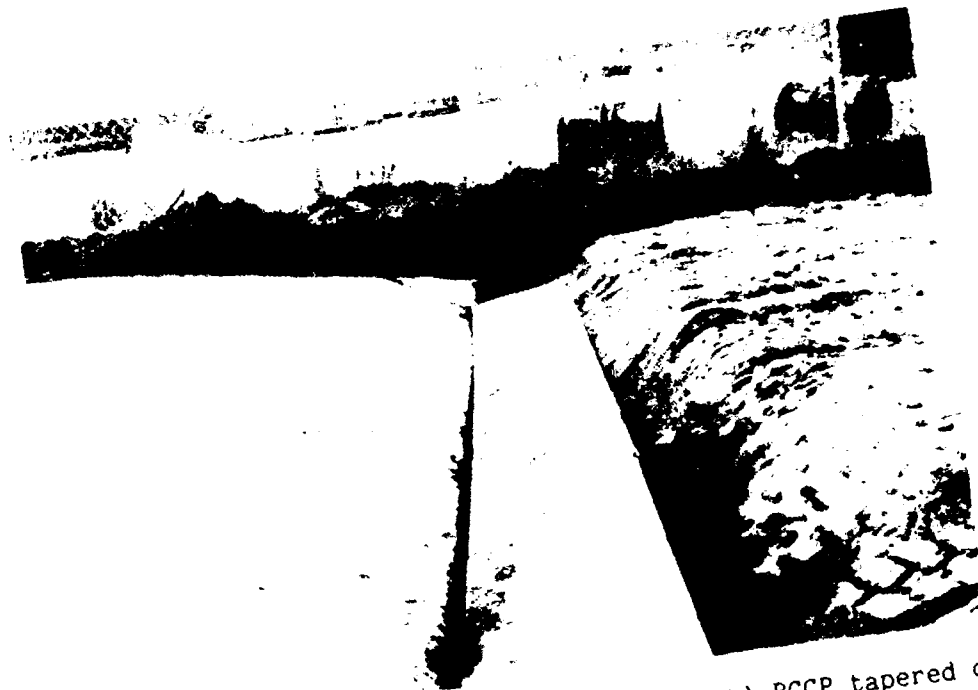
Photo 43. Thickened edge along Item K (right) RCCP tapered out for about 5 ft over the conventional concrete (board was removed before RCCP was placed)

44. Construction. Item K was placed in an area approximately 24 by 25 ft, in one 4-in.-thick layer, between Item J and an existing conventional PCC pavement. The climate during placement was ideal, consisting of cool temperatures, high humidity, and overcast skies. The concrete was placed directly onto the wetted base from the transit mixers and spread with a Gradall. As with Item J, the transition from the 6-in.-thick Item J to this 4-in.-thick item was made within a transition of 5 ft. The RCCP was also placed with two paving lanes alternately developed to allow for better equipment use in a confined area. The end of the RCCP adjoining the existing PCC pavement was tapered on top of the sloped end of the existing pavement for approximately 5 ft to form a continuous road surface (Photo 43). Approximately 1-1/2 gal of

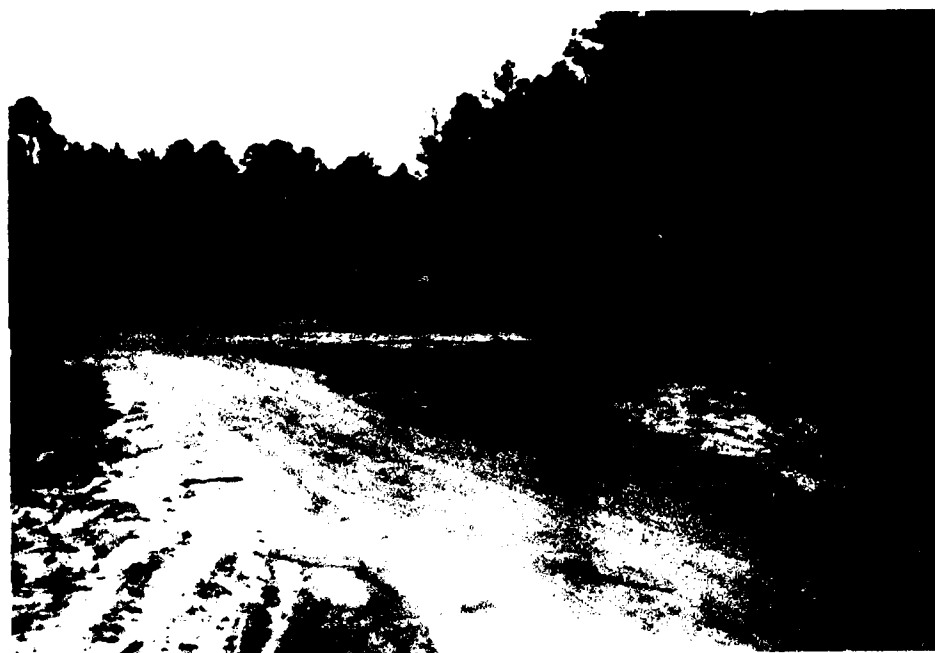
Photo 67. Dirt covering, from foreground to background  
(2 to 3 in.), Items L, H, G, and F

75. The effects of traffic on the test section, especially Items F, G, H, and L, have been tempered because of the amount of soil that has been dumped and washed onto these items. Because of the improper grading of the shoulders, an average of 2 to 3 in. of soil covers most of these items (Photo 67). Although this soil protects the pavement surface, it also allows the soil to be carried onto maintenance areas, requiring additional cleaning.
