# Special Report 87-16

Cold Regions Research &  
Engineering Laboratory

## *Evaluation of the Shasta waterless system as a remote site sanitation facility*

C. James Martel

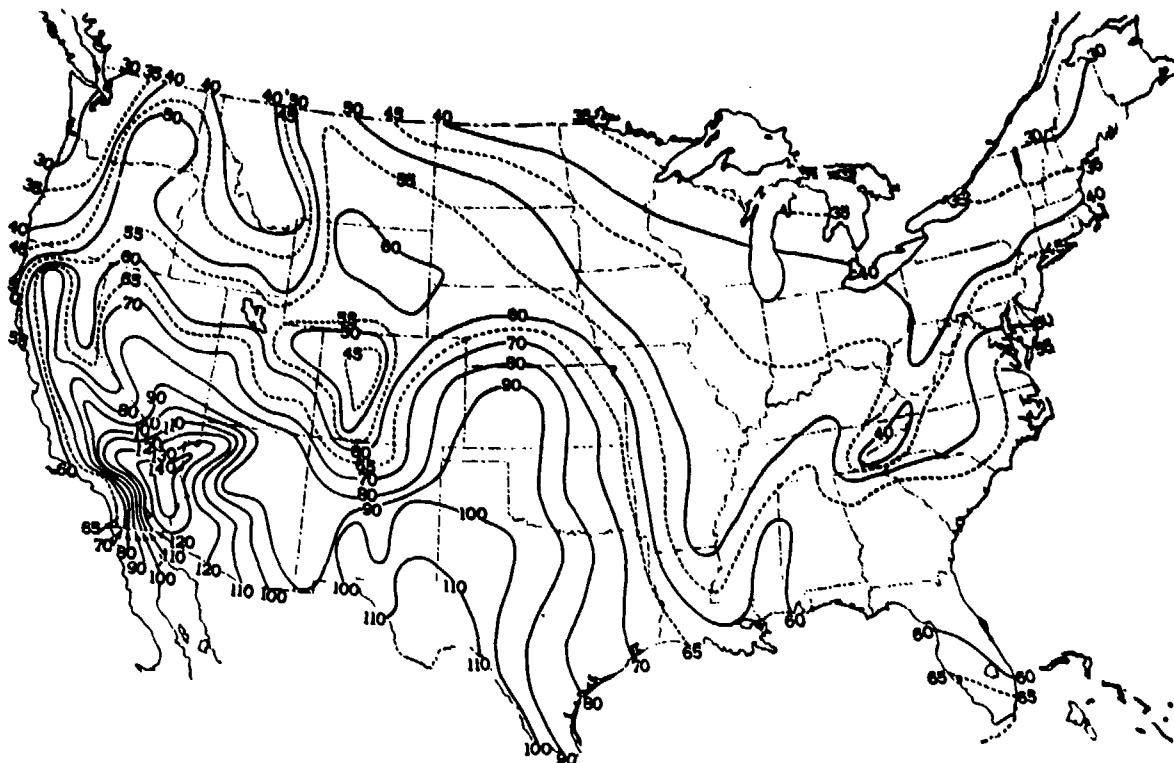
Figure 7. Normal annual Class A pan evaporation in inches (Linsley et al. 1958).

evaporation is measured daily. Isolines of mean annual pan evaporation in the U.S. are shown in Figure 7.

For design purposes it may be possible to estimate a value of  $E$  based on the average annual pan evaporation at the intended site. This approach has been used to estimate lake evaporation. A commonly accepted pan coefficient for lake evaporation is 0.70. For example, the estimated lake evaporation is 21 in. for a site where the average annual pan evaporation is 30 in. The pan coefficient for tank evaporation should be less than for lake evaporation because the liquid surface in the holding tank is shaded and below ground level, a condition which is not conducive to evaporation. Even with a vent fan it is doubtful that air movement over the surface will equal that of an average wind over an open lake. More research is needed to determine this coefficient before this sizing procedure can be implemented.

From Figure 7 the mean annual pan evaporation rate in the Ft. Drum area is approximately 35 in. Based on previous discussions the pan coefficient for tank evaporation is estimated to be 0.50. Therefore, the E value for Ft. Drum will be 17.5 in. (1.45 ft). Substituting this E value in eq 3, 4 and 5,
